Hazardous Building Material Survey Report

MULTNOMAH COUNTY

Wikman Juvenile/MCCAA Weatherization

Property # 465

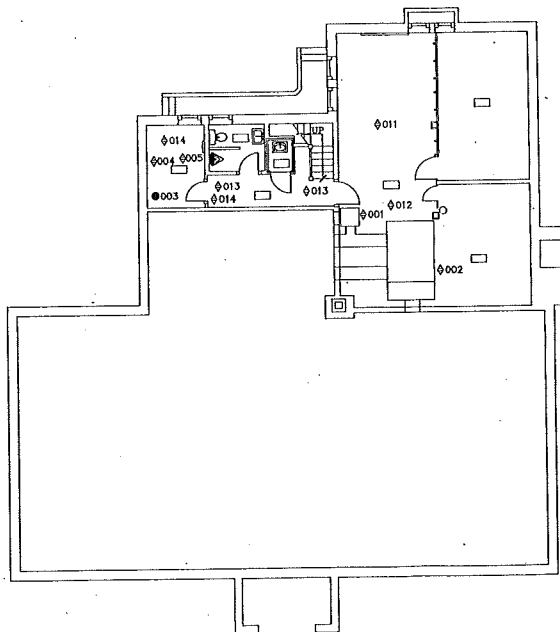
1 BASEMENT
1/16" = 1'-0"

| DRAWING REFERENCE | FIELD CODE | LAB RESULT | MATERIAL SAMPLED |
|---|---|---|---|
| 0003 | 15194.045-003 | (+) | FELT LA |

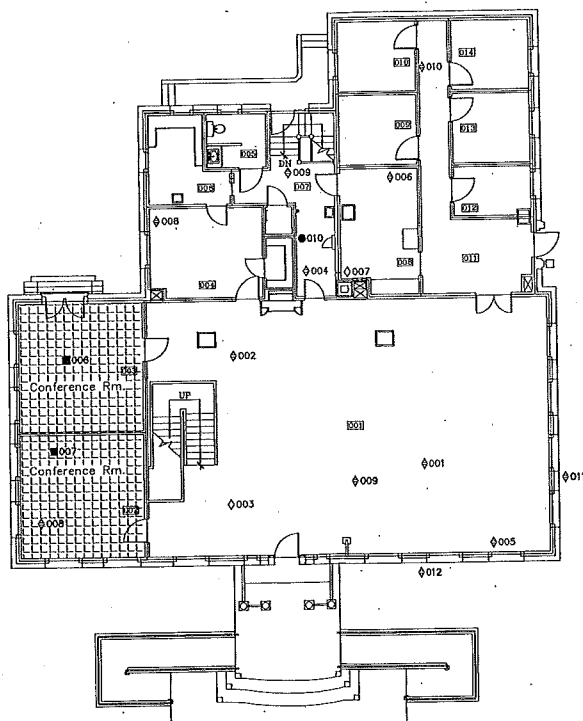
1 FIRST FLOOR
1/8" = 1'-0"

ASBESTOS-CONTAINING TEXTURED CEILING MATERIAL

| DRAWING REFERENCE | FIELD CODE | LAB RESULT | MA SA |
|---|---|---|---|
| 006 | 15194.045-006 | (+) | TI |
| 007 | 15194.045-007 | (+) | TI |

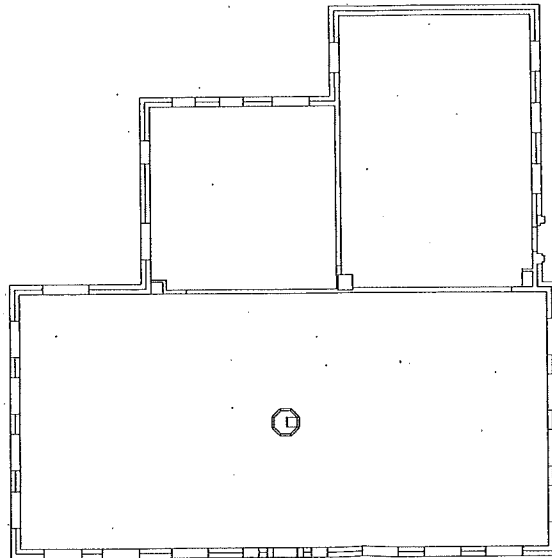
1. ROOFING MATERIALS LOCATED ON THIS STRUCTURE PRESUMED TO CONTAIN ASBESTOS.
