PORTLAND

PROJECT NAME:	Transition Center for Women	PROJECT #:	OR12-081
FIELD REPORT:	Basement Assessment	ISSUE DATE:	3-20-12

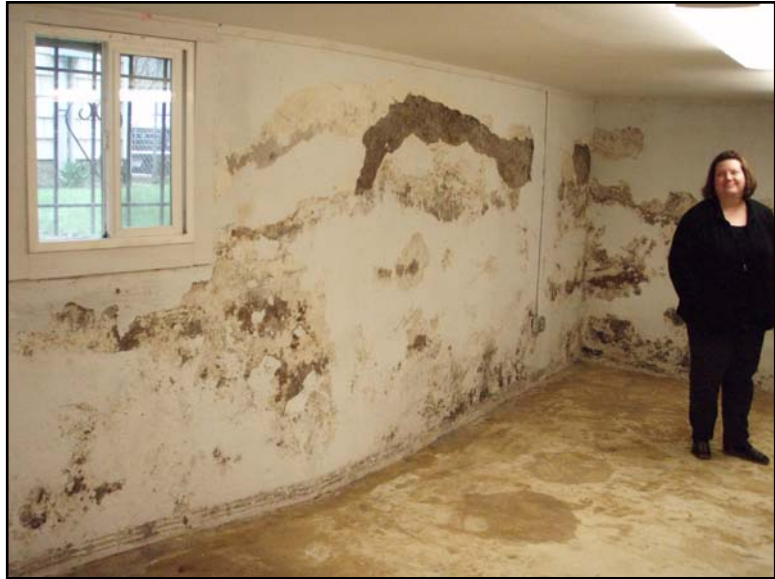
That being said, even this imperfect concrete maintains a 1500 psi compression strength and, at six inches thick, is more than capable of supporting the dead and live loads of the houses. Several large areas along the east basement wall of 722 NE Couch show reduced wall thickness due to mold abatement efforts. The remaining wall thickness appeared to be roughly 5 inches and still does not represent a structural problem. However, these areas should be patched with repair mortar (e.g. Ardex B20) to restore the wall’s appearance and original structural strength, as to well as prevent any further reduction.

- 1.01 The east basement wall of 722 NE Couch has been remediated for mold. Large areas of concrete on this wall have been removed, exposing voids, “rock pockets”, and reducing the effective wall thickness.

The walls should be repaired by a skilled contractor, using Ardex B20 or a similar product to patch the damaged areas, and epoxy injections to fill structural cracks.

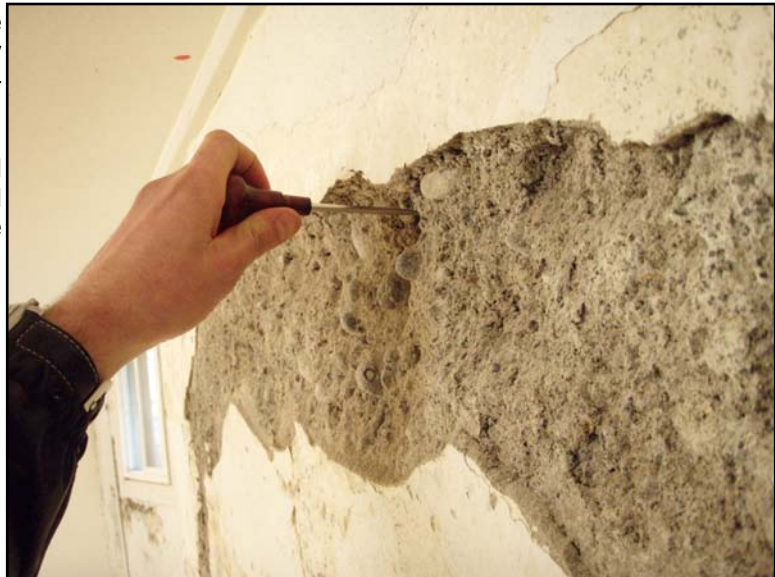
- 1.02 The turn-of-the-century concrete could easily be picked apart by hand. This is typical for basement walls of this vintage.

These areas should be patched to restore their appearance and prevent further erosion of the wall thickness.

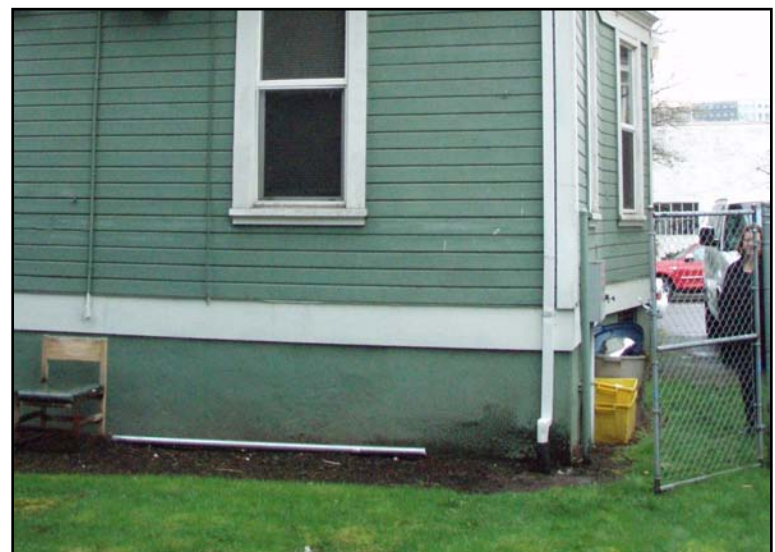
The most common source of basement-damaging water is roof drainage. Improperly installed gutters, downspouts, and drain pipes can deposit large quantities of water around basements and foundations. There are many reasons to believe roof drainage water is responsible for the problems at these three houses. The drain line along the west side of 722 was visibly backed up. The drain line along the east

- 1.03 On the other side of this wall, a gutter downspout routes water to a drain line running along the exterior side of this wall.

The drain line may be clogged, disconnected, missing, or otherwise depositing large quantities of storm water to the soil surrounding the basement.

The first order of business must be to investigate, test, scope or otherwise verify the proper functioning of the existing rain drain lines. They may need to be cleared using a water jet technique. New drain lines may be required. The new lines will need to terminate in new catch basins, or tie into the City storm water system.

These drain lines must be investigated and repaired or replaced as the first order of business in addressing the basement leaks.

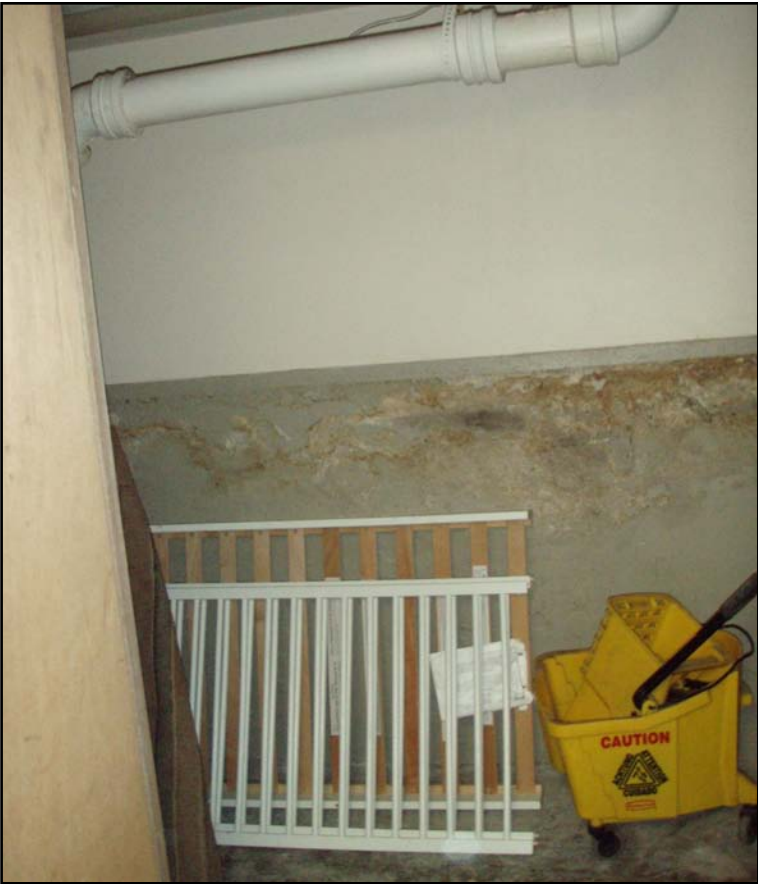
1.04 The concrete basement walls at 732 NE Couch exhibit the same poor concrete quality and moisture intrusion issues as 722.

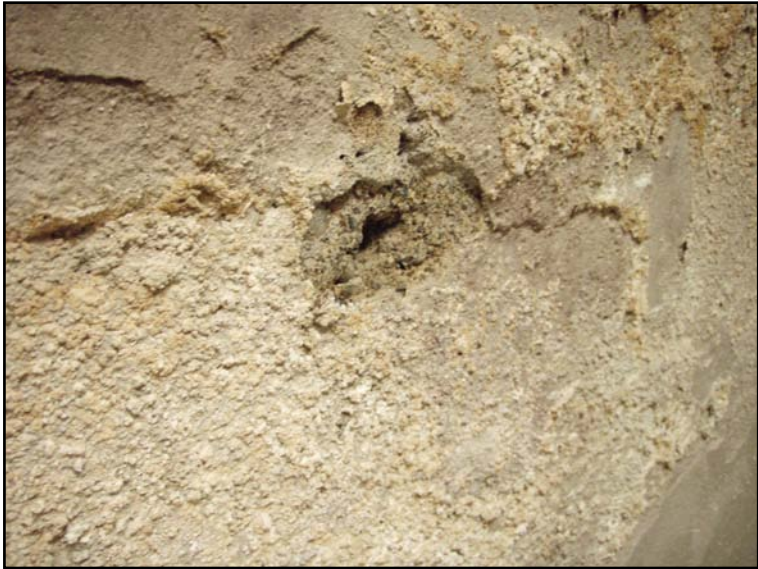
1.05 This wall could be picked apart by hand, revealing visibly moist concrete behind the surface.

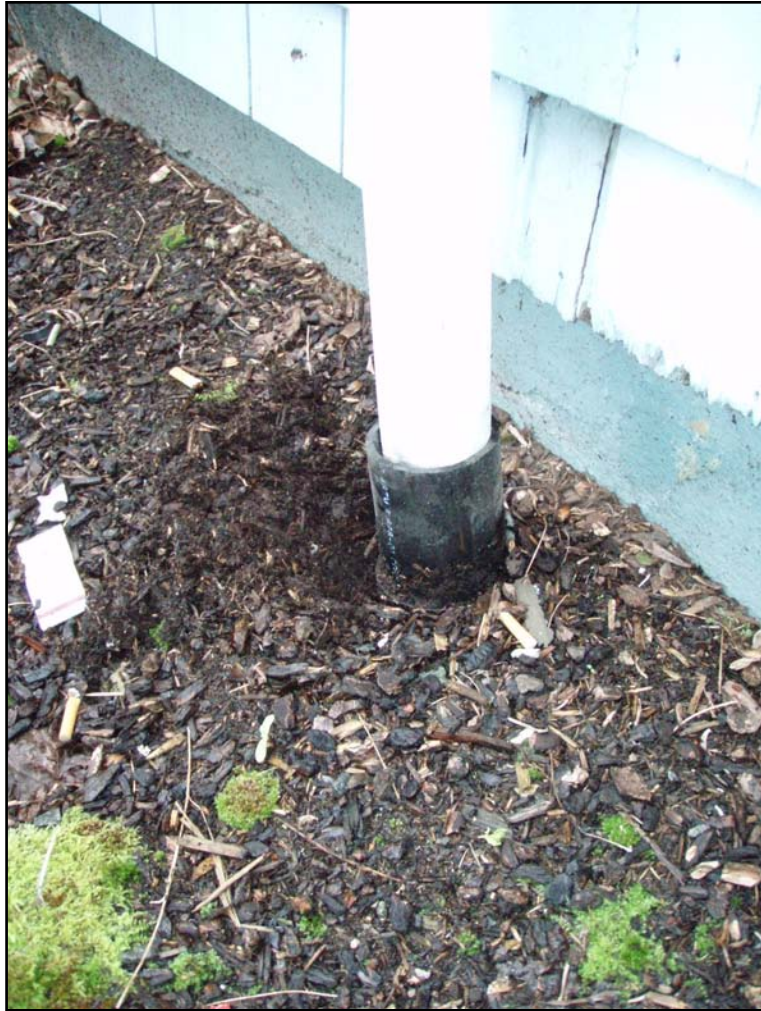
side of 722 was found to be disconnected and full of debris. The drain line along the west side of 736 was found to be disconnected.

1.06 This protruding conduit at 736 receives water from a downspout, but is disconnected from any functional rain drain below grade, as I discovered when I moved it by hand.

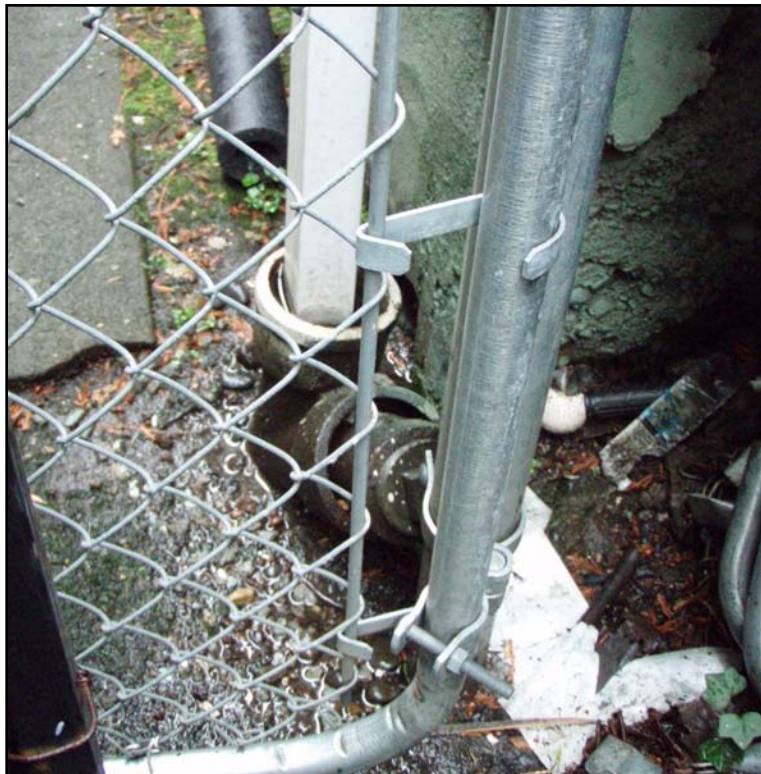
1.07 This downspout at the southwest corner of 722 leads to a drain line featuring a typical bell as well as a clean out. This drain line appears blocked/clogged, as standing water was visible at the surface of the bell.
