Wikman Building Renovation

October 2, 2012

THA ARCHITECTURE
INC

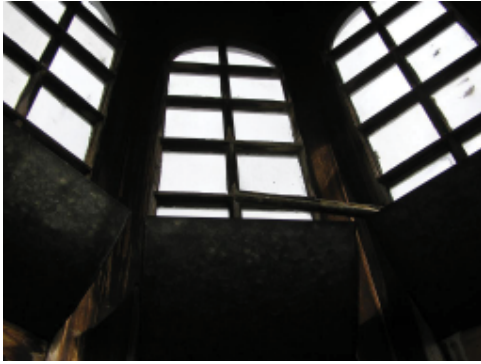
Interior of Lantern

The lantern at the top of the roof is in fair condition. The glazing compound of the lites needs to be repaired. Some of the wood elements need to be repaired or replaced in-kind.

- Fix glazing in lantern.
 - Repair flashing at lantern/ roof intersection.

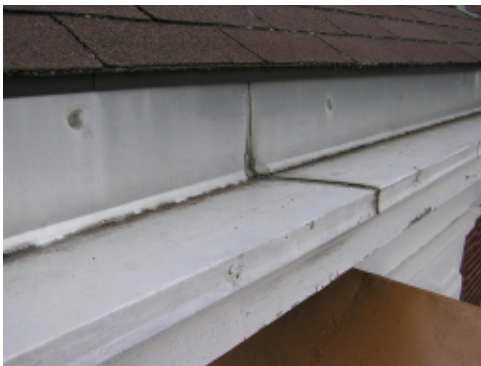
Exterior gutter

- Repair/Replace gutter liner.
- Repair leaking scupper at northeast corner.
- Check all downspouts and rain drains for proper operation
- Painted steel bike racks
- Exterior ramp and stair railings

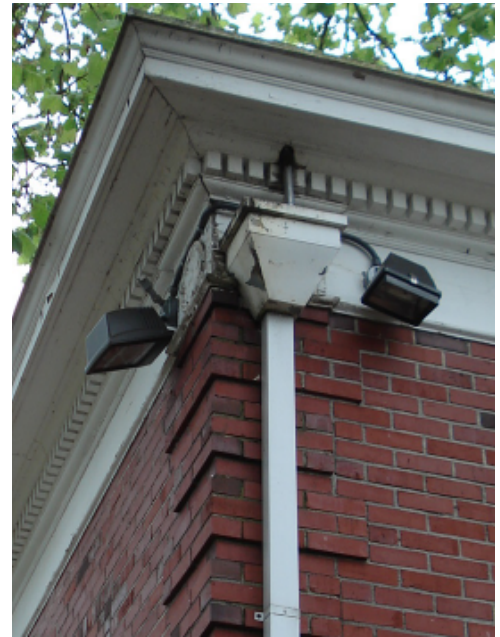
Scupper northeast corner of kitchen wing.

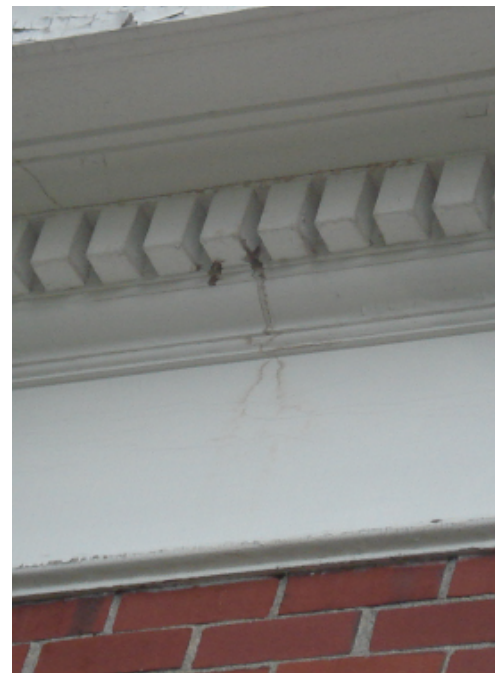
Water intrusion at dentils, underside of integral gutter

5. Metals	-	Gutters & Downspouts:
	5,300.00	Provide standard 5" fascia style gutter within existing built in gutter system and connect to existing down spout leader heads.
	1,590.00	Repair leaking downspout leader heads @ \$390/ea.

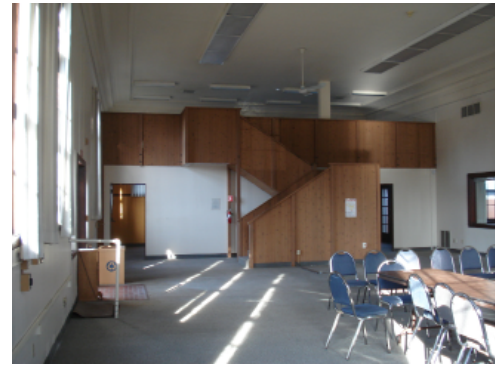
1973 mezzanine addition in Reading Room

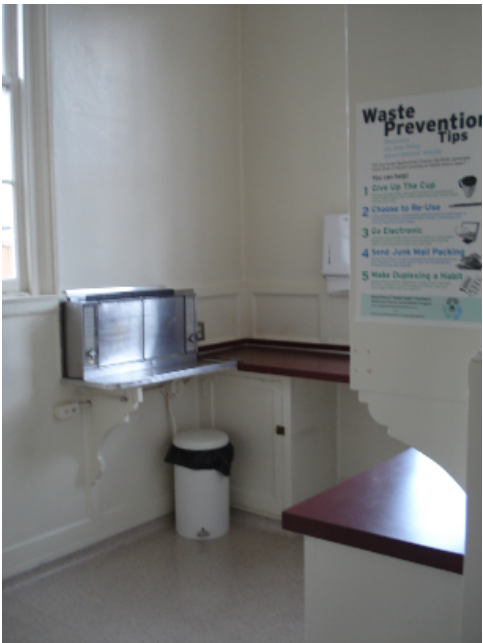
The kitchen still has the original cabinets but the sink was replaced with a contemporary stainless steel sink.

- Repair miscellaneous plaster as needed.
 - Fix water damaged ceiling in Kitchen 006.
- New gypboard walls and ceiling in new restrooms
 - Prep and paint
- Replace broken or damaged ceiling tiles in east wing Offices.
- Paint walls and ceilings throughout.
- Sand and stain wood stairs 007.
- Prepare and paint exterior wood surfaces for new paint
- Remove existing flooring materials
- Install new Flooring
 - Install new linoleum flooring in Reading Room/Meeting Room, Kitchen, Janitor's Closet, and new restrooms
 - Install new carpet in Offices 009-014, Conference Rooms 002, 003, 004, Office 100, Hall 007.
- Clean basement.
- Revise counter and sink in Kitchen 006 to meet accessibility requirements
- Bring grab bars and toilet accessories up to current code in existing accessible restroom
- New accessible accessories in new restrooms
- New toilet stalls, p-lam or painted steel partitions

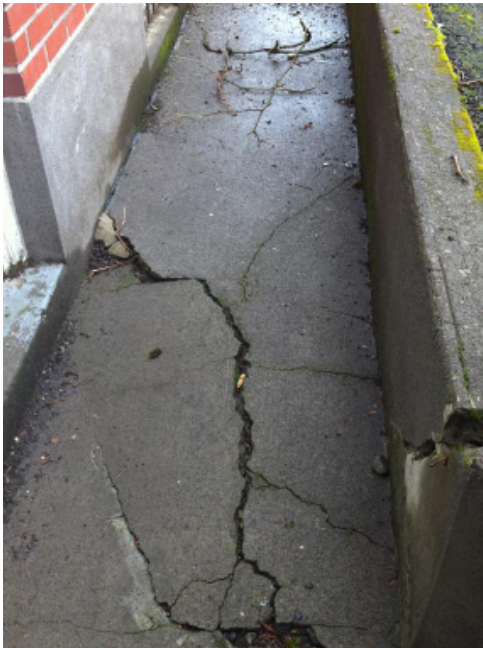
Damaged concrete slab outside Door X007

- Remove and repair concrete at east entry
- Revise north ramp at front to be correct slope. As the ramps were constructed under a building permit, it is not required that they be upgraded. However, it is recommended that the main entrance be brought up to current code for accessibility to meet the intent of Universal Access.
- Add new ramp and stair on the south side of the building.
- Clean and re-point exterior brick
- Exterior concrete pads for bike racks

3. Concrete	-	CIP:
	1,325.00	Remove concrete walkway at east entry and replace with new concrete to slope away from building.
	26,500.00	Demolition, excavation and concrete work required for new south and west entry wheel chair ramps and stairs. Includes new work and modifications

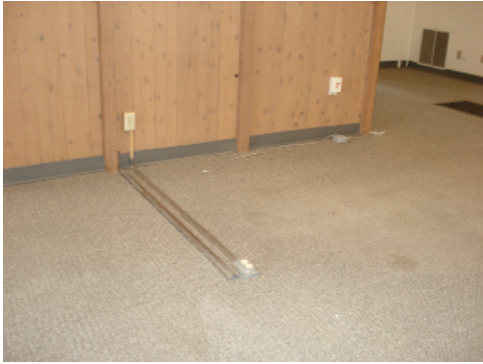
Electrical to be removed at base of mezzanine stair

- Remove wiremold and 220 receptacles in Reading Room, primarily on the west wall.
- Remove floor-mounted receptacle at the north end of the room near the stair.
- Remove surface-mounted wiremold where feasible.
- Update lighting in the Reading Room.
- Add LED exit signs with battery back up.
- Extend electrical for new refrigerator in Kitchen 006.
- Relocate electrical panel in Hall 007.
- Replace old light switches with toggle switches.
- Replace receptacles with commercial grade receptacles.
- Tie smoke detectors to security monitoring system.
- Add exit lighting and emergency lighting.
- New electrical exhaust fans, lighting, switching etc for two new restrooms.

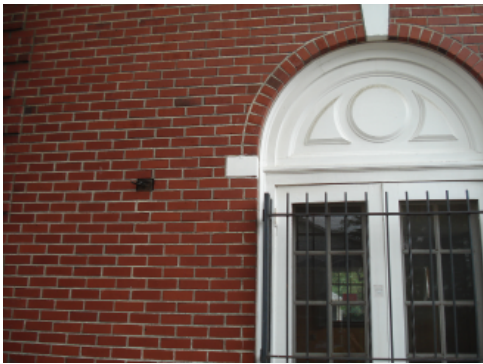
Electrical at door X003
