State of Oregon
Department of Environmental Quality

Memorandum

Subject: No Further Action Proposal for Wagstaff Battery
Corrected Copy

Date: December 16, 1997

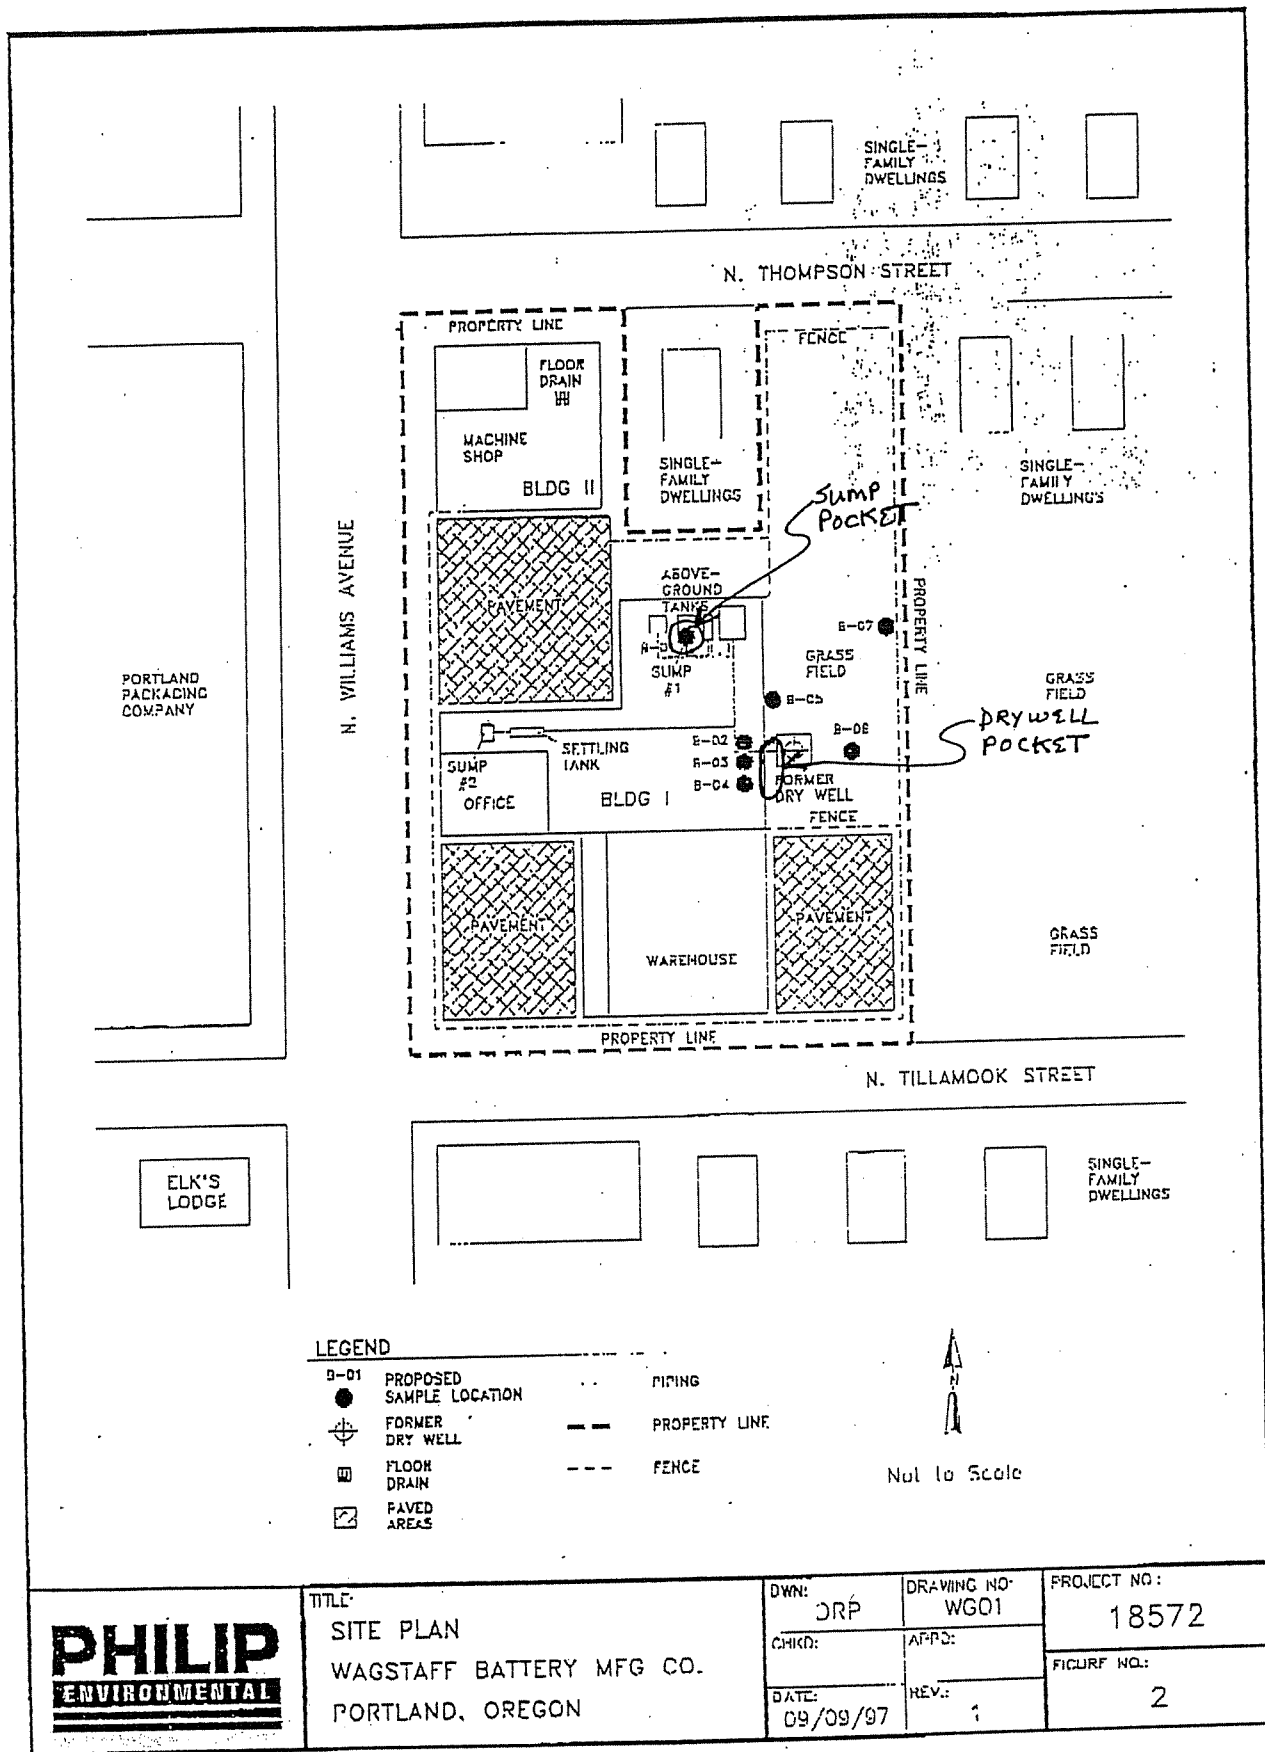
Environmental concern initially focused on the drywell, located on the east side of Building #1 where historic discharges of water, dilute sulfuric acid, and lead had occurred (See Figures 1 and 2). In 1993, the majority of the contaminated soil within and surrounding the drywell was excavated and stockpiled on-site. The amount of soil to be excavated was based on RCRA hazardous waste criteria rather than soil cleanup standards. Therefore, confirmatory samples were only evaluated by toxic characteristic leaching procedure (TCLP) and pH. Confirmatory

The DEQ has determined that a pocket of lead contaminated soil is present at approximately three to twenty feet bgs at the eastern side of Building #1. The contaminated soil has a gray discoloration and a nearby sample had a concentration of 383 mg/kg. The total volume of residual, lead-contaminated soil is estimated at 22 cubic yards. The pocket of contamination is illustrated on Figure 1.

Historic discharges of dilute sulfuric acid to the drywell probably contributed to the high concentration of leachable lead. The sulfuric acid created a low pH environment in which lead is more soluble compared to more typical conditions of rainwater infiltration. In evaluating this site as a pocket closure, DEQ considered that the discharge of dilute sulfuric acid terminated approximately five years ago, future infiltration of rainwater should buffer the low pH environment and further reduce lead solubility, and an estimated thirty feet of uncontaminated soil is between the pocket of contamination and groundwater. DEQ approves leaving this pocket of contamination because the removal of this contamination would endanger the integrity of the building and the pocket does not threaten human health, safety, welfare or the environment.

This cleanup was conducted consistent with OAR 340-122-045. Remaining concentrations of contaminants are currently inaccessible or below concentrations which are protective of public health and the environment. It is therefore recommended that no further action be performed for the Wagstaff Battery site. A Notice of Hazard and site map (attached) will be attached to the property deed to document the nature and extent of actionable contamination remaining beneath and adjacent to site Building #1. This contamination should be addressed when it becomes accessible.
