PHASE I ENVIRONMENTAL SITE ASSESSMENT

Former Manufacturing Facility
2110 - 2156 North Williams Avenue
Portland, Oregon

Project 938-01

November 23, 1999

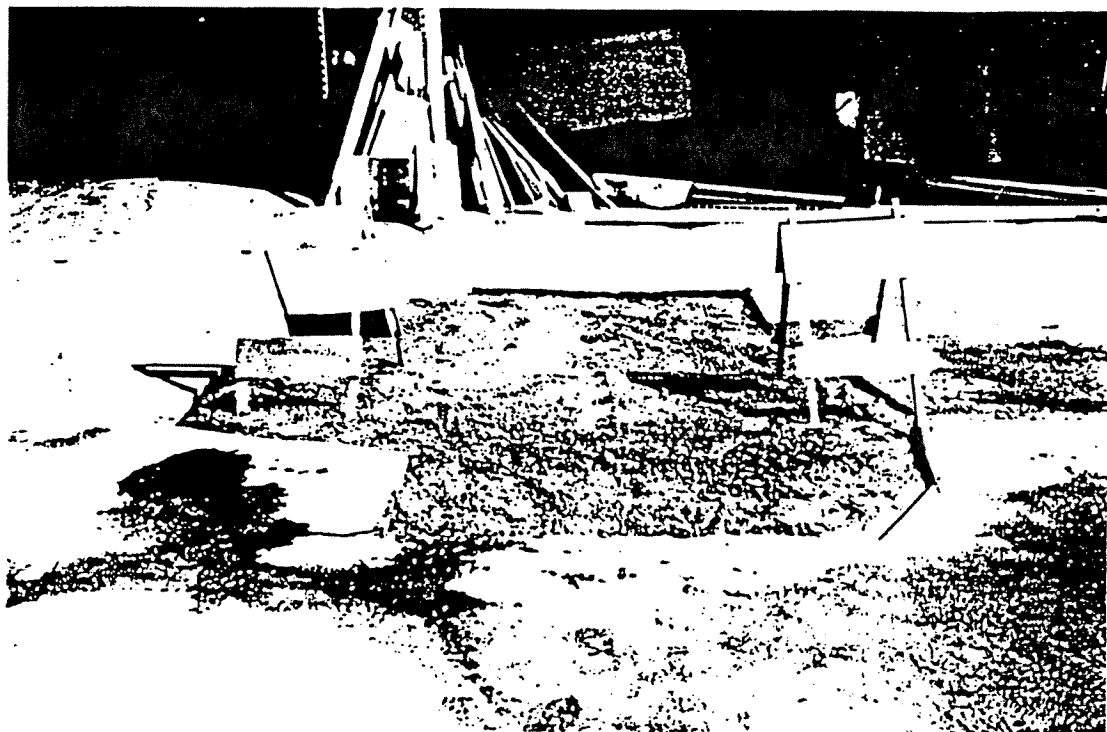
PHOTOGRAPH NUMBER 4: Backfilled and compacted excavation as it appeared on the afternoon of September 10, 1993.
