National Scenic Area Site Review

Case File: T2-2017-8199

Proposal: Applicant is proposing to alter two bays of the Vista House in an attempt to waterproof the structure. The proposed work will include new concrete apron with waterproof membrane underneath, sidewalk skylights, storm windows and waterproofing membrane behind the existing stone from the first floor up to the main roof gutter. The balcony will also receive a new roofing membrane at the east and west stair enclosures. If the work is successful, the repairs will be applied to all other bays at a future point in time.

EAST SIDE WATERPROOFING DESIGN

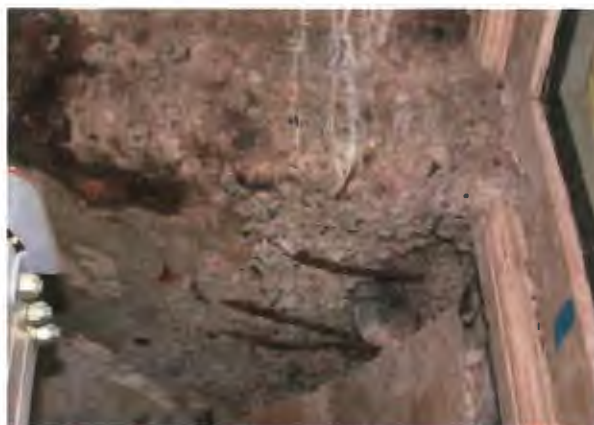
- Plaster repair
- Concrete substrate repaired as necessary due to poor condition of existing concrete include exposed rebar (Change order #2 during Interior Rehab construction, hiring WDY structural engineers, 2004)

Image of concrete condition

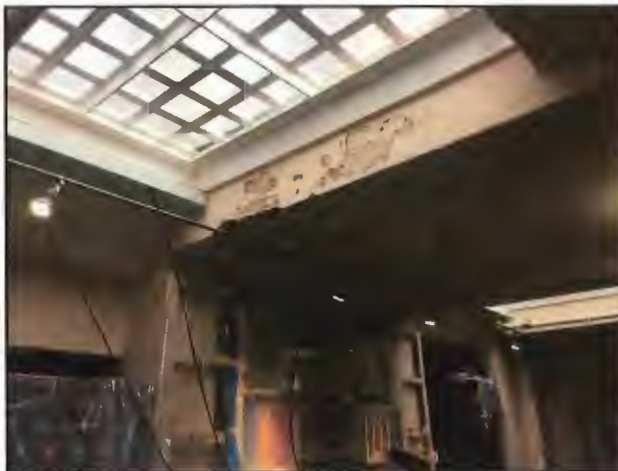
12 EXISTING CONDITIONS - BASEMENT
NTS

WATER DAMAGE TO INTERIOR FINISHES.

INTERIOR "GUTTER" TO CATCH LEAKS AT SKYLIGHT

BUBBLING OF PAINT IS SEEN THROUGHOUT THE BASEMENT LEVEL

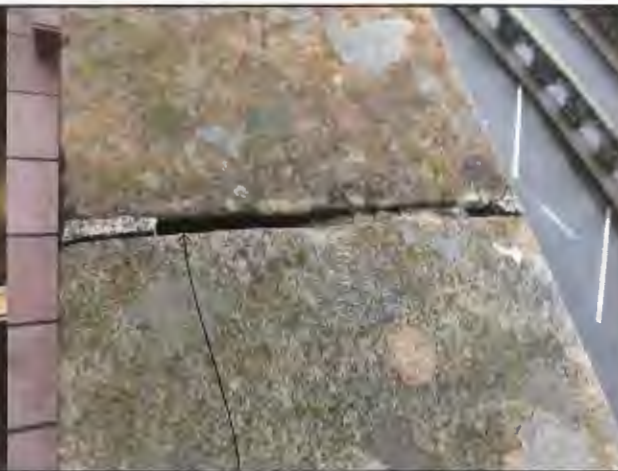
9 EXISTING CONDITIONS - SKY-FACING JOINTS
NTS

MORTAR IS SPALLING OUT OF SKY-FACING JOINTS

2 Poor detailing at stone sills and capstones.	No flashings were ever provided at the sills and capstones and with porous sky-facing joints, it is highly likely water is able to get trapped behind the stone façade in these areas.	Add zinc flashing underneath the capstones and stone sill at the balcony windows. Zinc is a highly durable material that is more muted in tone so it will blend better with the stone (versus stainless steel which is shiny). Sky facing joints between stone will be sanded sealant so they match the appearance of a grouted joint but provide better water protection.	The new flashing will only extend a half inch (1/2") from the stone facade and will have a very minimal visual impact at the capstones and even less visual impact at the stone sill due to the sill overhang that covers it.	11/A-501 9/A-502 6 & 12/A-504 A-600
3 Sky-facing joints along the west side of the Vista House are spalling out, creating hazards and allowing water into the wall assembly.	Many of these joints were repointed and sealed during the 2010 west side stair waterproofing project. The sky facing joints were a combination of sealant and grout which isn't compatible.	Sky facing joints between stone will be sanded sealant only so they match the appearance of a grouted joint but provide better water protection and adhesion.	None. Texture and color will be the same as the horizontal grouted joints.	9/AE-101 9/A-504

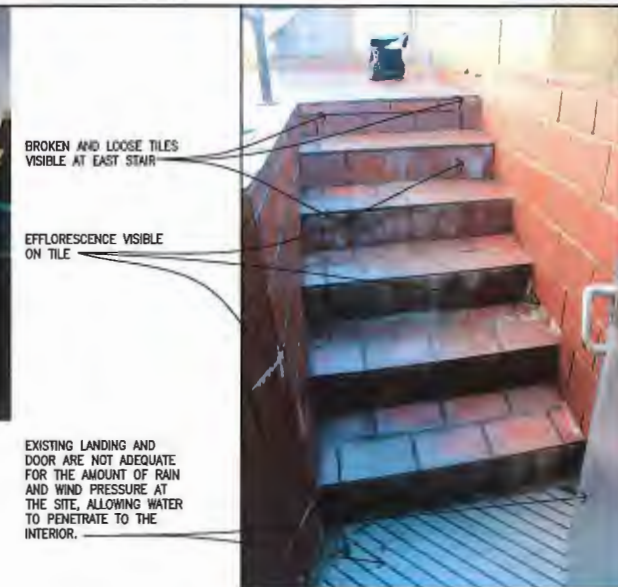
3 EXISTING CONDITIONS - EAST STAIR TO BALCONY
NTS

EXISTING LANDING AND DOOR ARE NOT ADEQUATE FOR THE AMOUNT OF RAIN AND WIND PRESSURE AT THE SITE, ALLOWING WATER TO PENETRATE TO THE INTERIOR.

7	Water infiltration through the east side door to the balcony.	The current hollow metal door does not properly withstand the high wind gusts that happen at the gorge, allowing for water infiltration. The landing at the door also frequently overflows with water which then spills in over the door threshold into the interior space.	The east side entry door will be following repairs and modifications made at the west side entry door in 2009 and has been successful at keeping water out at the west opening. These modifications include replacing the existing door with a hurricane resistant door and frame and modifying the landing to create a deep sump to hold water from the balcony surface and discharge at a new exterior downspout that is in the same location (but lower) as an existing downspout.	There will be minimal visual impact. The downspout and scupper will be dropped approximately 14" from its current location and will match the West side location. The scuppers and downspouts are not original to the building. The new door will match the existing door at the west side. Drainage channels will be provided in the concrete apron at the downspout to improve the movement of water away from the building.	West Side Multnomah County Case File #T2-09-021 A-301 A-400 1/A-502 2, 3, 5, 6, 8, 9, 11, 12/A-503

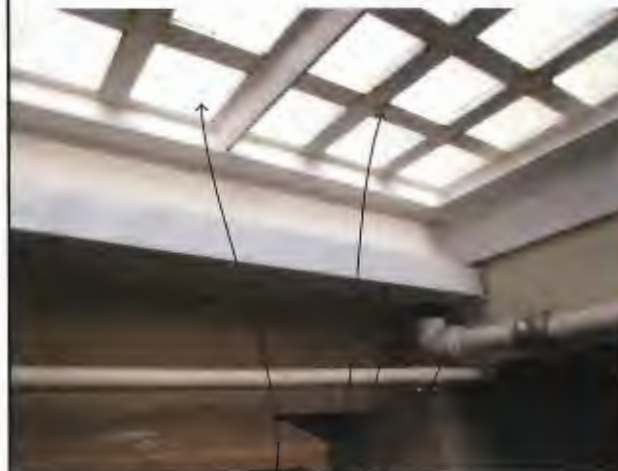
11 EXISTING CONDITIONS - SKYLIGHT
NTS

CONDENSATION VISIBLE ON INTERIOR SIDE OF SKYLIGHTS.

METAL FRAME IS CORRODING AND NOT HISTORICALLY APPROPRIATE. (WAS HISTORICALLY A CONCRETE AND GLASS PAVER SKYLIGHT).

5 Water infiltration at steel skylights in concrete apron as well as considerable condensation on the glass and metal surfaces.	Metal skylights replaced the historic glass paver and reinforced concrete skylights in the 2001 restoration project.	The skylights will be removed and replaced with a pre-cast concrete and glass paver skylight panel unit that is more historically appropriate. The deeper thickness of the concrete and the glass paver will significantly improve any condensation issues (plus concrete will not have the same thermal issues as metal). The panel system is pre-manufactured and provided with a water tight warranty. New waterproofing at the concrete apron will tie into the new system.	This will have a visual impact but in a positive way. It will be returning the skylights to a more historically appropriate aesthetic with the concrete and glass paver system.	2, 11, & 12/AE-101 1/AD-101 1/A-400 1, 7, & 10/ A-503

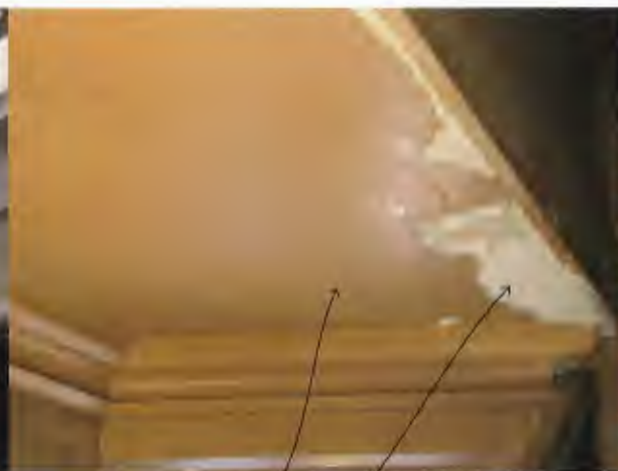
8 EXISTING CONDITIONS - FIRST LEVEL CEILING
NTS

CONDENSATION VISIBLE ON THE ENTIRE CEILING SURFACE

PLASTER DAMAGE FROM WATER INFILTRATION AT THE EAST BALCONY DOORWAY.

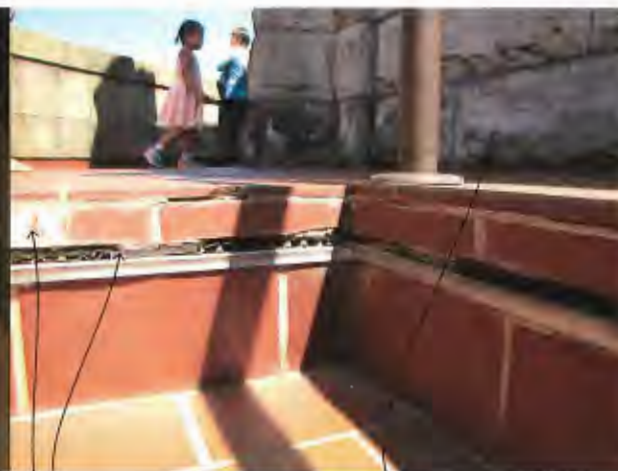
5 EXISTING CONDITIONS - BALCONY TILE
NTS

DRAINAGE MAT BECOMES CLOGGED WITH DEBRIS AND DOES NOT PERMIT WATER TO PROPERLY DRAIN UNDER THE TILE.

EFFLORESCENCE VISIBLE ON TILE

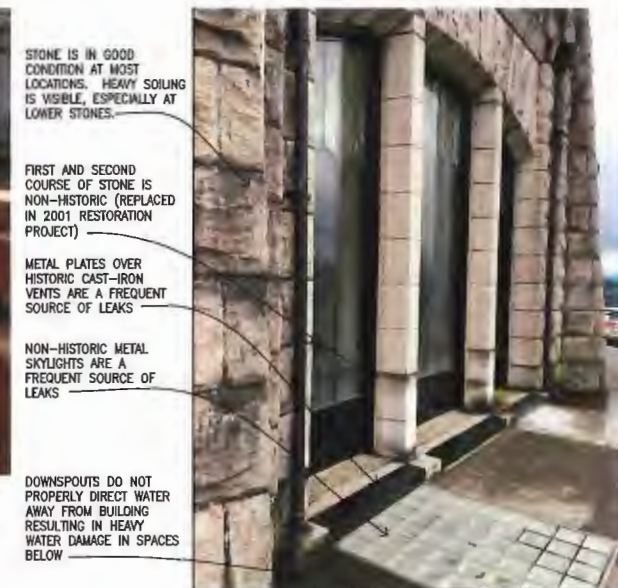
2 EXISTING CONDITIONS - EXTERIOR
NTS

STONE IS IN GOOD CONDITION AT MOST LOCATIONS. HEAVY SOILING IS VISIBLE, ESPECIALLY AT LOWER STONES.

FIRST AND SECOND COURSE OF STONE IS NON-HISTORIC (REPLACED IN 2001 RESTORATION PROJECT)

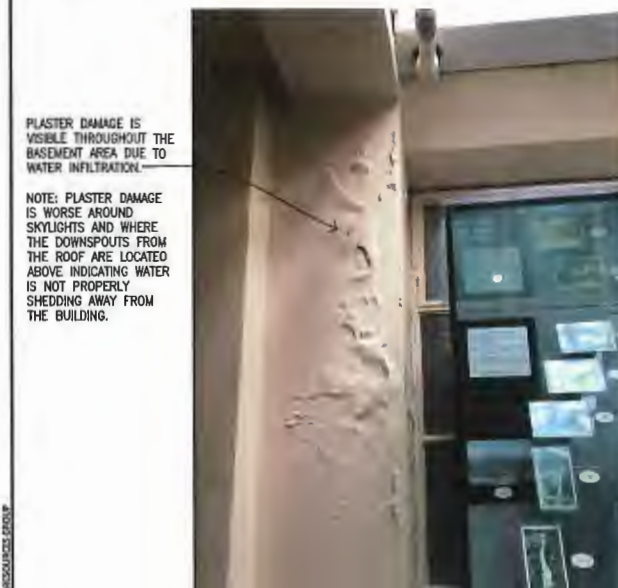
10 EXISTING CONDITIONS - BASEMENT
NTS

PLASTER DAMAGE IS VISIBLE THROUGHOUT THE BASEMENT AREA DUE TO WATER INFILTRATION.

NOTE: PLASTER DAMAGE IS WORSE AROUND SKYLIGHTS AND WHERE THE DOWNSPOUTS FROM THE ROOF ARE LOCATED ABOVE, INDICATING WATER IS NOT PROPERLY SHEDDING AWAY FROM THE BUILDING.

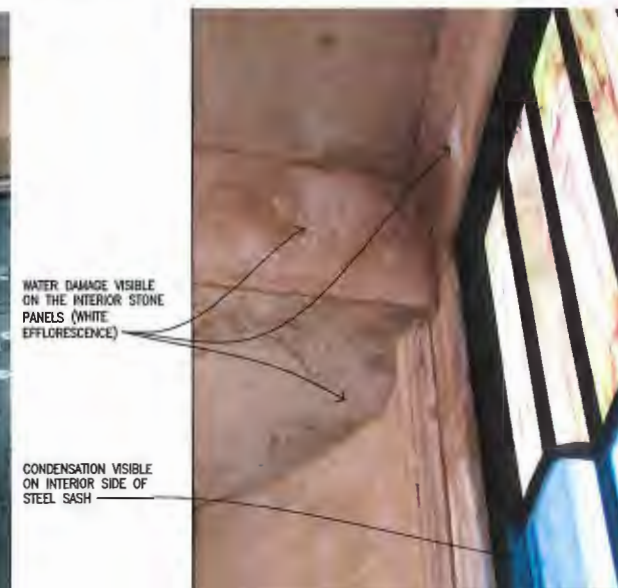
7 EXISTING CONDITIONS - FIRST LEVEL
NTS

WATER DAMAGE VISIBLE ON THE INTERIOR STONE PANELS (WHITE EFFLORESCENCE)

CONDENSATION VISIBLE ON INTERIOR SIDE OF STEEL SASH

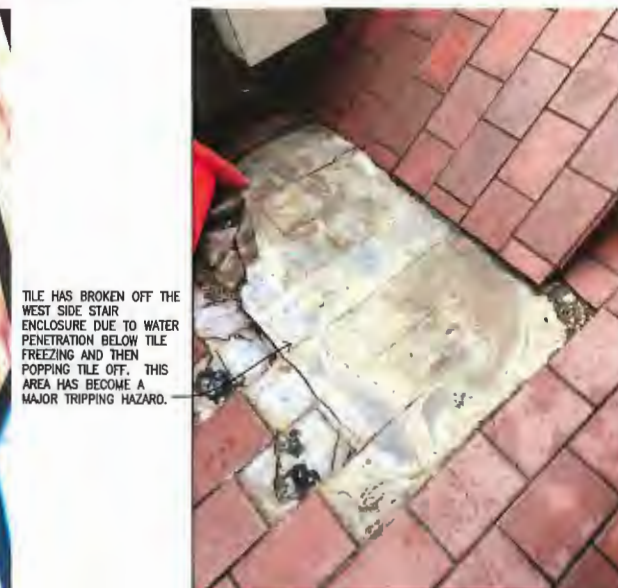
4 EXISTING CONDITIONS - BALCONY TILE
NTS

TILE HAS BROKEN OFF THE WEST SIDE STAIR ENCLOSURE DUE TO WATER PENETRATION BELOW TILE FREEZING AND THEN POPPING TILE OFF. THIS AREA HAS BECOME A MAJOR TRIPPING HAZARD.

9	Balcony roofing is failing, resulting in damage to the existing membrane and tiles breaking and popping off resulting in water infiltration.	The original surface of the balcony was tile, but due to issues with the tile almost immediately, this surface was replaced with a continuous membrane in 1941-42. During the large restoration project in 2001, it was decided to reinstall a tile system with a new membrane system underneath and a drainage matt which is visible at the entry stairs. These tiles have since created problems with breaking and popping off, most likely due to water getting in underneath the tile with the porous grout, becoming trapped, and freezing. The drainage matt that is supposed to help with directing water out of the assembly has become plugged where visible and the waterproofing membrane has proved to be an inferior product exacerbating the issues.	To properly detail a tile system on the balcony, a pedestal paver system would need to be utilized that sits on top of a very robust asphalt waterproofing system. Unfortunately, the balcony at the Vista House is a very constrained space making this option infeasible. Especially with how it would transition to the historic perimeter gutter system and the existing stairs to the balcony and resist wind uplift. This system also requires more height than what is currently at the balcony. The height of the balcony surface can not be increased since it will result in an unsafe condition at the perimeter walls (which would then result in guardrails at the tops of the walls which would have a very large visual impact). Because of this, it was decided to remove the existing tile and replace it with a PMMA liquid-applied roofing system with a decorative tile pattern to match the current pattern. This seamless roof system will be able to easily transition between vertical and horizontal surfaced and is extremely robust. It is also easy to repair if need be and has a long track record of successful projects in Europe (over 30 years).	There will be no visual impact from any location around the Vista House, but you will notice a difference of material when you're actually on the balcony. While we are able to provide the same tile pattern with the new fluid-applied roofing membrane, the color will be much more uniform than glazed tile. A mock up is currently being created to better understand what the final result will be.	1, 3, 4, 5, & 6/ AE-101 AD-102, AD-103 A-102, A-103 A-300, A-301 2 & 3/A-400 3, 6, 8, & 11/A-502 2, 3, 5, 6, 8, 9, 11, 12/A-503 2, 3, 4, 5, 6, 8, 11/A-504

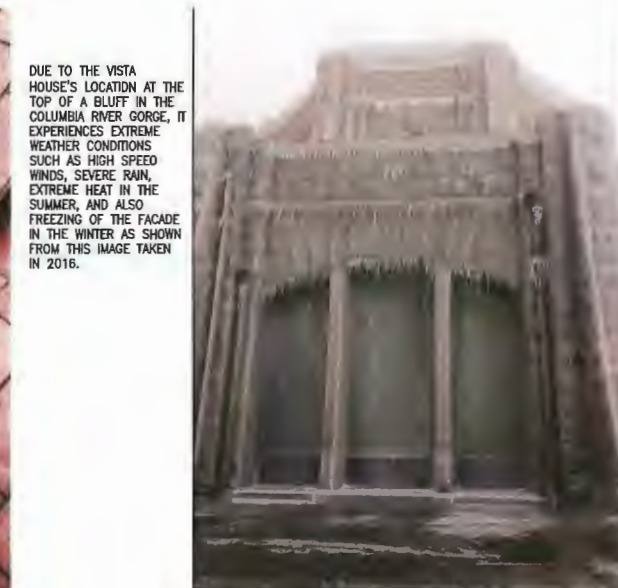
1 EXISTING CONDITIONS - WEATHER
NTS

DUE TO THE VISTA HOUSE'S LOCATION AT THE TOP OF A BLUFF IN THE COLUMBIA RIVER GORGE, IT EXPERIENCES EXTREME WEATHER CONDITIONS SUCH AS HIGH SPEED WINDS, SEVERE RAIN, EXTREME HEAT IN THE SUMMER, AND ALSO FREEZING OF THE FACADE IN THE WINTER AS SHOWN FROM THIS IMAGE TAKEN IN 2016.
