ROAD SAFETY AUDIT

Cornelius Pass Road Multnomah County, Oregon July 1-3, 2008

Primary Author:
Nicholas Fortey, P.E
Safety Engineer
Federal Highway Administration, Oregon Division

December 2008

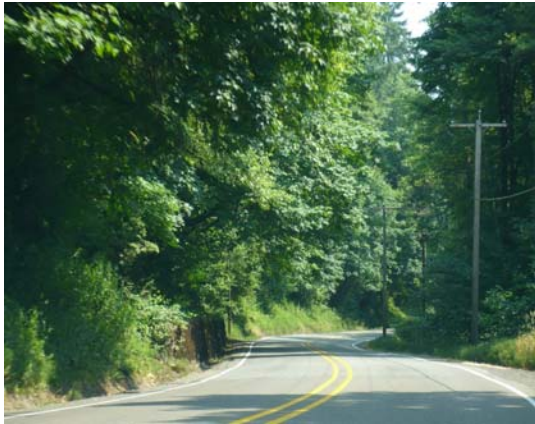
The lower section of Cornelius Pass Road in the SB direction had two rock walls close to the roadway. The aged concrete and moss covering made the wall difficult to see in the daylight hours due to shadows from trees and very difficult to see at night as the wall did not markedly stand out from the dark background.

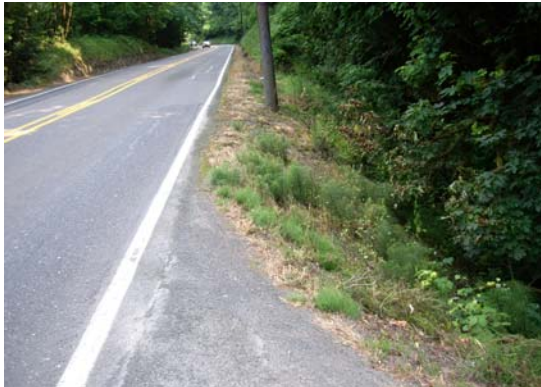
There were numerous utility poles along the corridor. Several of the poles were close to the roadway; moreover, several of these were not delineated or were located near the outside of curves where they might be struck by errant vehicles. Of note, several crash reports noted collisions with utility poles although it was difficult to determine which pole had been struck. Perhaps even more surprising was that in none of those crashes did serious injuries apparently result.

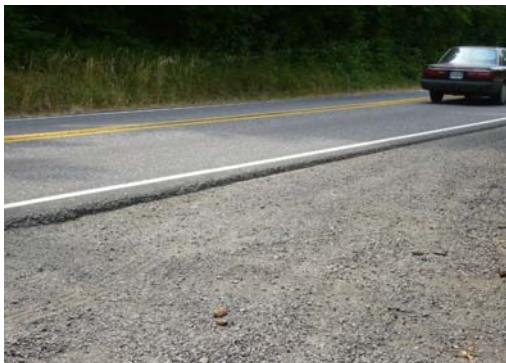
As noted, the narrow traveled way and lack of continuous shoulders and, where present, only narrow shoulders, points to the need for improved efforts to keep vehicles on the roadway. As may be expected, the narrow travel way, curvilinear alignment, and speeds increase the likelihood of vehicles occasionally straying across the paved edge of the roadway. The likely incursions of a vehicle's tires onto the gravel shoulder could result in, and was noted to result in, a drop-off condition at several locations. An errant driver losing control

of a vehicle due to a tire straying of the edge of the paved roadway may attempt to wrest control back, with the tire scrubbing the edge of the paved roadway prism; the driver may become frustrated by efforts to redirect the vehicle and may overcorrect by pulling hard on the steering wheel. This can cause the vehicle to lurch to the right or to

cross over the centerline and collide with an opposing direction vehicle or continue and run off the roadway on the opposite side.

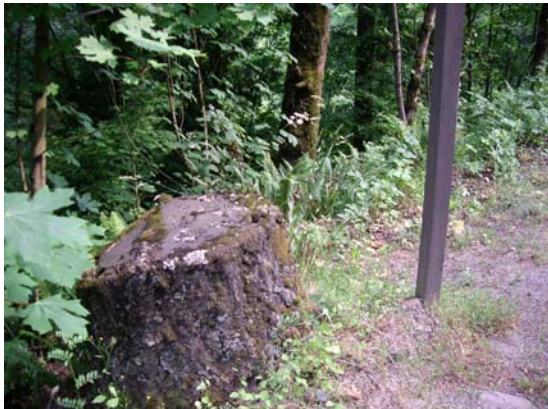
The review also noted other fixed objects adjacent to the roadway, beyond the already mentioned telephone poles and drop-offs, which are also remarkable due to the limited number of incidences, and in this case, the limited efforts necessary for their removal. For example, on the outside of one curve, just beyond the useable shoulder, lay a tree stump. While a single point hazard, its existence is less remarkable for its representation of the range of fixed objects than by the ease with which this one hazard could be removed. There were

also numerous small trees and brush which could grow into larger and potentially more difficult-to-remove hazards (such objects can also reduce sight distance although that is dealt with in a separate issue section of the report).

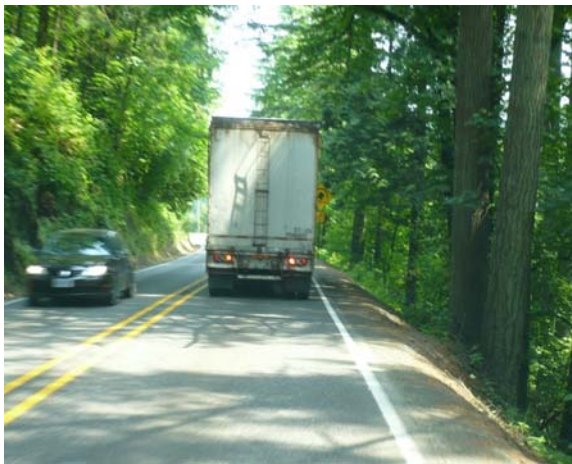
The steep embankment northbound just prior to the S-curves is unshielded and has only a minimal shoulder past the striped edge line. Large trees are present about 10 feet off the edge of the traveled way and a steep (1:1 or steeper) drop-off (in excess of 100 feet) exists. While these conditions lead to a high ranking based on severity of outcome, the roadway is on tangent alignment at this point and there is no record of adverse crash history. Additionally, the length of the hazard, the constrained roadway prism, and the likely need to perform slope stabilization would result in a relatively costly remediation

(placement of guardrail). Thus, guardrail is not considered cost-effective in this location.

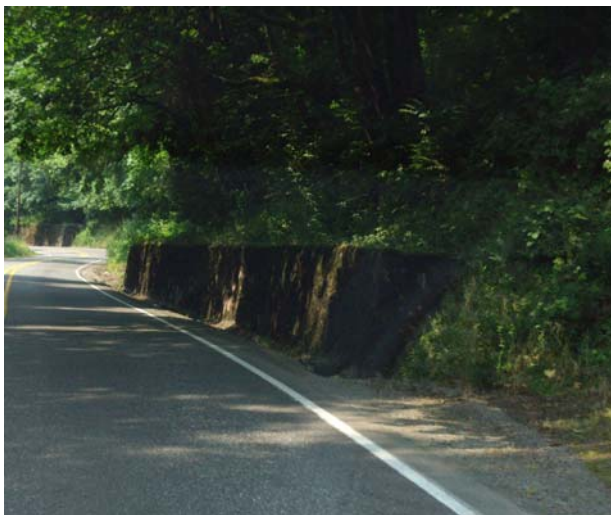
Proceeding southbound from Highway 30, the driver is presented with a series of rock walls on the right. The rock walls are linear hazards but the ends are considered point hazards. The potential for an errant vehicle to strike the walls is considered high as approaching vehicles come off Highway 30 with its considerably more open road context leading to higher expected speeds, while horizontal curves become introduced in this section. The consequence of a crash is also considered severe as errant vehicles would abruptly stop upon collision with attendant high deceleration forces.

The cost of treatment of these point hazards, however, would be relatively low. Given the high severity and moderate to high expected likelihood of errant vehicles in spite of no adverse crash history, installing

appropriate end treatments, such as tapered end cut into the back slope, is considered a high priority. Removal or relocation of the rock walls is not feasible as they provide slope stability in the presence of steep cut slopes. The walls are masonry rock walls with the rocks forming a rough curvilinear surface paralleling the roadway. While the rough surface may be a concern for vehicle snagging, a fronting guardrail would reduce the shoulder width and a cast-in-place safety shape rock wall would be expensive; the road safety audit team concludes that while this should be examined an appropriate end treatment remains the far higher priority. Currently the ends are unprotected. Casting a concrete safety shape end section which could then be itself terminated by standard practice of burying into the back slope of the cut would provided a safe transition. Similarly an alternative design could be employed to use a guardrail end section buried into the back slope or terminal section. Given the presence of the cut section and, limited space to generate acceptable end section performance, a buried into the back slope treatment is recommended.

While the recommend treatment for the rock walls is to install a crash-worthy end treatment, the leading edge of these walls should be delineated as the walls are close to the roadway, on horizontal curves, and difficult to see due to the forest canopy and dark color of the walls.

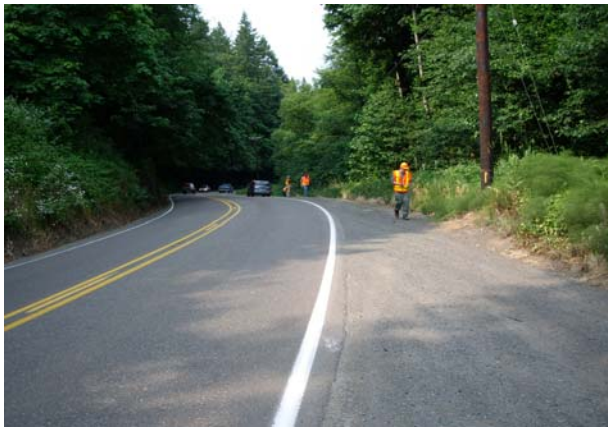
In the opposing direction a slight curve to the right is followed by a curve to the left. Both curves are unsigned and follow a section of the roadway where, based on observation and roadway character (the descending grade and the transition out of the section with a high density of horizontal curves), vehicle speeds are likely to increase. Additionally, there was a recent fatal crash at this location where a vehicle went off the roadway embankment. While the crash report does not enable firm

conclusions to be made on the cause, the severity may be addressed by guardrail installation. Moreover, the physical conditions here would appear to allow installation with sufficient offset from the traveled way and allow installation of a crash worthy end terminal without requiring extensive additional grading or fill material.

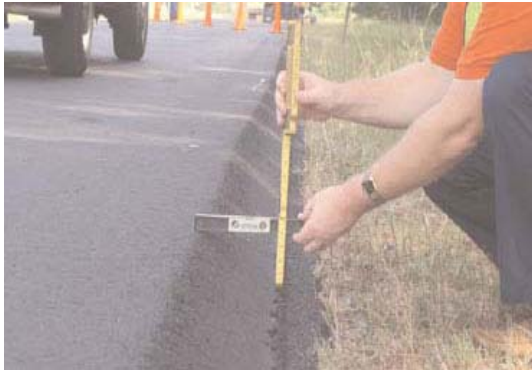
While acknowledging that pavement resurfacing is both a relatively costly and future year action (the condition of the pavement during the review did not indicate a need for resurfacing), future planned resurfacing should strongly consider incorporating an asphalt wedge to minimize sharp drop-offs. The bevelled edge reduces the sharpness of the pavement edge drop-off and the associated loss of driver control allowing an errant driver to regain control.¹⁰ Shoulder rock could also be pulled up adjacent to the traveled

way. While valuable in the short run, the traffic volume and limited paved width support consideration of a more permanent asphalt wedge.

Introduce an asphalt wedge during repaving or under maintenance operations to limit pavement drop-offs

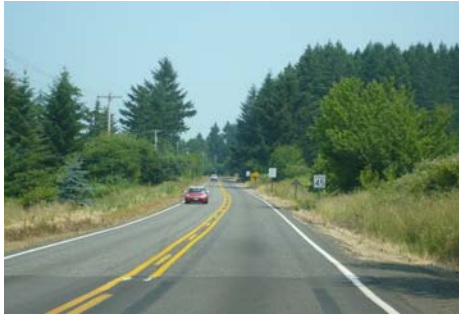
As noted previously, several months ago the County took a proactive position and striped the entire corridor as a no-passing zone (the corridor had previously had sections where passing was allowed). While the audit team concluded that this was a positive safety step and should be retained, the marking patterns and material created concerns in the near future. The existing passing stripe was not obliterated in advance of the placement of the solid yellow lines, thus leaving a non-standard and potentially confusing marking to the driver. Of more concern is that the outer no-pass solid line has

been marked with paint while the existing passing line, marked in thermoplastic, has been retained.

This creates a potential safety problem as the two materials wear at different rates: the paint will wear much faster than the thermoplastic such that after traffic, rain, and beginning of winter the marking will appear to allow passing. While these “revealed passing zones” will be in the same location as the original passing zones, this will negate the safety benefits of a no-passing zone; further, immediate correction will be highly unlikely and undesirable in

winter conditions due to cold temperatures, wet pavement conditions, and potential snow and ice conditions as winter intrudes.

A two-stage approach is suggested. The existing skip lines should be permanently removed by grinding and shot-blasting. This would leave a consistent no-pass marking. The second stage would involve analyzing the cost effectiveness of placing a durable no-passing line in place of the painted lines. The analysis should also consider the use of a profiled line to provide an audible warning to drivers who cross the centerline. Use of a durable marking product would provide a greater presence throughout the year and should yield improved retroreflectivity especially in inclement weather conditions and would remove the need for yearly re-tracing. The ice and snow conditions and the attendant plowing, however, would necessitate that the line be recessed to prevent destruction by the plow blades. Since the elevation (and attendant linear roadway distance) affected by snow and ice is not known and the elevation gain is fairly rapid, a continual durable line should be considered for the entire corridor that is under County jurisdiction.

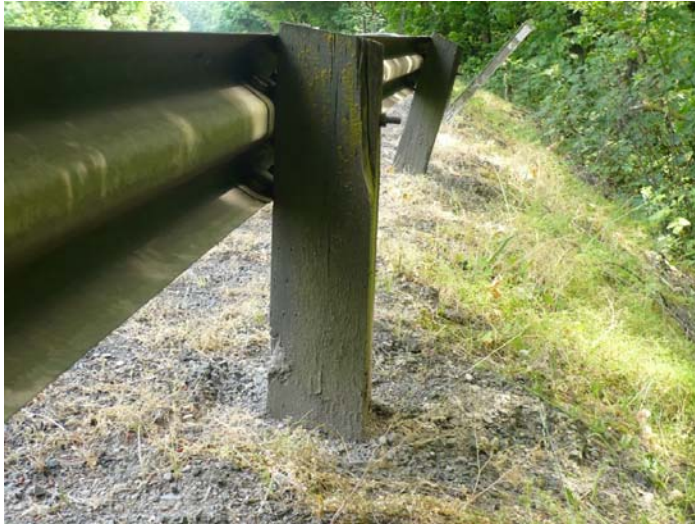
The road safety audit also noted several deficiencies with existing guardrail runs. Some sections were too far back from the roadway such that shoulder and roadside discontinuities may result in the rail being hit at an undesirable height.¹² On some guardrail runs, the supporting posts were leaning, which resulted in a lower height of the rail and may indicate that there would be insufficient resistance in the case of a crash. Further compounding this latter concern was the apparent minimal support for some guardrail

posts. Providing adequate support behind posts helps ensure the rail functions as intended. Several existing barriers appeared to be too short to adequately shield the hazardous object they were installed to shield. Finally, there were, as previously mentioned, several sections of the roadway where additional guardrail runs appeared warranted but had not been installed.

A guardrail needs analysis should be done comprehensively in league with a hazard assessment for the entire roadside.¹³ This review should include the need for barriers, a prioritization to identify the most needed areas, and an assessment of length of need for the attendant guardrail runs.

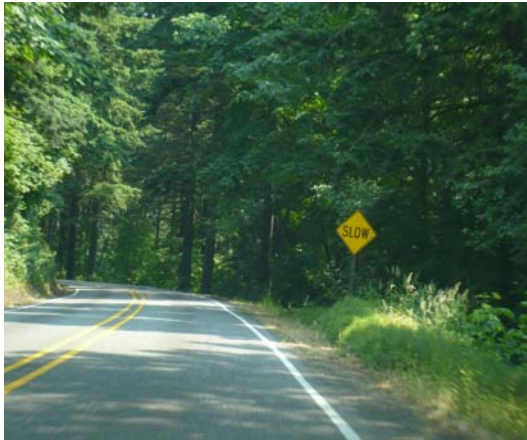
The audit noted the need to review some signs for appropriateness; certain curves appeared to be able to be safely navigated at the posted speed of the roadway, thus they do not need to be signed. The “oversigning” of a facility or network can lead to driver disregard of the signs, especially when the sign may be critical to safely negotiating a curve; in short, curve advisory signing should only be used if necessary per the Manual on Uniform Traffic Control Devices.

In other cases there seemed to be a number of unnecessary signs in the corridor (e.g. “Slow” sign). These signs may offer unspecific information to the driver, may distract from other more pertinent messages, or may obscure other signs. A comprehensive review of sign placement should suffice to address those few signs that are unneeded.

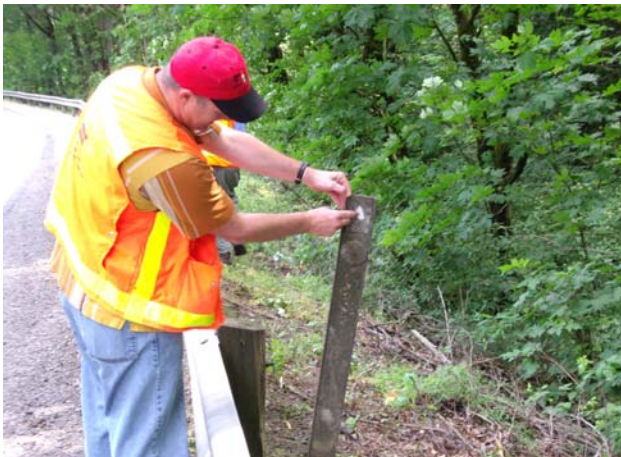
Previous recommendations addressed upgrades to signing along Cornelius Pass Road. The audit also noted that many of the existing signs and delineators were obscured with a film of grime and algae on signs and delineators, reducing daytime and night-time visibility. While the number

of delineators on the corridor is small and they are not placed uniformly through the corridor, immediate improvements could be made to increase their visibility. To ensure that there is an adequate level of sign visibility at day and night throughout the year the County should consider increasing the frequency of maintenance cycles.

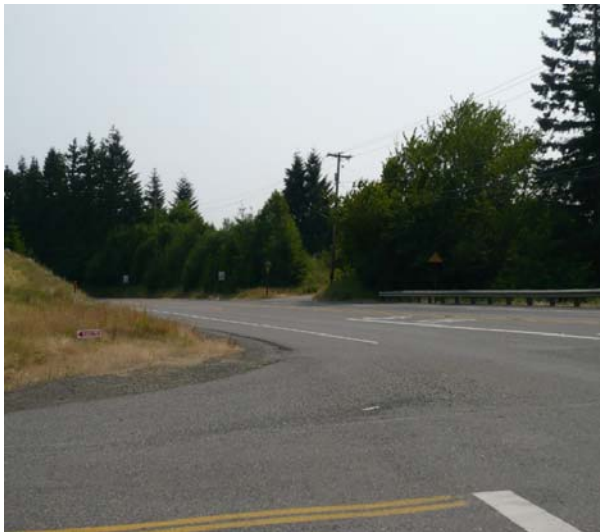
Poles and signs may obscure the sight distance of an oncoming vehicle and require the driver to pull further forward or to stop beyond the stop bar. In some cases multiple man-made objects were aligned or the man-made objects had been placed to align with natural features. Limited sight distance reduces the driver's ability to see oncoming traffic or to judge acceptable gaps in traffic to enter or cross the roadway. Among natural features a range of constraints was present leading to a range of solutions and attendant costs. For example, there were sight distance restrictions caused by horizontal and

vertical curves (Highway 30, Skyline Road (photo to left), Sheltered Nook, and several driveways) and there was a traffic signal obstruction for northbound drivers at Highway 30 (vertical curve combined with vegetation). These latter cases would necessitate more involved solutions than simple brushing or trimming (although that may reduce the severity of horizontal restrictions).

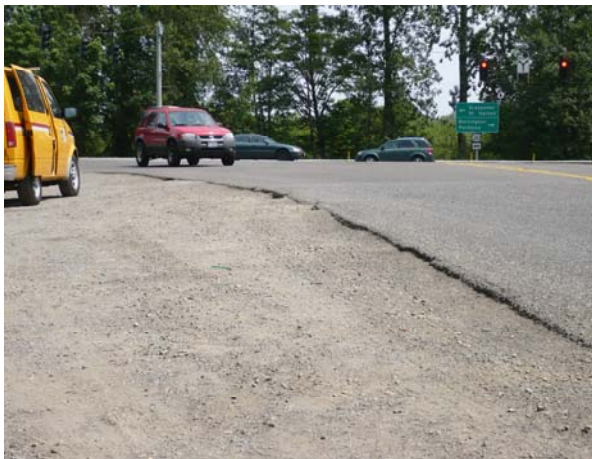
While acknowledging that the State has conceptual plans for the Highway 30 and Cornelius Pass Road intersection, there remain actions that can be taken in conjunction with or absent that project. The team noted that the sweeping eastbound right turn lane off Highway 30 resulted in high exiting speeds for Highway 30 traffic and created an undesirable speed “impression” for newly entering traffic. The lack of a deceleration/turning lane, edgeline delineation, and the presence of a large unpaved area adjacent to the turn raised

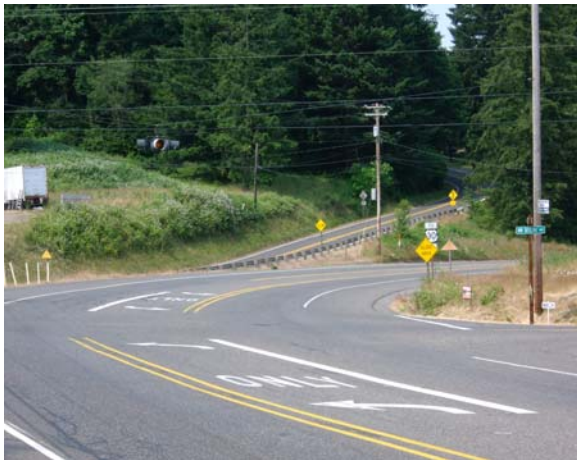
The road safety audit team observed a potential for driver confusion at this intersection. Northbound drivers on Cornelius Pass Road could mistake the old roadway alignment as being part of the mainline. The new mainline has a horizontal curve whereas the old alignment creates a visual continuation of the mainline prior to Skyline Road. While the grass shoulder makes the separation of the roads apparent in the day, these visual cues are not present at night. Even a small potential straying could cause drivers to enter the opposing direction of

traffic and with the horizontal curve to the right past Skyline, driver alignment correction is more difficult than on a tangent alignment.
