Enhanced Seismic Retrofit Technical Report

Multnomah County | Earthquake Ready
Burnside Bridge

January 29, 2021

Earthquake Ready Burnside Bridge Enhanced Seismic Retrofit Technical Report

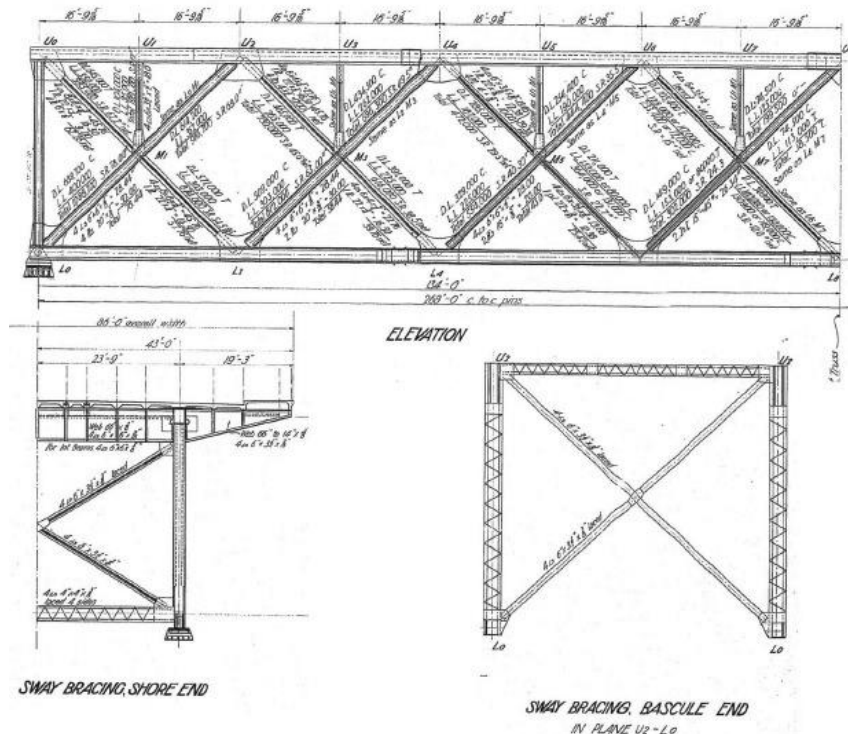
Figure 5-24. Truss Span Bracings

Sway bracing is absent from four of the eight bays in the fixed spans. Sway bracing is required in each bay to prevent the collapse of the deck and top chord caused by lateral movement. Due to the limited bracing, the bracing that currently is in place would become overloaded during a seismic event. The out-of-plane bracing near the bascule end of the fixed span has a C/D ratio of 0.08. The bridge deck to steel floor-beam connection shear capacity is insufficient based on the as-built plans, shop drawings, and rehabilitation plans. There are no connectors between the deck and floor beams of the fixed span, so the existing deck will not act compositely under seismic loading.

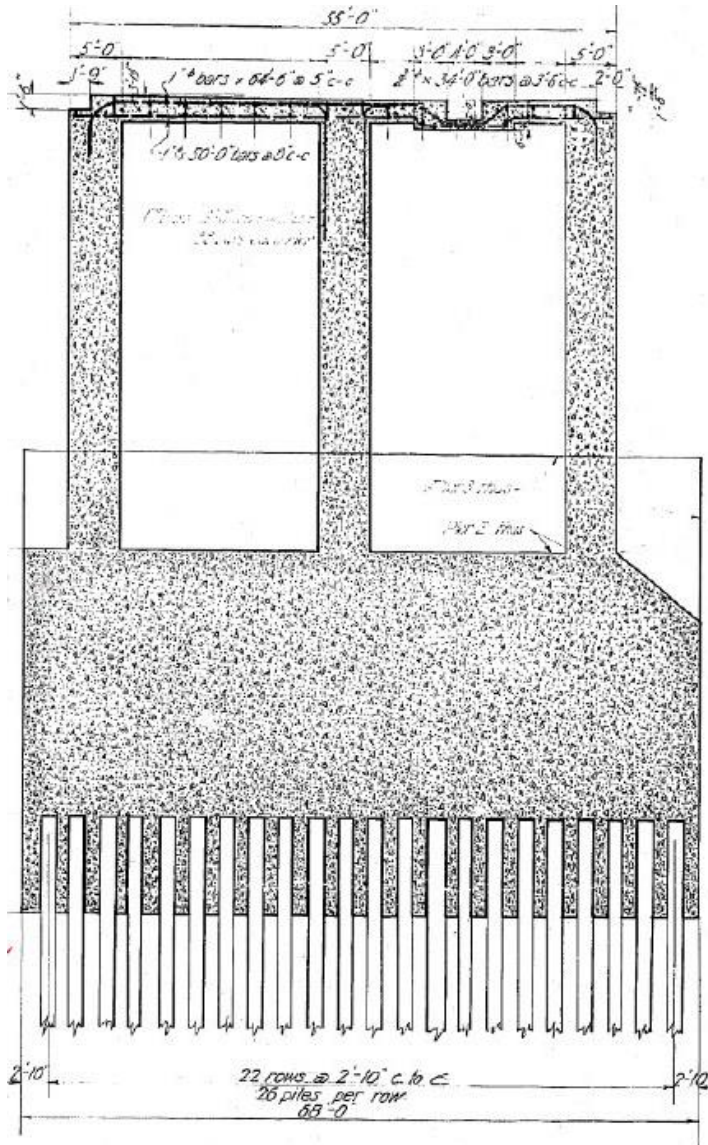
Figure 5-28. Bascule Pier Lower Walls Unreinforced

In examining the as-built plans (Multnomah County 1924), the lower parts of the piers below the pit floor are not reinforced (see Figure 5-28). The unreinforced and under-reinforced concrete pier wall is vulnerable under seismic loads and lateral movement. The pier wall reinforcing is not detailed as required per current seismic design standards. Major deficiencies include:

- No dimensions appear in the as-built plans for rebar embedment length, lapping splice length, and seismic hook details. Bridges built in the 1920s typically do not meet current seismic design requirements for the embedment length and splice length, etc. During an earthquake, the reinforcement would likely pull out and lose the load-carrying capacity.
- Unreinforced plain concrete was used in the lower portion of the piers and the walls. This unreinforced concrete will crack and fall apart during an earthquake, causing the piers to collapse. This concrete has a C/D ratio of 0.20 for this failure mode.

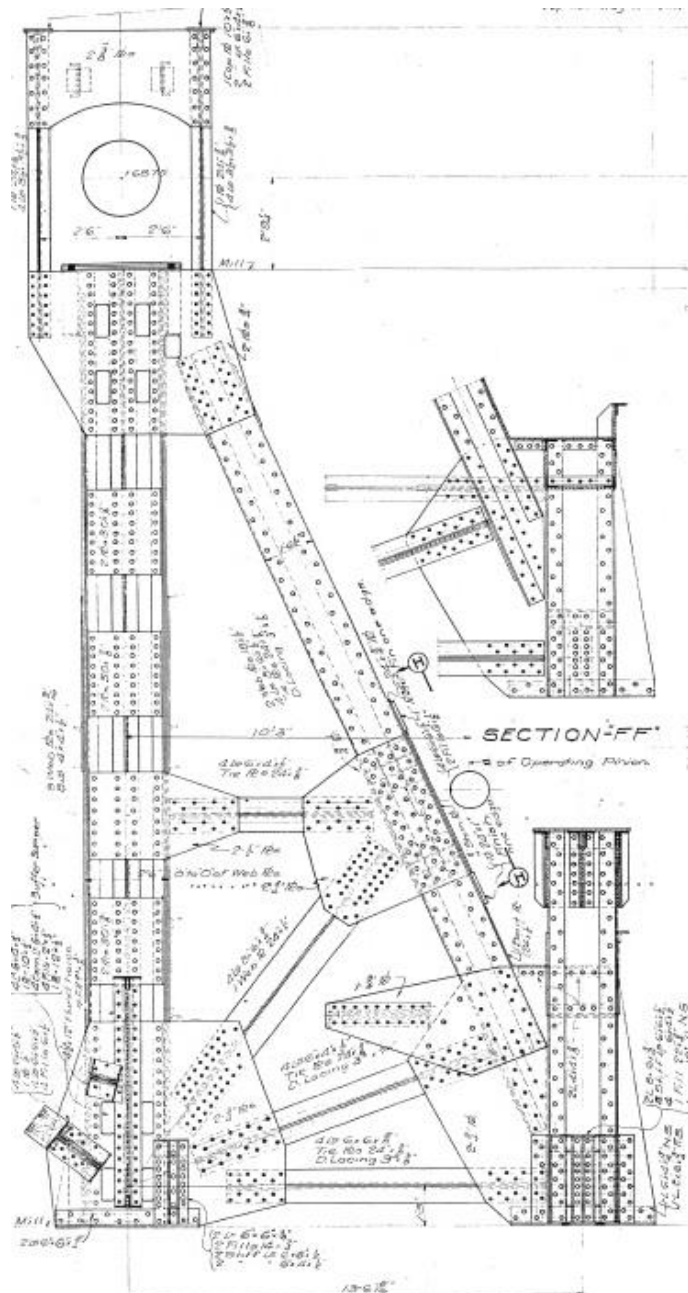
Figure 5-29. Trunnion Tower Support Frame

Lateral restrainers were installed during the main span rehabilitation in 2005 (Multnomah County 2005). These restrainers were installed to connect the trunnion tower support frames to the side walls of the bascule piers. Since the pier walls are not reinforced for seismic loads, these restrainers will not be effective during a design-level seismic event.

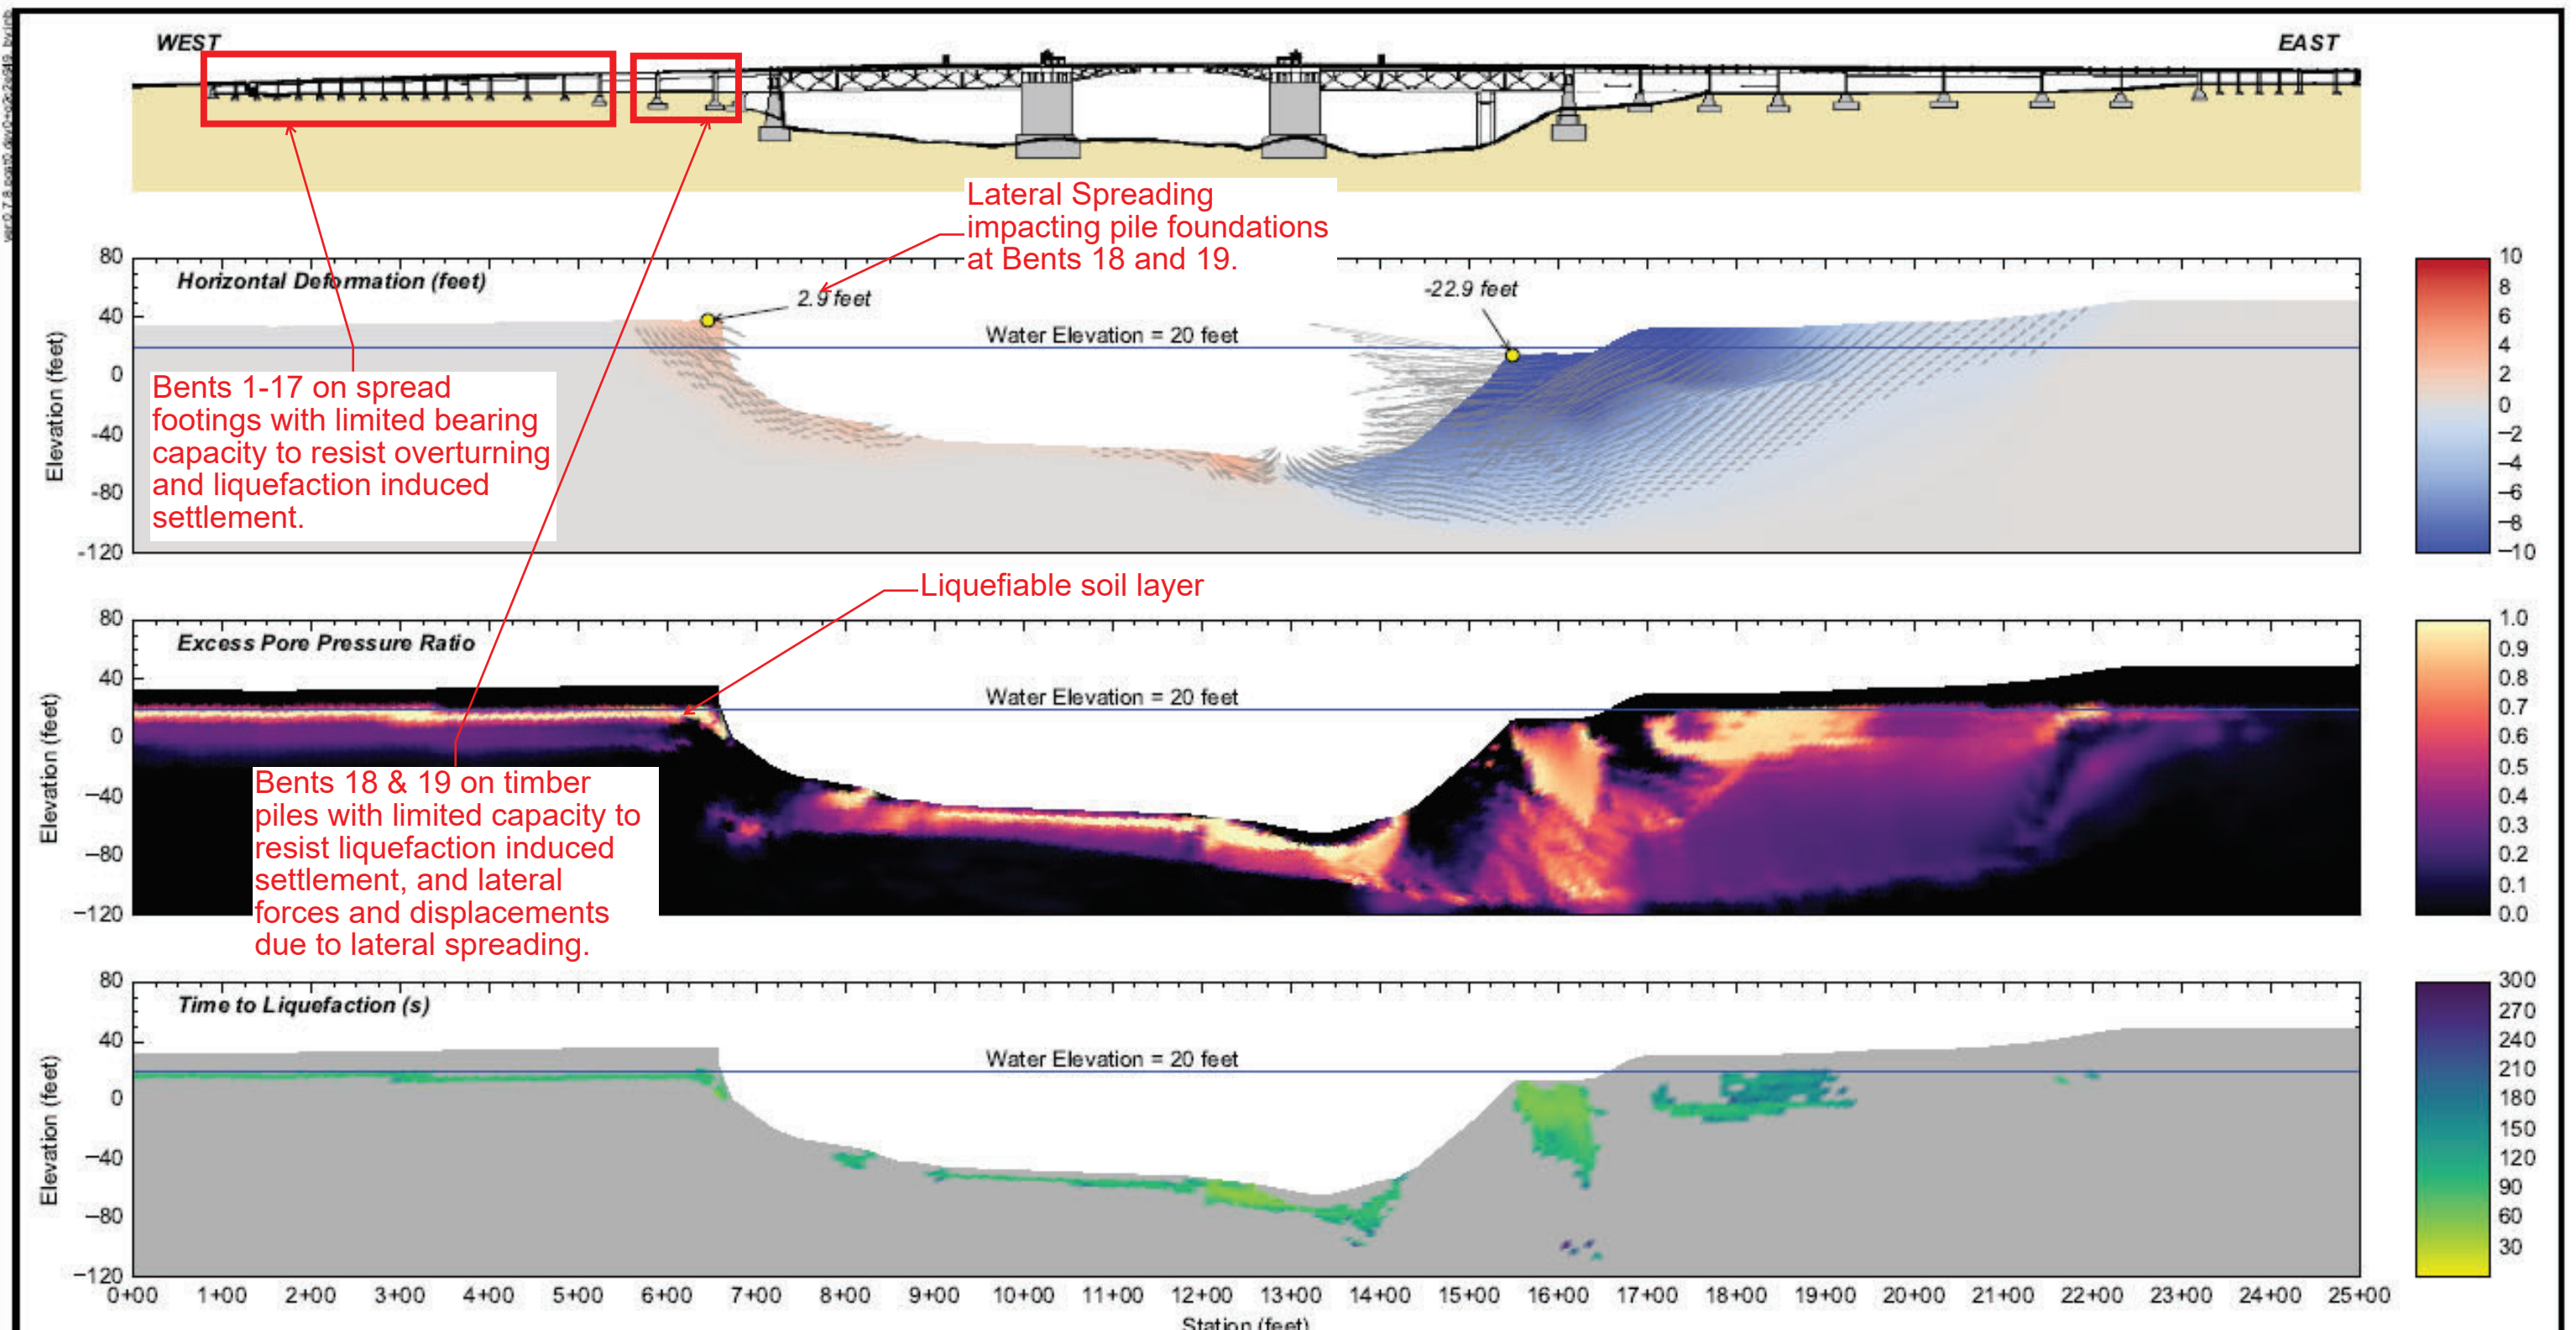
W6

Bents 1-17 on spread footings with limited bearing capacity to resist overturning and liquefaction induced settlement.

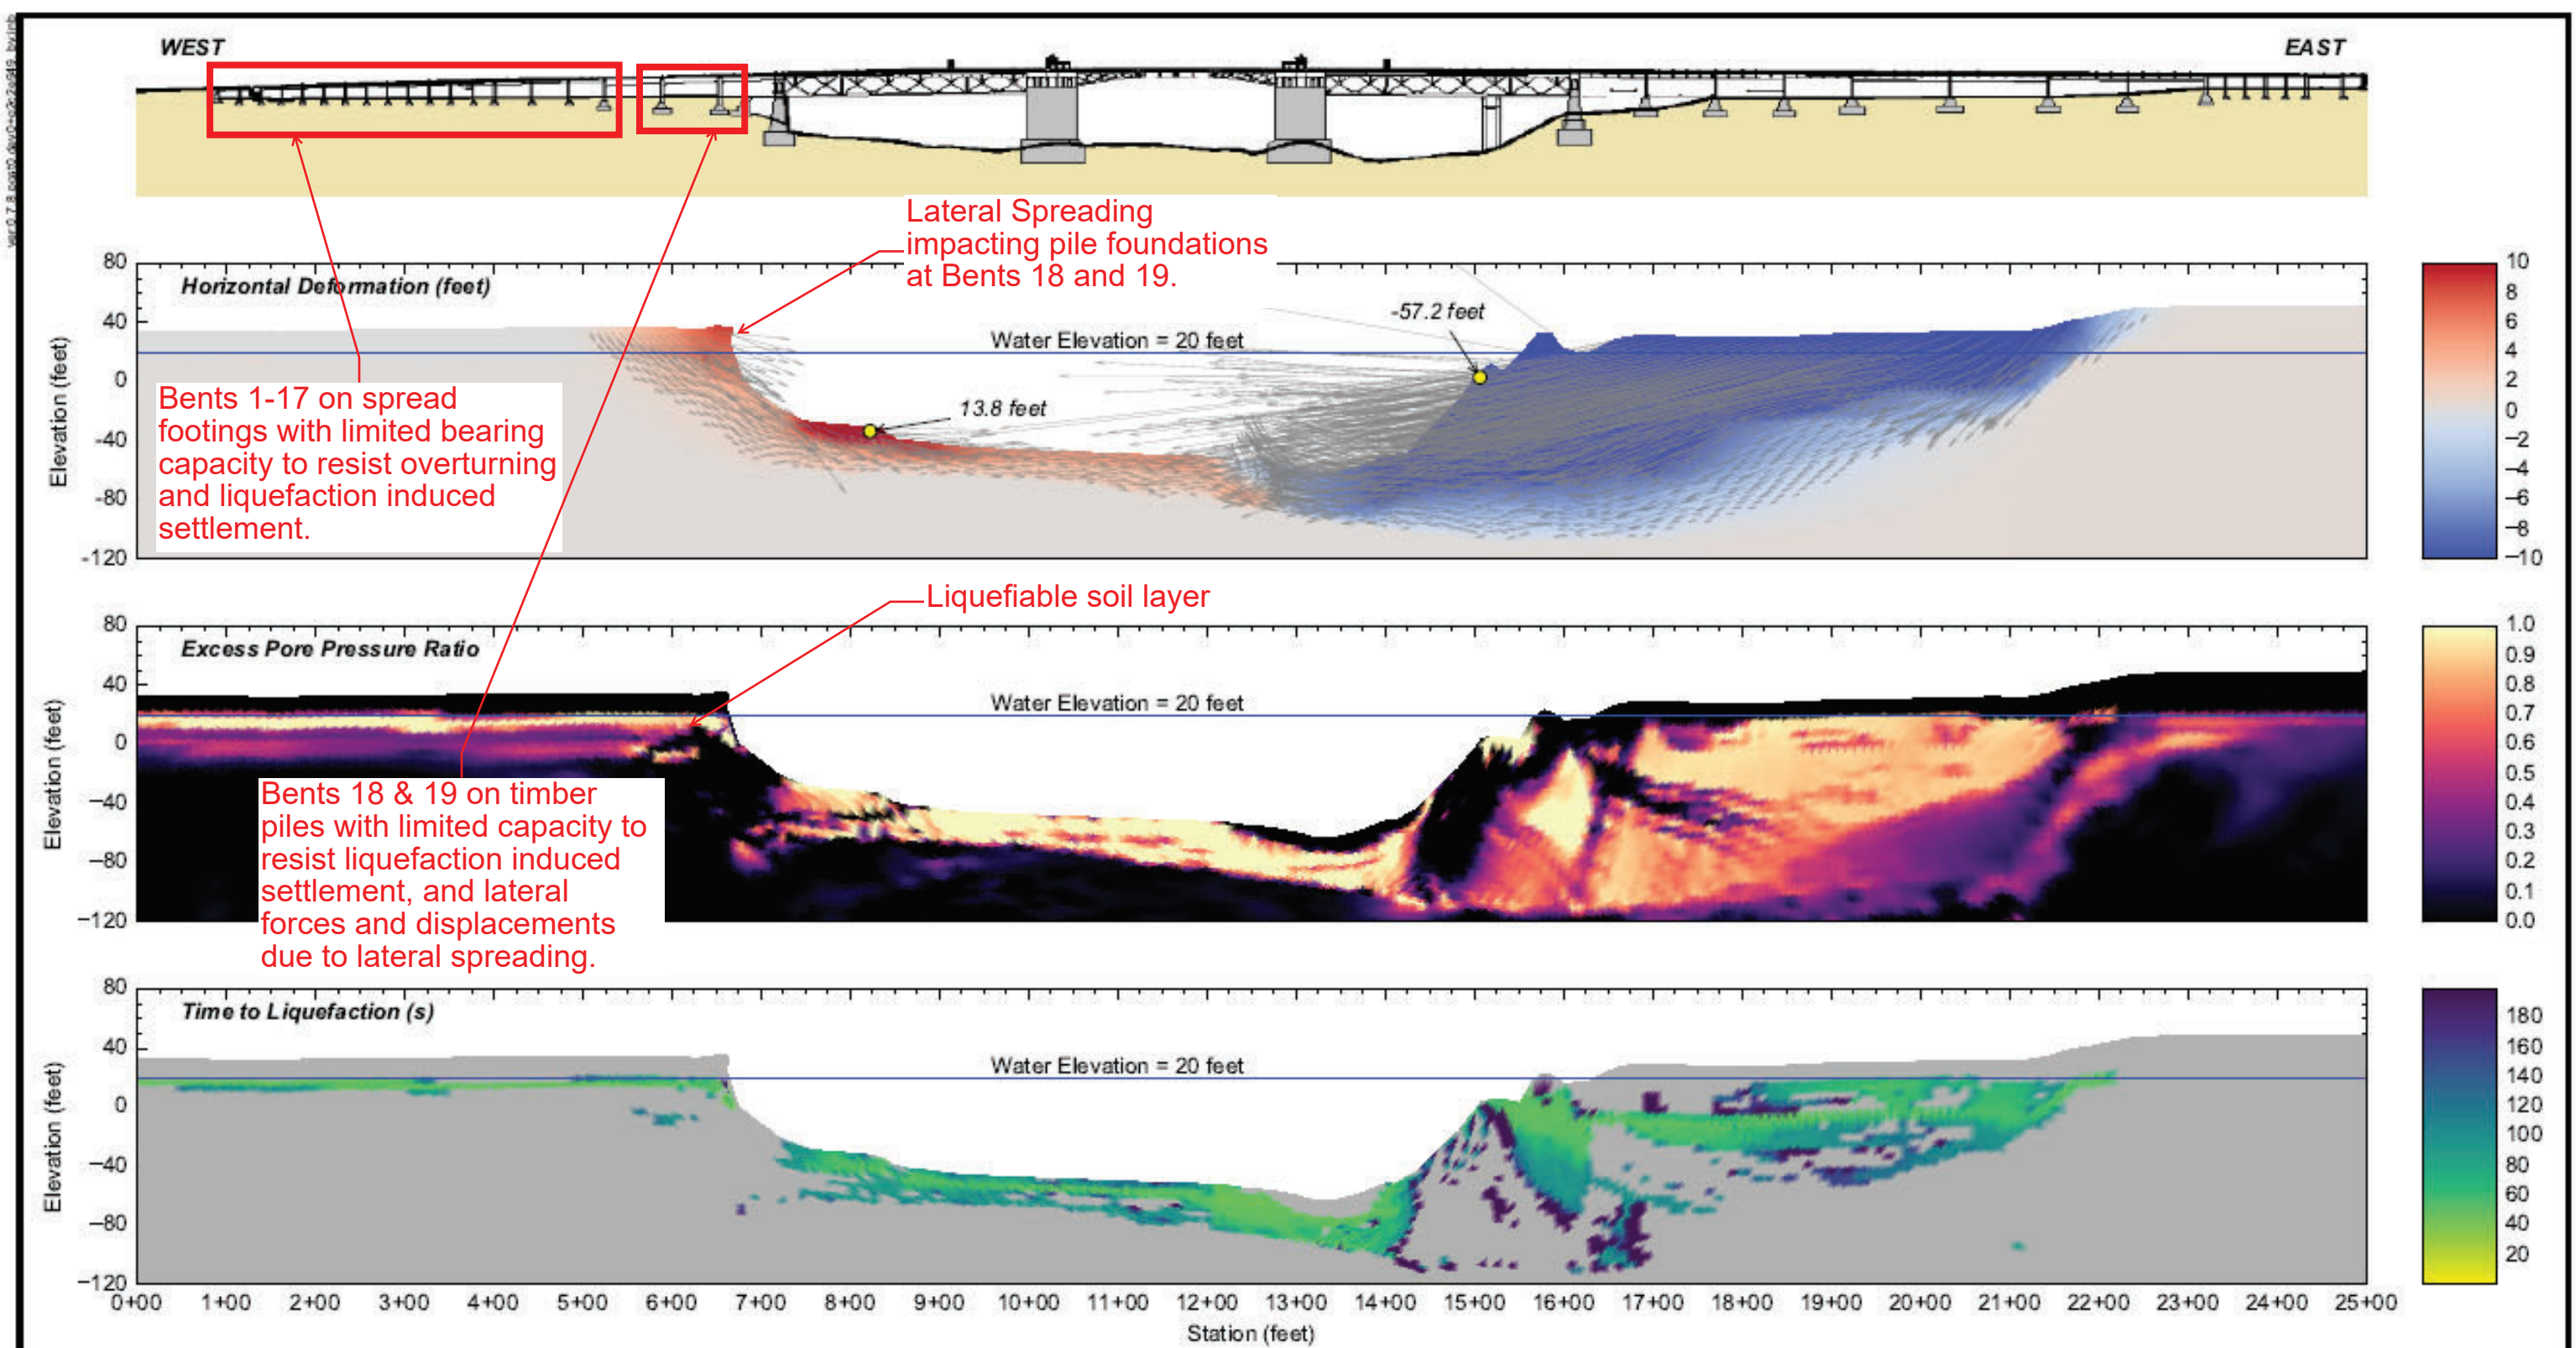
W7
CSZ

Bents 1-17 on spread footings with limited bearing capacity to resist overturning and liquefaction induced settlement.

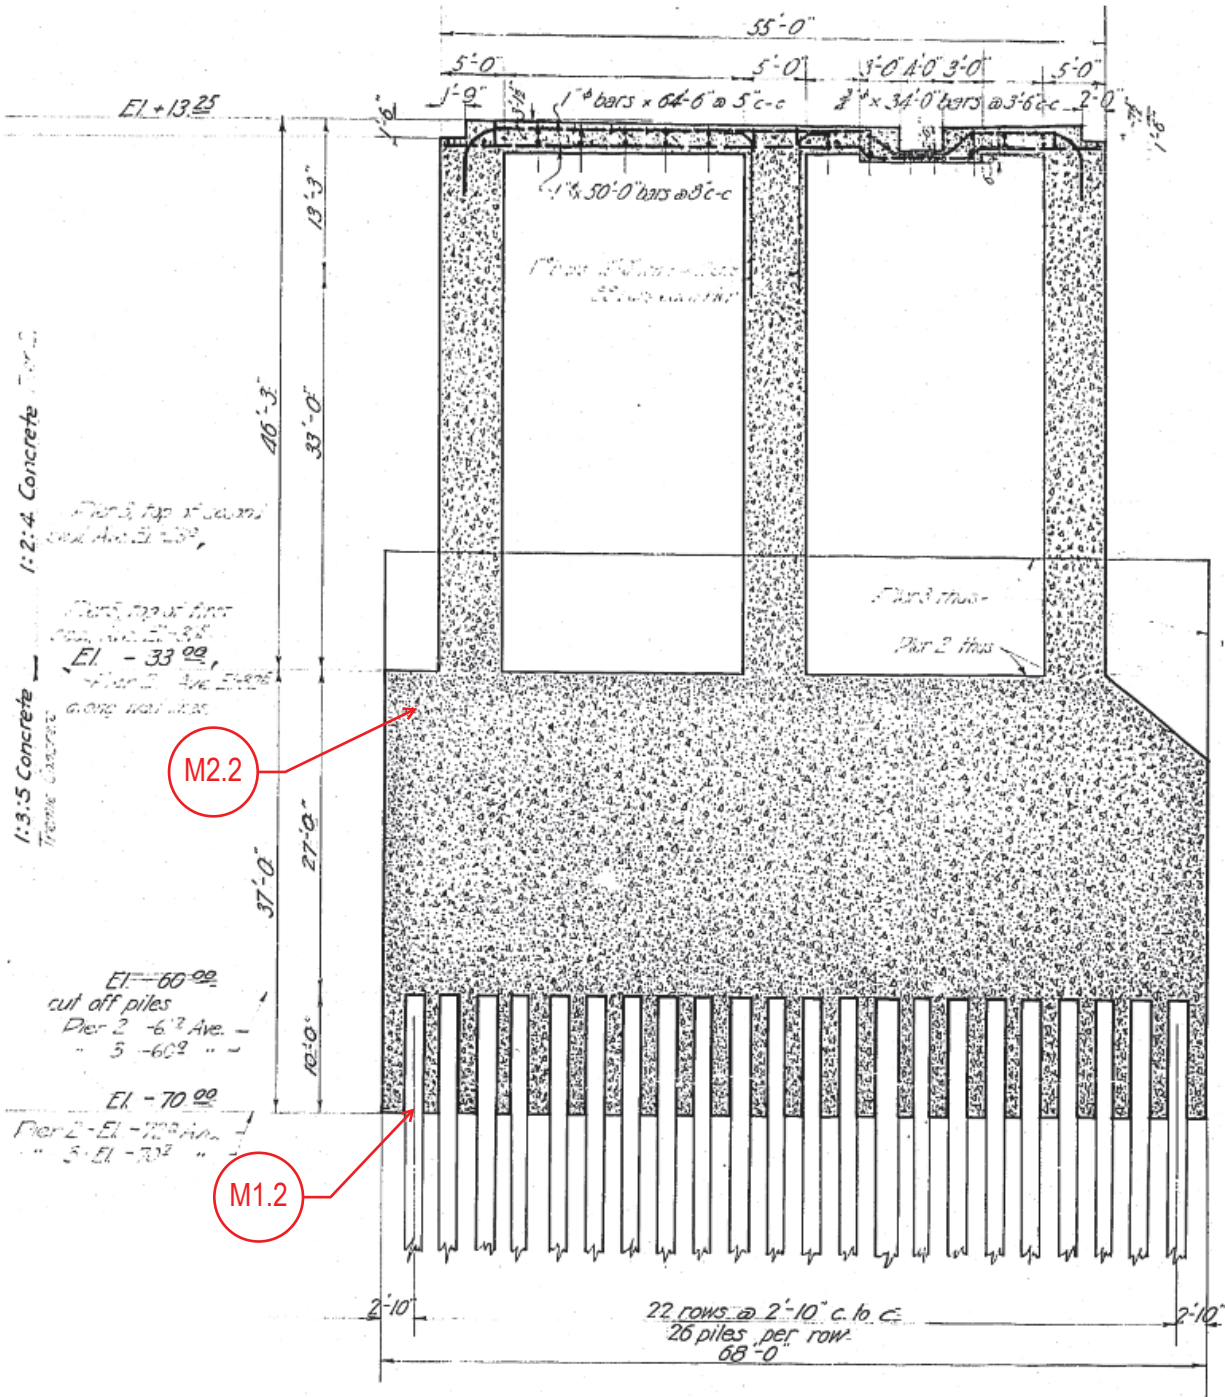
Concrete pile caps are unreinforced. This limits flexural capacity to the cracking strength of the concrete. Shear capacity is limited to V_c .

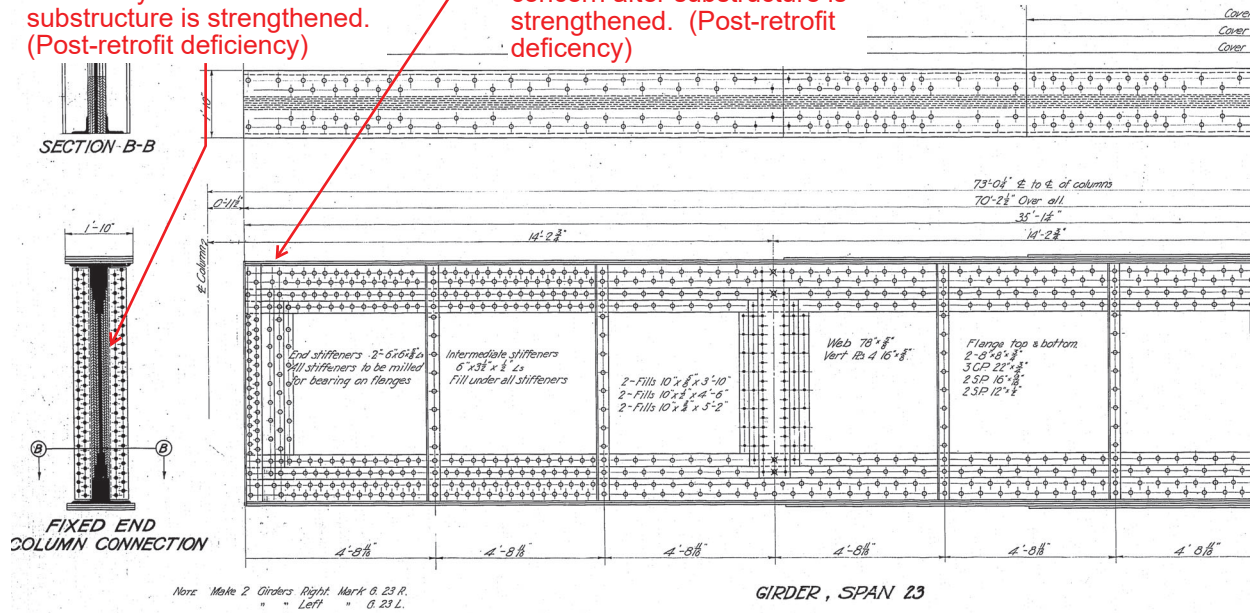
Reduced flange section at fixed end impacts moment capacity of girder / floorbeam connection. Potentially a concern after substructure is strengthened. (Post-retrofit deficiency)

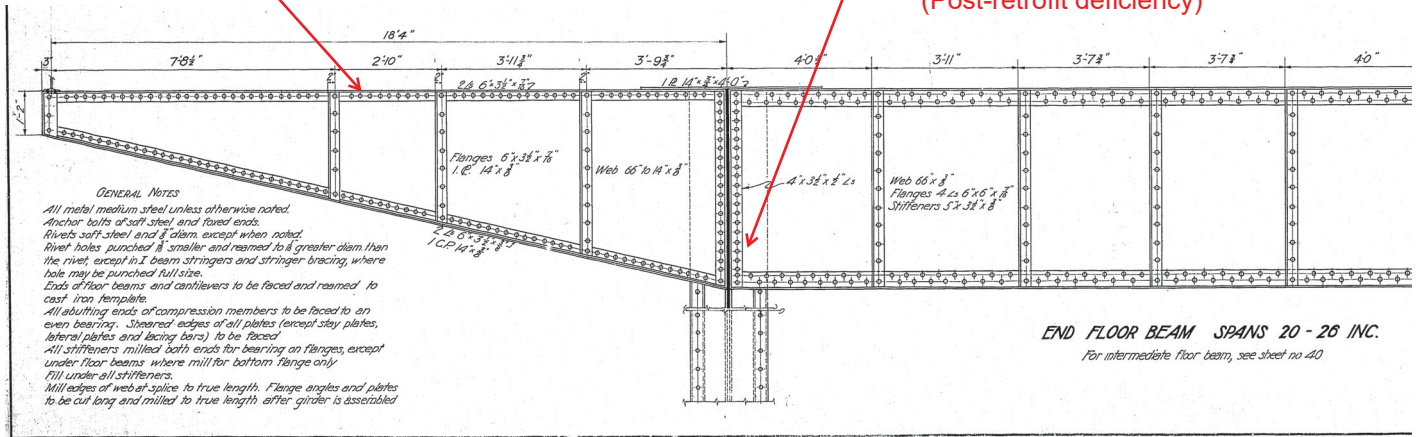
Riveted connection not originally designed to resist additional moment from seismic loading. Potentially a concern after substructure is strengthened. (Post-retrofit deficiency)

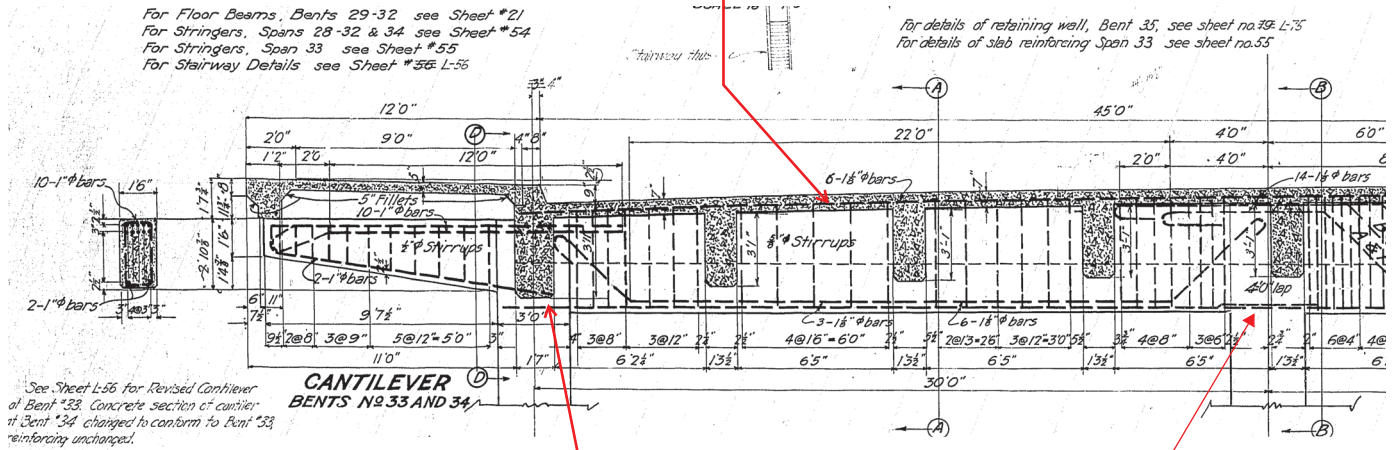
At isolated locations, inadequate negative moment capacity at midspan to remain maintain elastic behavior for CSZ event.

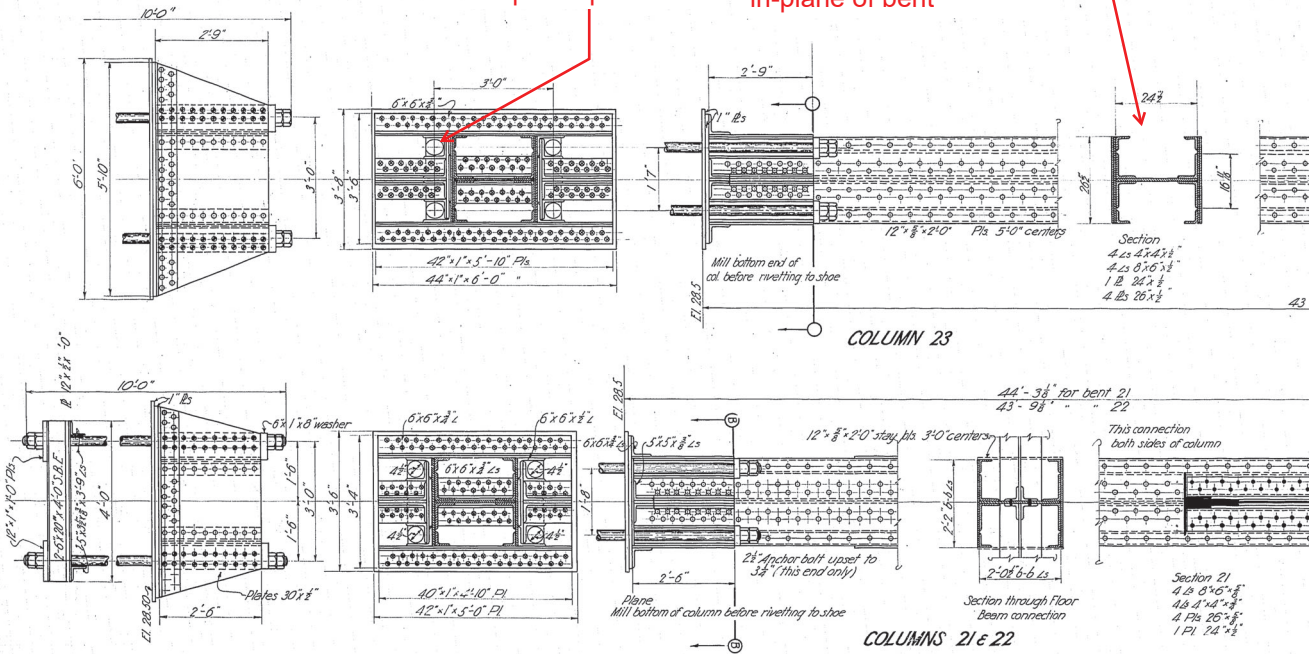
Column orientation does not consider seismic induced transverse movement. Limited weak axis flexural strength in-plane of bent

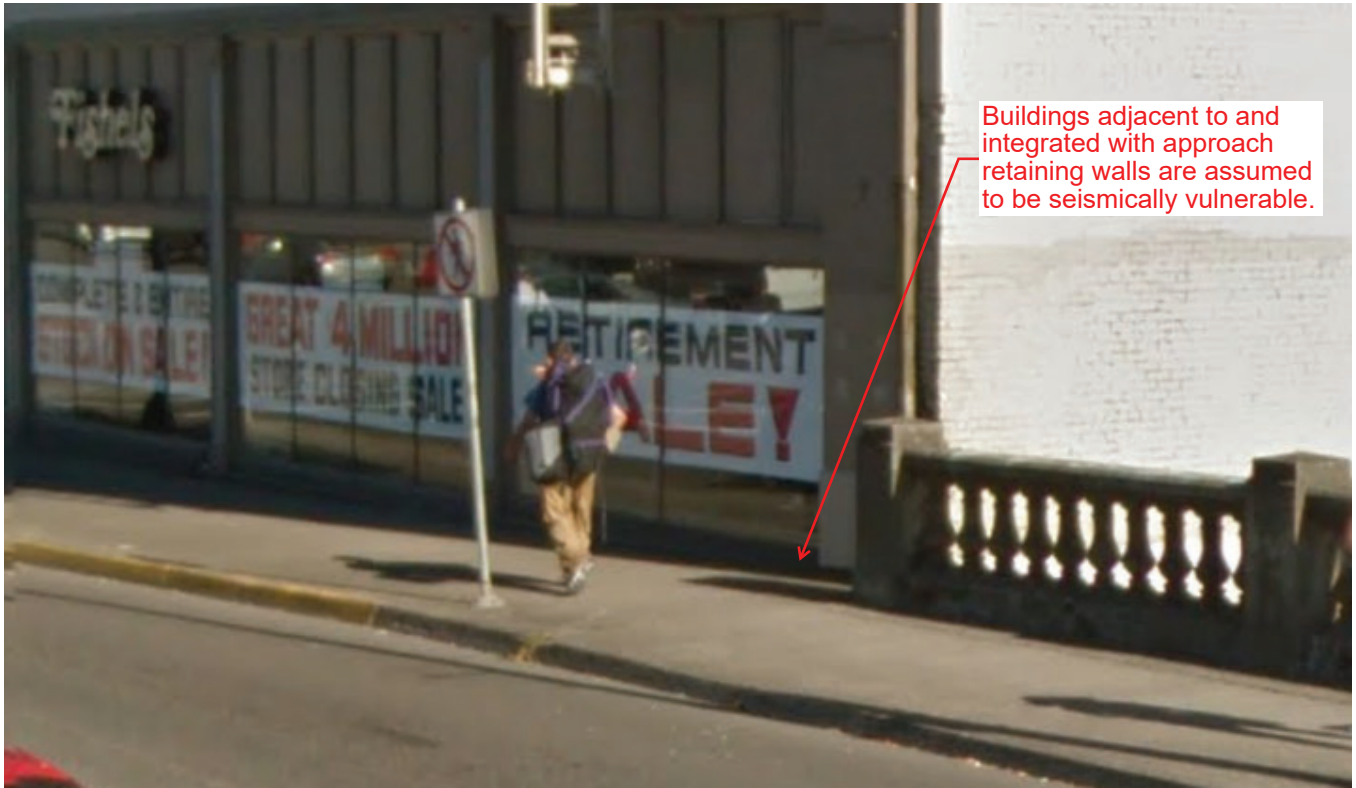
E10

Buildings adjacent to and integrated with approach retaining walls are assumed to be seismically vulnerable.
