October 1, 2025

Acom Consulting, Inc.  
5200 Meadows Road, Suite 150  
Lake Oswego, OR 97035

**Re:   Geologic Hazards Evaluation  
      POR TUMALT  
      11499 NE McLoughlin Parkway  
      Cascade Locks, Oregon  
      CWE Project: Acom-13-01-1**

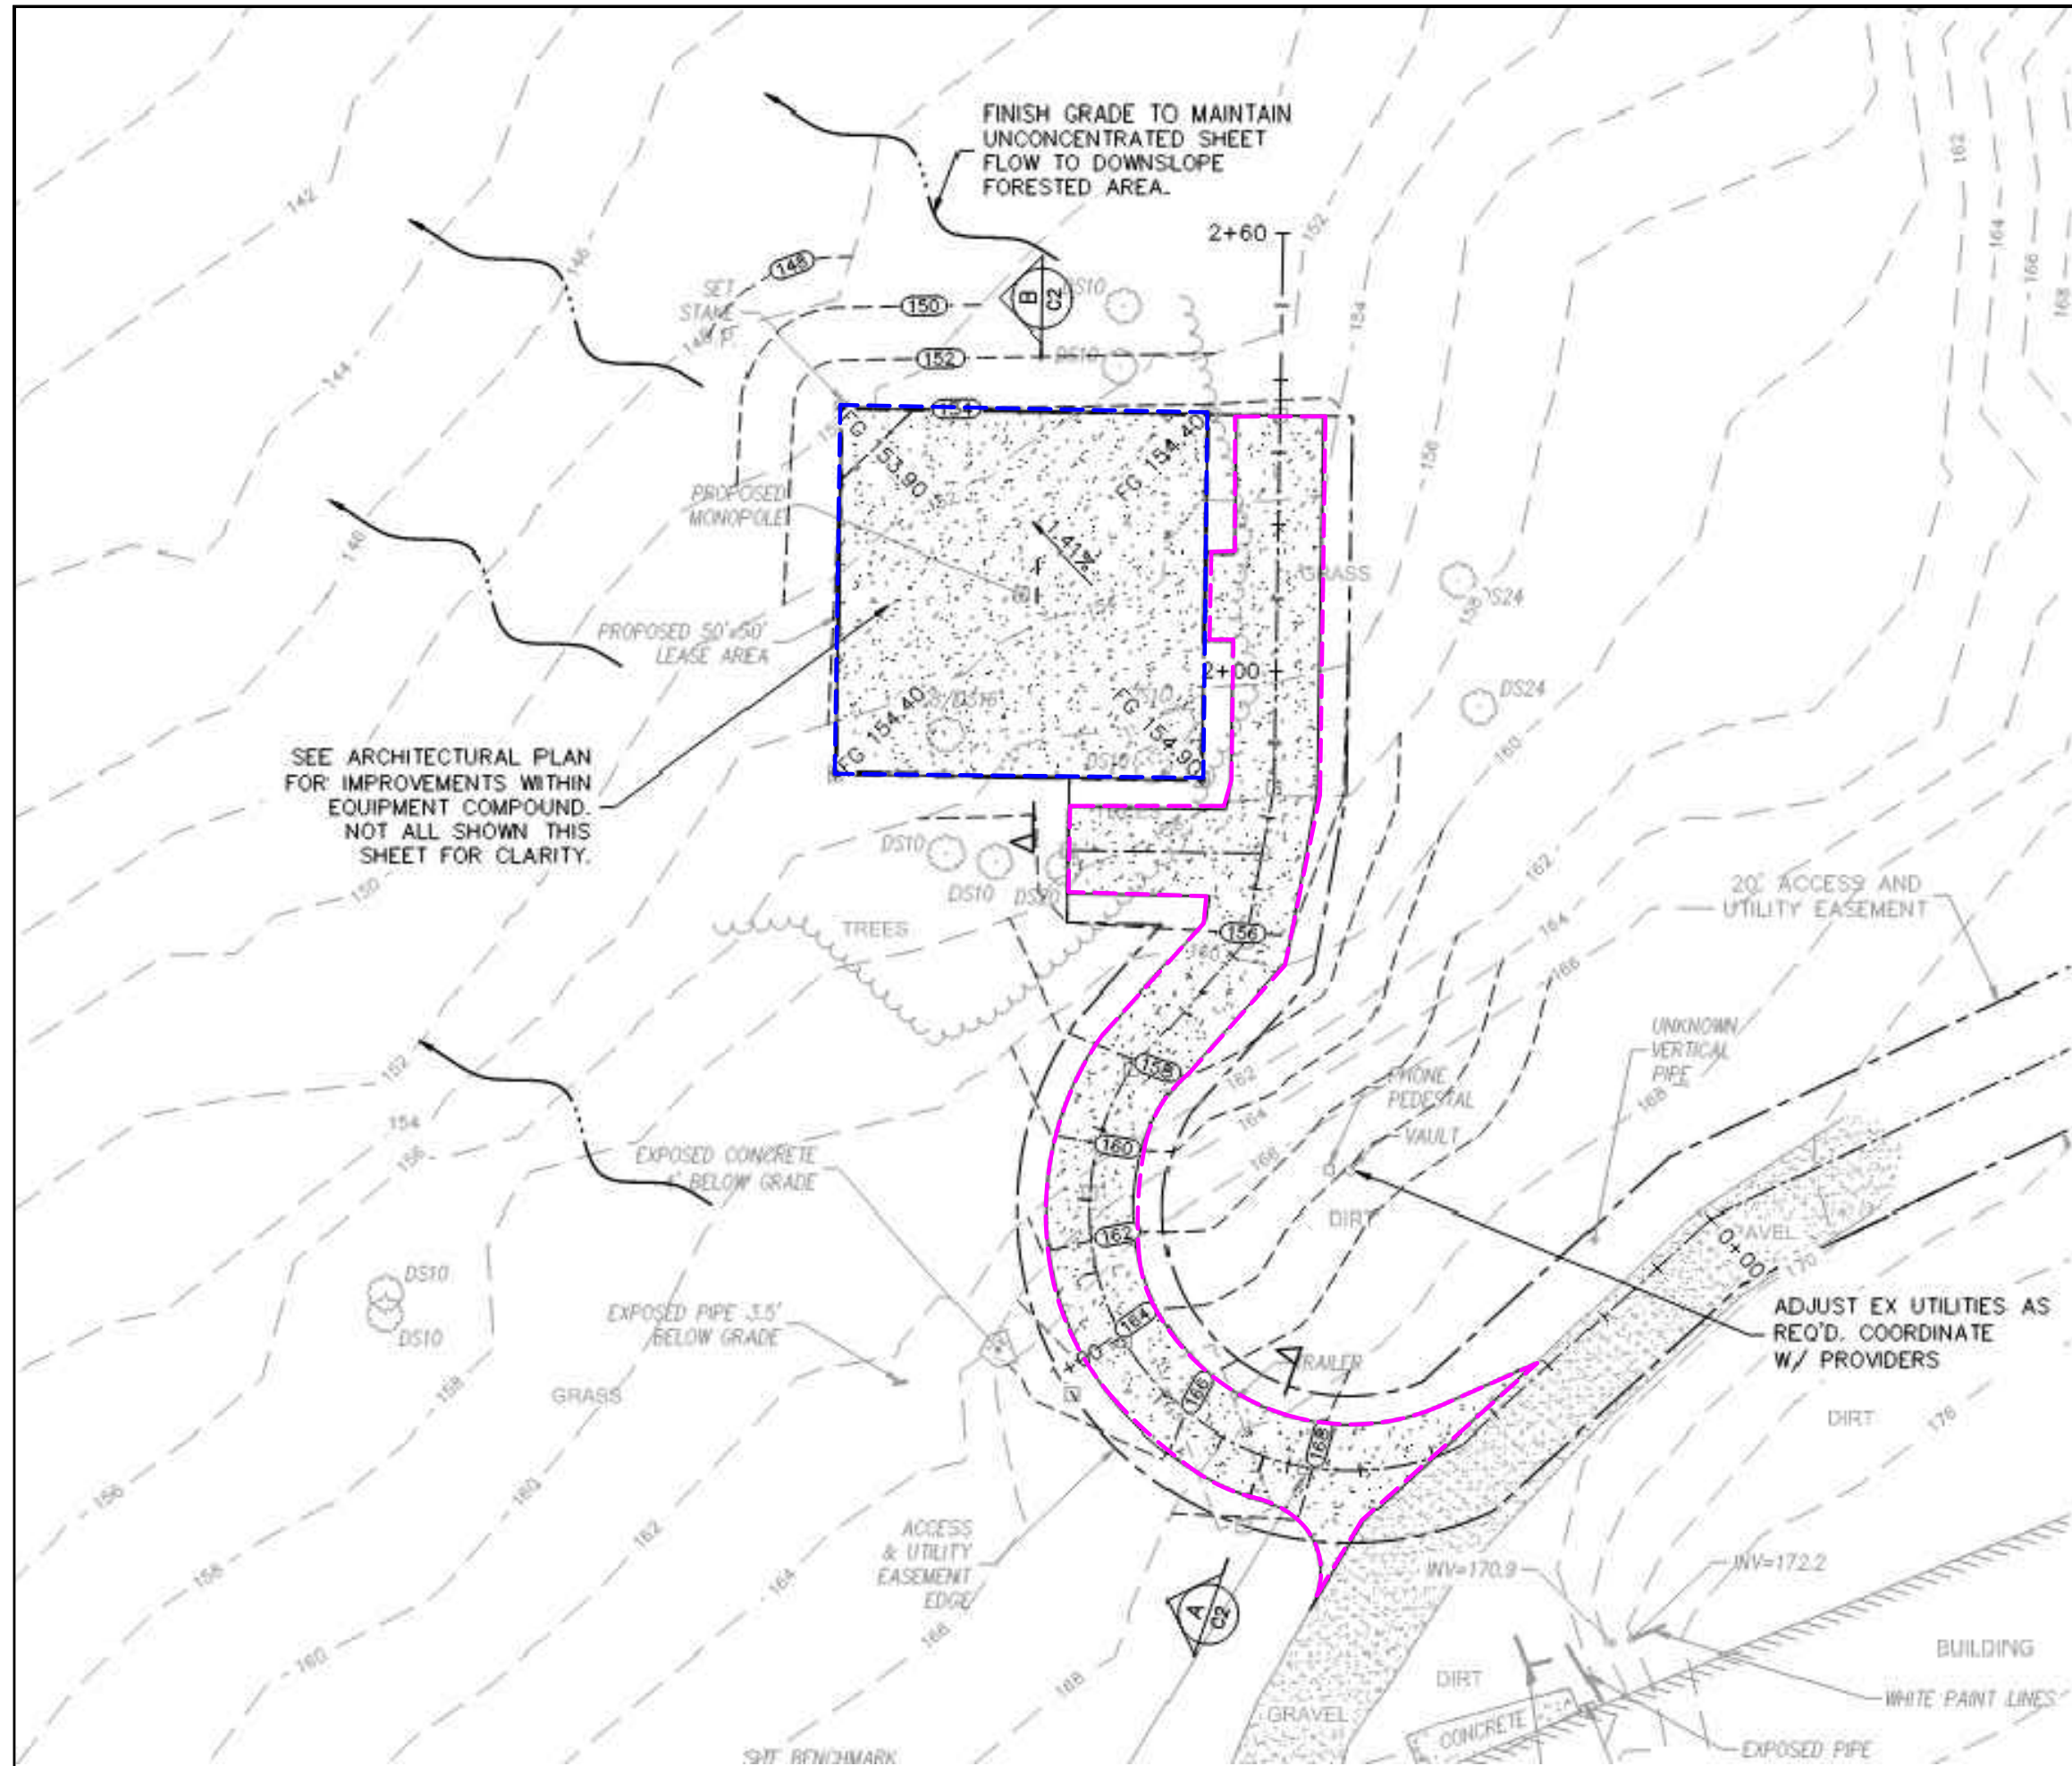
As shown on Figure 2, the monopole tower and equipment compound are proposed approximately 140 feet northwest of the existing building. The proposed access drive extends from the equipment compound to the existing gravel drive located adjacent to the building. The site is generally vacant and vegetated with mature trees, grass, and brush. Several feet of exposed gravelly fill soil is present north of the existing gravel driveway. Boulders were observed to be stockpiled near the fill material. The envelope of the equipment compound had not been cleared of vegetation at the time of our site reconnaissance.

The site slopes down from the southeast to the northwest, with elevations ranging from approximately 170 to 150 feet. Grades range from approximately 10 to 20 percent, with localized steeper areas along the exposed fill slope. During our site reconnaissance, we did not observe any areas of groundwater seepage or encounter evidence of significant erosion, slope failures, or recent debris flows.
