Real-World Geotechnical Solutions
Investigation • Design • Construction Support

April 30, 2019
Project No. 19-5200

**RE: GEOTECHNICAL INVESTIGATION & LANDSLIDE HAZARD STUDY
WAIBLINGER HOMESITE
13195 NW MCNAMEE ROAD
MULTNOMAH COUNTY, OREGON**

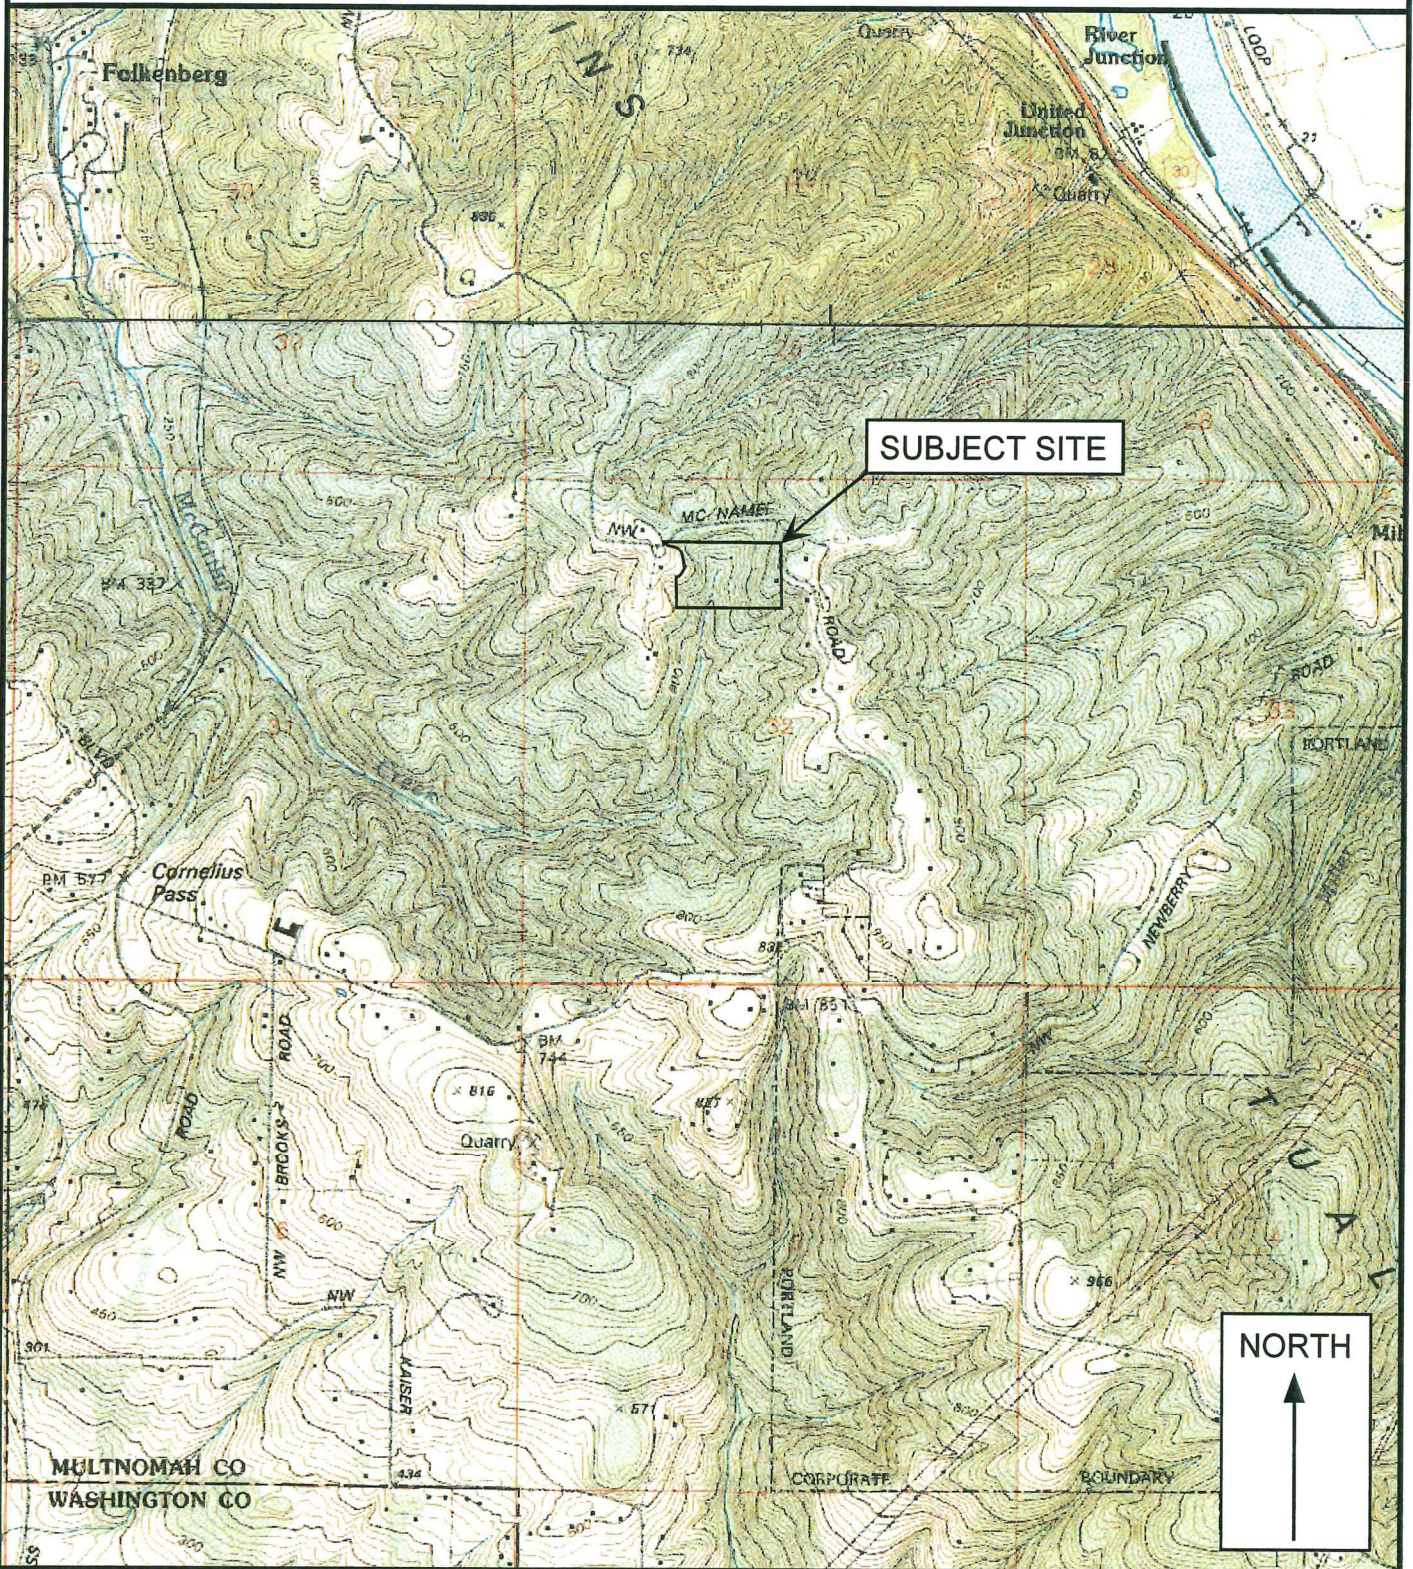
Project: Waiblinger Homesite Multnomah County, Oregon	Project No. 19-5200	FIGURE 1A
--	---------------------	-----------

Our review 1:24,000 scale topographic mapping by the U.S. Geological Survey indicate that the vicinity topography is smooth and uniform, consistent with relatively stable slope conditions. Our review of Lidar based high resolution digital elevation maps depict smooth topography in the vicinity of the proposed home, as indicated on Figure 2 (Dogami, 2019). The statewide landslide database and available landslide inventory mapping indicate two mapped landslides are present on the subject lot, as presented on Figure 2 (Burns et al, 2011; SLIDO, 2019). Both slides are classified as earth flow type landslides that are shallow and historic with movement within the last 150 years (Burns et al, 2011; SLIDO, 2019). The northern earthflow is the slope repair that occurred in 2010. Additionally, a prehistoric (>150 years old) debris flow is mapped adjacent to the incised drainage gully located approximately 500 feet to the west of the proposed homesite (Burns et al, 2011; SLIDO, 2019) as shown on Figure 1B. Several other historic and prehistoric earthflow type landslides are mapped along the McCarthy Creek drainage located southwest of the site (SLIDO, 2019). Seismic slope instability hazard mapping identifies the site vicinity as being in a low relative slope instability hazard zone based primarily on slope steepness (Mabey et al., 1996).

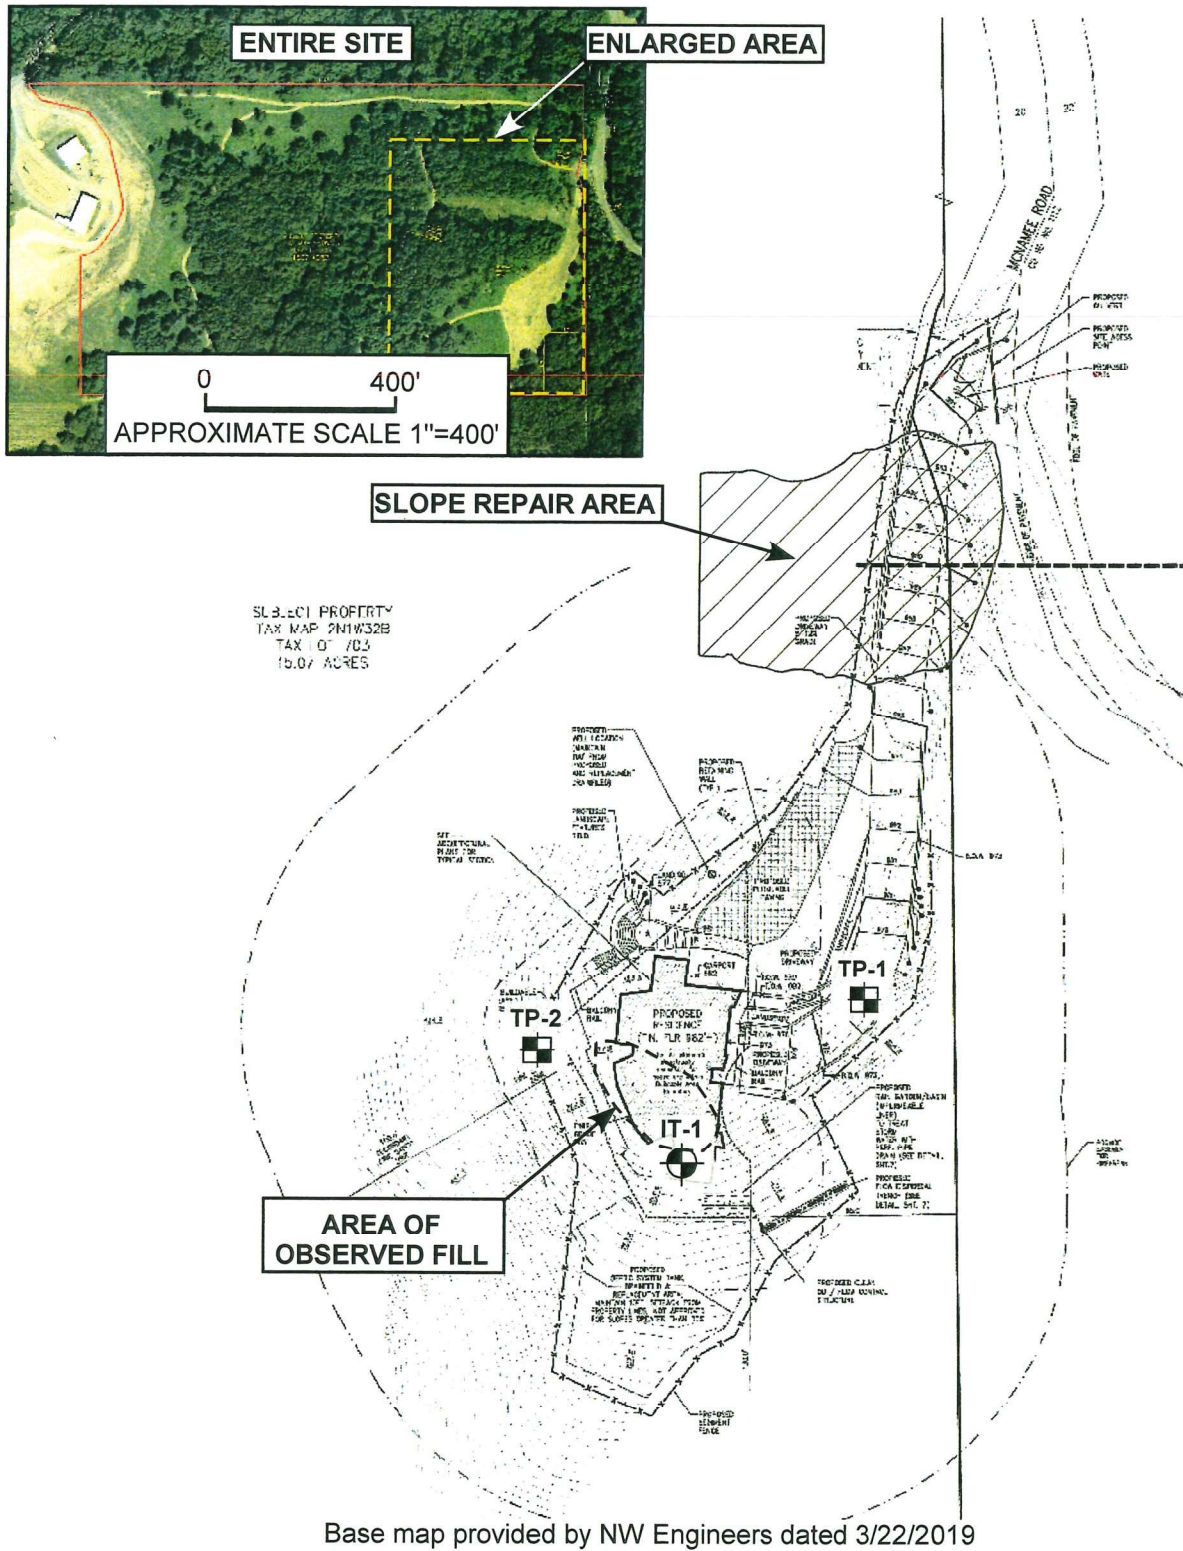
SITE PLAN AND EXPLORATION LOCATIONS

Undocumented Fill: Undocumented fill was not encountered in our explorations conducted for this study; however, an area of fill was observed during our reconnaissance. The approximate location of this fill area is presented on Figure 2. Other areas of fill may be present outside our exploration locations and should be encountered along the existing driveway alignment – in the vicinity of the prior slope repair.

On February 10, 2010, three open-hole, falling-head infiltration tests were performed at the home site in general accordance with City of Portland Stormwater Management Manual guidelines. The tests were conducted in 8-inch diameter holes excavated into native soils at an approximate depth of 4 feet below the ground surface. On March 3, 2010, an additional infiltration test was conducted in an 8-inch-diameter hole excavated into native soils at a depth of 2 feet. All of the test holes were pre-saturated for 4 hours prior to performing the final test measurements. During the tests, water levels were measured over 15 minute intervals with approximate head pressures ranging between 8 and 10 inches until three successive measurements showing a consistent infiltration rate were achieved. Soils encountered in the pits consisted of clayey silt with a field determined Unified Soil Classification System designation of ML. The approximate test location is shown in Figure 2.
