October 19, 2010

Project No. 10-1938

**RE: ADDENDUM TO GEOTECHNICAL INVESTIGATION AND LANDSLIDE HAZARD STUDY
LUETHE PARTITION LOT 2
SECTION 32 2N 1W TAX LOT 800
MULTNOMAH COUNTY, OREGON**

**RE: GEOTECHNICAL INVESTIGATION AND LANDSLIDE HAZARD STUDY
LUETHE PARTITION LOT 2
SECTION 32 2N 1W TAX LOT 800
MULTNOMAH COUNTY, OREGON**

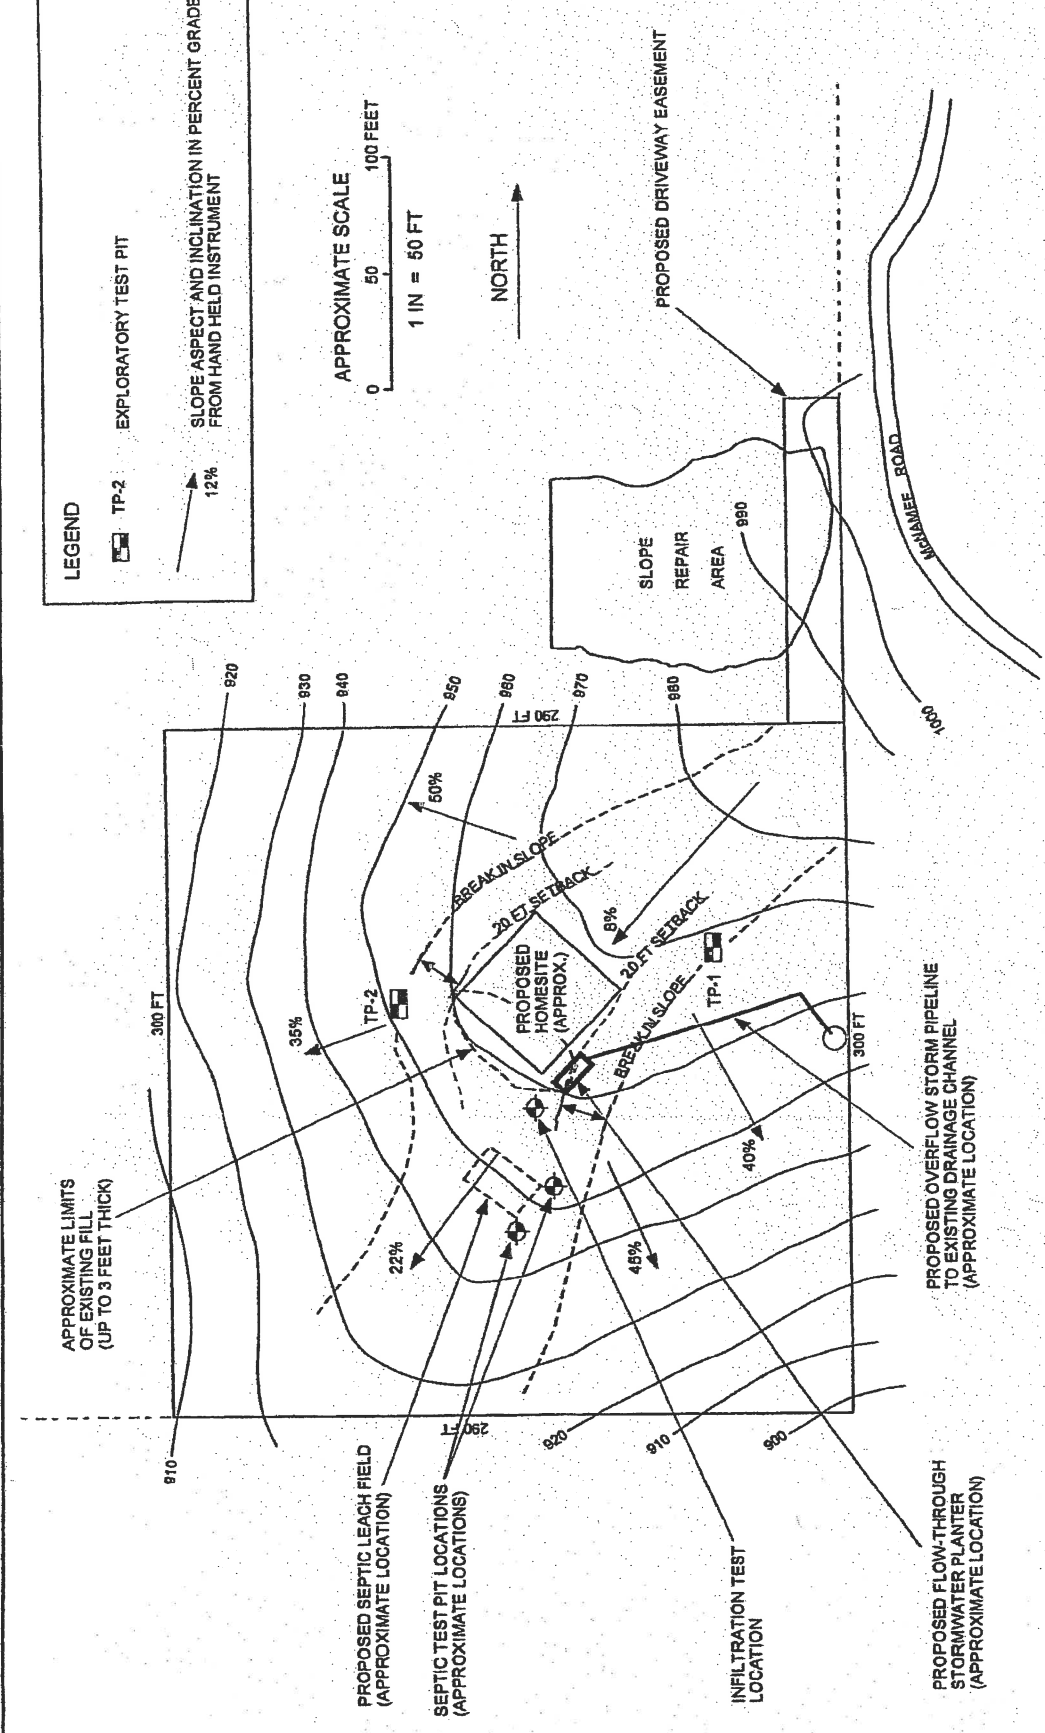
FIGURE 2

It is our understanding that a septic leach field is proposed on the slope south of the proposed homesite at the approximate location shown in Figure 2 (attached). We further understand that geotechnical review of possible adverse effects that the system might pose to slope stability have been requested because the slope at the leach field location exceeds 20% grade.

On October 15, 2010, GeoPacific engineering geologist, Paul A. Crenna, visited the project site and reviewed slope conditions in the vicinity of the proposed leach field and stormwater facilities. Field measurements with a hand-held clinometer indicate that the slope at this location inclines at about 22% grade. Slope geomorphology is smooth and uniform consistent with relatively stable slope conditions, and no evidence of prior slope instability was observed on slopes immediately below the proposed leach field.

In our opinion, the proposed septic leach field has a low potential for adverse effects on slope stability; however, due to space conflicts with the planned on-site stormwater infiltration system, we recommend that the stormwater management plan for the homesite be modified. We recommend that roof runoff be discharged to a stormwater flow-through planter constructed in accordance with the standard City of Portland detail (attached) with the overflow outlet discharging to the natural drainage along the eastern property line as shown in Figure 2. We anticipate that the pipeline can be installed in a shallow hand dug trench in accordance with the International Plumbing Code.

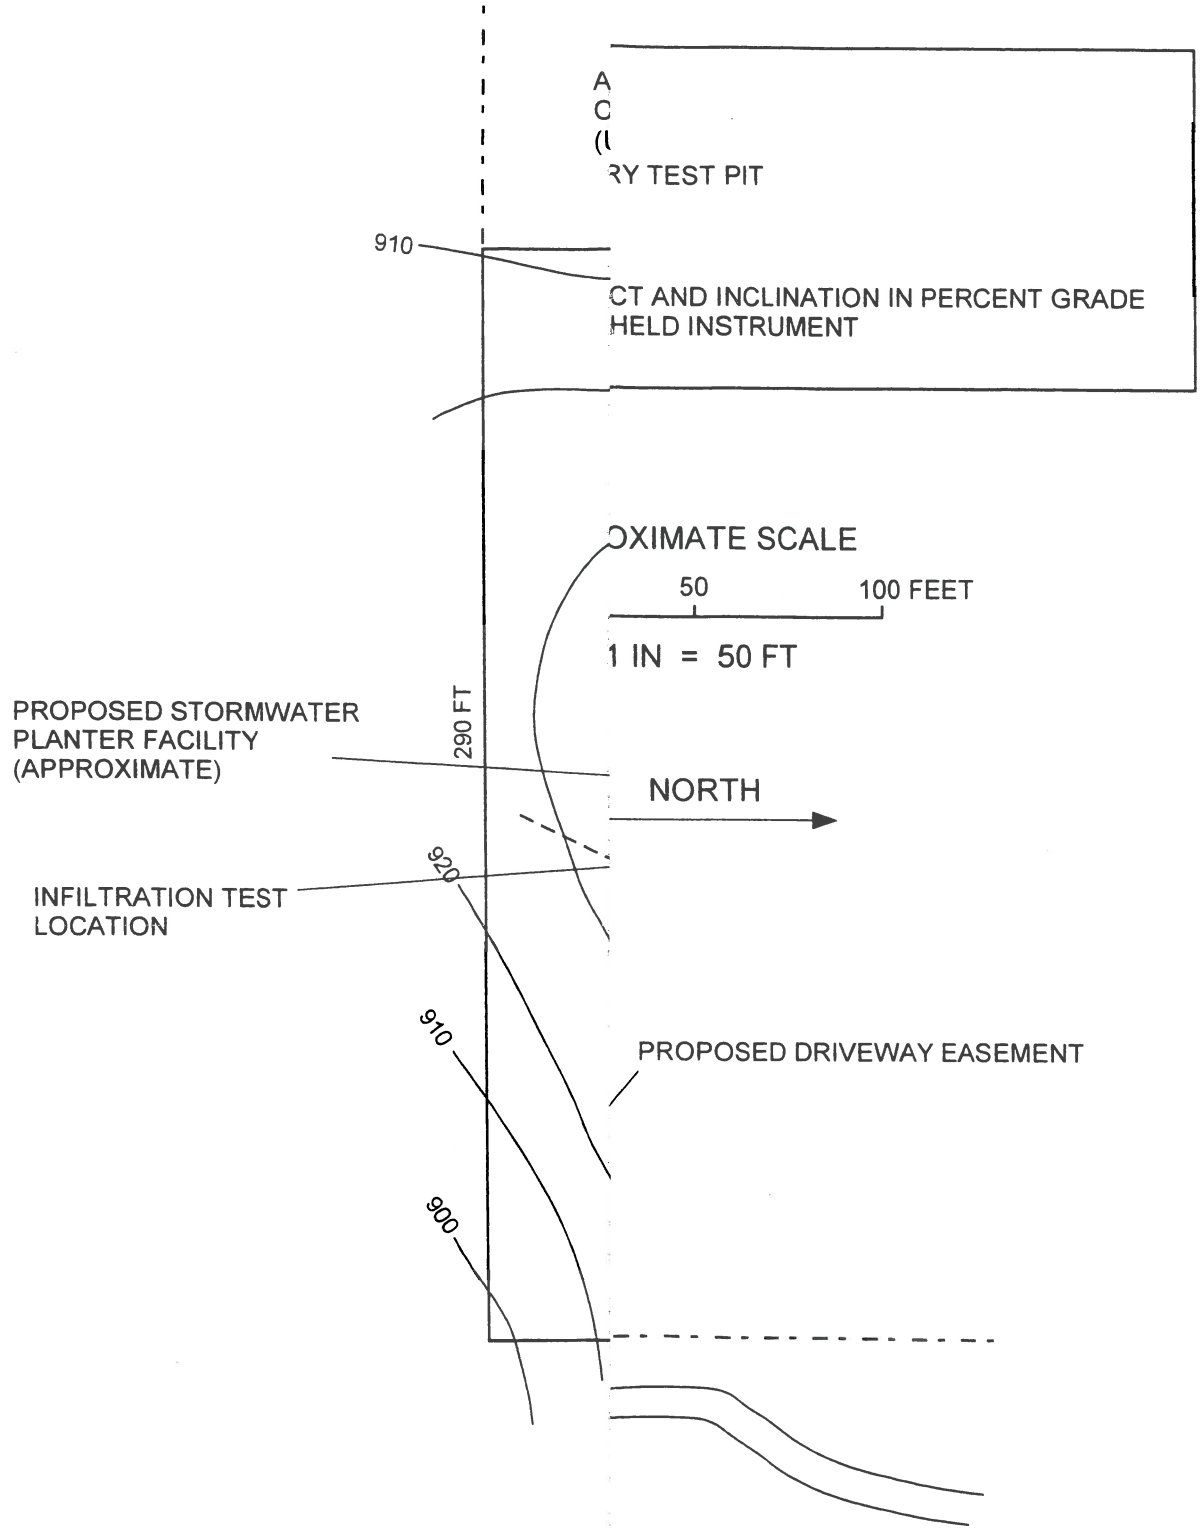
FIGURE 2

The proposed homesite is situated on a gently sloping ridgeline inclining at about 8% to 22% grade (Figure 2). The side slopes on the southeast incline at 40% to 45% grade descending to an incised drainage channel beyond the boundaries of the property. Reconnaissance observations indicate that slope geomorphology is generally smooth and uniform, consistent with relatively stable slope conditions. No geomorphic evidence of prior deep-seated slope instability (such as hummocky topography, benches or old scarps) was observed. The side slopes on the northwest incline at 35% to 50% grade descending to an incised drainage on the central portion of the Tax Lot 800 property. Reconnaissance observations indicate that slope geomorphology on the Lot 2 property is generally smooth and uniform, consistent with relatively stable slope conditions. No geomorphic evidence of prior deep-seated slope instability (such as hummocky topography, benches or old scarps) was observed.

The proposed Lot 2 property is to include a driveway easement that extends from the northeast corner of the property to the McNamee Road right-of-way (Figure 2). This easement lies at the head of a drainage gully which, in January of 2009, experienced a slope failure that encroached into the easement towards McNamee Road (see Figure 2).

On February 10, 2010, three open-hole, falling-head infiltration tests were performed at the home site in general accordance with City of Portland Stormwater Management Manual guidelines. The tests were conducted in 8-inch diameter holes excavated into native soils at an approximate depth of 4 feet below the ground surface. On March 3, 2010, an additional infiltration test was conducted in an 8-inch-diameter hole excavated into native soils at a depth of 2 feet. All of the test holes were pre-saturated for 4 hours prior to performing the final test measurements. During the tests, water levels were measured over 15 minute intervals with approximate head pressures ranging between 8 and 10 inches until three successive measurements showing a consistent infiltration rate were achieved. Soils encountered in the pits consisted of clayey silt with a field determined Unified Soil Classification System designation of ML. The approximate test location is shown in Figure 2.
