Real-World Geotechnical Solutions  
Investigation • Design • Construction Support

January 29, 2019  
Project No. 10-1938

**RE: GEOTECHNICAL INVESTIGATION & LANDSLIDE HAZARD STUDY  
BRADLEE HOMESITE  
13221 NW MCNAMEE ROAD  
MULTNOMAH COUNTY, OREGON**

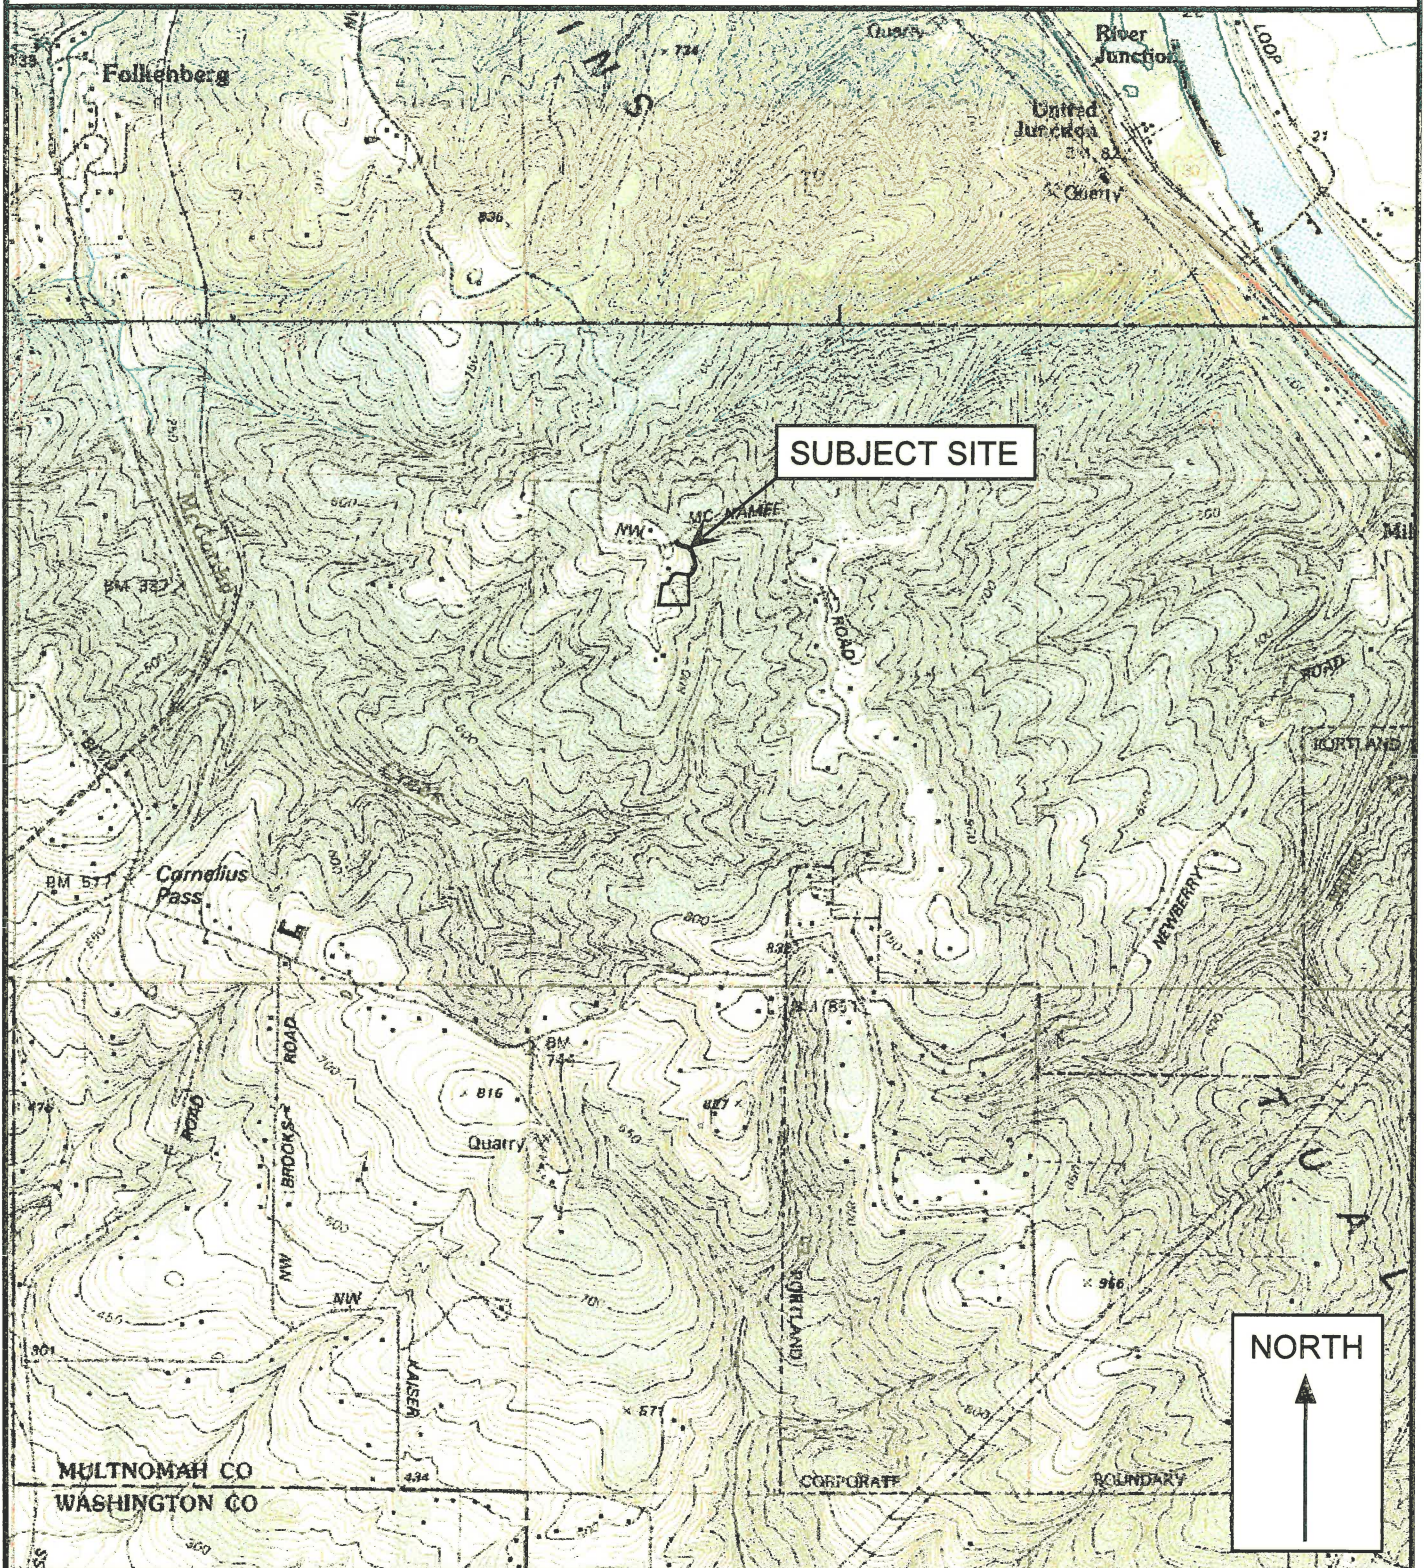
FIGURE 1A

Our review 1:24,000 scale topographic mapping by the U.S. Geological Survey indicate that the vicinity topography is smooth and uniform, consistent with relatively stable slope conditions. The Lidar based high resolution digital elevation maps depict topography following early site grading that occurred in the mid 1990's and prior to grading that was completed in 2016 (Dogami, 2019). The statewide landslide database and available landslide inventory mapping indicate no mapped landslides are present in the vicinity of the homesite; however, the headscarp of a prehistoric (>150 years old) debris flow is mapped within the incised drainage gully located approximately 60 feet to the north of the proposed homesite (Burns et al, 2011; SLIDO, 2019) as shown on Figure 1B. The head of this debris flow is located in an area that has since been filled with engineered fill. Several

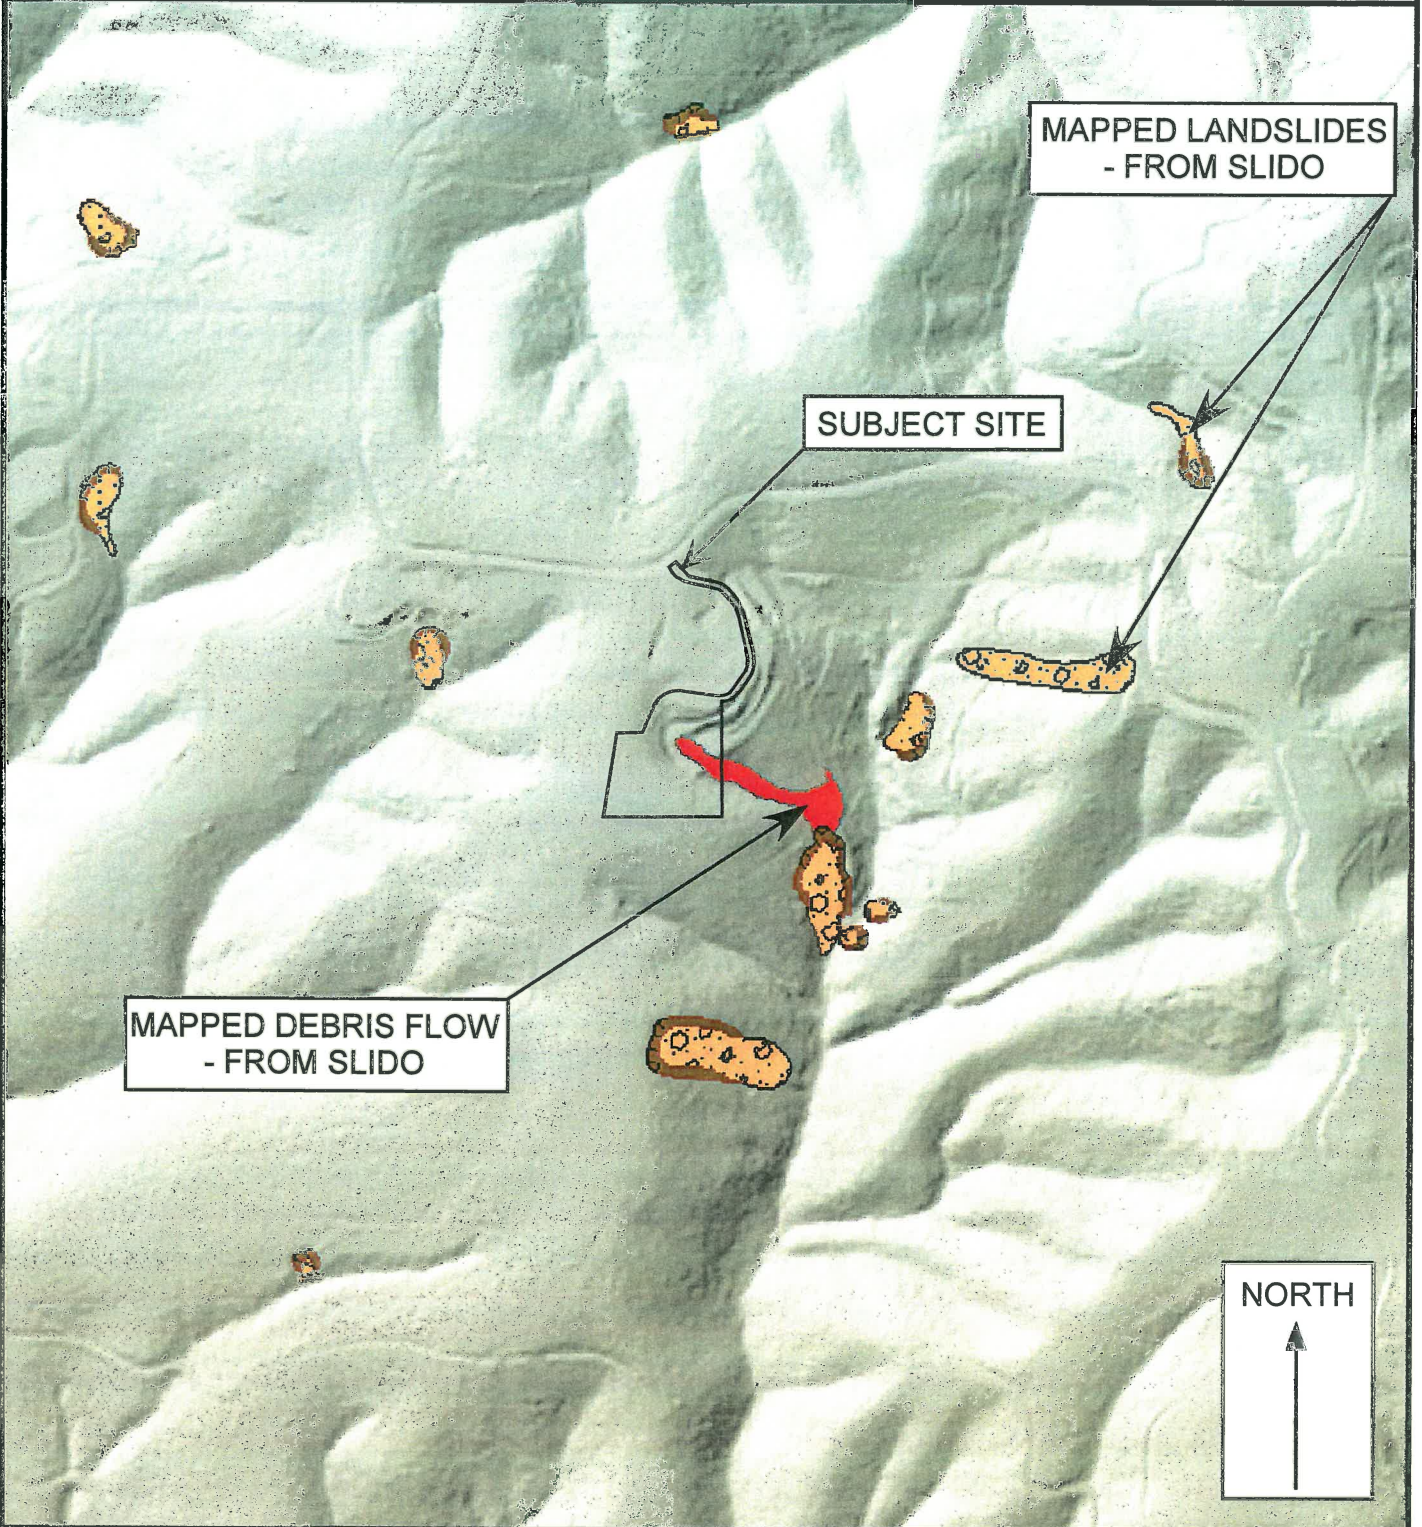
FIGURE 1B

other historic and prehistoric earthflow type landslides are mapped along the McCarthy Creek drainage located east of the site (SLIDO, 2019). Seismic slope instability hazard mapping identifies the site vicinity as being in a low relative slope instability hazard zone based primarily on slope steepness (Mabey et al., 1996).

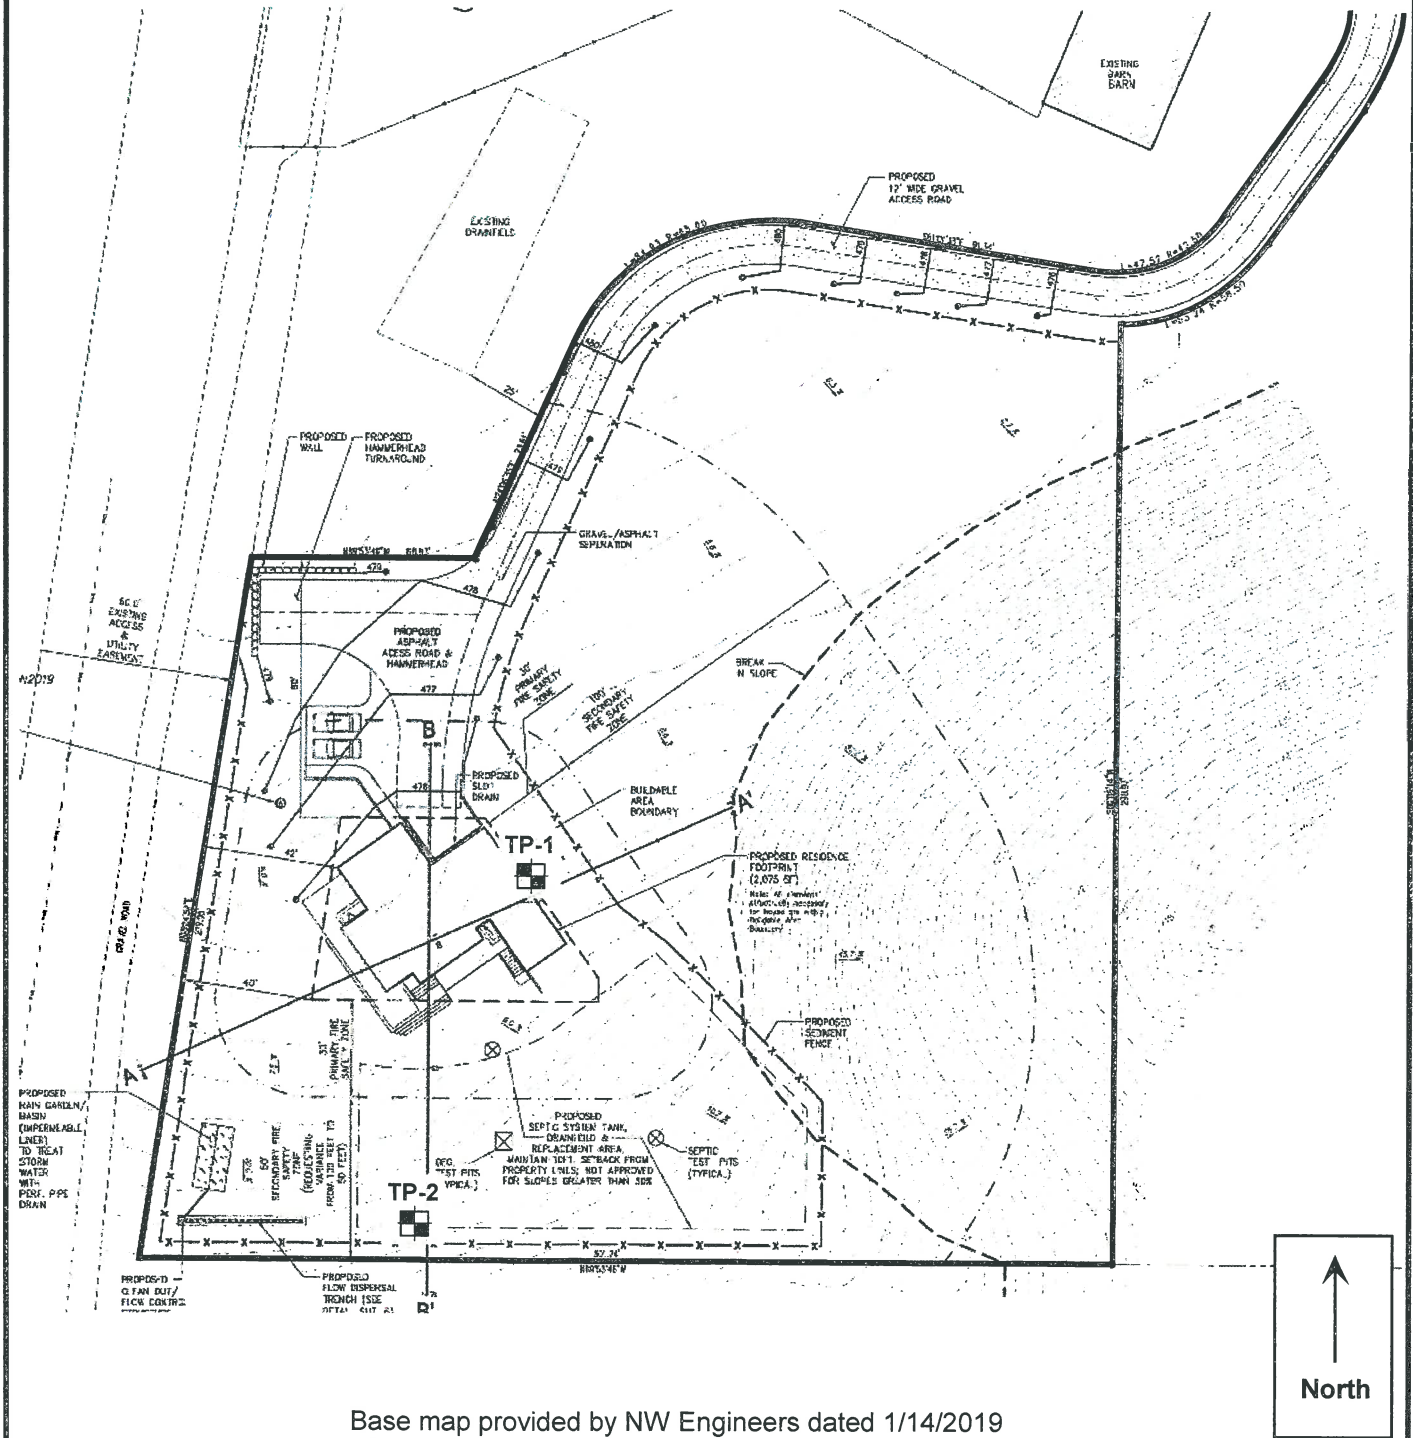
Topographic mapping indicates that the proposed building site is situated on a gently sloping ridge with grades of approximately 8 to 17 percent (Figure 2) at elevations of approximately 900 to 930 feet above mean sea level (Figure 1A). The homesite is adjacent to an engineered fill slope inclining at a gradient of 2H:1V.
