Updated April 5, 2021  
Project No. 20-5645

**RE: GEOTECHNICAL INVESTIGATION & LANDSLIDE HAZARD STUDY**  
**13221 NW MCNAMEE ROAD HOMESITE**  
**MULTNOMAH COUNTY, OREGON**

Reference: *Geotechnical Investigation and Landslide Hazard Study, Luethe Partition Lot 1, Section 32 2N 1W Tax Lot 800, Multnomah County, Oregon, GeoPacific Engineering, Inc. report dated March 17, 2010.*

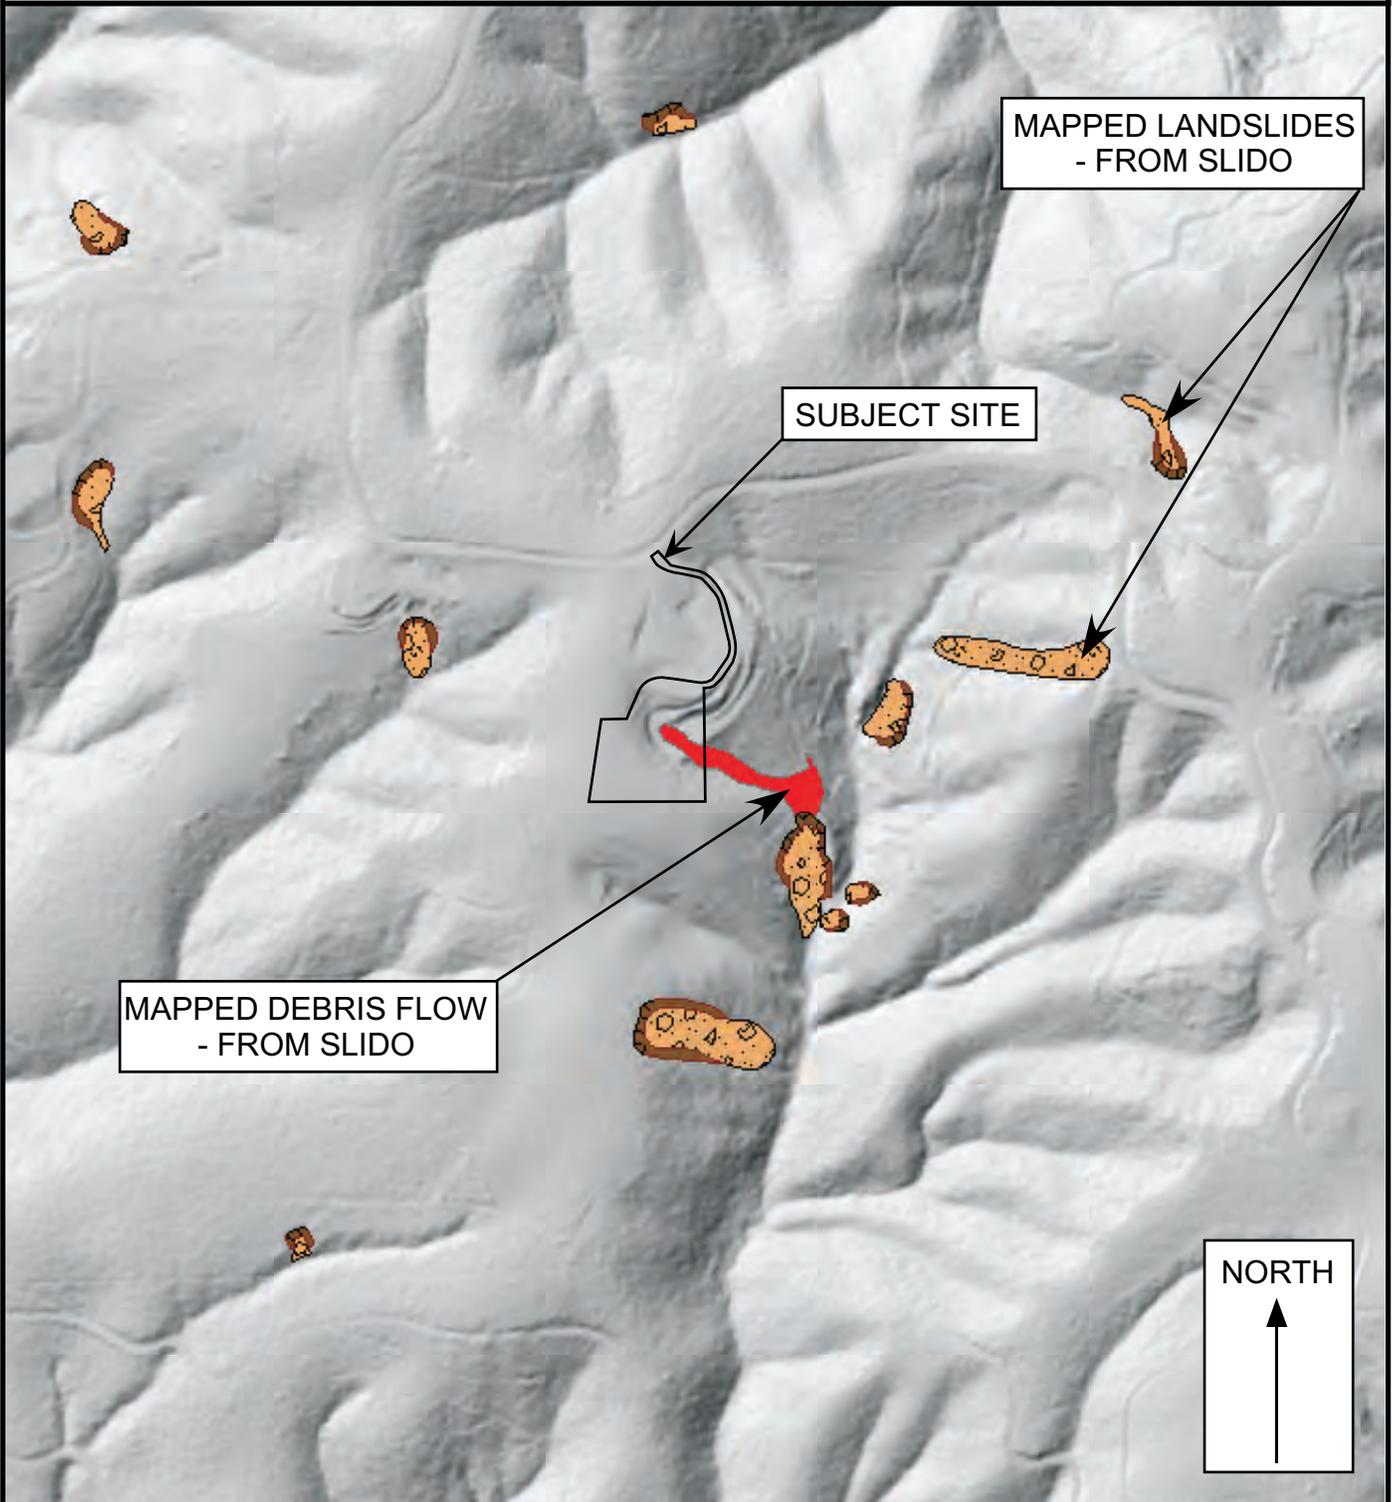
# LIDAR BASED VICINITY MAP - WITH MAPPED LANDSLIDES

Our review 1:24,000 scale topographic mapping by the U.S. Geological Survey indicate that the vicinity topography is smooth and uniform, consistent with relatively stable slope conditions. The Lidar based high resolution digital elevation maps depict topography following early site grading that occurred in the mid 1990's and prior to grading that was completed in 2016 (DOGAMI, 2021). The statewide landslide database and available landslide inventory mapping indicate no mapped

landslides are present in the vicinity of the homesite; however, the headscarp of a prehistoric (>150 years old) debris flow is mapped within the incised drainage gully located approximately 60 feet to the north of the proposed homesite (Burns et al, 2011; SLIDO, 2021) as shown on Figure 2. The head of this debris flow is located in an area that has since been filled with engineered fill. Several other historic and prehistoric earthflow type landslides are mapped along the McCarthy Creek drainage located east of the site (SLIDO, 2021). Seismic slope instability hazard mapping identifies the site vicinity as being in a low relative slope instability hazard zone based primarily on slope steepness (Mabey et al., 1996).

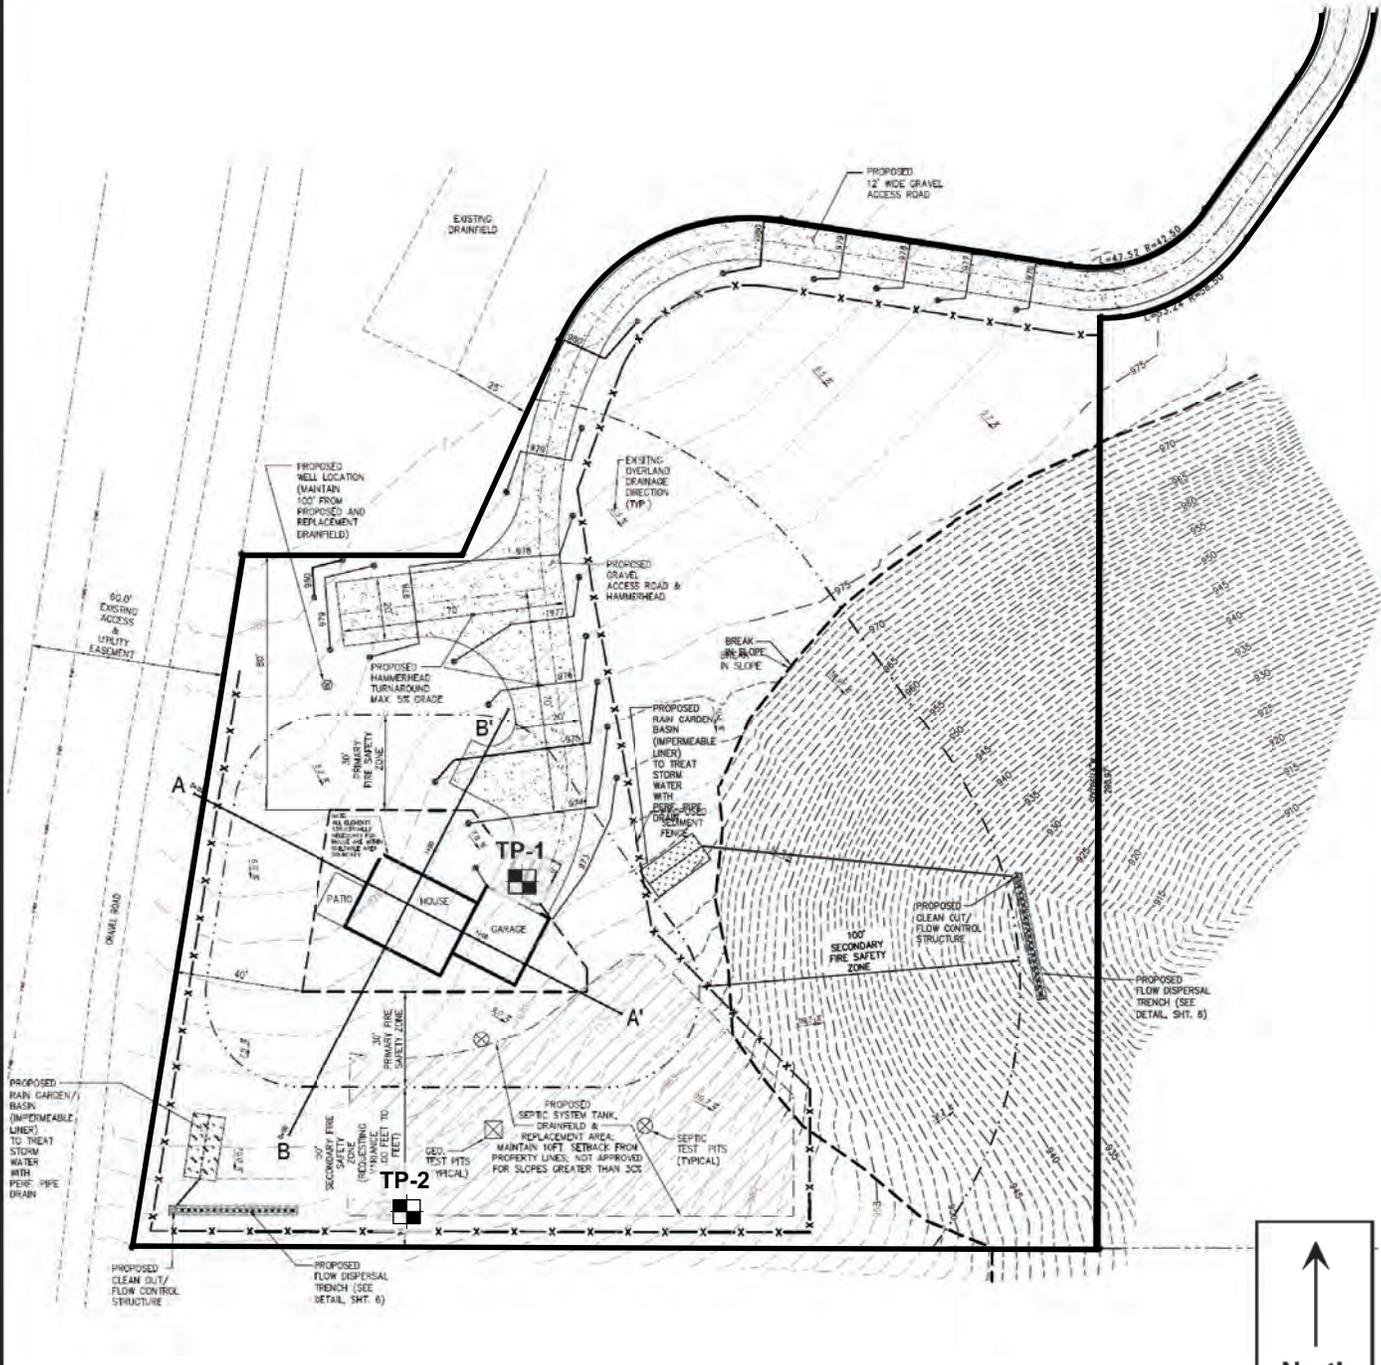
# SITE PLAN AND EXPLORATION LOCATIONS

For the purpose of evaluating slope stability, we reviewed regional site topography (Figure 1), reviewed published geologic mapping and Lidar based high resolution digital elevation maps (Figure 2), performed a field reconnaissance on November 20, 2020, and explored subsurface conditions at the proposed homesite with two exploratory test pits, the locations of which are indicated on Figure 3.

No geomorphic evidence of prior, deep seated slope instability (such as hummocky topography, benches, or old scarps) was observed during our reconnaissance. No seeps or springs were observed. Some areas of shallow slope instability were observed along the fillslope to the northeast of the proposed home. These features originated approximately 15 feet downslope of the existing driveway grade and were less than 3 feet in depth.
