RE: 6928 SE 282<sup>nd</sup> Ave. Gresham (FDG # E23-034)

This letter is prepared to document my observations during my site visit at 6928 SE 282<sup>nd</sup> Avenue, Gresham around 8:00 am on Monday 2/17/25. The purpose of the site visit was to assess the flow patterns for stormwater runoff in and around the site. At the time of my visit there was surface water runoff and it was raining lightly. The rain gauge data at the Gresham Fire station indicates that the previous 72 hours from my site visit the rain total was 0.91 inches of rain. The average daily rainfall for the Portland area in the month of February is 0.1 inches. Therefore, the amount of rain represents above average amount of rain fall for a typical February within this three-day period.

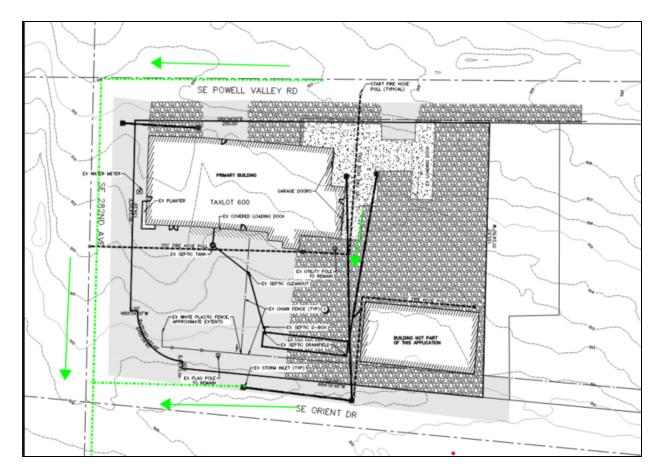
The off-site system includes storm infrastructure in SE Powell Valley Rd, SE 282<sup>nd</sup> and SE Orient Drive. The northern side of the primary building and a portion of the roof runoff is collected by a catch basin on the north side of the building, and this catch basin connects into the stormwater pipe in SE 282<sup>nd</sup>. The two on-site catch basins and likely part of the roof downspouts are collected and discharged into a catch basin in SE Orient Drive. The area south of the building slopes towards Orient Drive and runoff from this area flows into the catch basins on Orient Drive. The illustration below provides a sketch of the direction of flow.

In summary, during my site visit the stormwater collection and conveyance systems both on site and off-site were functioning and I did not observe any restrictions or issues related to the collection and conveyance of the stormwater runoff.
