## Post-Hearing submittal - RRV-2024-0004

### Driveway changes over time

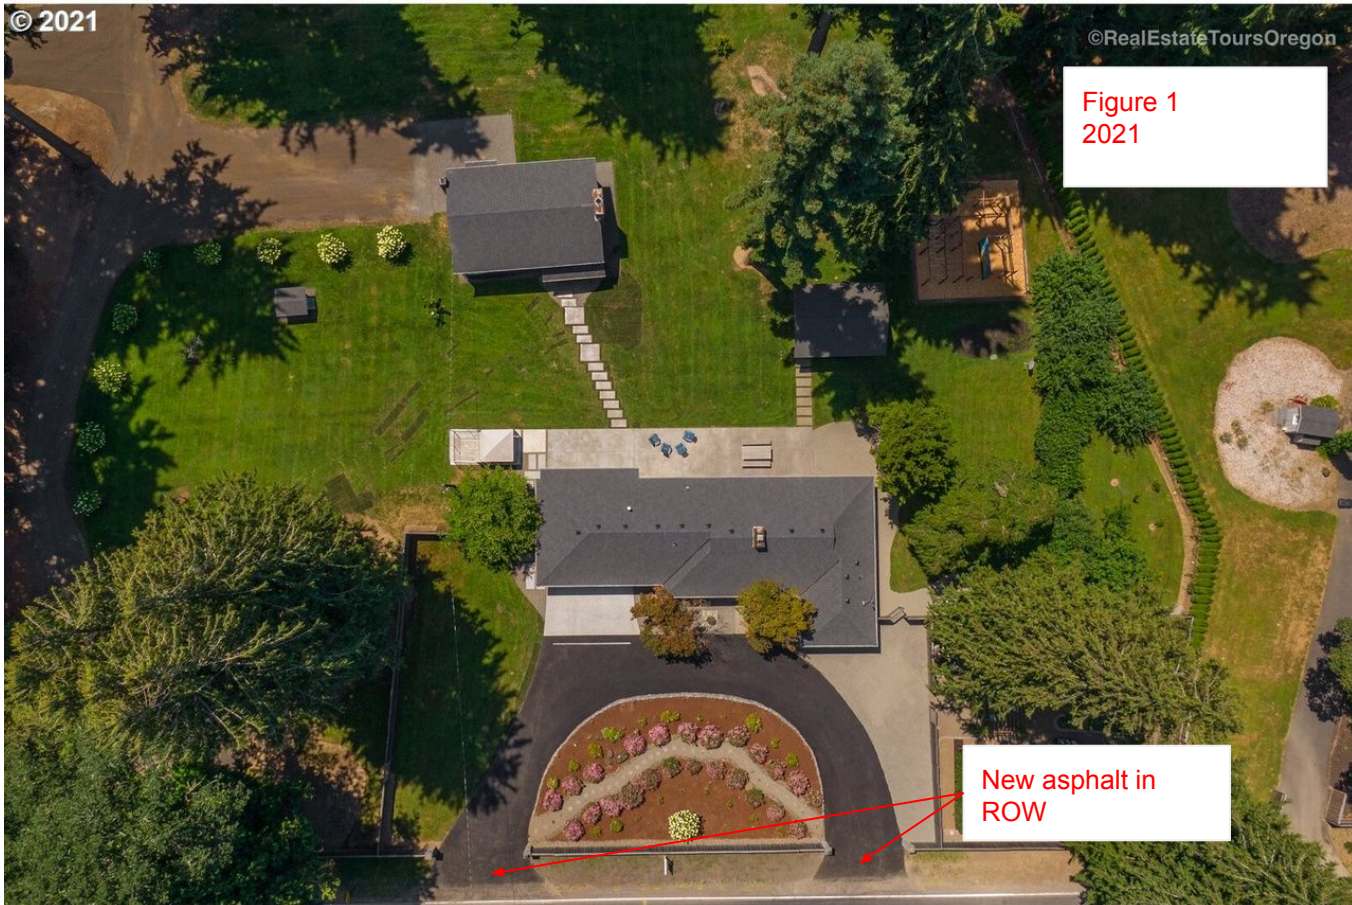
**Figure 1**

Photo shows recent asphalt layer on circular driveway. Encroachment of the asphalt extends into the ROW beyond the property line. Such encroachments/work in the ROW require ROW permits (MCRR 18.250).

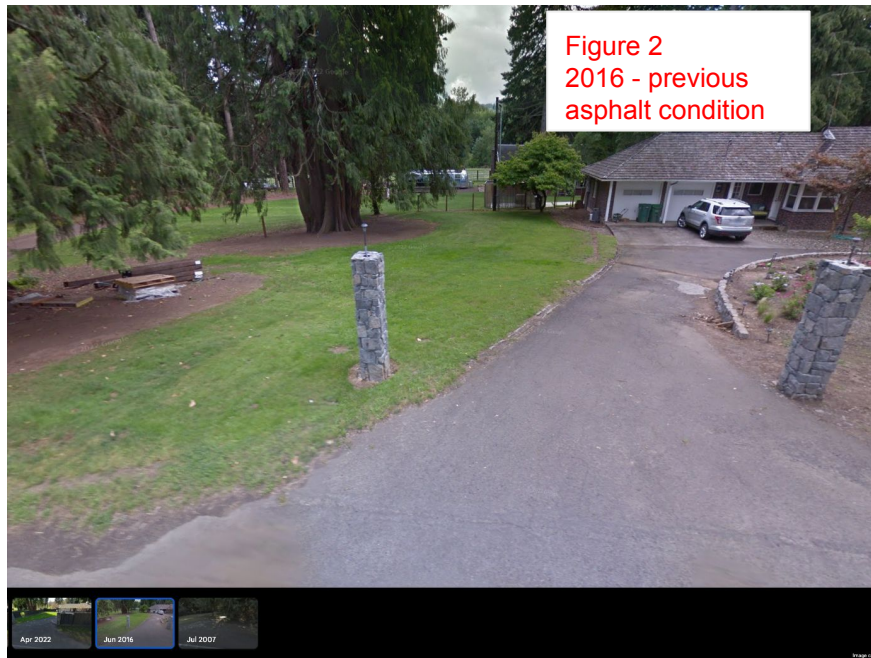
Figure 2  
2016 - previous  
asphalt condition

### “Access 2” - asphalt condition

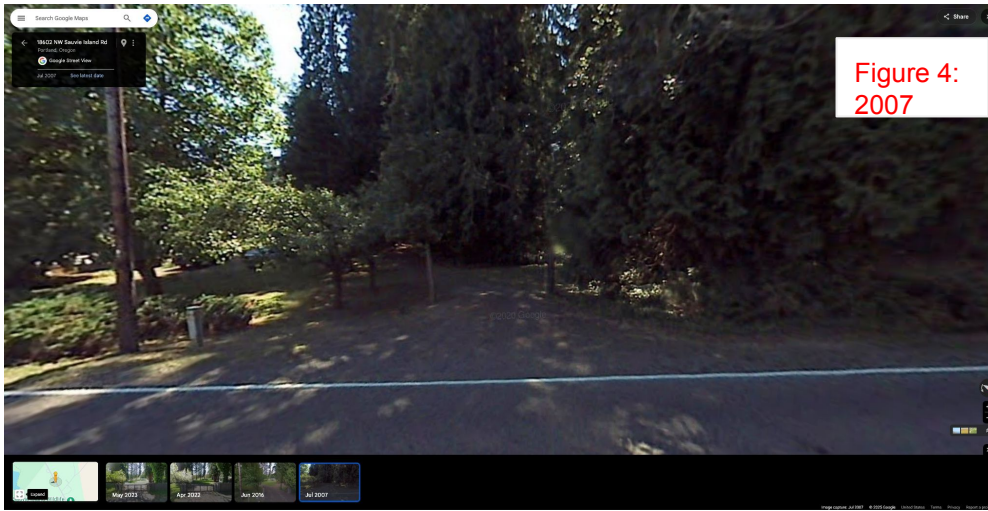
**Figures 4 and 5**

**Driveway width/ alterations to “Access 3”**

Google Street View shows there appears to have been driveway width widening between the [2007 capture](#) and [2023 capture](#) showing potential alterations to the accesses over time without ROW permits (see MCRR 4.100; MCRR 18.250 A[2] MCRR 18.250 A[4]; and, MCRR 18.250 C).

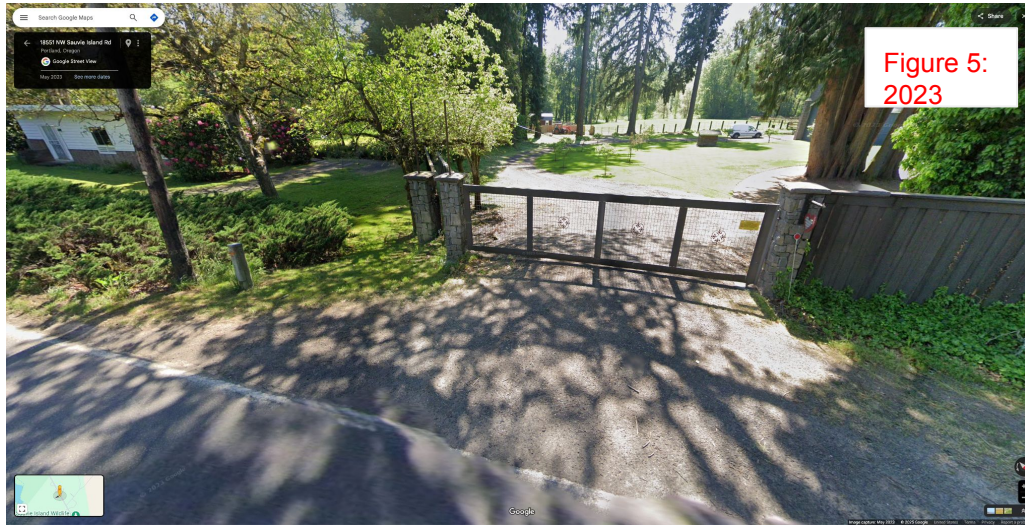
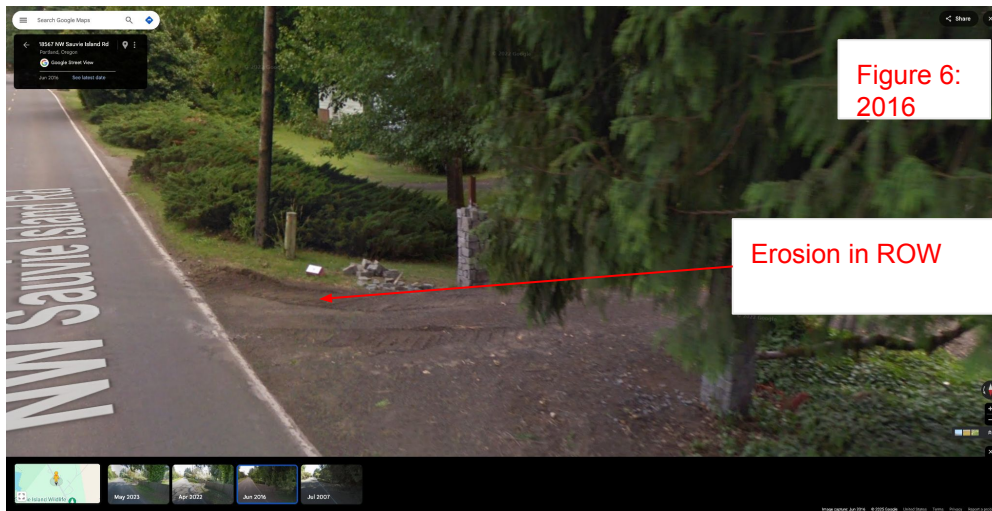
## Figures 6 and 7

### Driveway alterations to “Access 3”
