# Exhibit M – Geologic Hazards Permit

**GEOLOGIC HAZARDS PERMIT (GHP) Form 1:  
 GEOTECHNICAL RECONNAISSANCE AND STABILITY  
 PRELIMINARY STUDY**

# Geotechnical Report & Landslide Hazard Study

12424 NW Springville Road  
Portland, Oregon

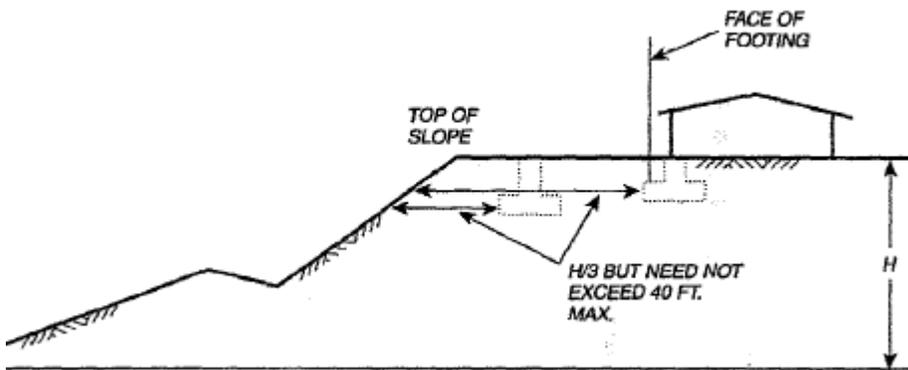
Given the slopes surrounding the house site vary from 13 to 24% the house shall follow the typical setback requirement from IBC and OSSC. See below figure 1805.3.1

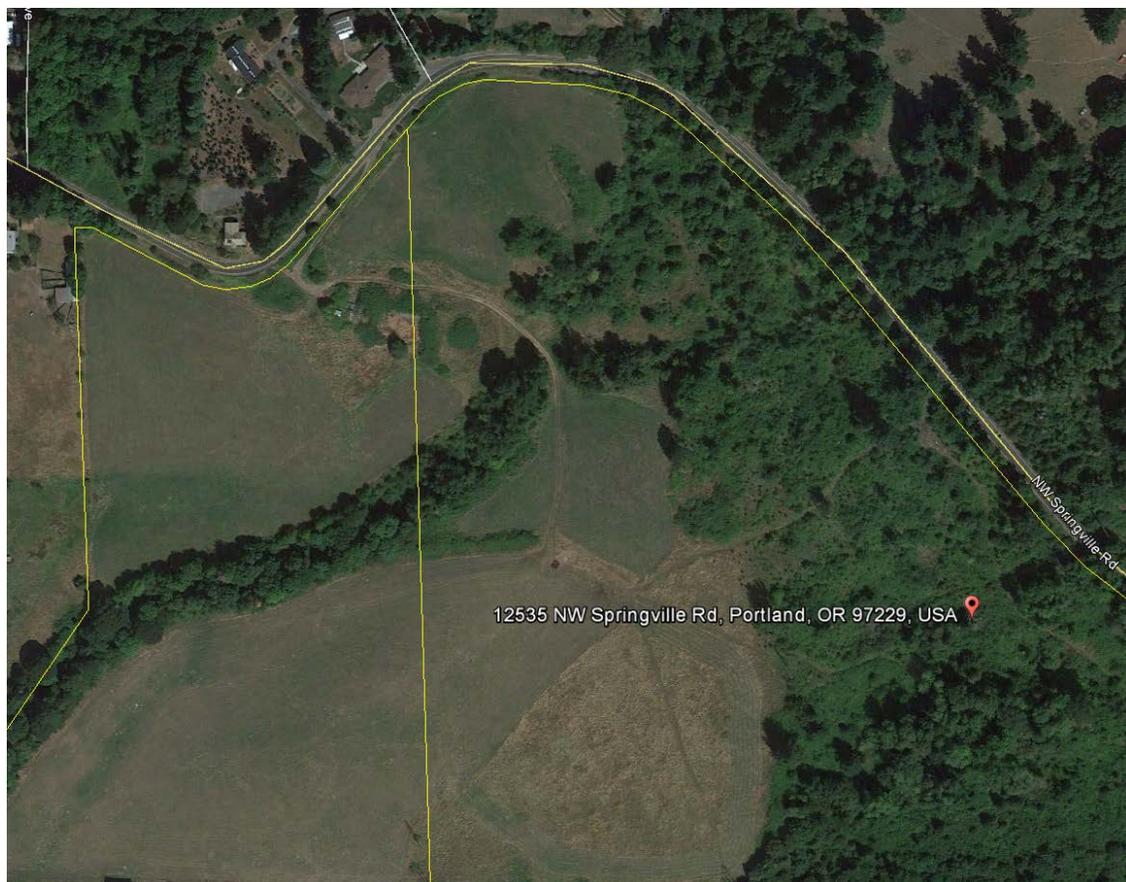
Figure 2- site plan and aerial with testing locations

A total of three (3) test pits were excavated with an excavator. The locations of the test pits are shown on figure 2 in Appendix A. A registered professional engineer observed the excavation and logged the subsurface materials. Boring log detailing materials encountered is in Appendix B. The logs were created using the Unified Soil Classification and Visual Manual Procedure (ASTM-D 2488). Samples were transported to the laboratory for further classification in seal bags. Please see Appendix B for further laboratory results. The soil conditions were stiff to very stiff silty CLAY to a depth of 6 feet. Basalt layer was not encountered. Moisture contents were 22.2% to 28.4%. Groundwater was not encountered.

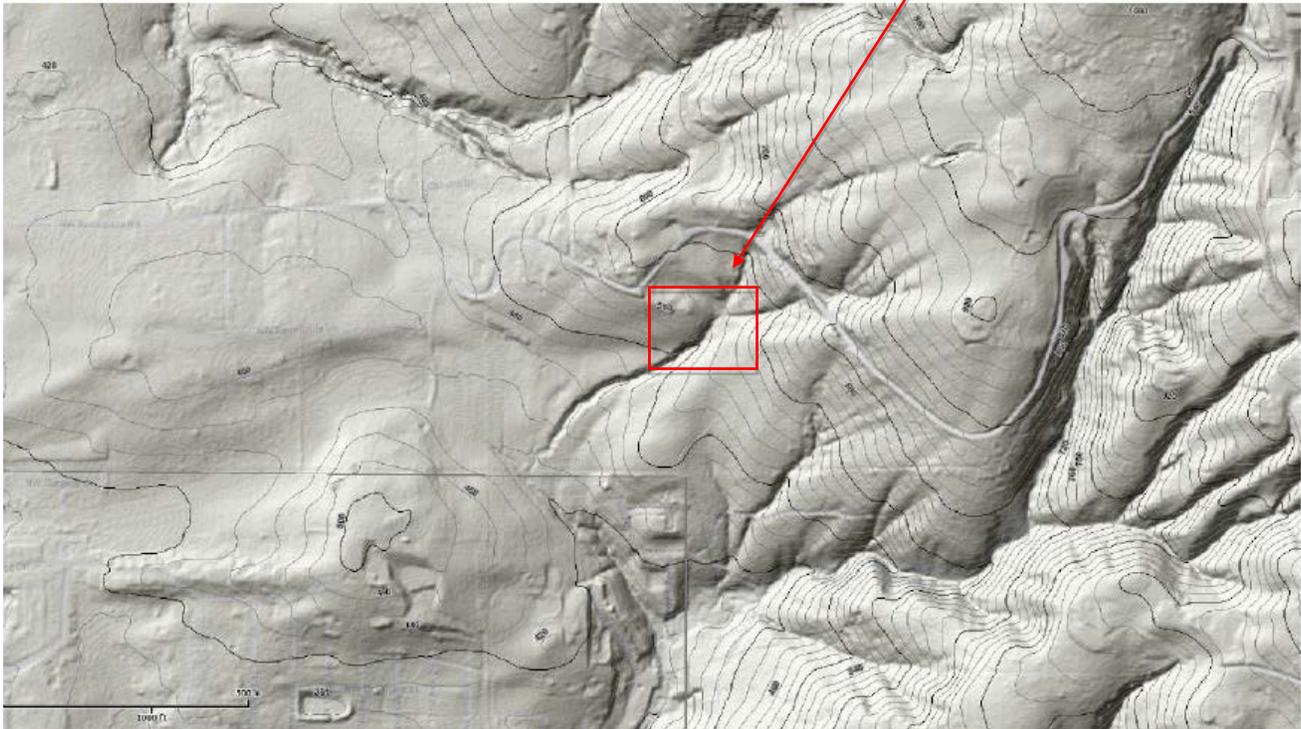
Figure 3- Hazards

O-90-02 and O-08-06 map the Oatfield Fault traversing the southwest corner of tax lot 2800 in a northwesterly direction, downthrown to the southwest. Much of the surface south and southwest of the Oatfield Fault in the site vicinity is mapped as landslide debris, or massive coalesced debris fans. Three small debris fans are mapped in the creek drainages immediately east and northeast of the proposed house location above the Oatfield Fault. A landslide is mapped near the middle of tax lot 600 several hundred feet southeast of the proposed house location. See figure 3. There are no known mapped landslides on the project site. Soil maps are shown below.

LIDAR imaging of the site vicinity figure 3 shows several bowl-shaped scarps with associated down slope debris channels above the project site.

Head-ward erosion of drainages will continue, therefore steeper site slopes along the creek drainages should be protected with deep-rooted vegetation that will bind the soil and reduce erosion. Slopes immediately adjacent to Springville Road north of the project site are at the highest risk of instability in our opinion, and proposed development of wooded riparian zones, bio-swales and/or infiltration ponds/trenches would help mitigate erosion and also enhance water quality. Shallower slopes set back from the drainages should be suitable for grazing dairy cattle as planned.
