Multnomah County Willamette River Bridges Capital Improvement Plan

Seismic Vulnerabilities and Retrofit Report

*David Evans and Associates
2100 SW River Parkway
Portland, OR 97201
503 223-6663*

Dated: November 9, 2014

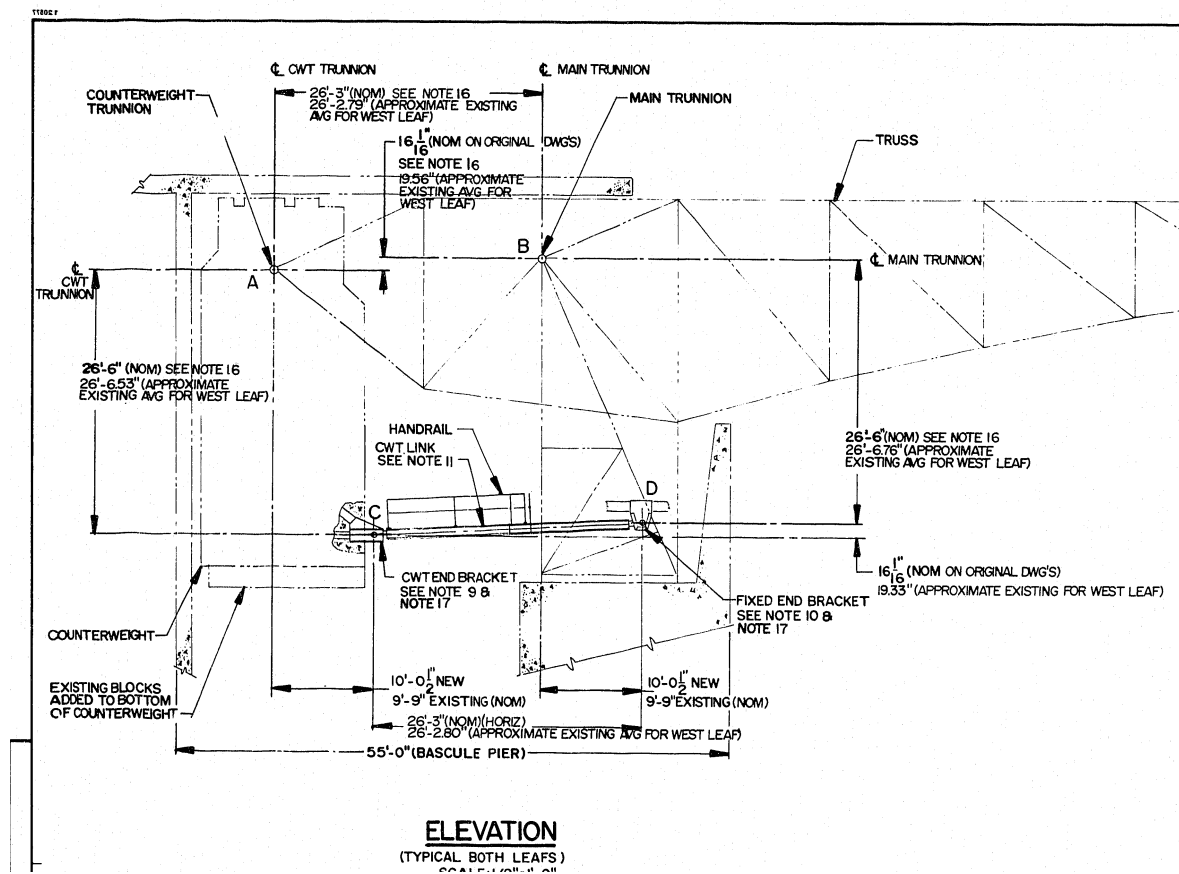
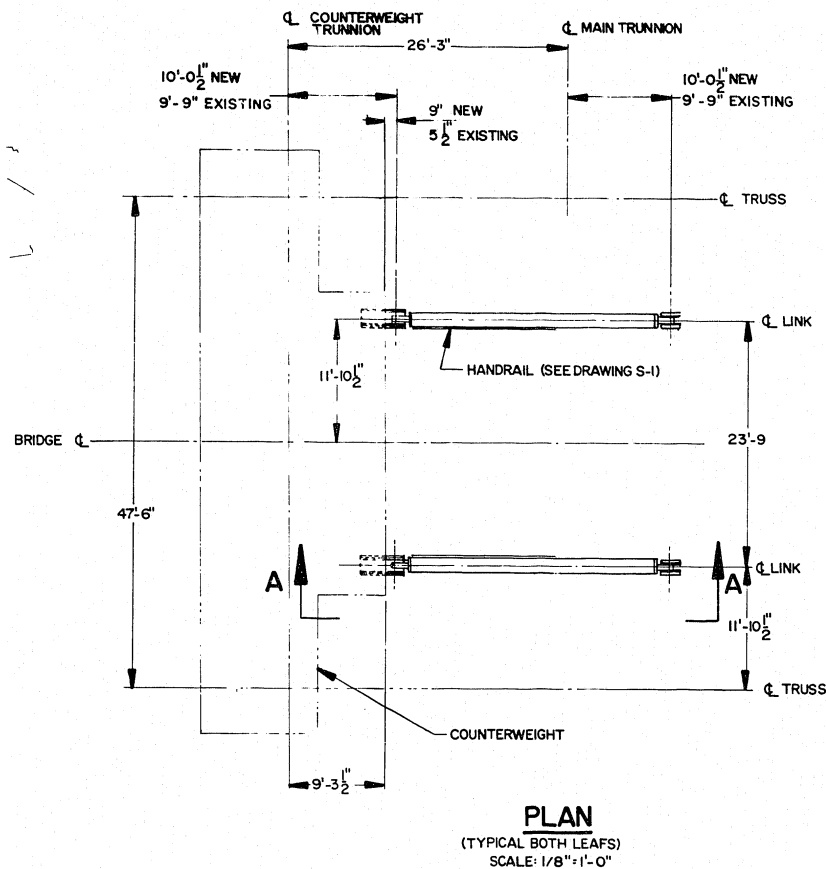
Figure BU107: Burnside Bridge Bascule Leaf Transverse Bracing will be weak if Transverse Restraint is added to Bascule Leaf at Point 14

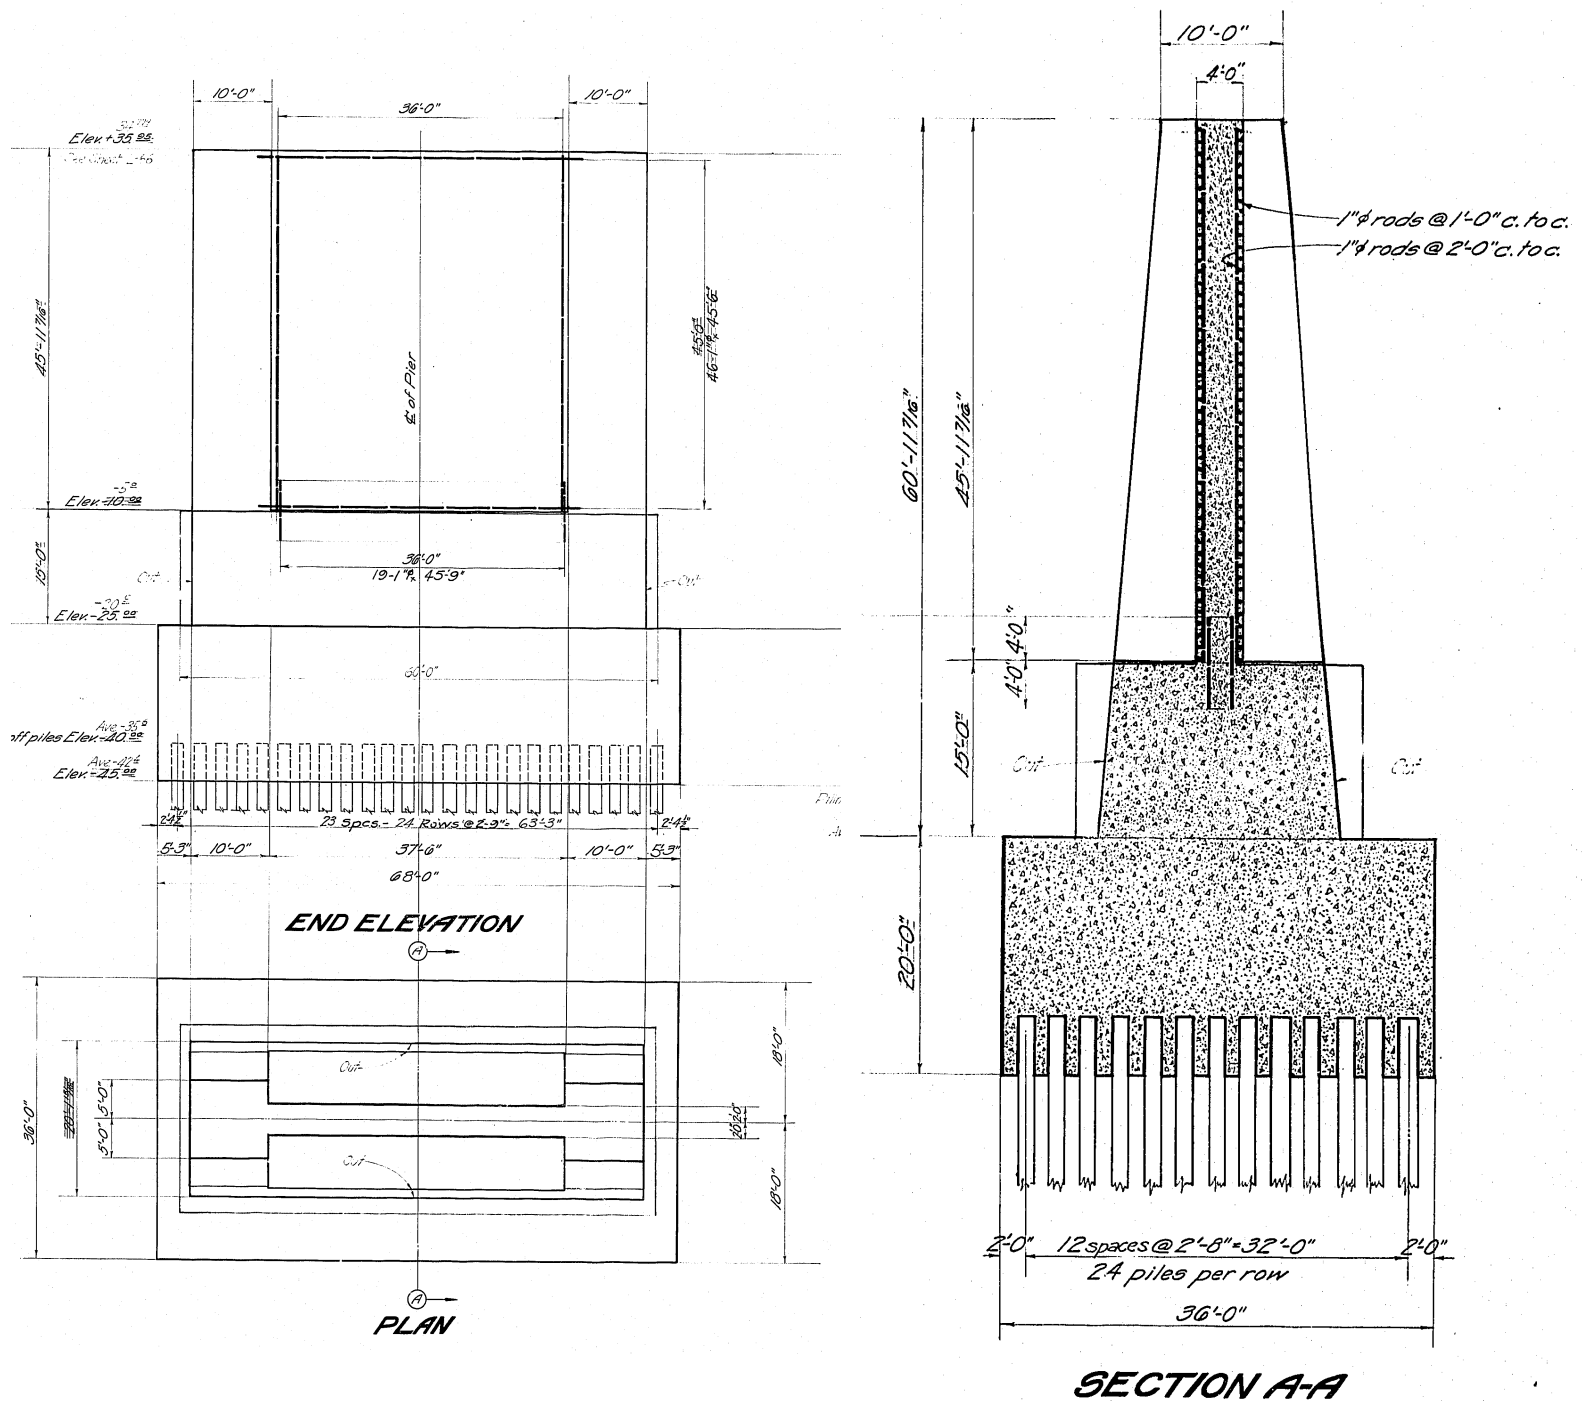
Figure BU201: Burnside Bridge Fixed Spans Piers 1 & 4 - showing sloping bank onto pile cap due to liquefaction

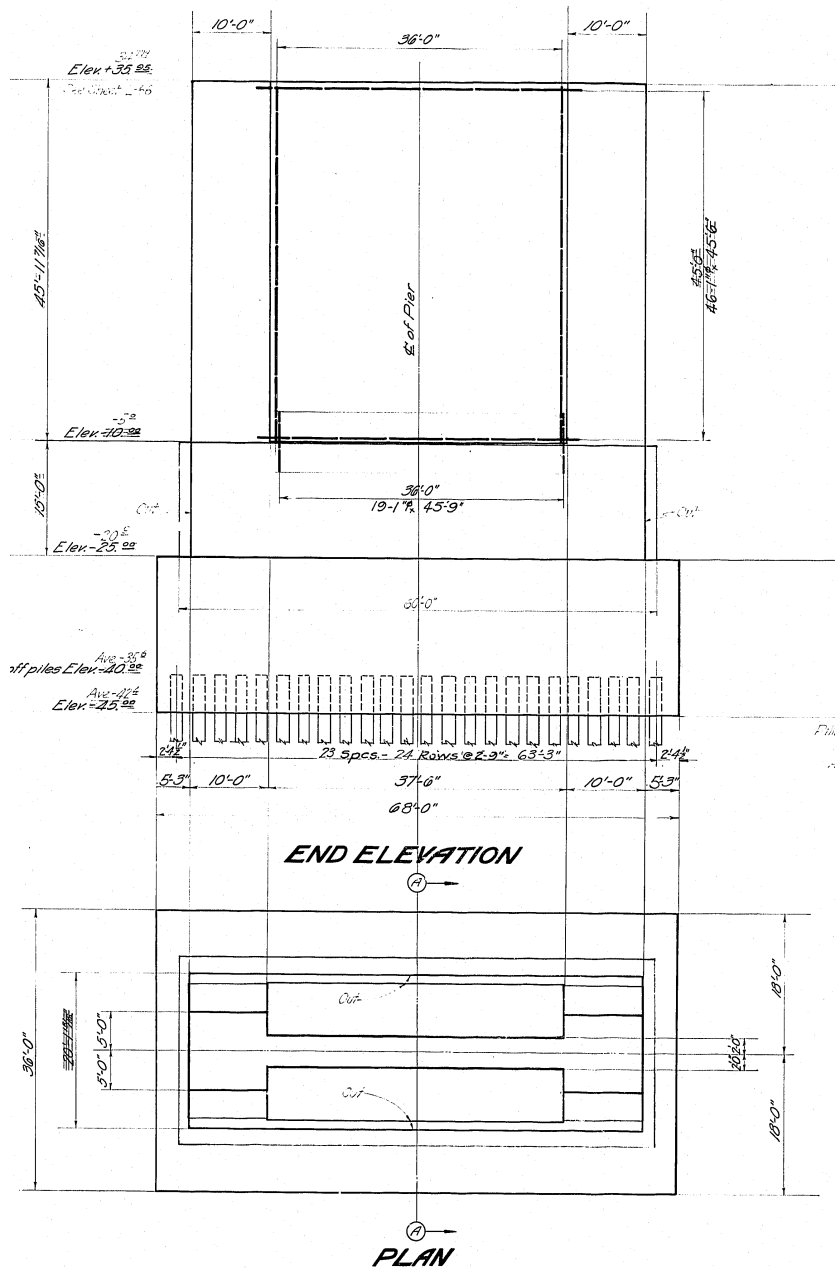
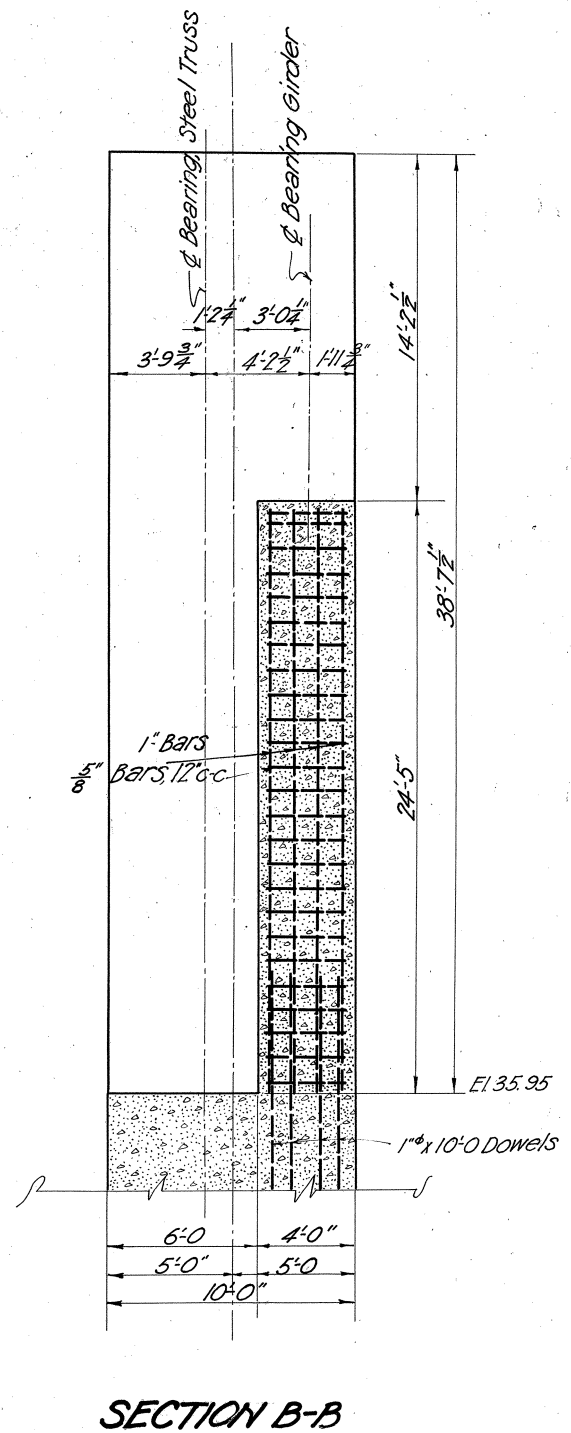
Figure BU202: Burnside Bridge Fixed Spans Piers 1 & 4, foundation piles (outer piles) in uplift, in bridge longitudinal direction

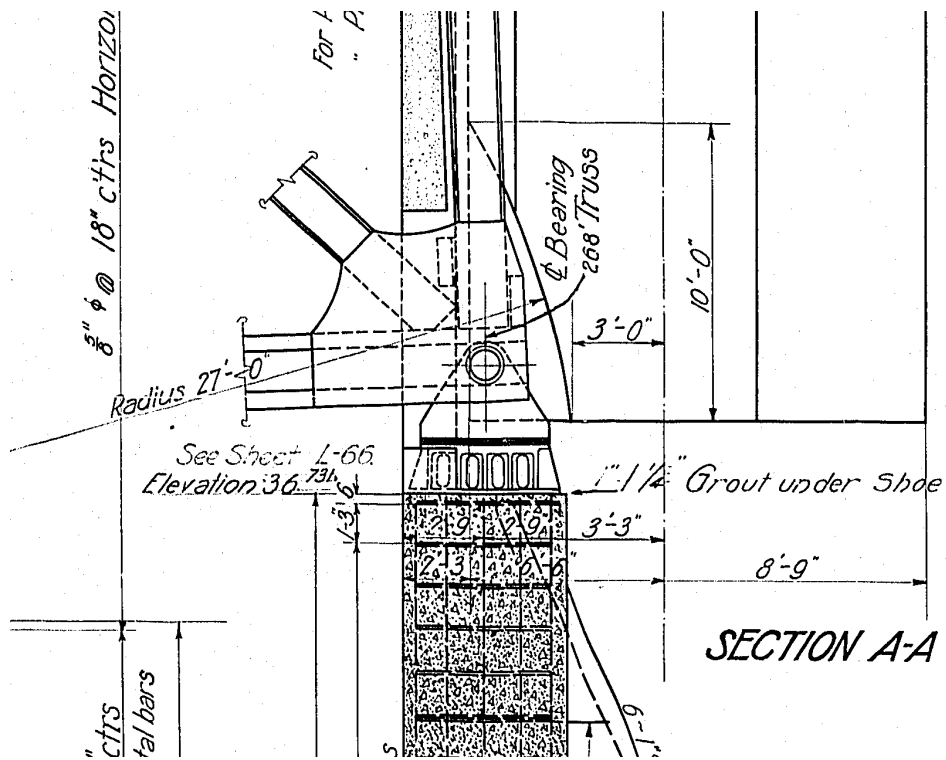
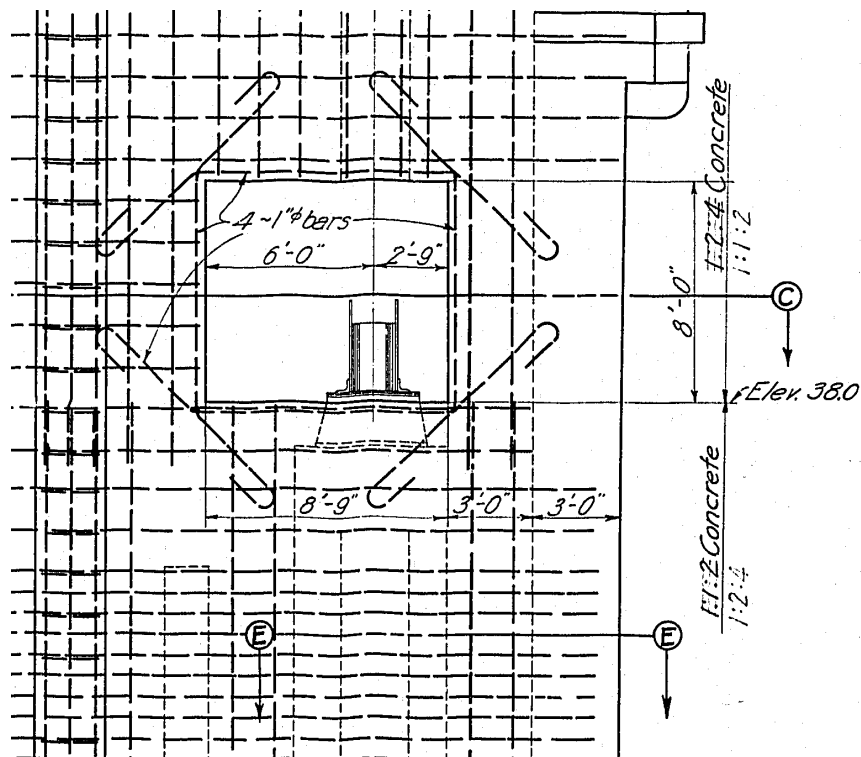
Figure BU203: Burnside Bridge Fixed Spans Piers 1 & 4 Columns, lightly reinforced and without proper seismic reinforcing detailing

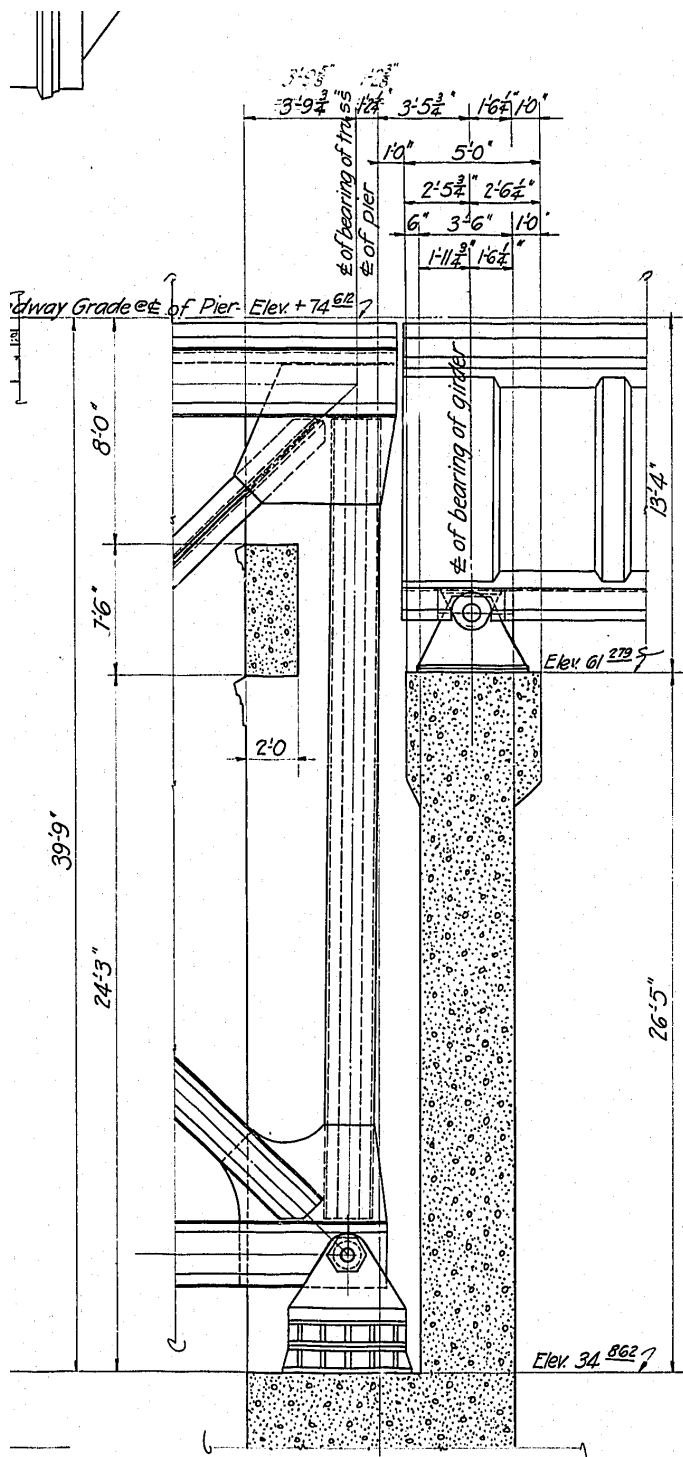
Figure BU204: Burnside Bridge Fixed Spans Truss Fixed Bearing and Bearing Seat Width (top, side view; bottom, front view) at Piers 2 & 3

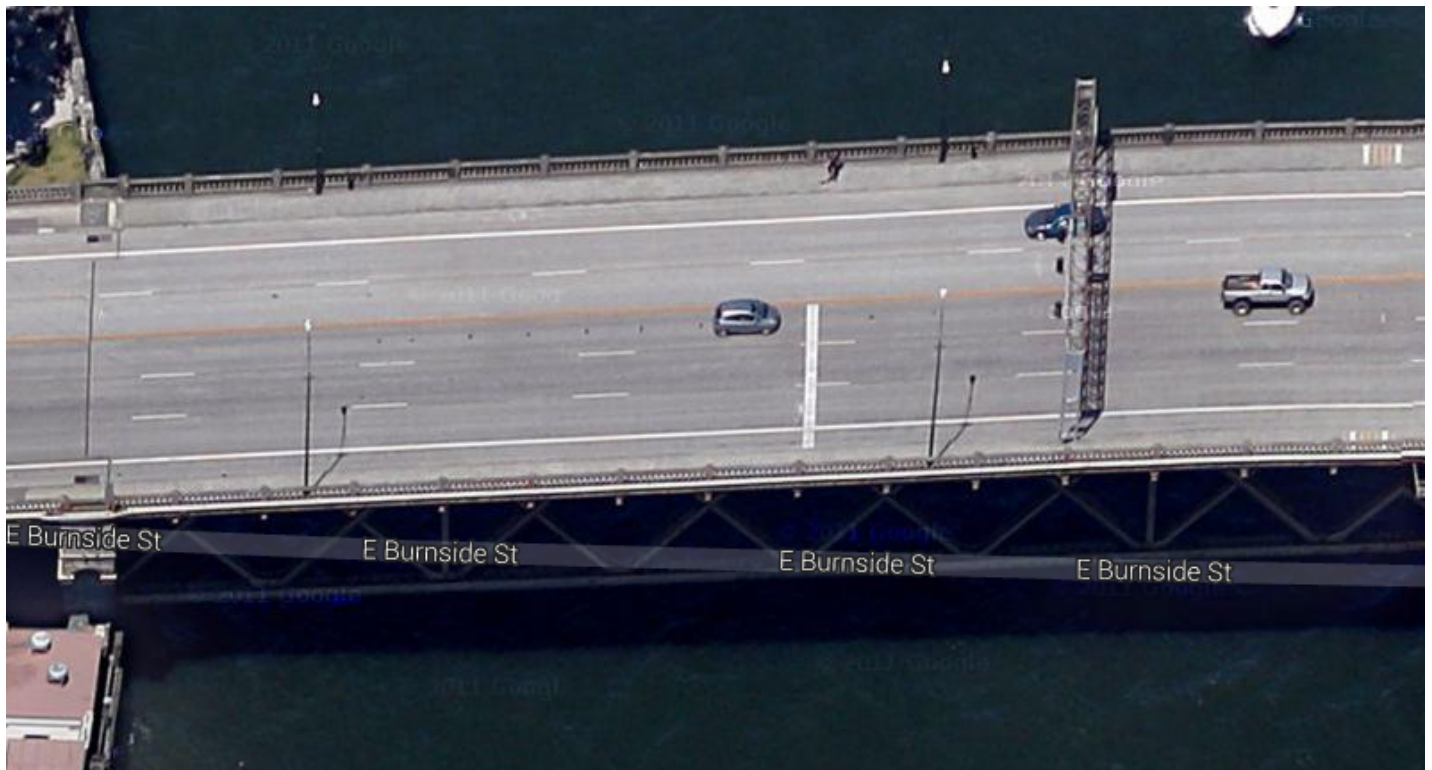
Figure BU209: Burnside Bridge Fixed Spans Aerial View
- showing overhead structure and lightings on West Fixed
Span (similar on East Fixed Span)

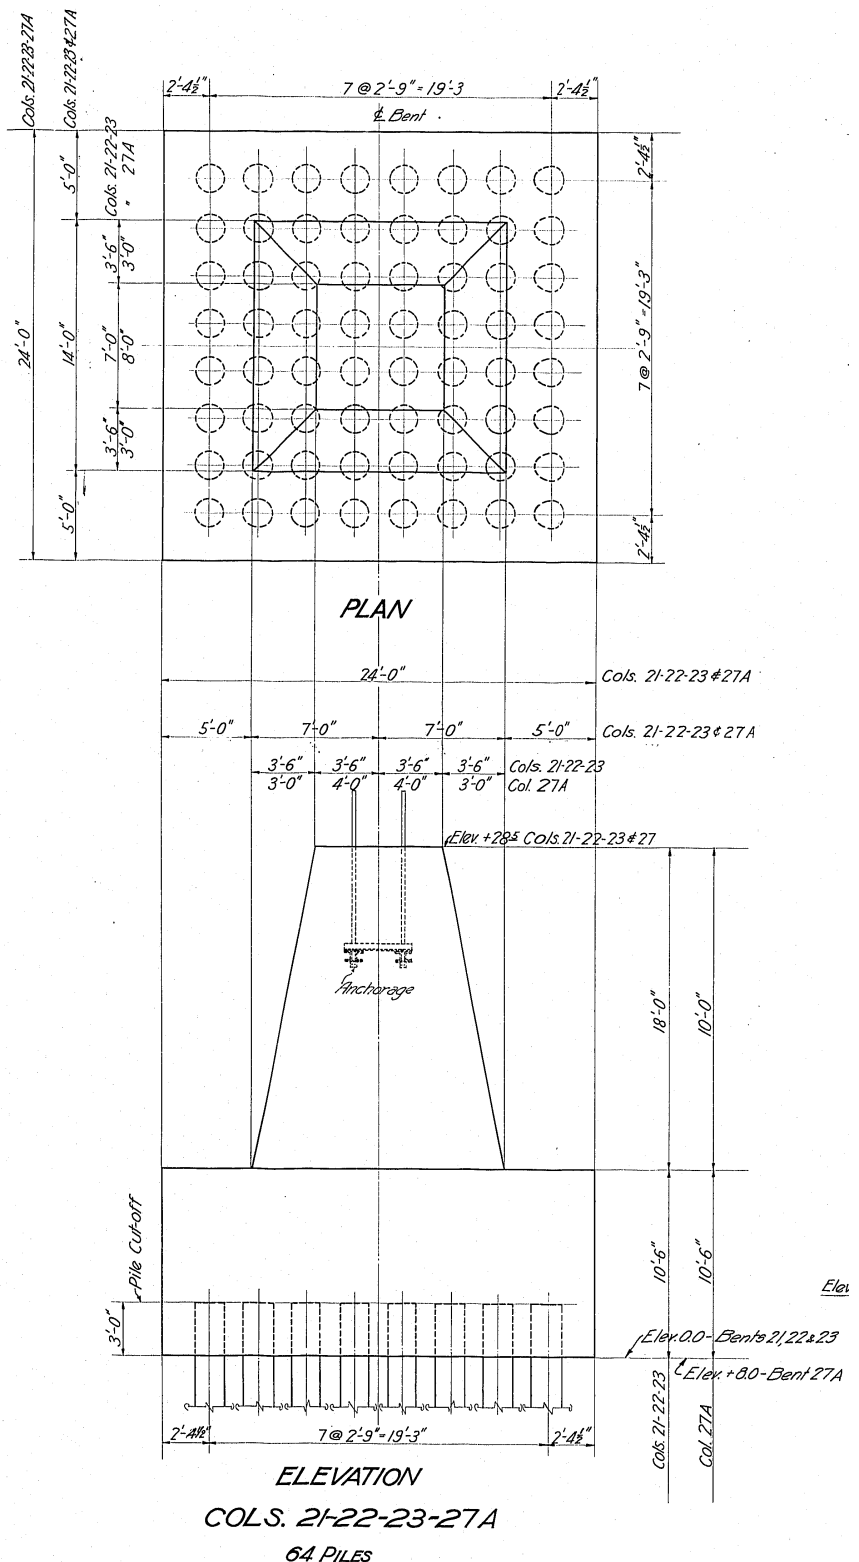
Figure BU401: Burnside Bridge East Approach Bents 21-27, Unreinforced pile cap with timber pile. Bents 21-23 not buried. Bents 24 to 27 buried 20ft in ground.
