Memorandum

Subject: Response to Testimony Related to Pipelines

Project #s: PWB: W02563 BC: 152606

Date: May 5, 2025

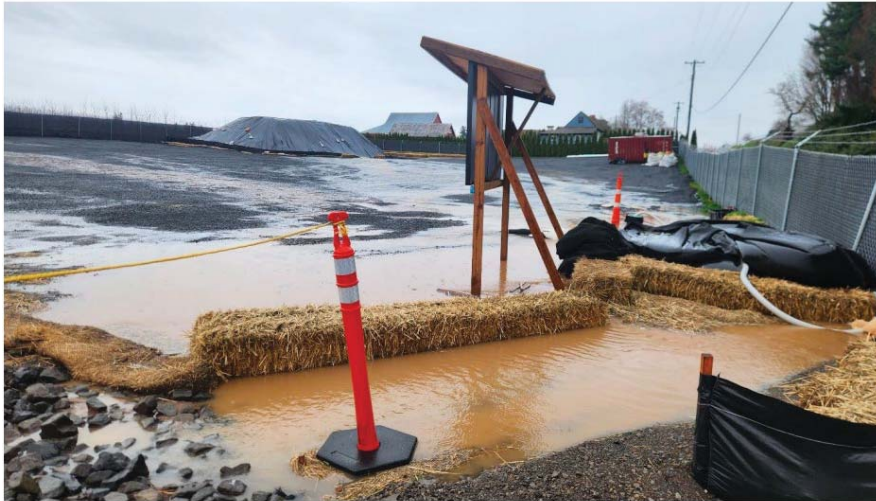
“Beaver Creek is also being adversely affected by the PWB Filtration Plant construction on Lusted Road. An area of field that never had water runoff has been packed and graveled, so it is no longer permeable. I have documented on several occasions muddy water running off this site and down the road into Beaver Creek.”

Uncontrolled water runoff into Beaver Creek from the PWB Lusted site. March 21 2025

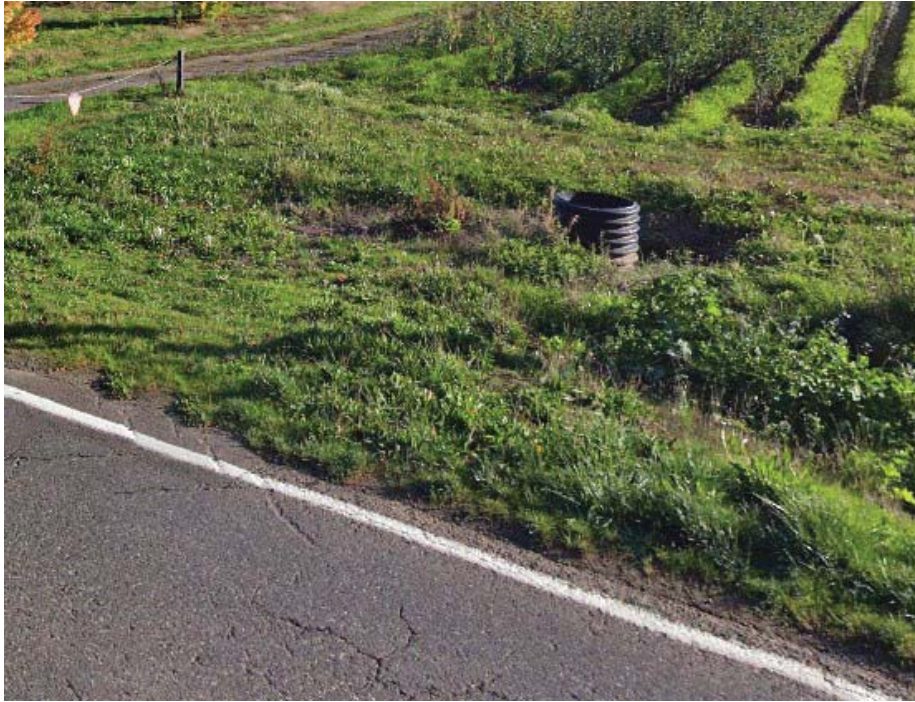
As shown in Photo 1 below, the pre-construction drainage collection and disposal system was constructed several years prior to construction commencement.² That system was constructed by the landowner to address the runoff issues that had

Photo 1:
Image from Google
StreetView from
October, 2023
(Pre-Construction)
showing vertical
HDPE pipe
installed by
property owner

previously occurred. The landowner created a system where water from subsurface drainage collection tiles in the farm field is combined with surface water runoff, which is all then delivered to a culvert which was placed under SE Lusted Road and eventually discharges to one of the Beaver Creek arms, north of SE Lusted Rd. The system consists of a vertical HDPE pipe where subsurface drainage tiles from the farm field enter the bottom of the vertical pipe. As the water fills and eventually overflows this vertical pipe, it flows into the nearby catch basin. This grated surface catch basin (catch basin cannot be seen in the weeds of Photo 1) collects water from the HDPE pipe and surface water runoff from the farmland. When the water discharged from the drain tiles overwhelms the volume of the vertical standpipe, water bubbles out the top of the vertical pipe and spills onto the ground, with the intent of being collected into the grated inlet catch basin. Once the water is collected into the catch basin, it is transmitted into the culvert crossing Lusted Rd and then drains to Beaver Creek.

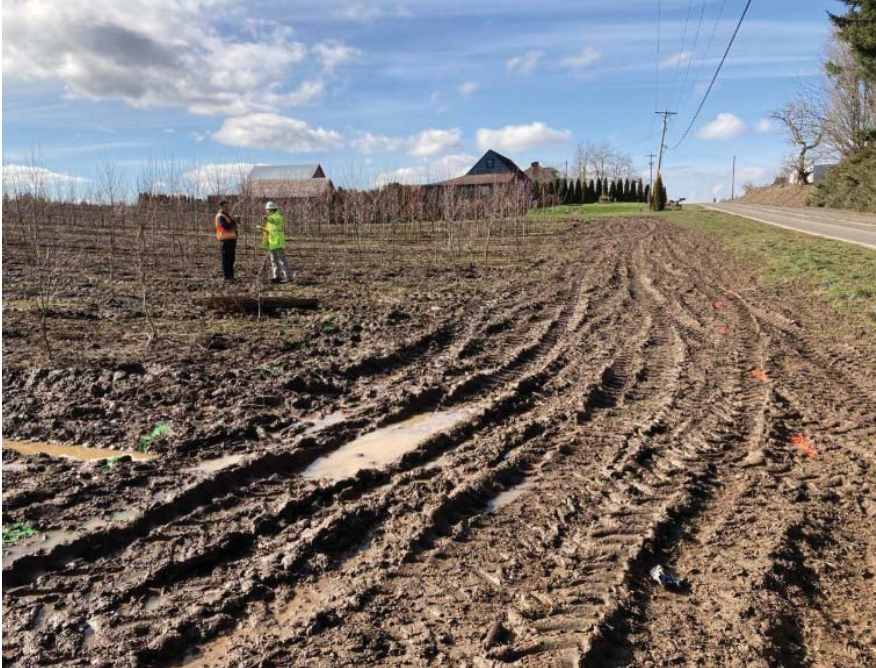
As shown in Photo 2 and 3, pre-construction, the farm field created significant turbidity in the runoff as shown in Photo 2. The catch basin and the vertical HDPE are located near the NE corner of what will be the FWI site.

Photo 2: Taken February 15, 2023 on a dry day showing muddy, pooling water from surface runoff at the site before draining to the pre-existing collection point and grated catch basin and prior to conducting any construction

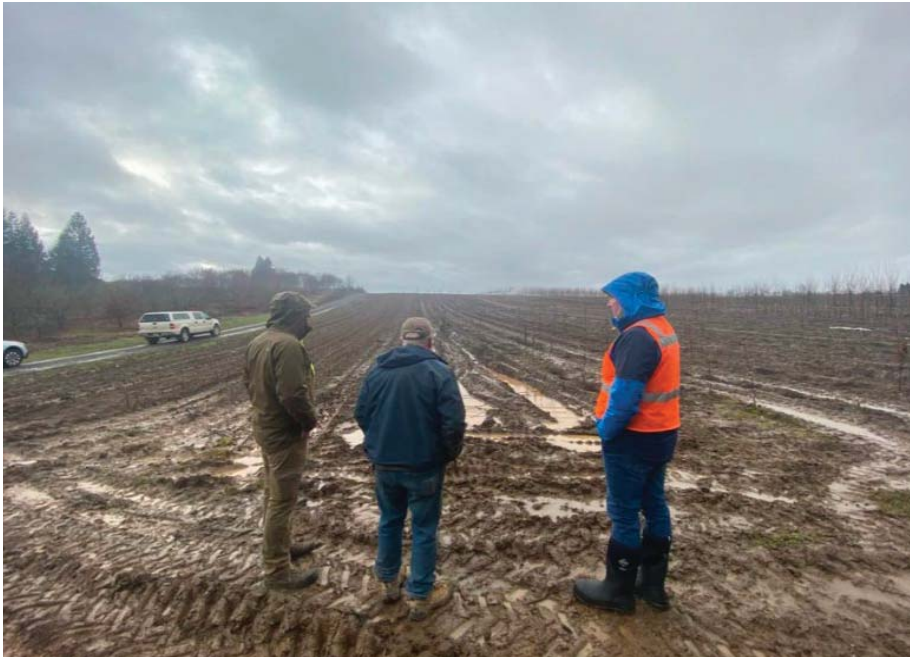
Photo 3: Taken February 9, 2023, on a wet day showing muddy, turbid runoff prior to commencing work, delivering water to the pre-existing collection point and grated catch basin

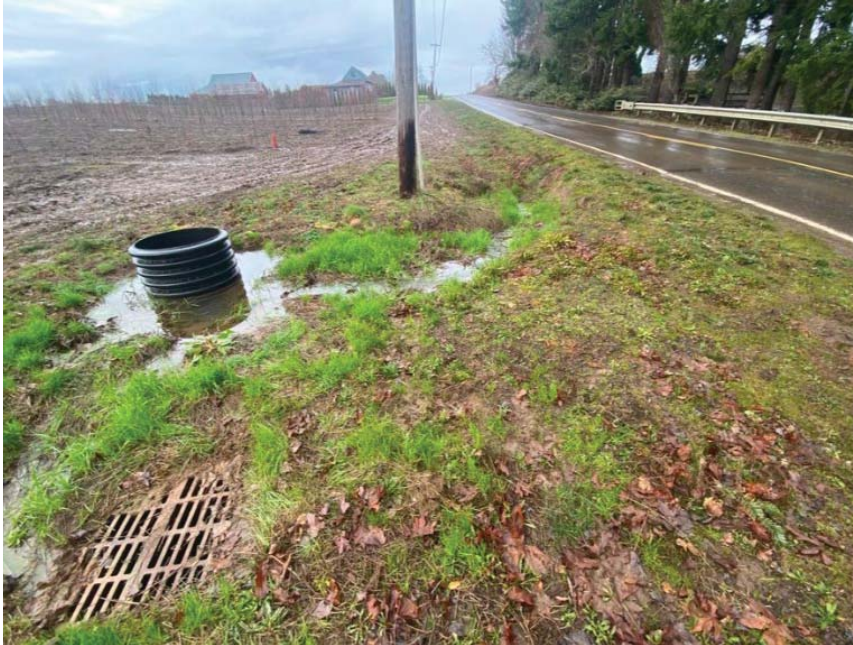
Photo 4: Taken February 9, 2023 showing excess drainage around the pre-existing collection system and unprotected catch basin prior to conducting work

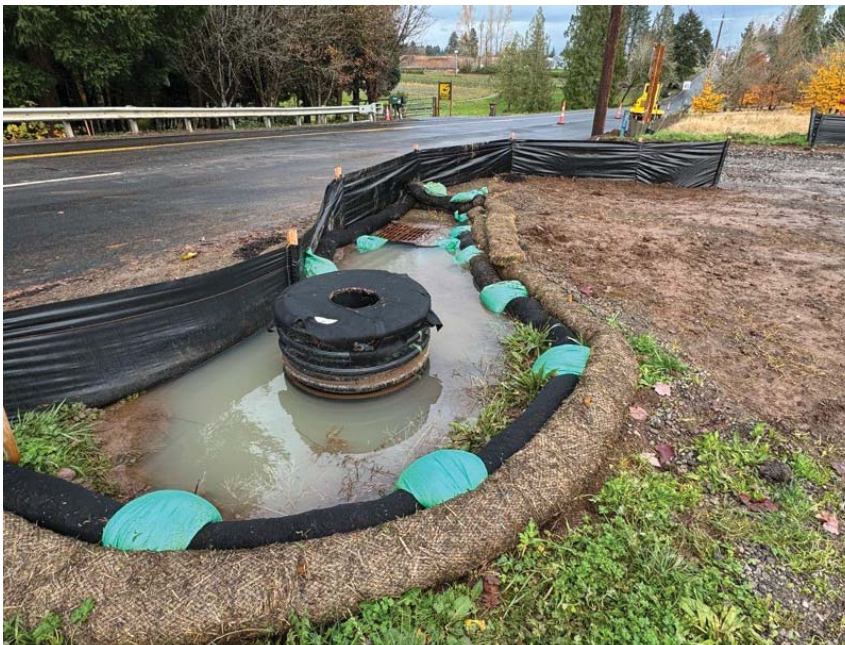
Photo 5: Taken November 13, 2024, showing construction stormwater management improvements surrounding the pre-existing vertical HDPE pipe in the foreground and grated catch basin behind.

At commencement of construction at the FWI, sediment fences and straw wattles were installed, as shown in Photo 5.

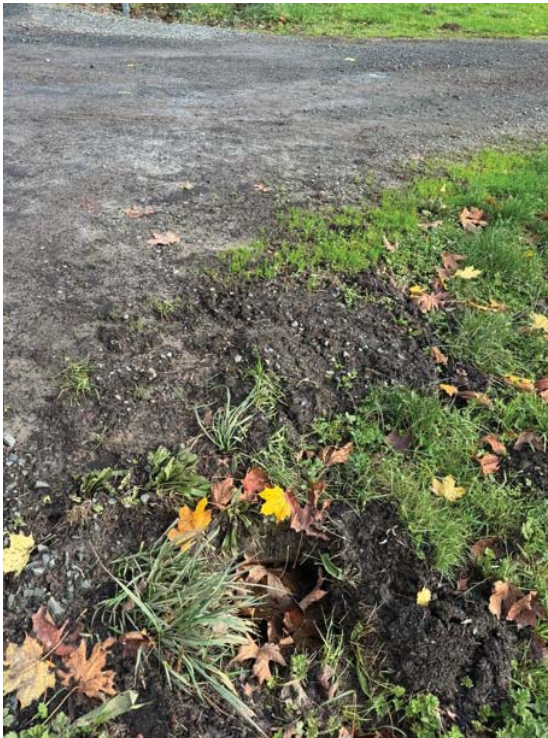
Also of note, Photo 6 below documents a clogged culvert underneath the adjoining easterly driveway at the bottom of the hill (33608 SE Lusted Rd) on November 14, 2024, well before construction mobilization to the FWI site on January 13, 2025. The pre-existing clogged culvert in this area contributed to the observed ponding due to a lack of maintenance to keep the culvert open. To date, this culvert has yet to be cleaned, as evidenced in the Photo 7 below. For a culvert in the right of way (like this one is), cleaning would be performed by the County.

Photo 6: Taken November 14, 2024 showing clogged culvert under the driveway at 33608 SE Lusted Rd

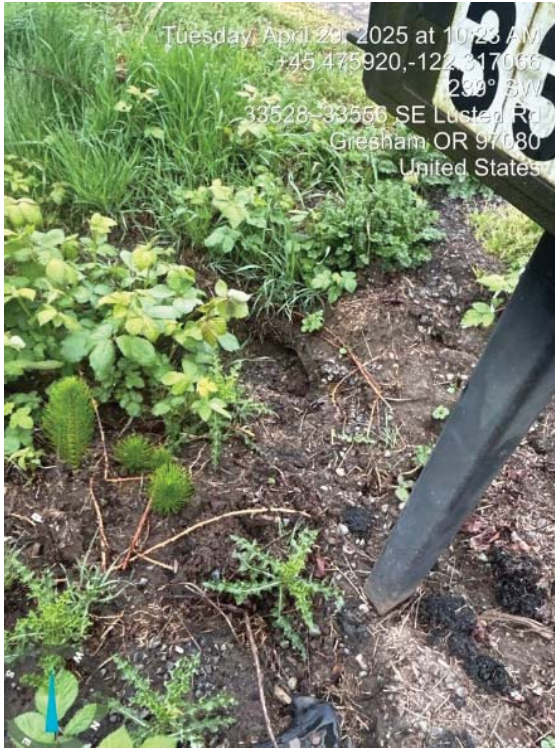
Photo 7: Taken April 29, 2025 showing culvert still filled with mud and rock, not allowing water to pass through the culvert.

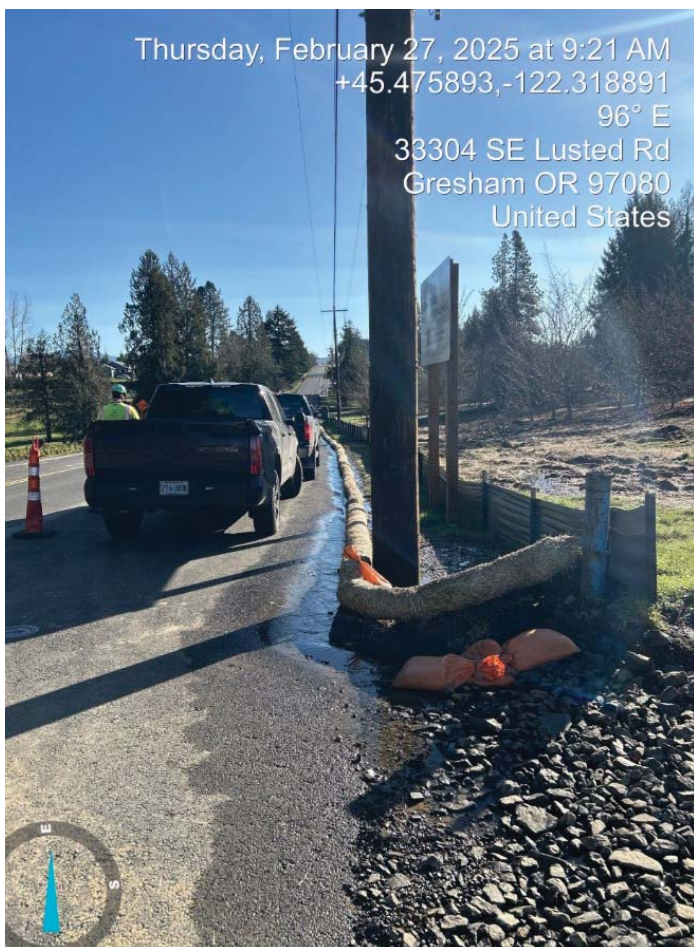
After having installed the water management and control system shown in Photo 5, in February 2025, the contractor damaged existing unmapped clay drainage tiles on the FWI site while removing the top 18" of topsoil in preparation for construction.

This tile damage created an uncontrolled water discharge being released from the drain tile system, which is believed to have been previously clogged. The water released above ground instead of being routed underground to the vertical HDPE pipe caused additional turbid flow. The condition was further exacerbated by excess water from ongoing large rain events combined with the surface drainage from the farm field. All of this water together was enough to bypass the pre-construction collection point and catch basin, leaving the site, flowing east down SE Lusted Rd, and create the temporary ponding observed at the driveway on the property located at 33608 SE Lusted Rd (Exhibit N.10) on February 23, 2025. This driveway on the adjoining property to the east is also located at the low point the general vicinity. At this juncture, flows from the FWI site combined with runoff from the east and the south from the large rain events.

Photo 8: Taken February 27, 2025 shows water that was running under the FWI gravel pad and down the shoulder of SE Lusted Road. Since this picture was taken, a berm was built forcing the water to a small well with a pump that discharges water back to the grated catch basin.

In response to the damaged drain tiles at the FWI site in February, the contractor temporarily re-routed the water emerging from the damaged subsurface drain tiles to an above ground pipe (where it previously had been connected underground to the black vertical HDPE pipe shown in the Photo 1 above). Twenty-four inches of gravel base was also added to the FWI site to stabilize the muddy ground and help slow surface water sheet flowing across the property.

To accomplish the re-routing of the broken drain tile, a 6" HDPE temporary drain line was installed across the site from the broken drain tile area to the existing grated catch basin. A silt fence was also installed around the stockpiled soil along with straw wattles and straw bales to slow and filter overland surface flows before getting to the catch basin. A berm has also been added on the east side of the FWI site to provide a means to capture and contain drainage within the site and redirect water back into the catch basin through a 24" dewatering well and sump pump system that includes passing all water through sediment filter bags (see Photo 12 below). As shown in the photos below, these changes and improvements provide better means of maintaining the water quality leaving the site and controlling the site drainage.

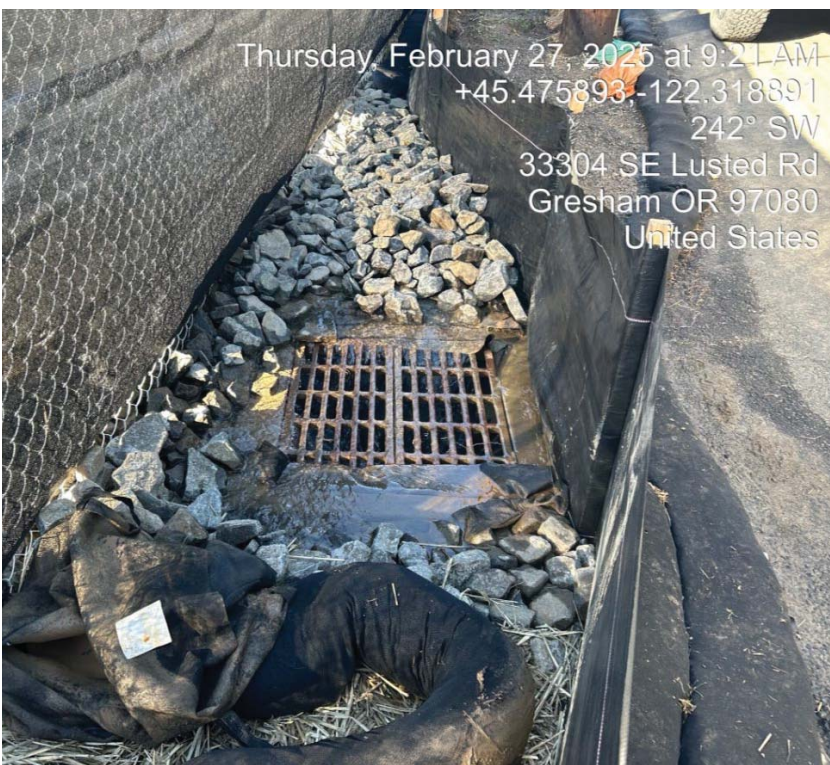
Photo 9: Taken February 27, 2025 shows clear/filtered water entering catch basin from sediment bags flowing through added rock.

As shown in Photo 9, the adjustments made to the pre-construction collection system greatly improved the collected and discharged water quality -- shown as clear water discharging into the catch basin.

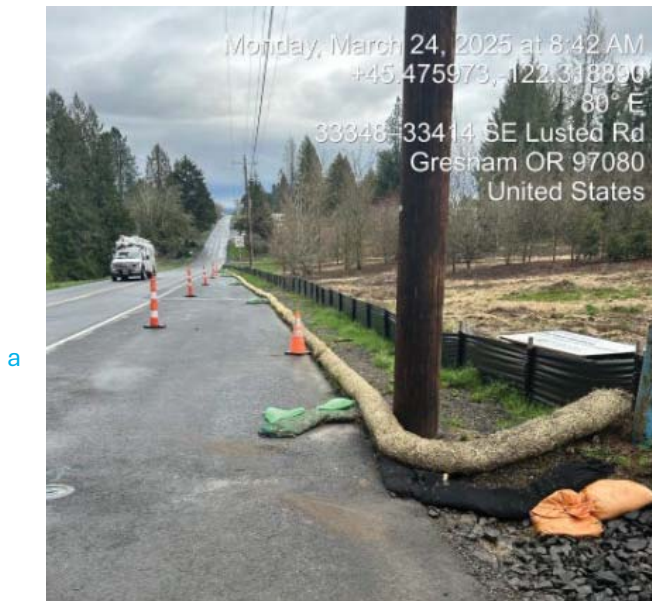
Photo 10: Taken March 24, 2025, after the rain event on March 21, 2025. In contrast to Photo 8, this photo shows no water running down the shoulder of SE Lusted Road. As noted in Photo 8, between Photo 8 and this photo, a berm was built forcing the water to a small well with a pump that discharges water back to the grated catch basin after passing through filter bag.

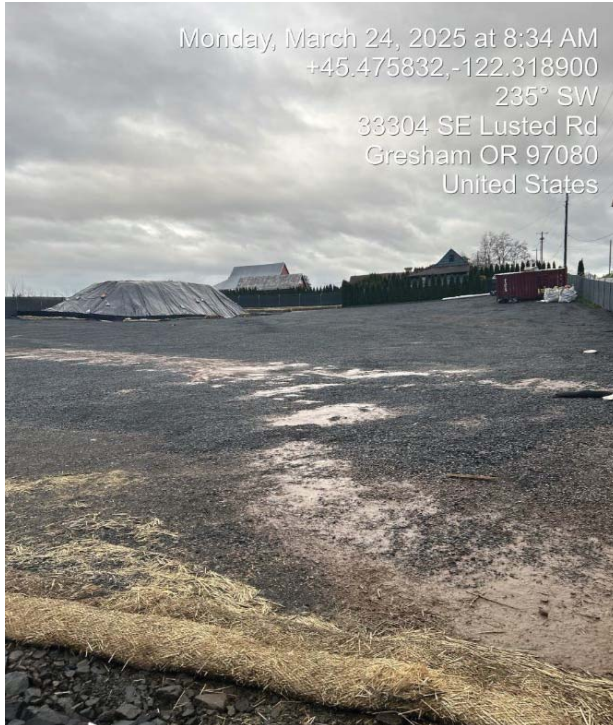
Photo 11: Taken March 24, 2025, showing no water leaving the site and running down the road due to the well and pump that had been installed.

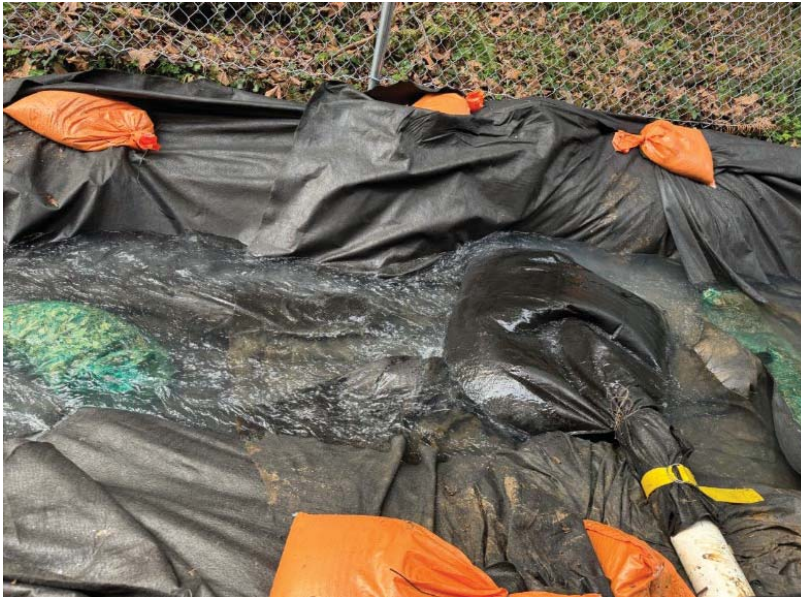
Photo 12: Taken March 24, 2025, showing clear water from the sump pump and 6" HDPE line filtered through sediment filter bags prior to entering the catch basin and discharging to the culvert across SE Lusted Rd

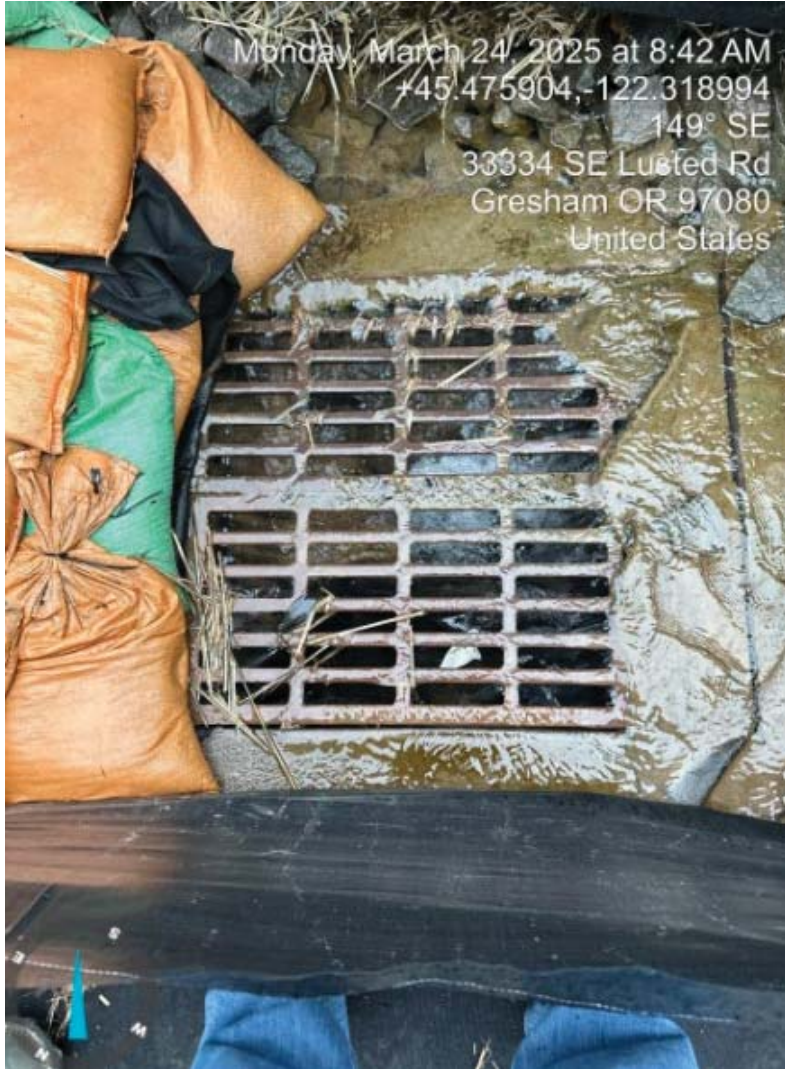
Photo 13: Taken March 24, 2025, showing filtered clear water from sediment filter bags discharging to the catch basin

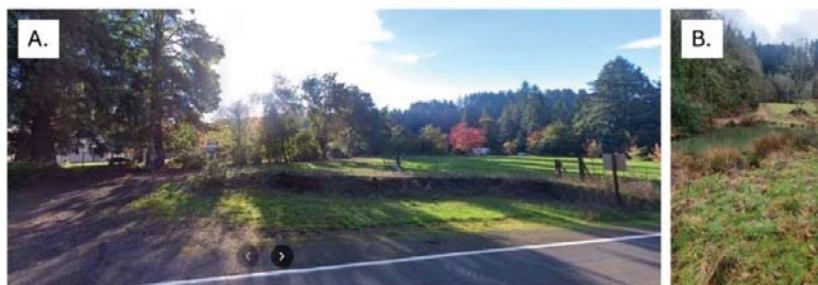
“In the fall of 2024, PWB began equipment staging and site preparations at the property adjacent to the raw water pipeline portal on SE Lusted Road. Significant modification to the property was completed to accommodate heavy equipment, construction materials, and construction traffic. This disturbance has inherently impaired natural resources since the start of construction activity, including surface water, wetlands, and associated wetland habitat. Site preparation resulted in the removal of at least 24 trees (> 6 inches in diameter) and an undetermined loss of existing shrubs. Contrary to Winterbrook’s report on habitat survey results that were conducted on October 19, 2021 (Exhibit G.1), a wetland features do exist on the affected properties (Figure 6). Exhibit G.1 nor any other evidence submitted into the record acknowledges the existence of the pond or wetland.”

Figure 6. Property associated with raw water portal near 37077 SE Lusted Rd. before raw water portal staging construction (A) Street view of the entrance of impacted property (October 2023, *GoogleMaps*); (B) Existing wetland, associated wetland grasses, pasture and surrounding trees (February 2024).

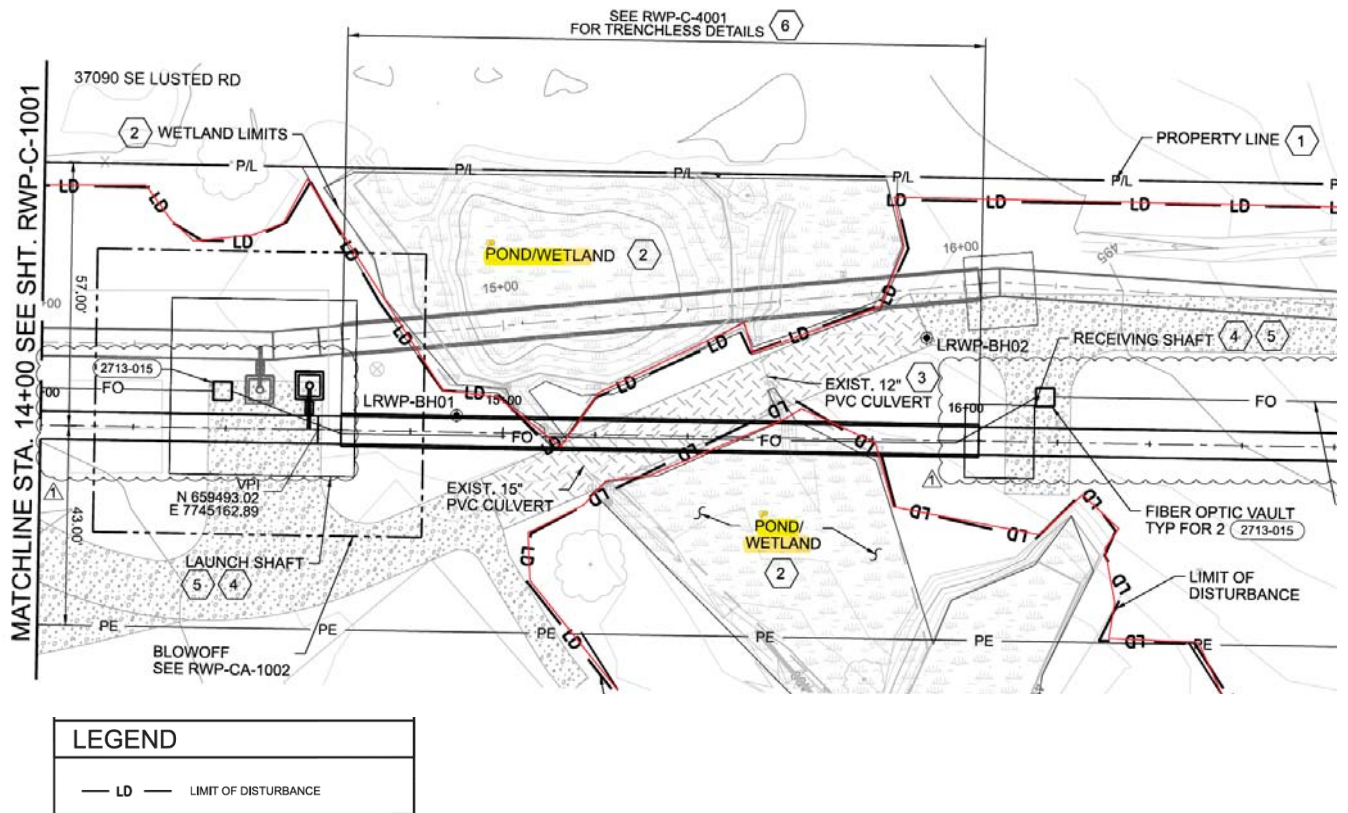
The wetland and pond delineation limits have been included on construction drawings and are designated as wetlands, as shown in this example section (note that north is down):

As shown on that construction drawing, the wetlands are outside of the construction limit of disturbance. A black sediment/silt fence has been installed to provide protection to the wetland. No activities are permitted to occur beyond this sediment fence into the wetland areas.

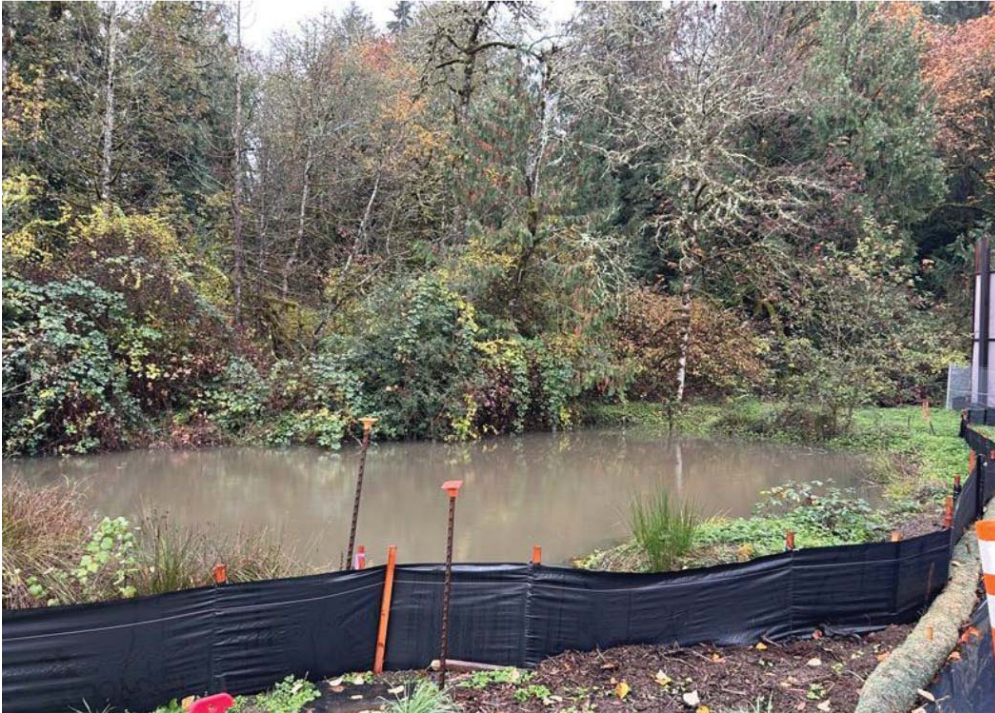
Photo 14:
Silt/Sediment
Fence
installed at
delineated
wetland
boundary –
Pond side of
Hardened
Road

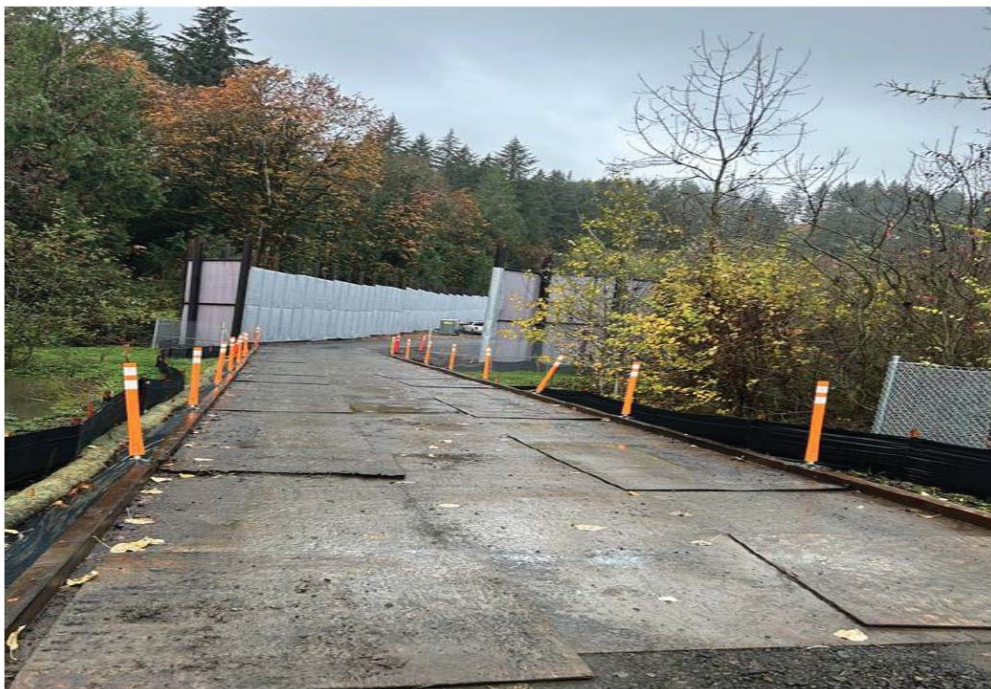
Photo 15:
View of
hardened
road
structure
with
sediment
fence and
straw wattles
on each side.

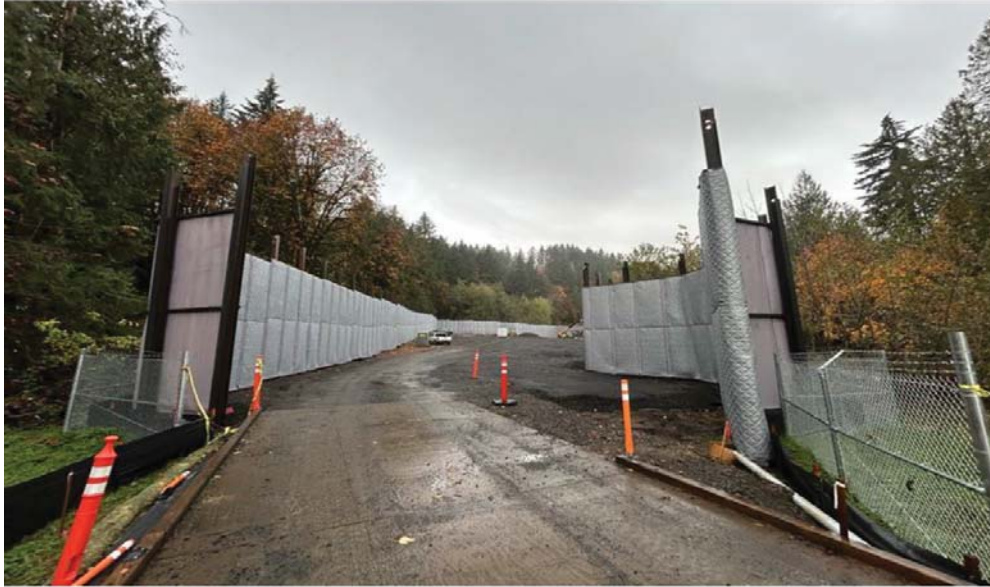
Photo 16: View of west end of hardened road with black sediment fencing below road protecting wetlands on each side from sediment/erosion. The taller grey fabric walls in background are sound wall material for noise mitigation during construction.

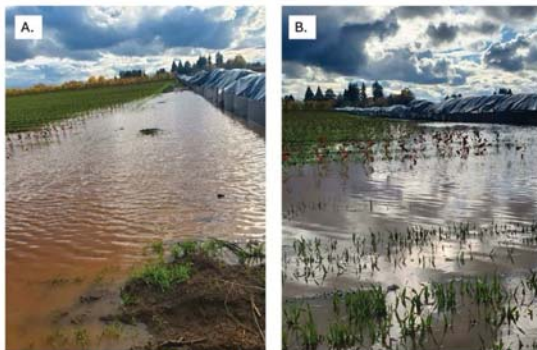
“The new easement road along the finished pipeline route is also negatively impacting farm operations and agricultural resources in a significant way. When the recent rainy season began in the fall of 2024, Surface Nursery experienced extreme impacts of the new PWB access road and altered landscape. To control dust and erosion, PWB implemented measures that included the installation of heavy impervious materials and silt fencing. As a result, significant flooding occurred (and continues to occur) during rain events (Figure 11). According to Surface Nursery, operators (including the neighboring farm, Ekstrom Nursery) experienced unprecedented flooding causing the inability to operate and access farmland, destruction of seedlings, and unworkable soils for farming (Figure 11B).”

Figure 11. Significant negative impacts of altered landscape and erosion control measures on agricultural resources and existing farmland in fall of 2024 (photo credit: Surface Nursery). The location captured in the photos are along the finished pipeline route between SE Dodge Park Blvd and SE Lusted Road. (A) Excessive flooding of Surface Nursery property following fall rain events causing inaccessibility for farm operators; and (B) Flooded field of newly planted nursery stock saplings.

morning, on November 15, 2024, the contractor opened gaps in the stockpile and silt fence and added wattles as check dams to prevent sediment movement from work areas with the water. This was intended to allow drainage to resume as would normally have occurred pre-construction from the Schoepper onto the Ekstrom property.

PWB received another complaint about ponding from Shawn Nerison on November 20, 2024. PWB visited the site on November 20 (that same day) and a conveyance pipe was added on November 21 to help convey the flow of water as would normally have occurred pre-construction from the Schoepper onto the Ekstrom property (see Nov 26 Photo 17 below). PWB has received no other complaints since these improvements were made and has not observed any additional ponding or issues similar to that raised by the commenter at this location. Therefore, this was a limited construction impact that is not relevant to compliance with MCC 39.7515(B).

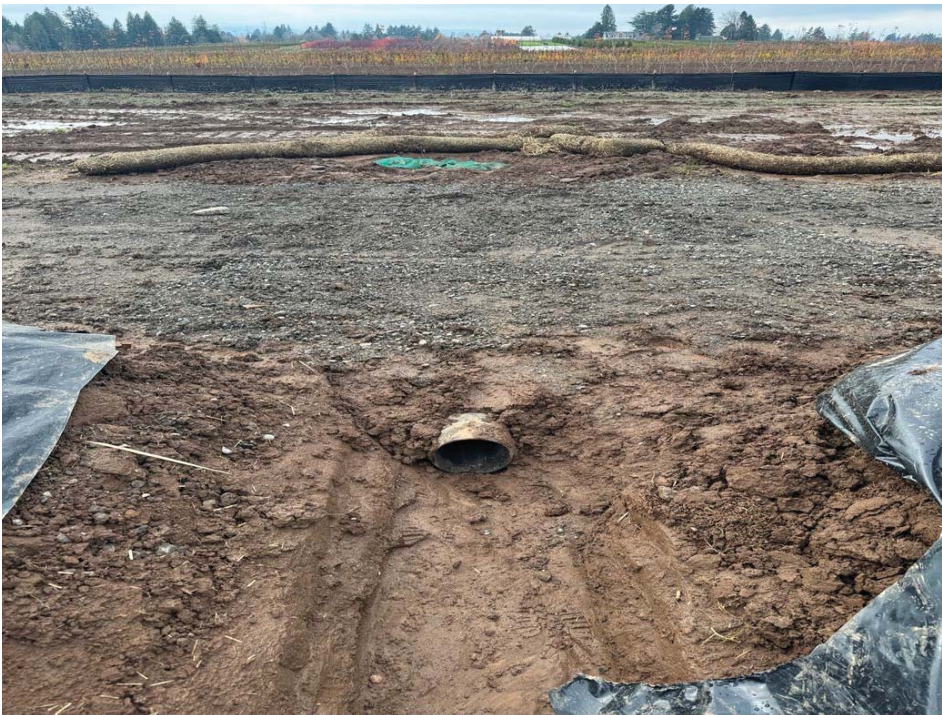
Photo 17: Taken November 26, 2024, showing installation of pipe to help convey water off the Schoepper property as pre-construction would have normally drained.
