## NOTICE OF DECISION

**Case File:** T2-2012-2423

**Permit:** Planning Director's Determination

**Summary:** Applicant is requesting a Planning Director's Determination that the structure on the subject property is a Lawfully Established and Habitable Dwelling as defined in MCC 33.0005.

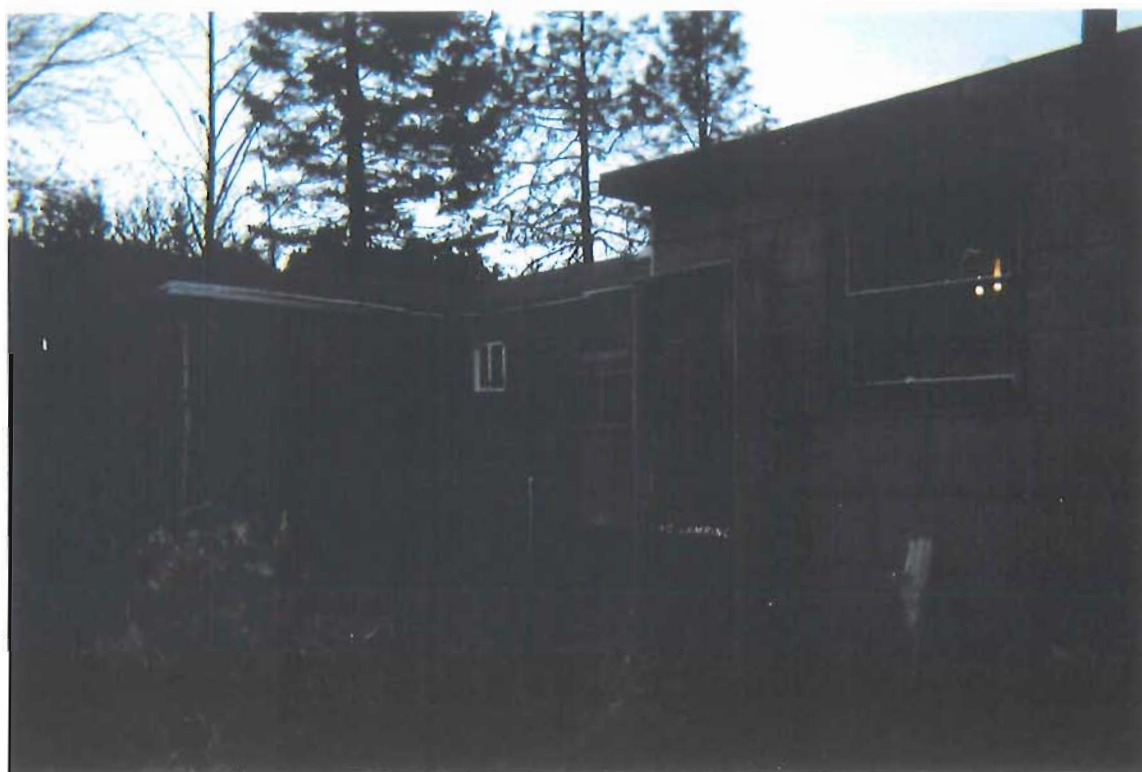
Exhibit 1: Exterior of Dwelling at 14027 Rock Creek Road, Portland, Oregon

View of south side of dwelling on Tax Lot 1100. Walls and roof are intact. Siding is in full repair and good condition

Applicant's photo Exhibits 1, 9, 10, 12, 13, 14, and 18 show electric lights turned on. Again, it should be noted that the electric panel in applicant's photo Exhibit 18 appears installed without evidence of a permit. Page 4 of the narrative for T2-09-064, for the subject property and written by the same applicant, notes that a new electrical panel was installed 1990. Again, while the physical elements are in the structure, unpermitted and unlawful elements cannot be considered.

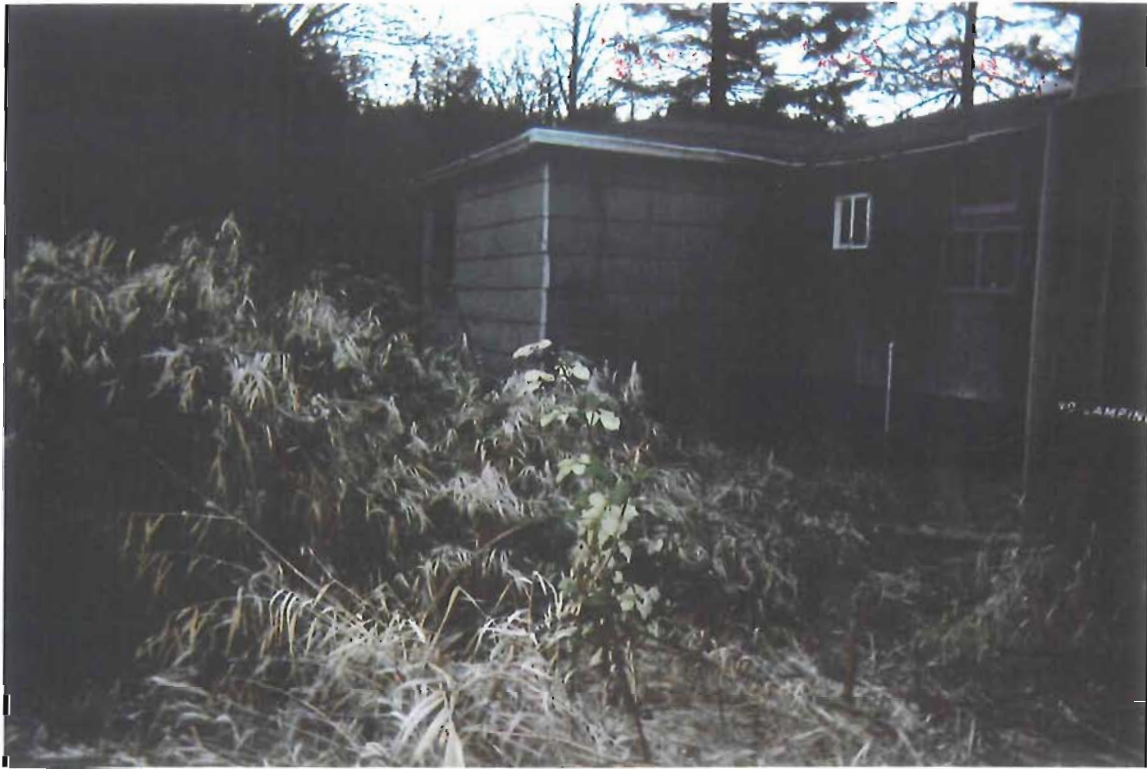
Exhibit 2: Exterior of Dwelling at 14027 Rock Creek Road, Portland, Oregon

View of south side of dwelling on Tax Lot 1100 with an orientation to the west. Walls and roof are intact. Siding and gutters are in full repair and good condition

The exterior of the dwelling in the photographs does not contain any readily apparent holes or gaps. However, it is clear that portions of the protective exterior siding are missing as seen in the applicant’s photos Exhibits 2, 5, 6, 7, 8, 9, and 10 (Exhibit A.9, A.16). It also appears that there were in fact holes in the structure that were covered with plywood in applicant’s picture Exhibits 3, 4, 5, and 6. Applicant’s picture Exhibit 7 shows an exterior door and window portion of the dwelling that is without protective siding; contains new lumber around the window; contains a haphazard collection of wood siding pieces near the door; and contains a precarious tin roof overhang as a protective porch cover. Two segments of the home, shown in applicant’s picture Exhibits 3, 4 and 5 clearly show areas of the home that were exposed and not intact as having been covered by plywood in order to keep out the elements. In applicant’s photo Exhibits 3 and 4 the area is explained to be a closed off front door but there is no explanation as to the boarded up hole in the wall in picture Exhibit 5. Lastly, in the narrative from case T2-09-064 (A request for a

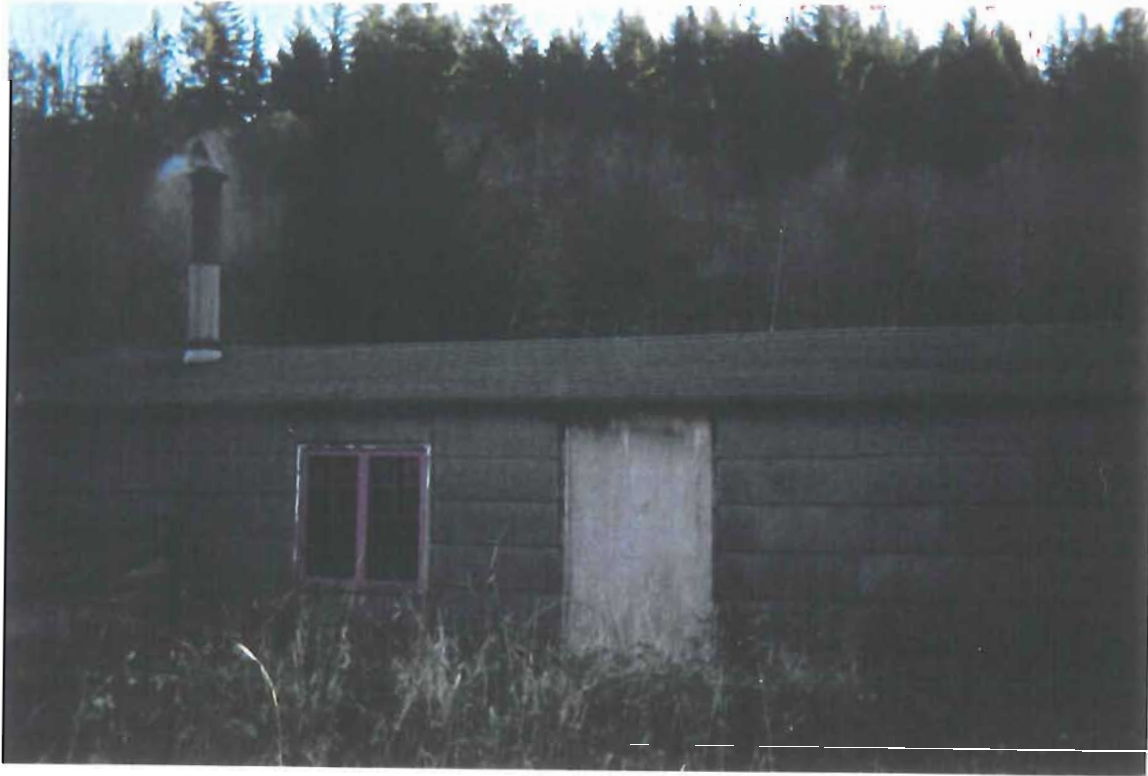
Exhibit 3: Exterior of Dwelling at 14027 Rock Creek Road, Portland, Oregon

View of north side of dwelling on Tax Lot 1100 with an orientation to the south. Walls and roof are intact. Asphaltic roll roofing is in excellent condition. The front door was sealed off in favor of using the doors on the east and west ends of the house. Chimney from interior wood stove is in excellent repair and is double walled for fire safety.

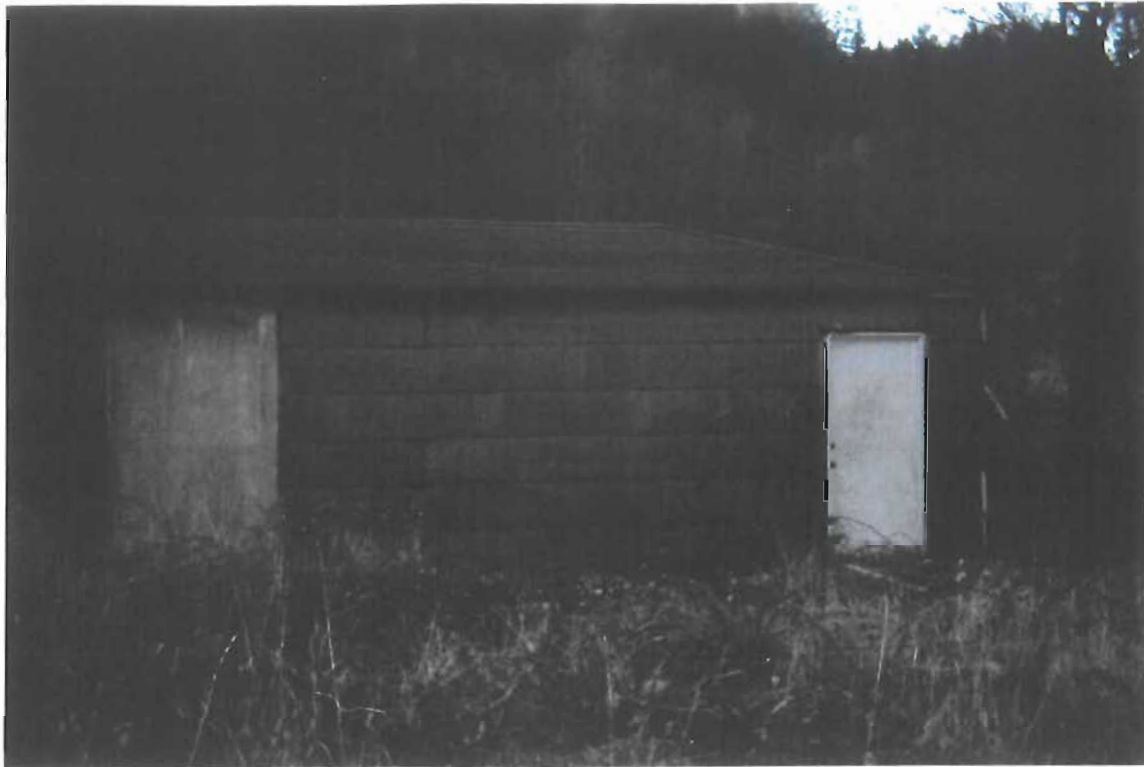
Exhibit 4: Exterior of Dwelling at 14027 Rock Creek Road, Portland, Oregon

View of north side of dwelling on Tax Lot 1100 with an orientation to the west end of structure. Walls and roof are intact. Asphaltic roll roofing is in excellent condition. The front door was sealed off in favor of using the doors on the east and west ends of the house. The new white door on the west end of the dwelling replaces the sealed off door.

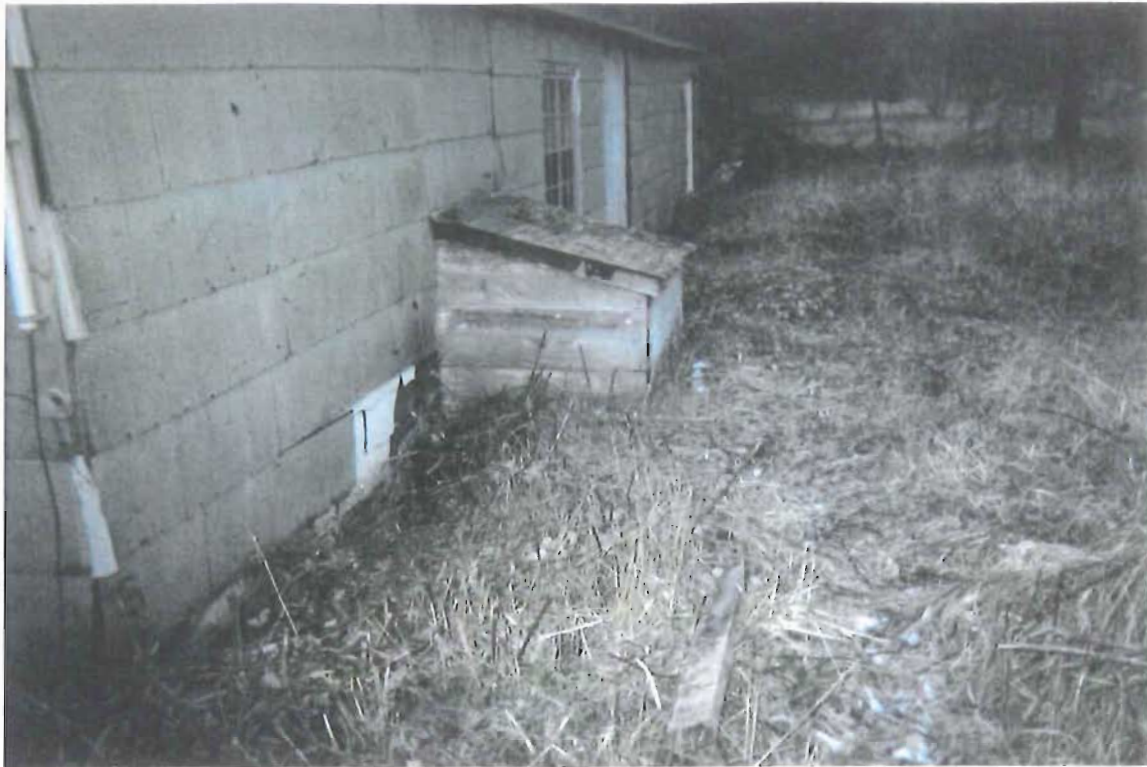
Exhibit 6: Exterior of Dwelling at 14027 Rock Creek Road, Portland, Oregon

View of north side of dwelling on Tax Lot 1100 with an orientation to the west end of structure. Siding is intact.

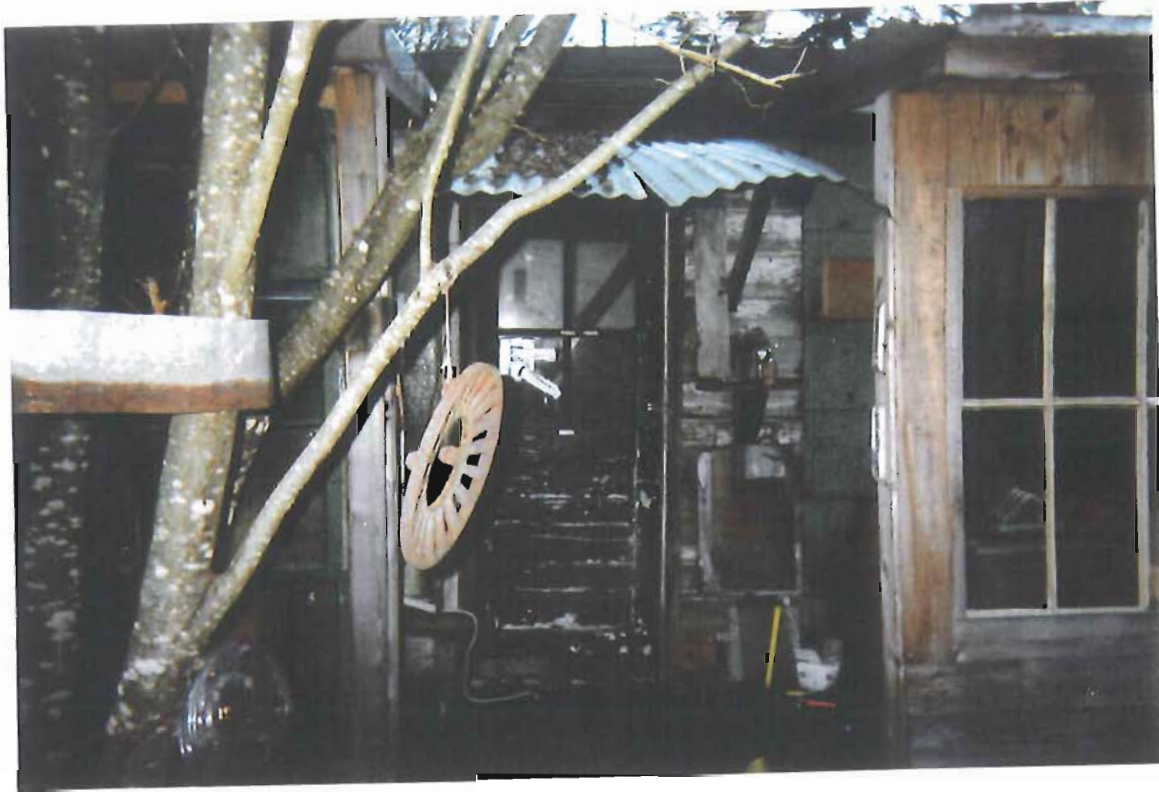
Exhibit 7: Exterior of Dwelling at 14027 Rock Creek Road, Portland, Oregon

View of east side of dwelling on Tax Lot 1100 with a view of the main entry door. Though in need of paint, the siding and exposed wood areas are very structurally sound. No dry rot or holes were noted anywhere on the east side of the structure. This portion of the building is actually located on Tax Lot 1200 due to inaccurate survey monumentation near the Willamette Meridian. The proposed Property Boundary Adjustment and the replacement of this dwelling to the portion of Tax Lot 1100 across the road would alleviate this situation.

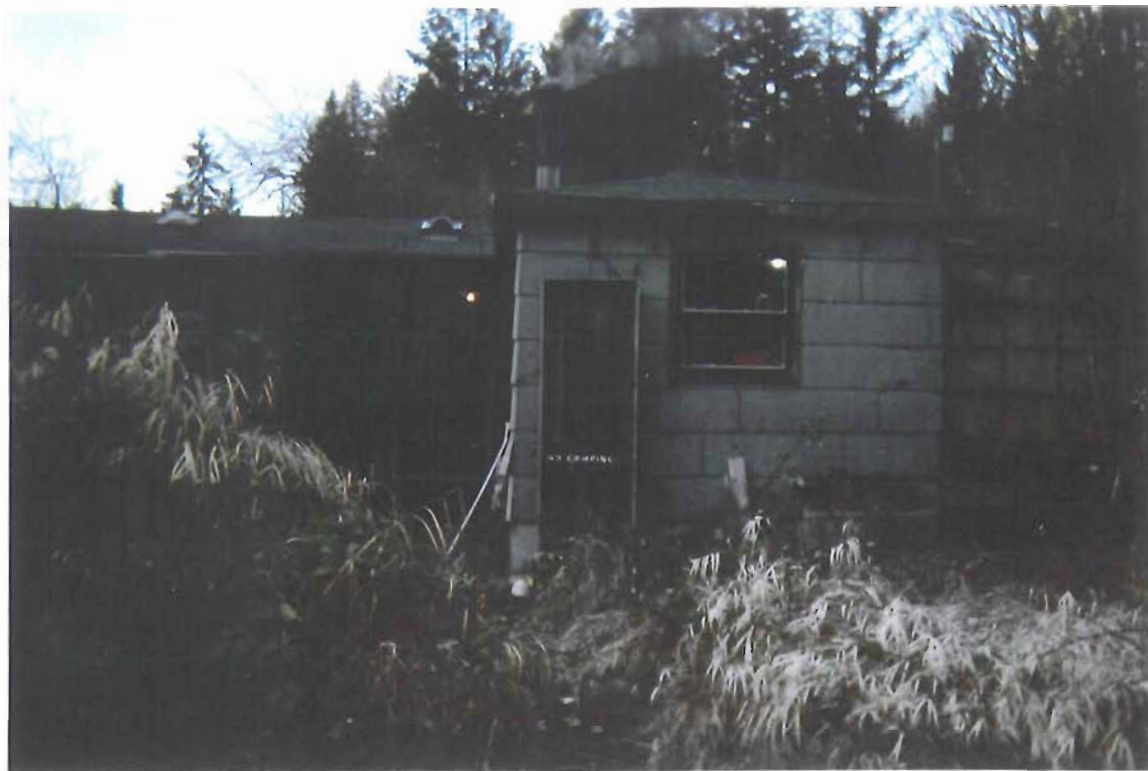
Exhibit 9: Exterior of Dwelling at 14027 Rock Creek Road, Portland, Oregon

View of west side of dwelling on Tax Lot 1100 with a view to the east. The siding and the roof are intact as can be seen in this photograph.

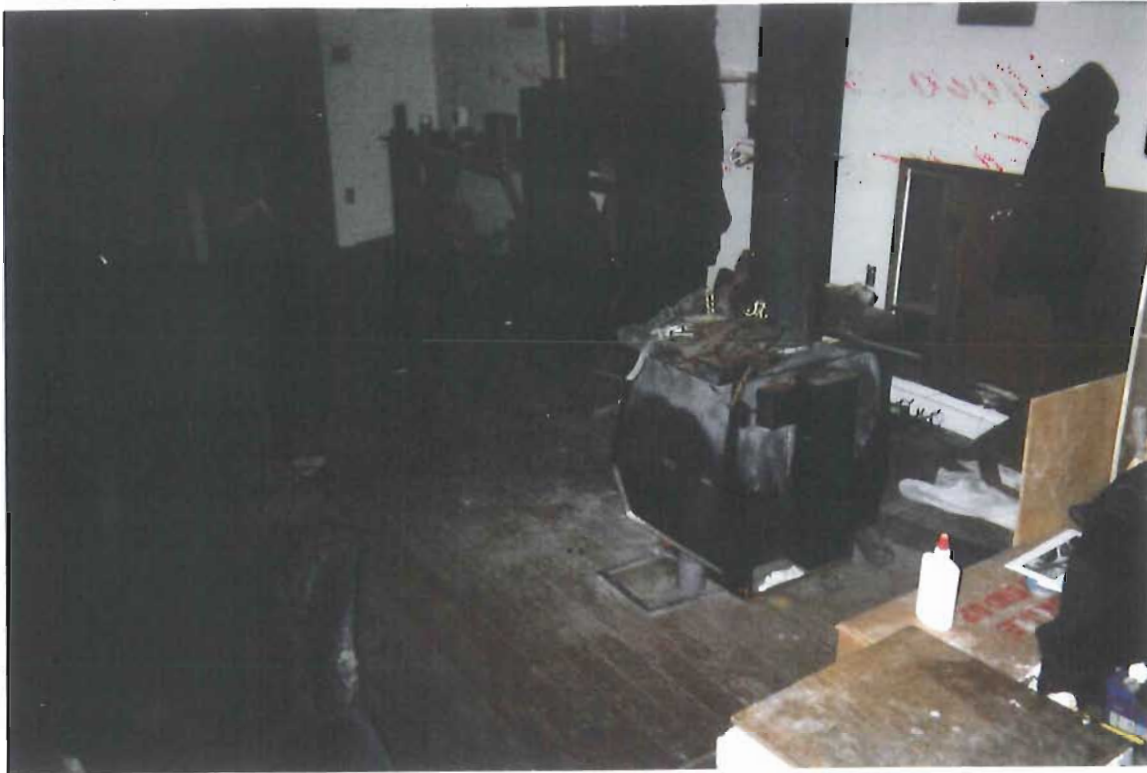
Exhibit 11: Interior of Dwelling at 14027 N.W. Rock Creek Road, Portland, Oregon

View of the interior of the dwelling showing the large capacity wood stove and the stainless steel triple walled chimney. Note the large size of the stove pipe. This pipe reduces the risk of fire danger and the large fire box capacity of the stove easily heats the interior of the structure. This hearing system was operating at the time of this photograph and the interior of the structure was very comfortable.

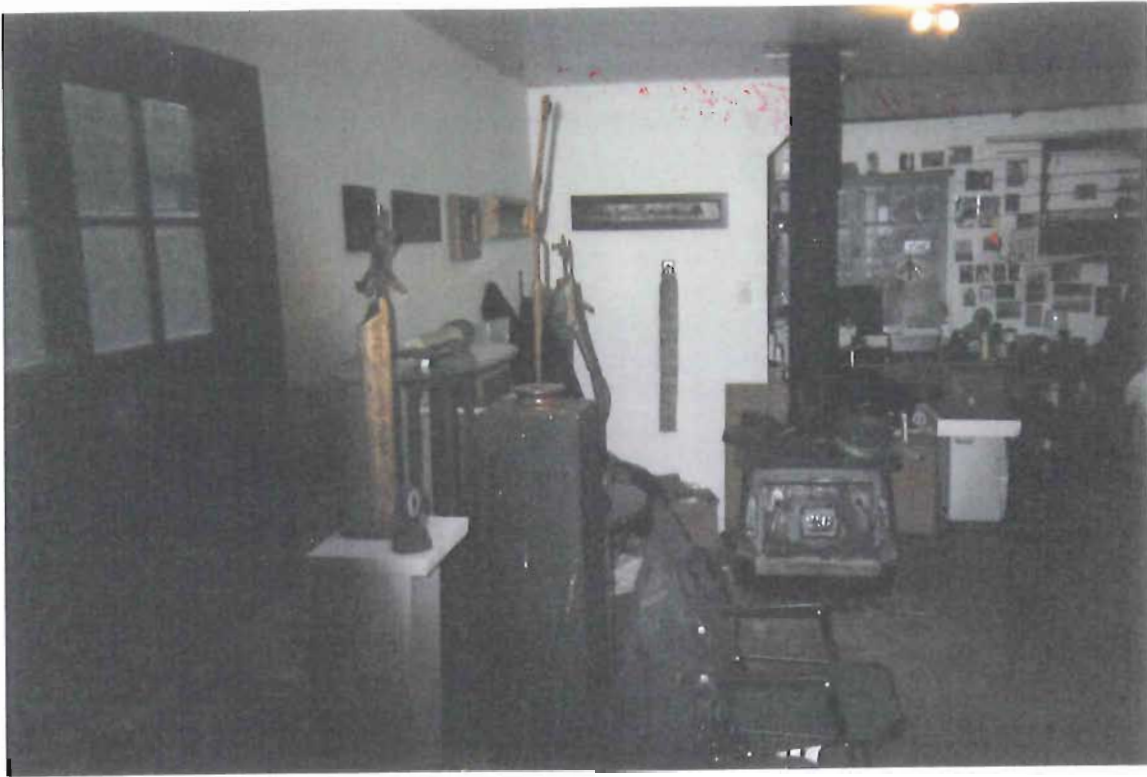
Exhibit 12: Interior of Dwelling at 14027 N.W. Rock Creek Road, Portland, Oregon

View of the interior of the dwelling. Note dry wall construction (intact) windows, electric lights hardwood floors and wood stove heating system. The abstract art in the photo is personal property only.

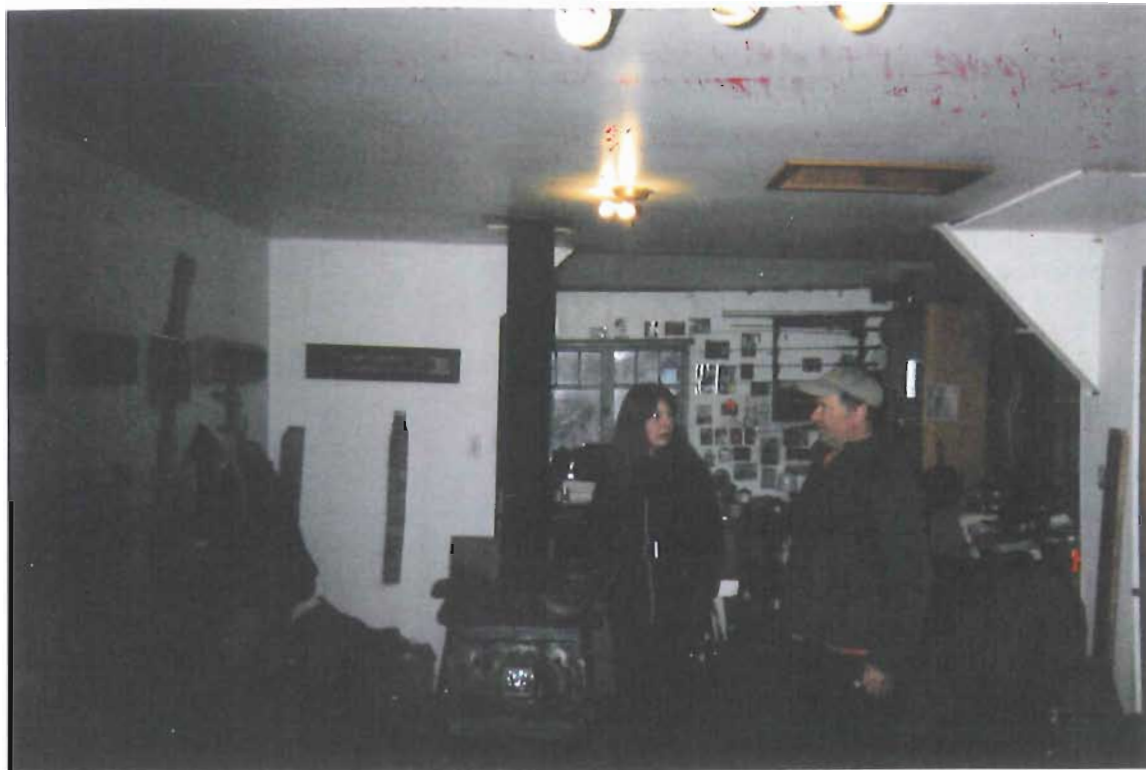
Exhibit 13: Interior of Dwelling at 14027 N.W. Rock Creek Road, Portland, Oregon

View of the interior of the dwelling. Note the electric lights, tract lights and ceiling access to attic. This photograph also demonstrates that the walls and ceilings are intact.

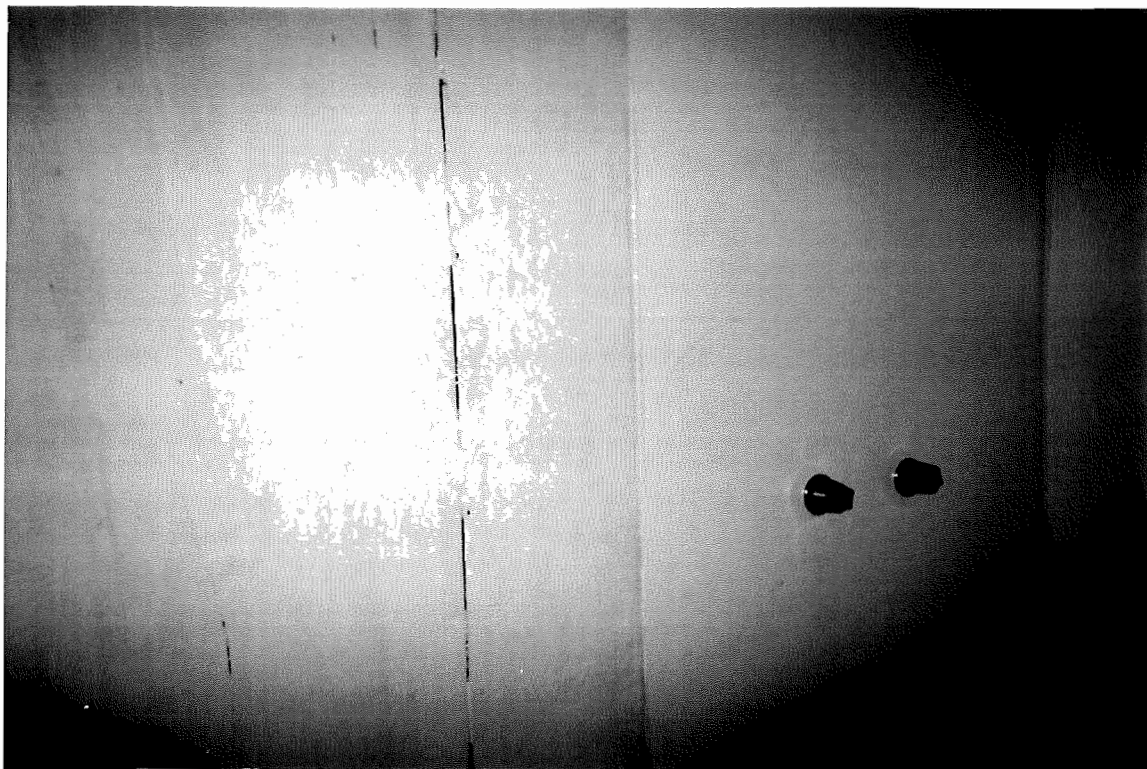
Exhibit 15: Interior of Dwelling at 14027 N.W. Rock Creek Road, Portland, Oregon

View of bathroom facility in subject dwelling. This is a view of the interior portion of the shower enclosure. Hot and cold water faucets.

Applicant's photo Exhibits 15, 16, 17, 20, and 21 show plumbing for the shower, bathroom sink, toilet, and kitchen sink. It should be noted that the shower, toilet, bathroom wash basin and possible water heater appear to have been recently installed in the structure and without evidence of building permits. Lastly, the structure was only recently connected to a sanitary waste disposal system – an unpermitted and installed system primarily placed for use by the dwelling on the adjacent property. The land owner also connected the subject structure to the system in roughly 2011. While the physical elements are in the structure, unpermitted and unlawful elements cannot be considered. As such, it appears the dwelling does not have plumbing as required under the definition of habitable.

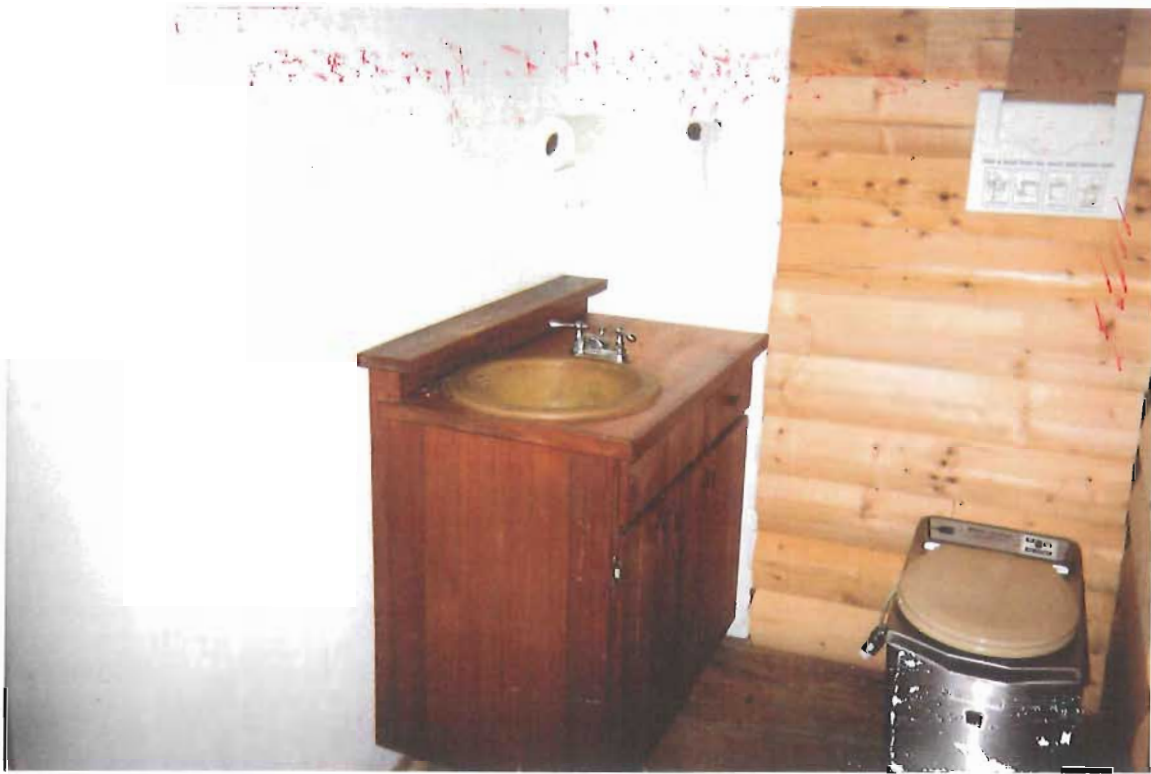
Exhibit 16: Interior of Dwelling at 14027 N.W. Rock Creek Road, Portland, Oregon

View of bathroom wash basin and toilet. Dual faucets for hot and cold running water.

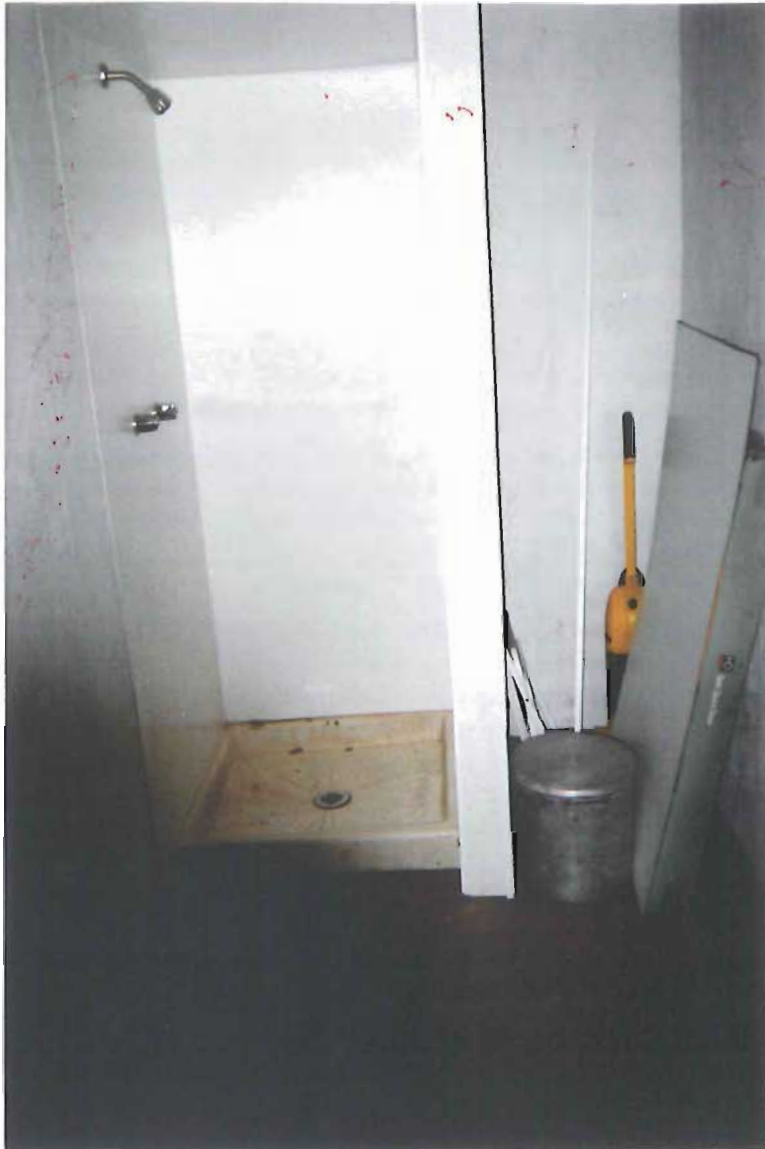
Exhibit 17: Interior of Dwelling at 14027 N.W. Rock Creek Road, Portland, Oregon

View of floor to ceiling shower stall including faucets and drain.

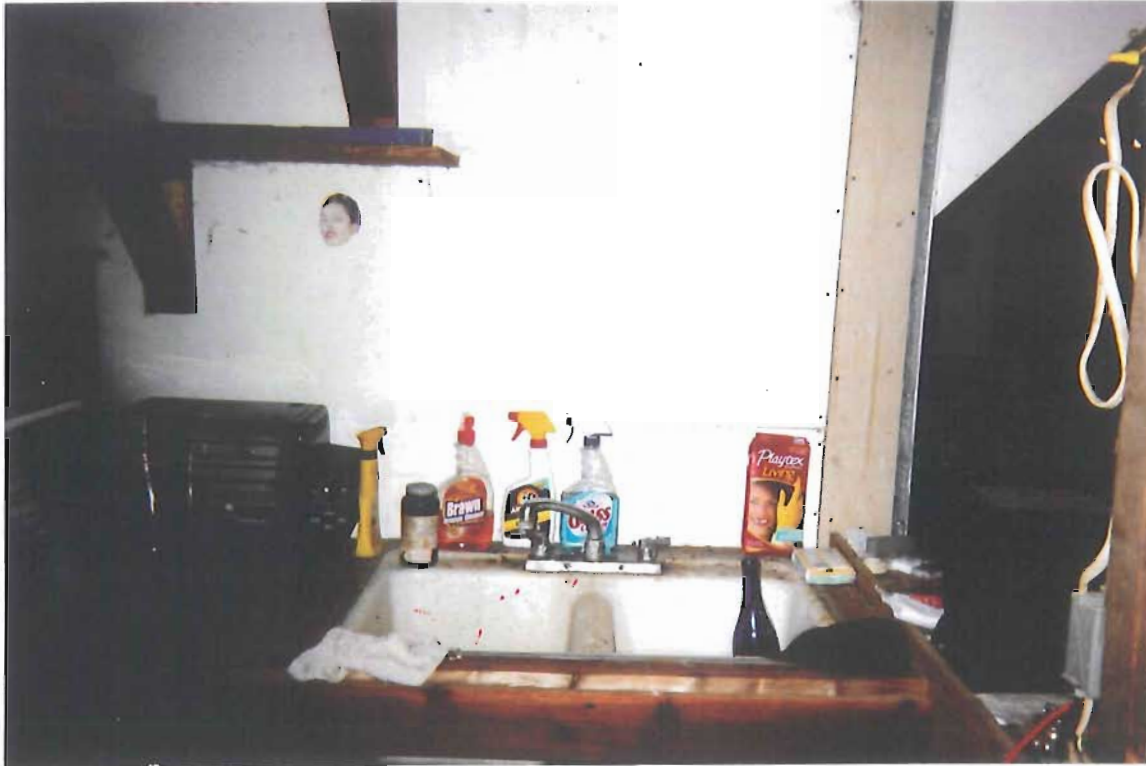
Exhibit 20: Interior of Dwelling at 14027 N.W. Rock Creek Road, Portland, Oregon

Newly installed kitchen sink with hot and cold swivel faucet. Note drywall construction in kitchen.

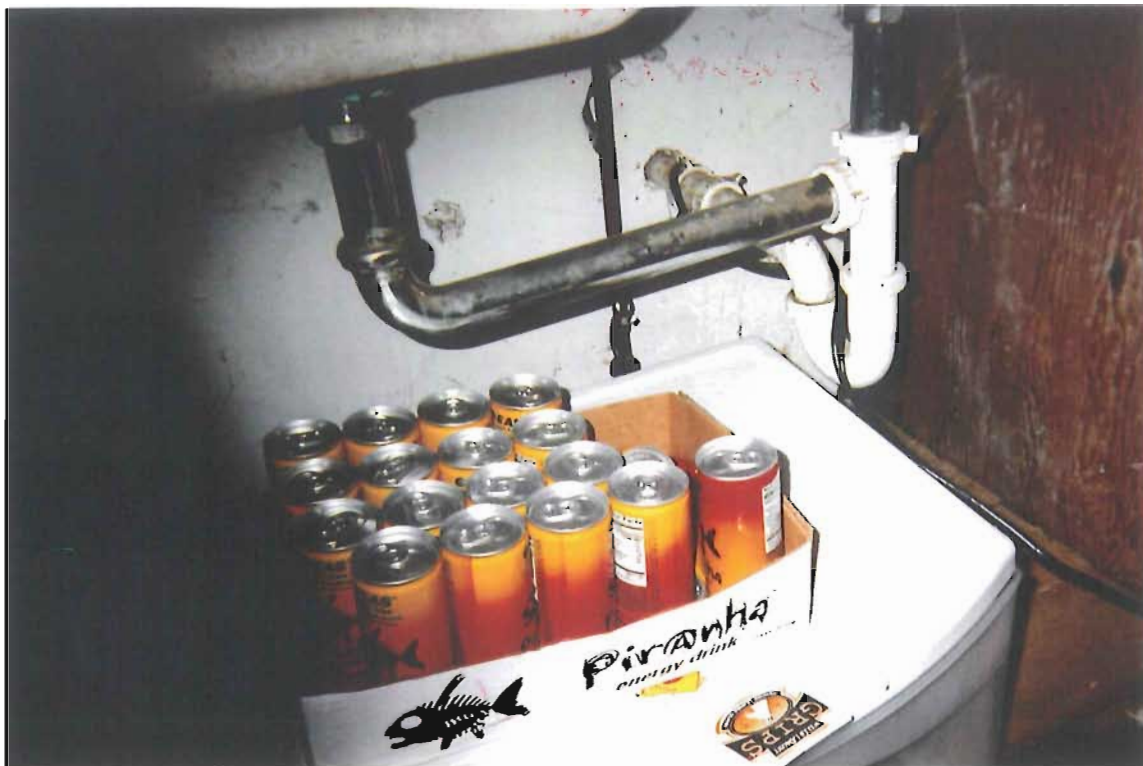
Exhibit 21: Interior of Dwelling at 14027 N.W. Rock Creek Road, Portland, Oregon

New chrome and white PVC pipe attached to kitchen sink.

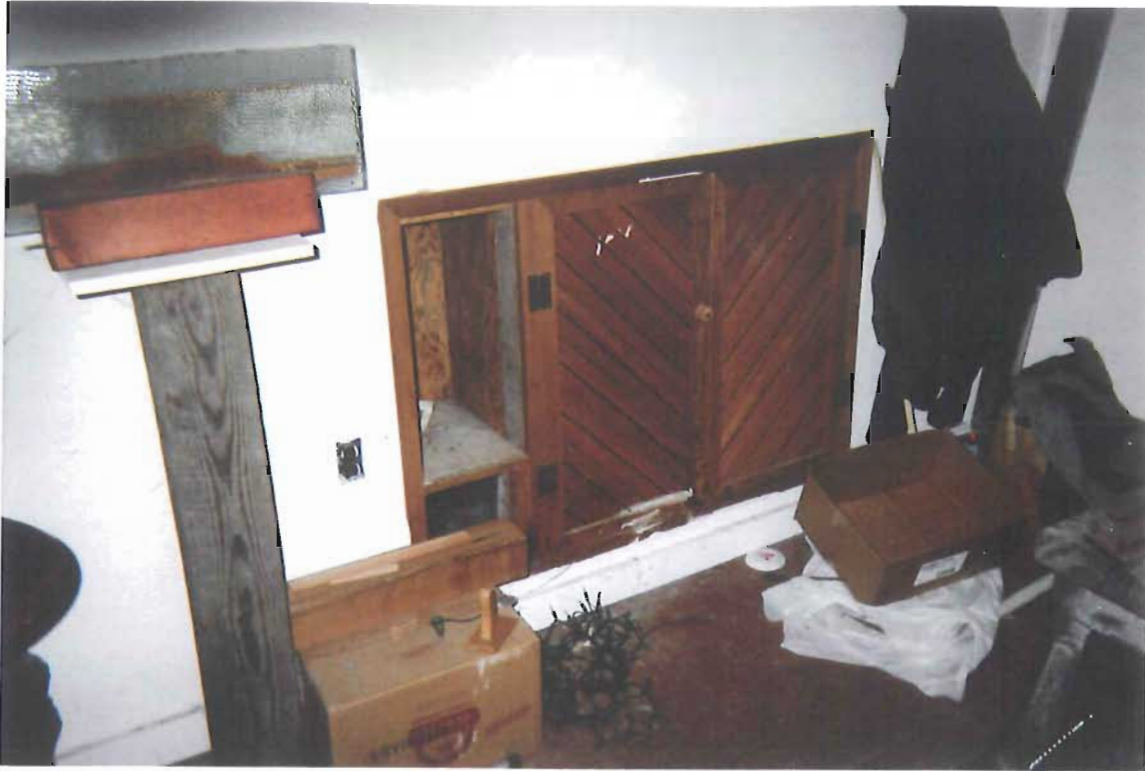
Exhibit 23: Interior of Dwelling at 14027 N.W. Rock Creek Road, Portland, Oregon

Wood intake doors to outside wood box. Note electrical plug to left of firewood door. Note baseboards and excellent conditions of drywall interior wall.

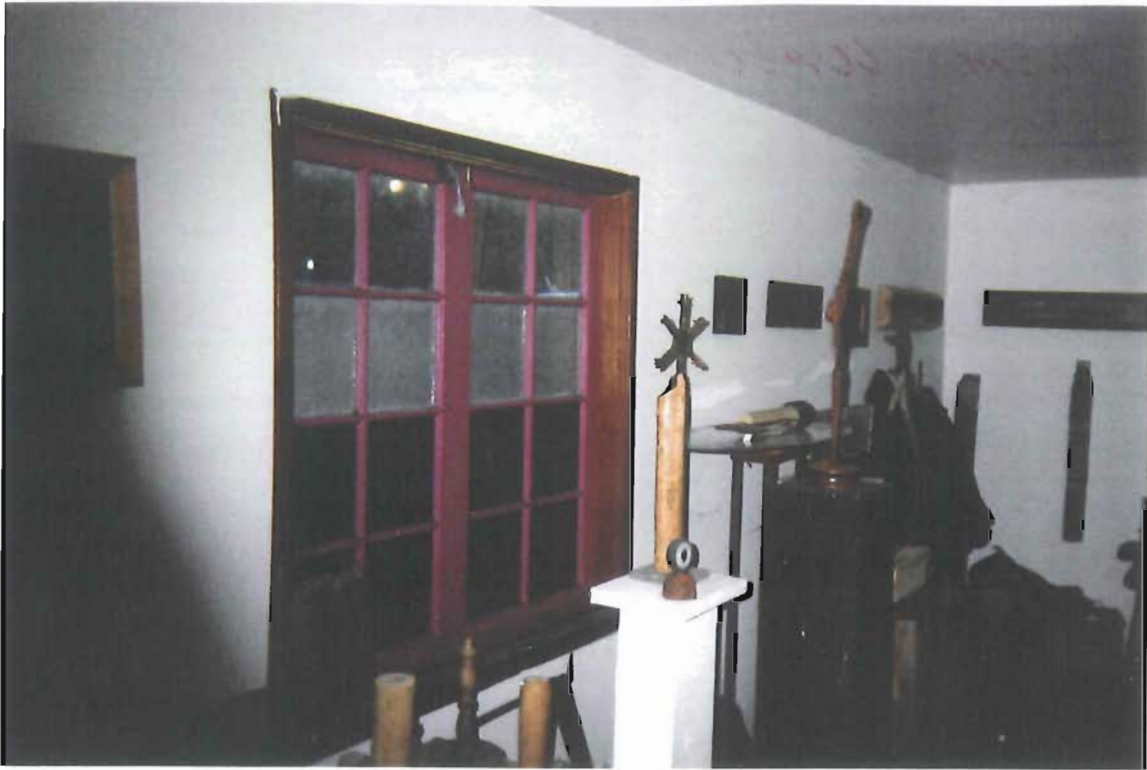
Exhibit 24: Interior of Dwelling at 14027 N.W. Rock Creek Road, Portland, Oregon.

View of newly remodeled living room. Note vintage windows and new drywall.

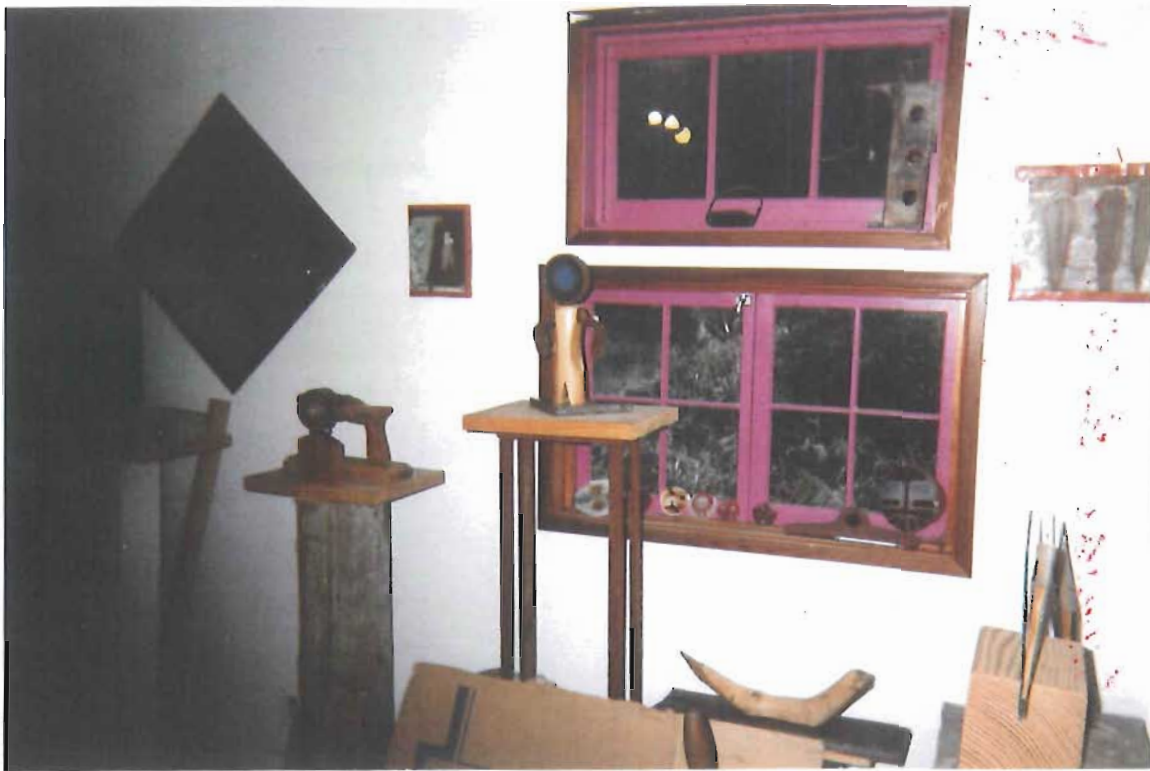
Exhibit 25: Interior of Dwelling at 14027 N.W. Rock Creek Road, Portland, Oregon.

View of newly remodeled living room on opposite side of room from Exhibit 24.
