### National Scenic Area Site Review

Case File: T2-2017-8783

Proposal: Applicant is applying for a NSA Post-Emergency / Disaster Response Site Review  
Application to authorize the construction of a new retaining wall on the subject property due to the failure of an existing wall.

**Subject: Geotechnical Investigation Report  
Retaining Wall Replacement  
2501 Northeast Rasmussen Road  
Corbett, Multnomah County, Oregon 97019  
EEI Report No. 17-028-1**

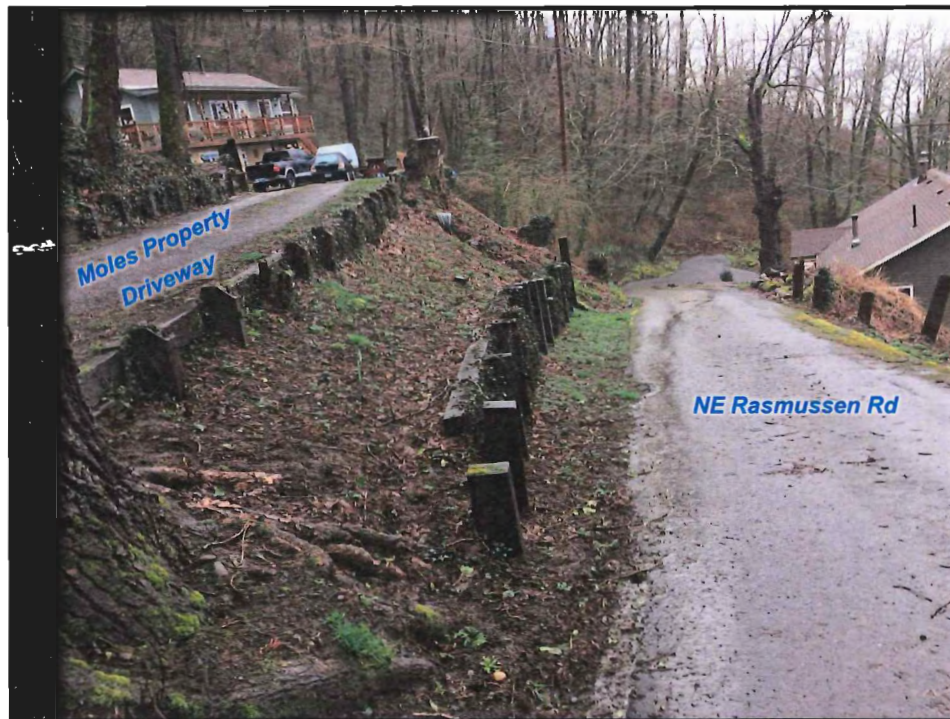
**PHOTO 1:** Viewing west at 2 existing wood retaining walls between NE Rasmussen Road and the private driveway, viewing from the northeast property corner.

Various retaining structures are present at the site. Three timber walls, running east-west, are at the site. The two upper walls are within the confines of the subject property and lines the north side of the subject property. The east end of the lower wall appears to at the property border with Northeast Rasmussen Road. See Photo 1 below.

The lower timber retaining wall shown in Photo 1 above lines the south edge of Northeast Rasmussen Road. The wall height ranges from a couple feet up to about 7 feet, and includes sloping backfill that ranges from about 2H:1V to 1/2H:1V (Horizontal:Vertical). It is noted the alignment of this lower wall is broken into 2 sections with about 70 lateral feet in this break of the timber wall alignment. Some regions of this alignment break do not include any retaining structure, only sloping soils upward from the edge of the roadway shoulder. A cement masonry unit (CMU) structure is retaining about 3 to 5 feet of soil for about 25 lateral feet of this break in the wall alignment. This CMU structure is battered (i.e. leaning) into the slope at about 20 to 25 degrees. See Photo 4 below. During each of our site visits, there was a lot of water observed flowing on the slope.

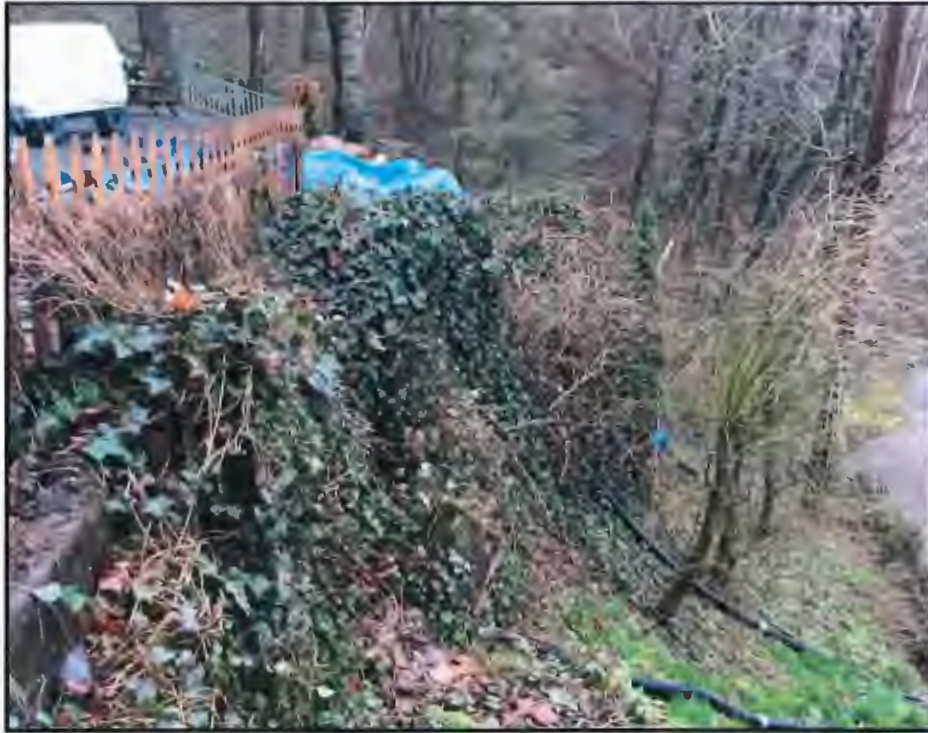
**PHOTO 2:** Viewing at the vegetation overhanging the west end of the upper timber wall lining the north side of the driveway.

A existing retaining wall along the north edge of the driveway tapers from about 1 foot in height at its east end (see Photo 1 above) up to about 11 feet at its west end. This retaining wall is covered with overhanging brush for the west approximate 40 feet (see Photo 2 below). The soils behind this retaining wall are generally level for about 50 feet (creating the house pad and driveway). The wall appears to be constructed using wood timbers as both the vertical posts and horizontal wall facing. It was noted that some of the wood posts and facing had deteriorated, and the tallest section of the wall appeared to be tilting outward. We also observed occasional round metal vertical posts in place in front of the wall facing. We presume these posts were added to provide additional support after the timber wall had been constructed. See Photo 3 below.

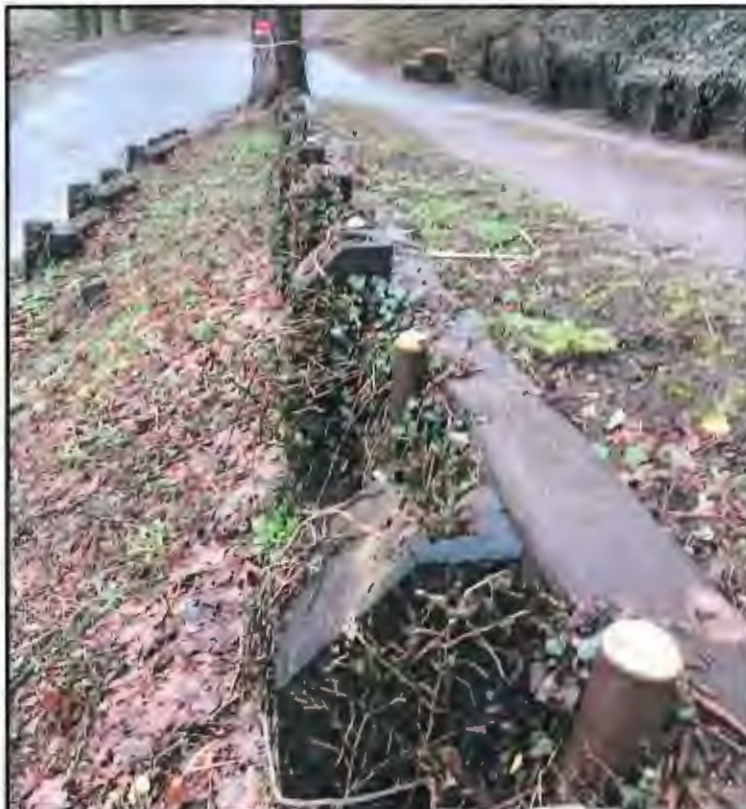
**PHOTO 3:** Viewing at the east end of the timber wall lining the north side of the driveway. Note the intermediate metal round posts between the timber posts.

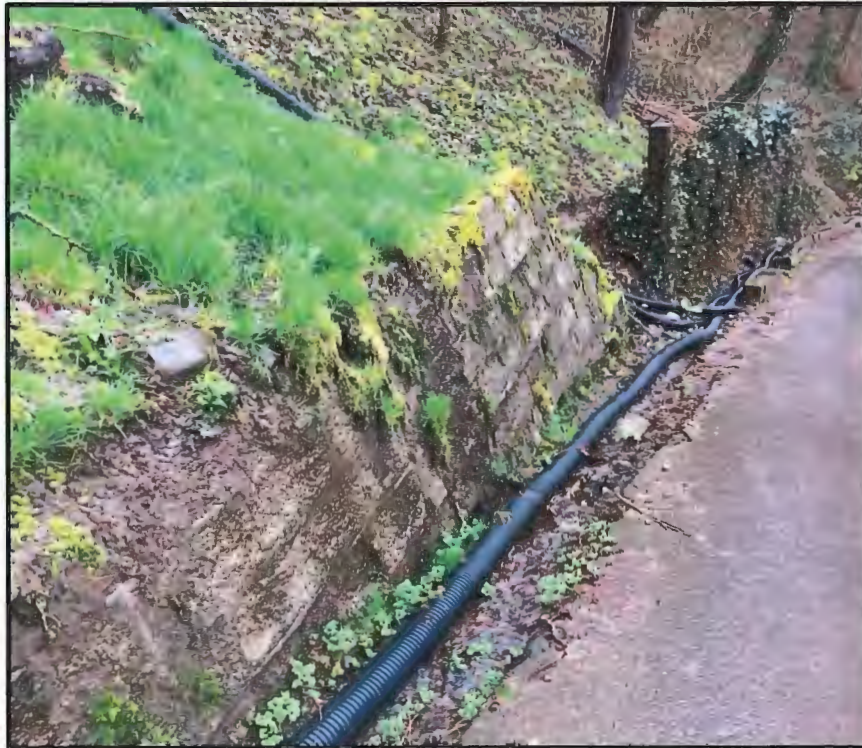
**PHOTO 4:** Viewing west at a CMU retaining structure along the south side of Northeast Rasmussen Road.
