MEMORANDUM

SUBJECT: Portland Water Bureau Bull Run Filtration Project Traffic Impact Analysis P18-035-000

This memorandum summarizes the traffic impact analysis for the proposed Portland Water Bureau (PWB) Bull Run Filtration Project (Project) located within Multnomah County and Clackamas County, Oregon. The purpose of this analysis is to evaluate the existing transportation facilities and to identify potential off-site improvements needed to adequately serve the proposed Project, which includes the main filtration facility as well as the pipelines, appurtenances, and the intertie. This evaluation is of the post-construction ongoing operation of the Project. This evaluation is based on the standards established by Multnomah and Clackamas County for each jurisdiction's roadways.

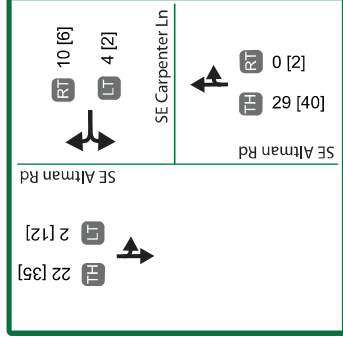
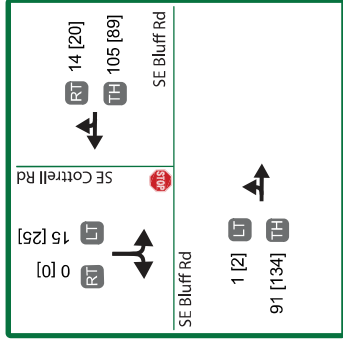
Figure 3: Traffic Volumes
 2022 Existing Conditions

⊗ = Study Intersection
 = Lane Configuration
 = Stop Sign
 = Left / Through / Right Turn
 AM [PM] = Peak Hour Traffic Volumes

Table 6 summarizes the 2022 existing traffic conditions and 2040 background traffic conditions. All intersections under both scenarios operate well within standards at a Level of Service B or better. Detailed analysis results are included in Appendix D.

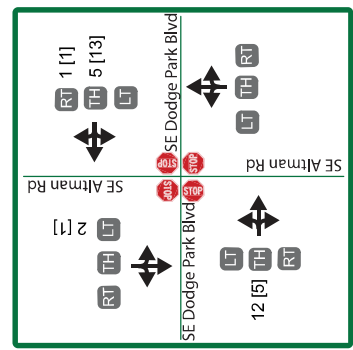
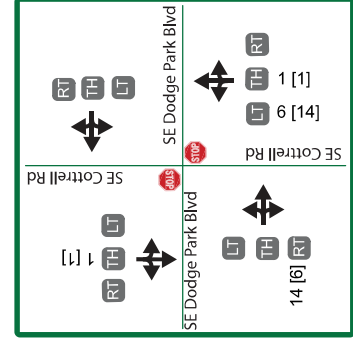
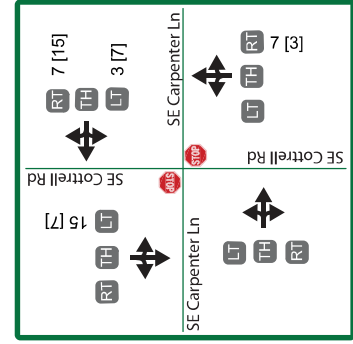
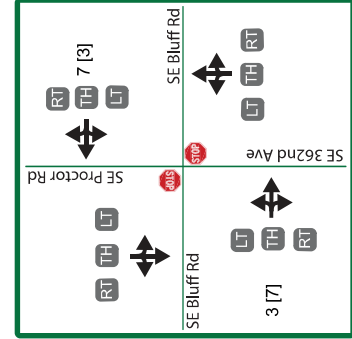
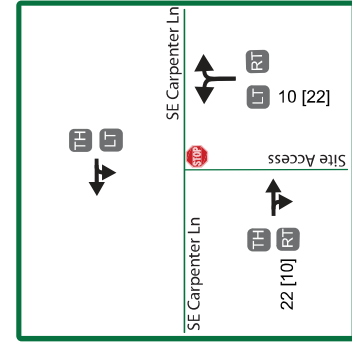
As summarized in Table 5, it is conservatively estimated that 32 AM peak hour trips and 32 PM peak hour trips will be added to the local transportation network. These peak hour trips were included in the future traffic volumes for the future conditions analysis. All peak hour site trips were modeled as entering and exiting the site from the primary access point on SE Carpenter Lane.

*Based on the turning movement count data at the study intersections, site generated trips are not anticipated to distribute through intersections 2, 7, 9, 12, and 13.

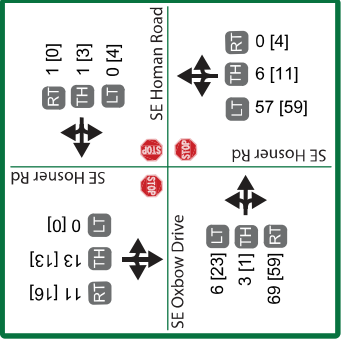
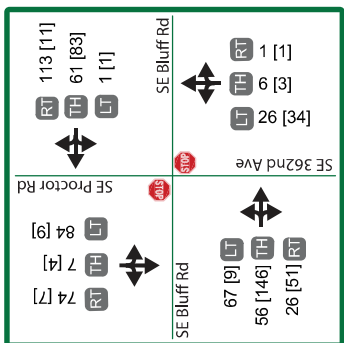
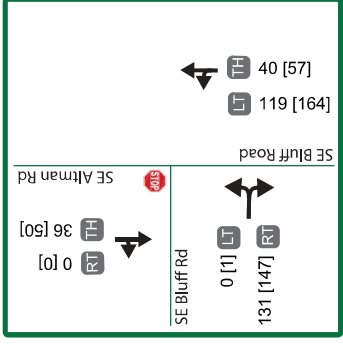
Figure 5: Traffic Volumes 2040 No-Build Conditions

⊗ = Study Intersection

↙ = Lane Configuration

AM [PM] = Peak Hour Traffic Volumes

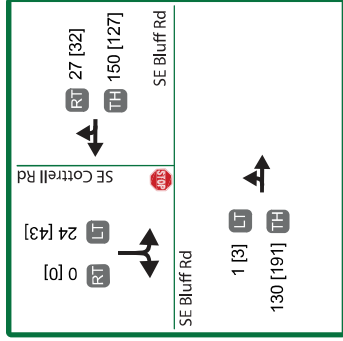
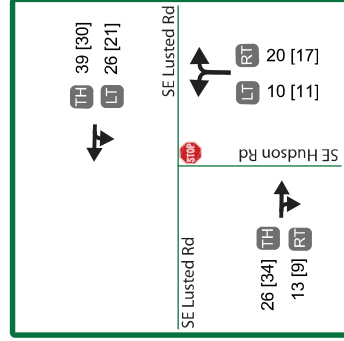
Figure 6: Traffic Volumes
 2040 Buildout Conditions

⊗ = Study Intersection ↙ = Lane Configuration ⛔ = Stop Sign
 ⬅️ ⬆️ ➡️ = Left / Through / Right Turn
 AM [PM] = Peak Hour Traffic Volumes

Table 7 summarizes intersection performance for the study intersections for the 2040 Total Traffic (Buildout) Scenario. As summarized in the table, all study intersections continue to operate at a Level of Service B or better, well exceeding the standards established by their corresponding jurisdictions under the 2040 Total Traffic (Buildout) conditions.
