То:	Multnomah County
From: Mike Sellinger, Bianca Popescu, Kelly Dunn, Rohan Oprisko, and David Wasserman,	
	Design
Date:	June 2025
Re:	East Multnomah County Systemic Safety Analysis Technical Memo

Introduction

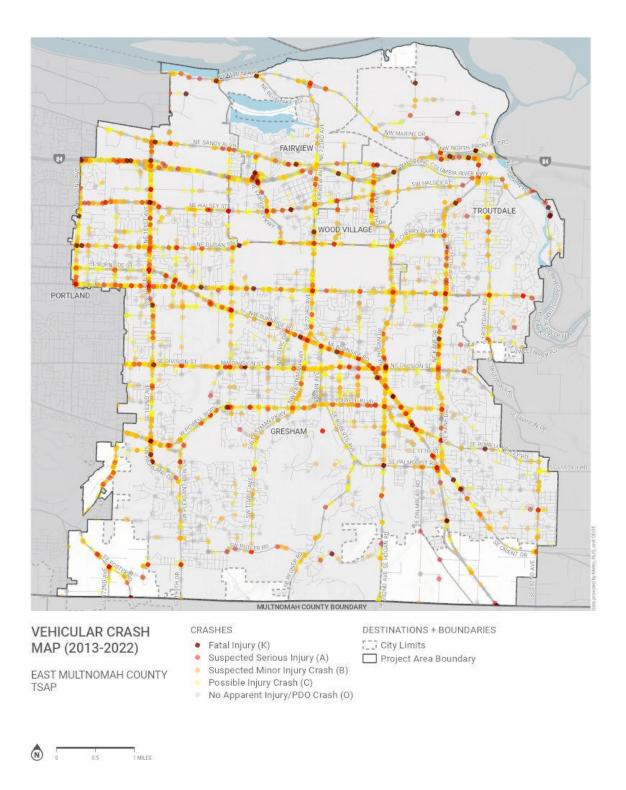
There are a significant number of crashes on every major arterial in the study area, particularly in the central and western areas. Fatalities are distributed throughout the study area and are especially concentrated on Burnside Road and 181st Avenue. Fatalities throughout the county are largely at intersections. Minor injury crashes are distributed throughout the study area.

Figure 10: Vehicle Crash Points by Severity

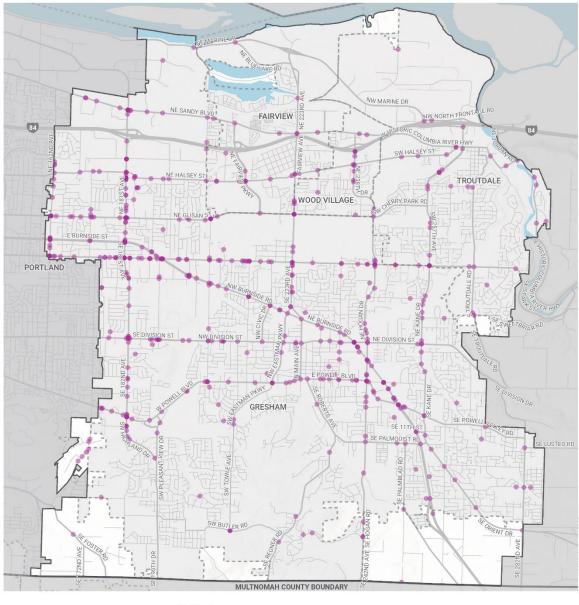
Figure 27: Crash Profile 1: Crashes with Alcohol or Drugs Involved

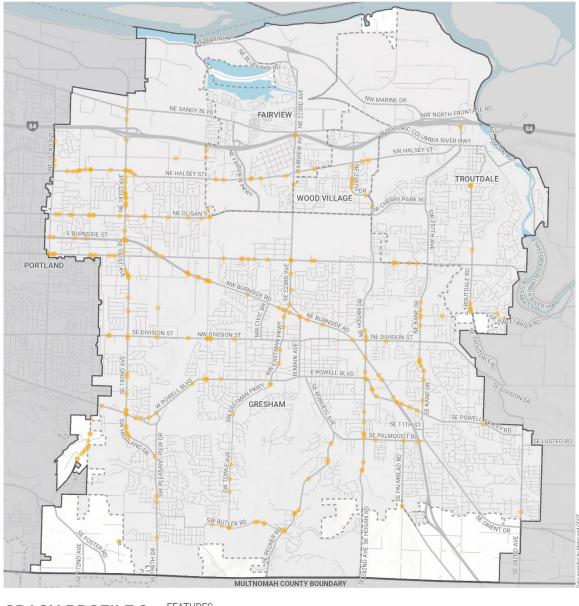
Figure 28: Crash Profile 2: Fixed Object Crashes on 35 MPH roads
