RE: Director Determination on Investigation

Location: Vacant - Adjacent to 12424 NW Springville Rd Portland OR 97229
Complaint #: CCINT-2025-0028
Code Case # CCPR1-2025-0003

Determination: Evidence of Code Violation

Appendix A: Director’s Determination on Investigation

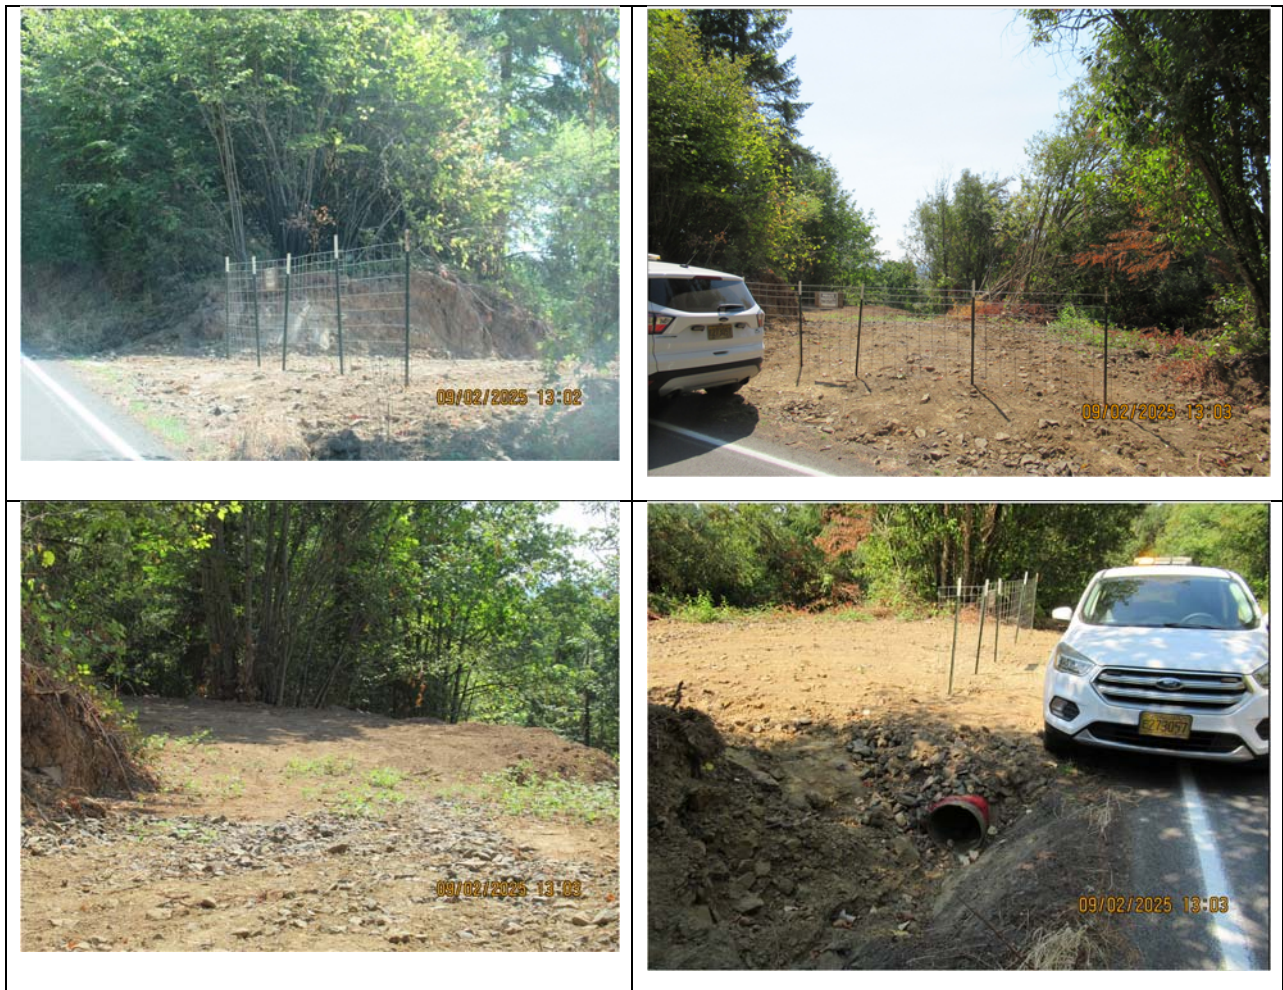
Inspection Photos – September 2, 2025

Multnomah County Code Compliance staff conducted a preliminary site inspection from a public location on September 2, 2025 following receipt of a complaint alleging non-permitted driveway development. The inspector found evidence of recent excavation within a sloped area of hillside adjacent to NW Springville Rd, in order to level and clear a driveway or private road. Photos taken during that inspection support the inspector’s findings.

Regardless of whether the driveway/connections were previously established as dirt tracks, current excavation in the vicinity of the driveway/connections is not consistent with maintenance of existing driveways and would require an SEC-s permit.

The findings of the Code Compliance inspection support the allegations of the complaint. Although a driveway is permitted at the subject location, development activity for a driveway is not permitted at this time.

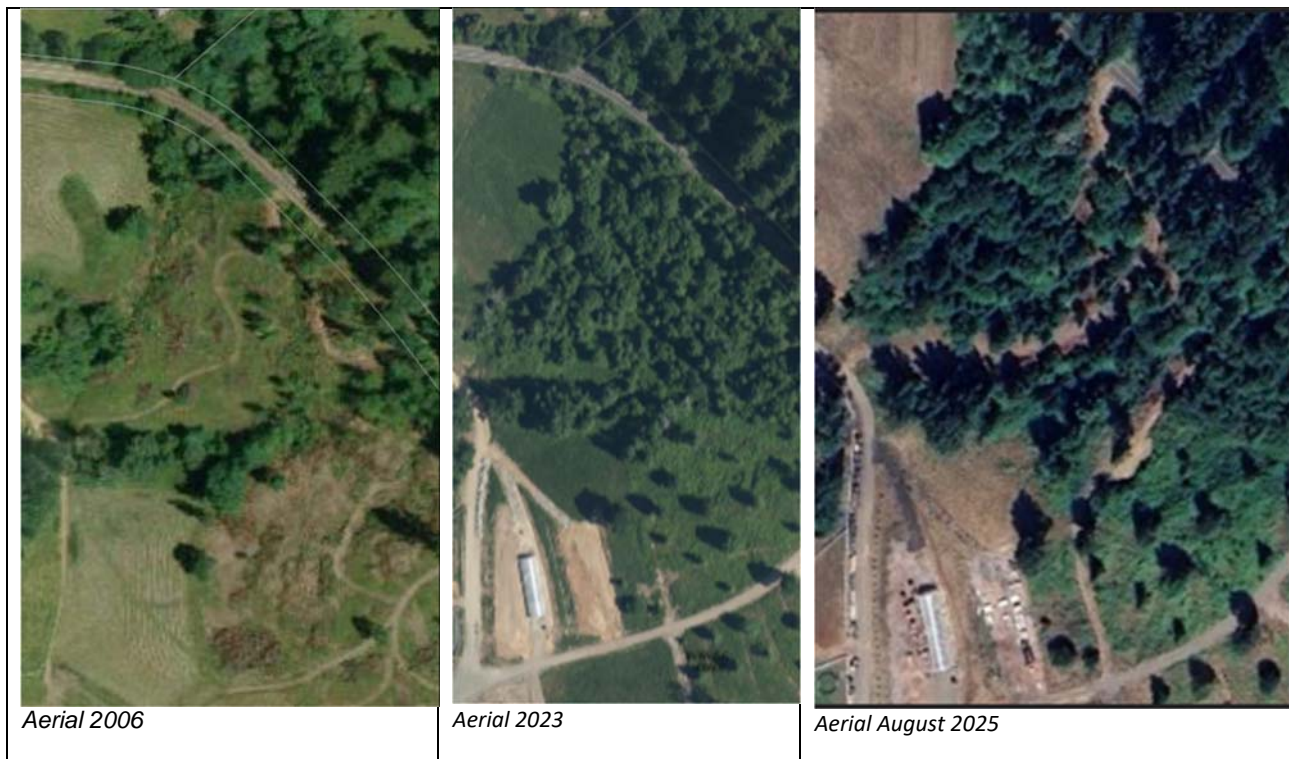
A review of Google street view images from June 2024 shows an area overgrown with vegetation/trees, with sloped ground. Google aerial images from August 2025 show a disturbed area, where vegetation and earth were cleared and leveled in order to open a driveway approach. The August 2025 Google aerial image also shows what appears to be two excavated driveway connections running from north to south, down the hillside. A portion of the driveway/access and the westernmost connection appears as a dirt track in 2006, but the eastern connection is not apparent.
