Land Use and Right-of-Way Complaint Form

Case #: ZV-2021-14224

FIELD INSPECTION REPORT

Property Address:	645 SE Pounder Rd		
Property Owner:	Heather Moon		
Tax Account #:	R994020700	Zone:	CFU4
Case File: UR-2020-13222			
Permits on File for property: None			
Other agencies/departments to notify: Mult Co. Sheriff			
Site Visit REMARKS			
Date/Time:	__1__ / __11__ / __2021__	Inspected By:	Robert Hyde
Permits on Location: None			
Measurements Taken:			
Witnesses Interviewed:

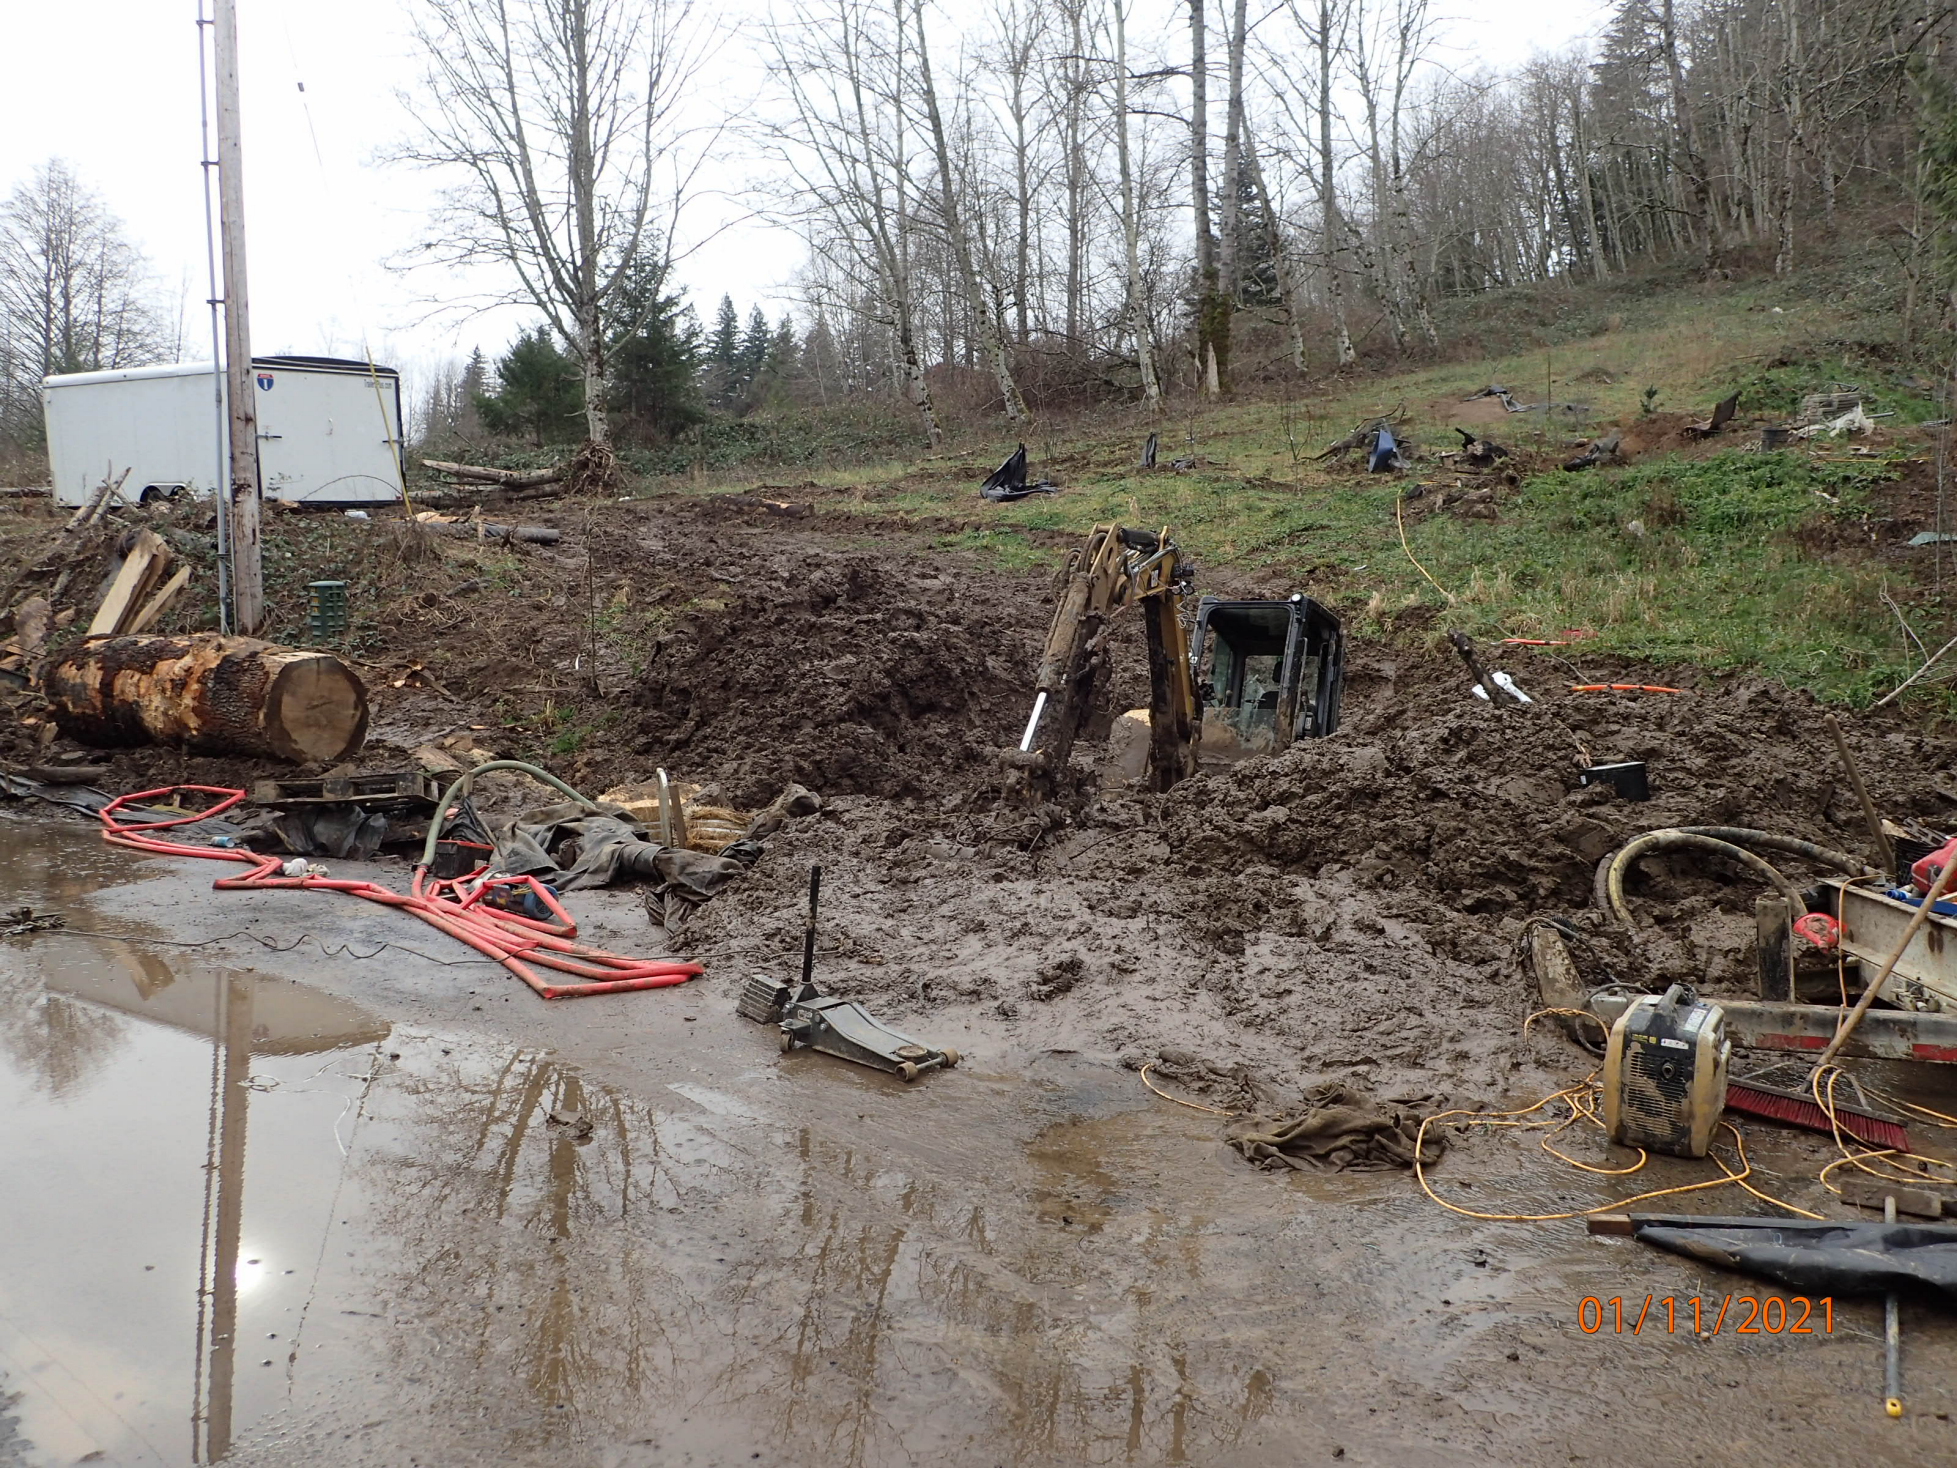
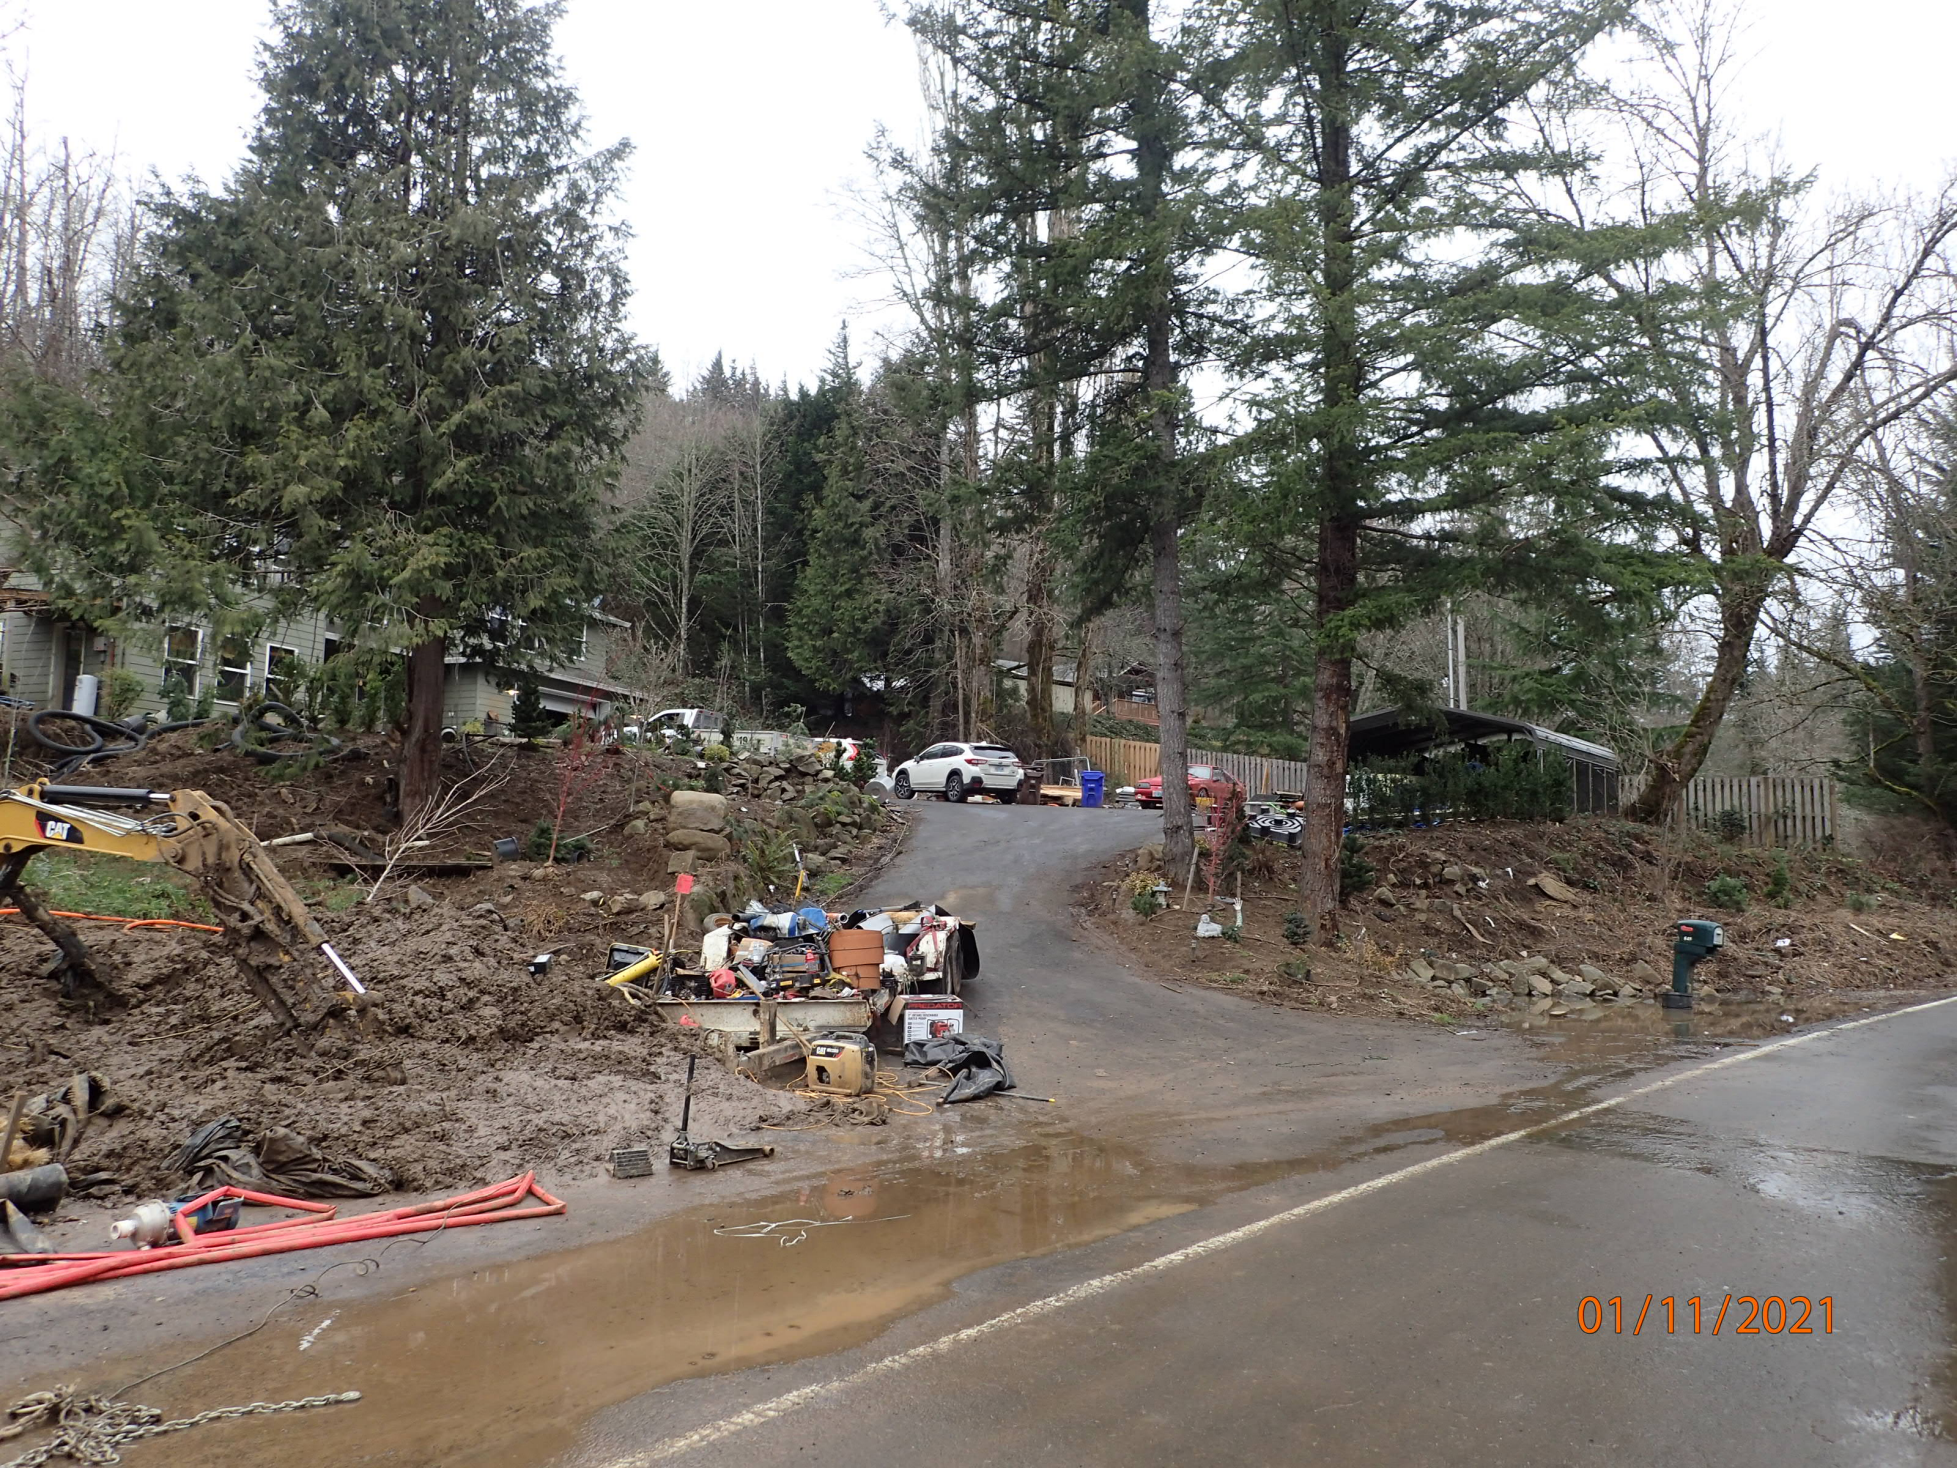
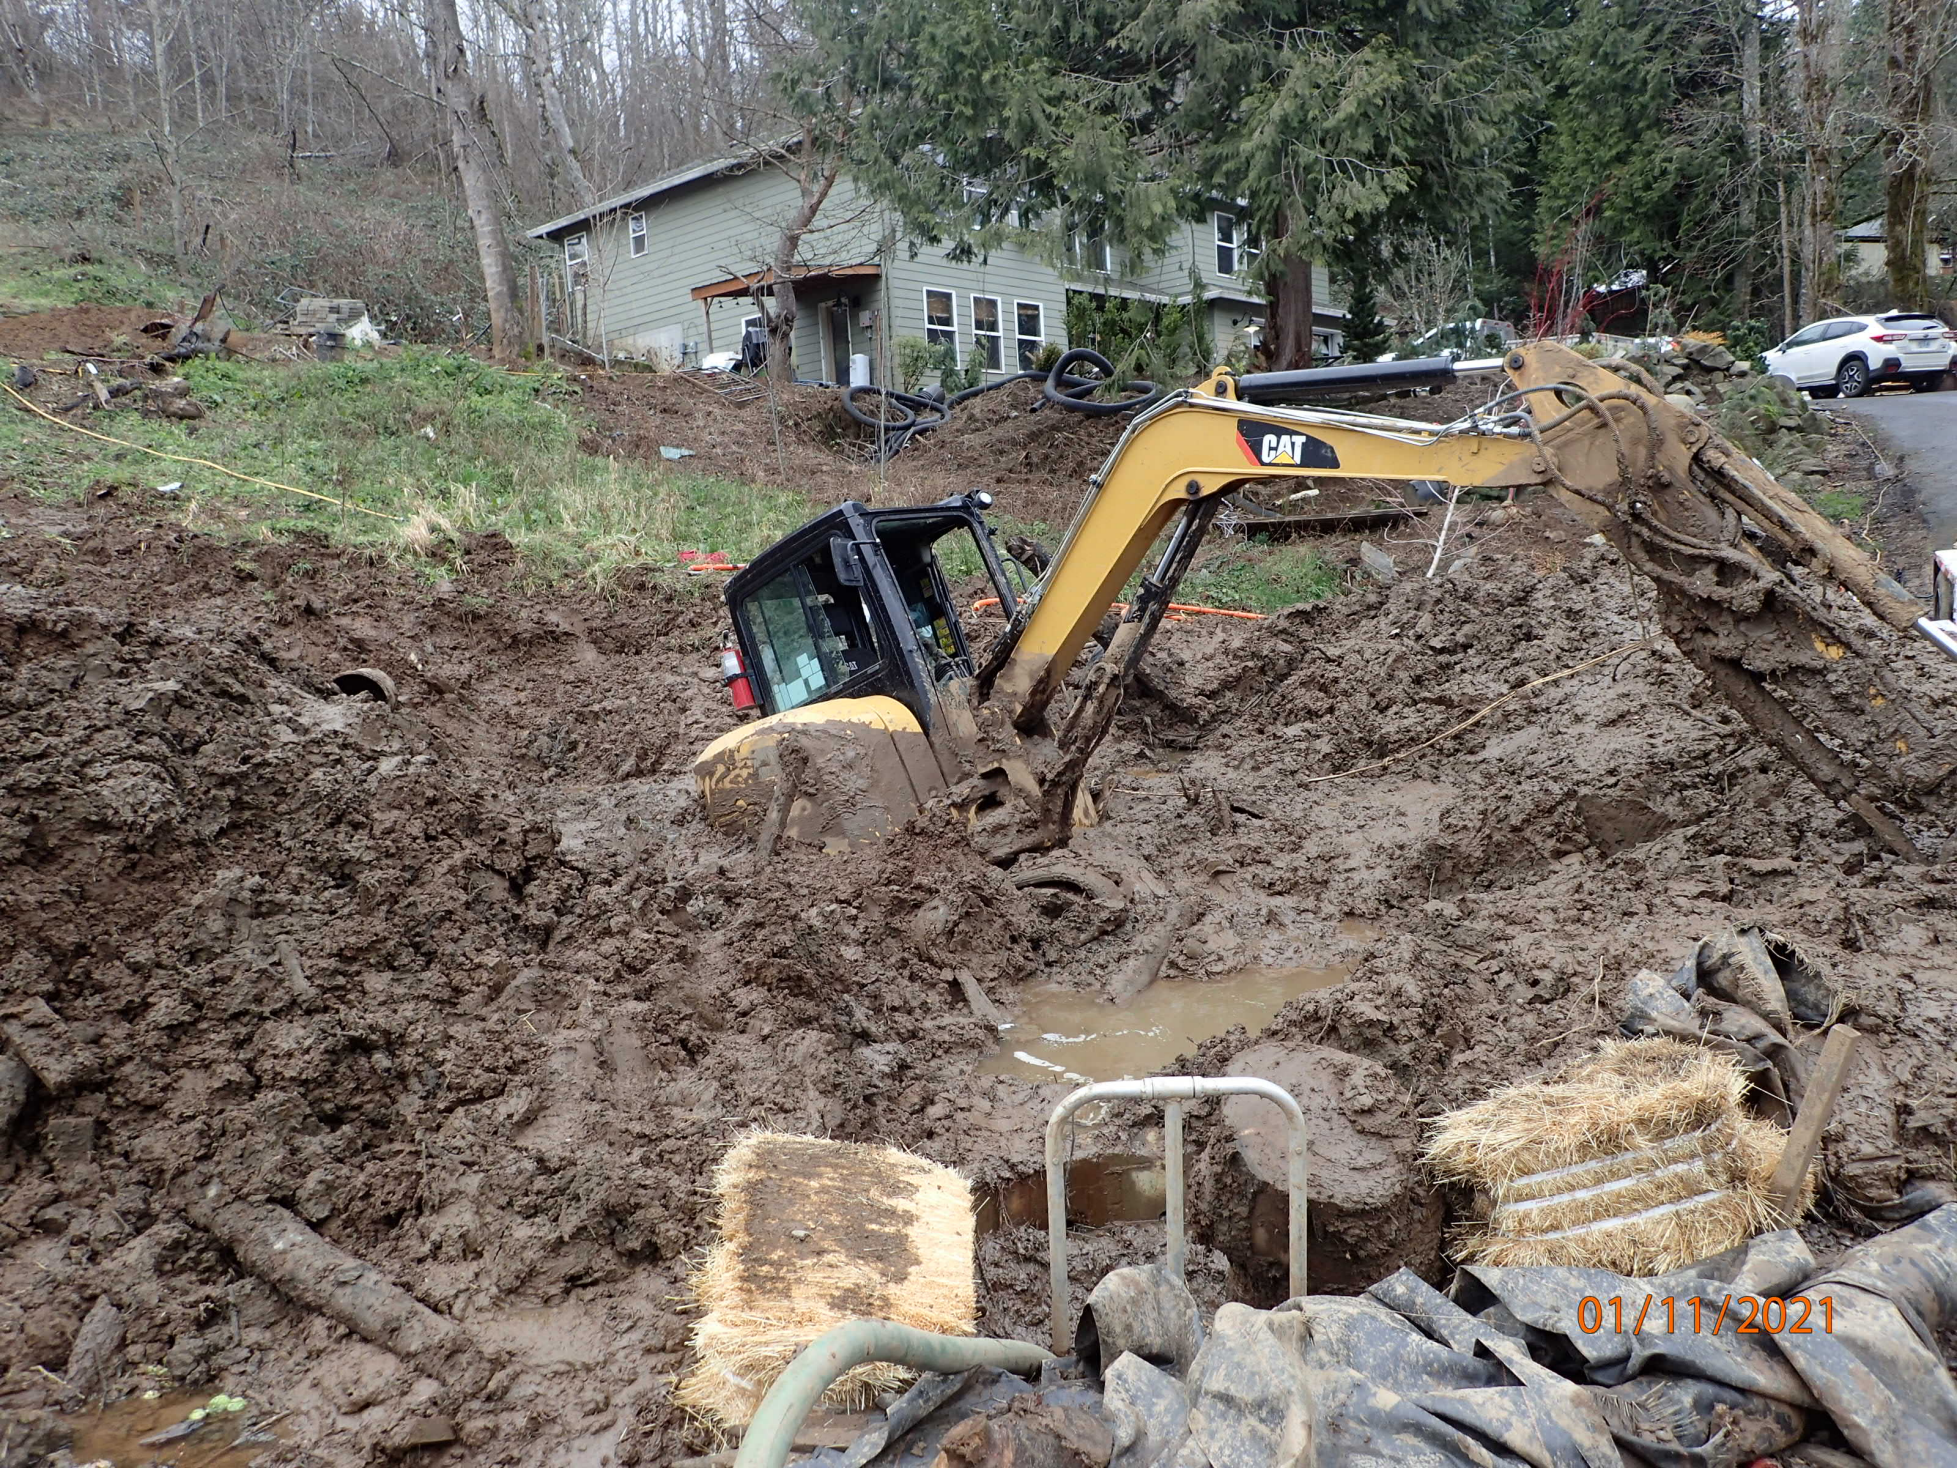
Updated Report: Excavator is now stuck in deep mud in the disturbed ground work area (pics in folder). I went to the front door to get more information about continued work and there was no answer.
