Land Use and Right-of-Way Complaint Form

Case #: ZV-2021-14224

FIELD INSPECTION REPORT

Property Address:	645 SE Pounder Rd		
Property Owner:	Heather Moon		
Tax Account #:	R994020700	Zone:	CFU4
Case File: UR-2020-13222			
Permits on File for property: None			
Other agencies/departments to notify: Mult Co. Sheriff			
Site Visit REMARKS			
Date/Time:	__1__ / __11__ / __2021__	Inspected By:	Robert Hyde
Permits on Location: None			
Measurements Taken:			
Witnesses Interviewed:

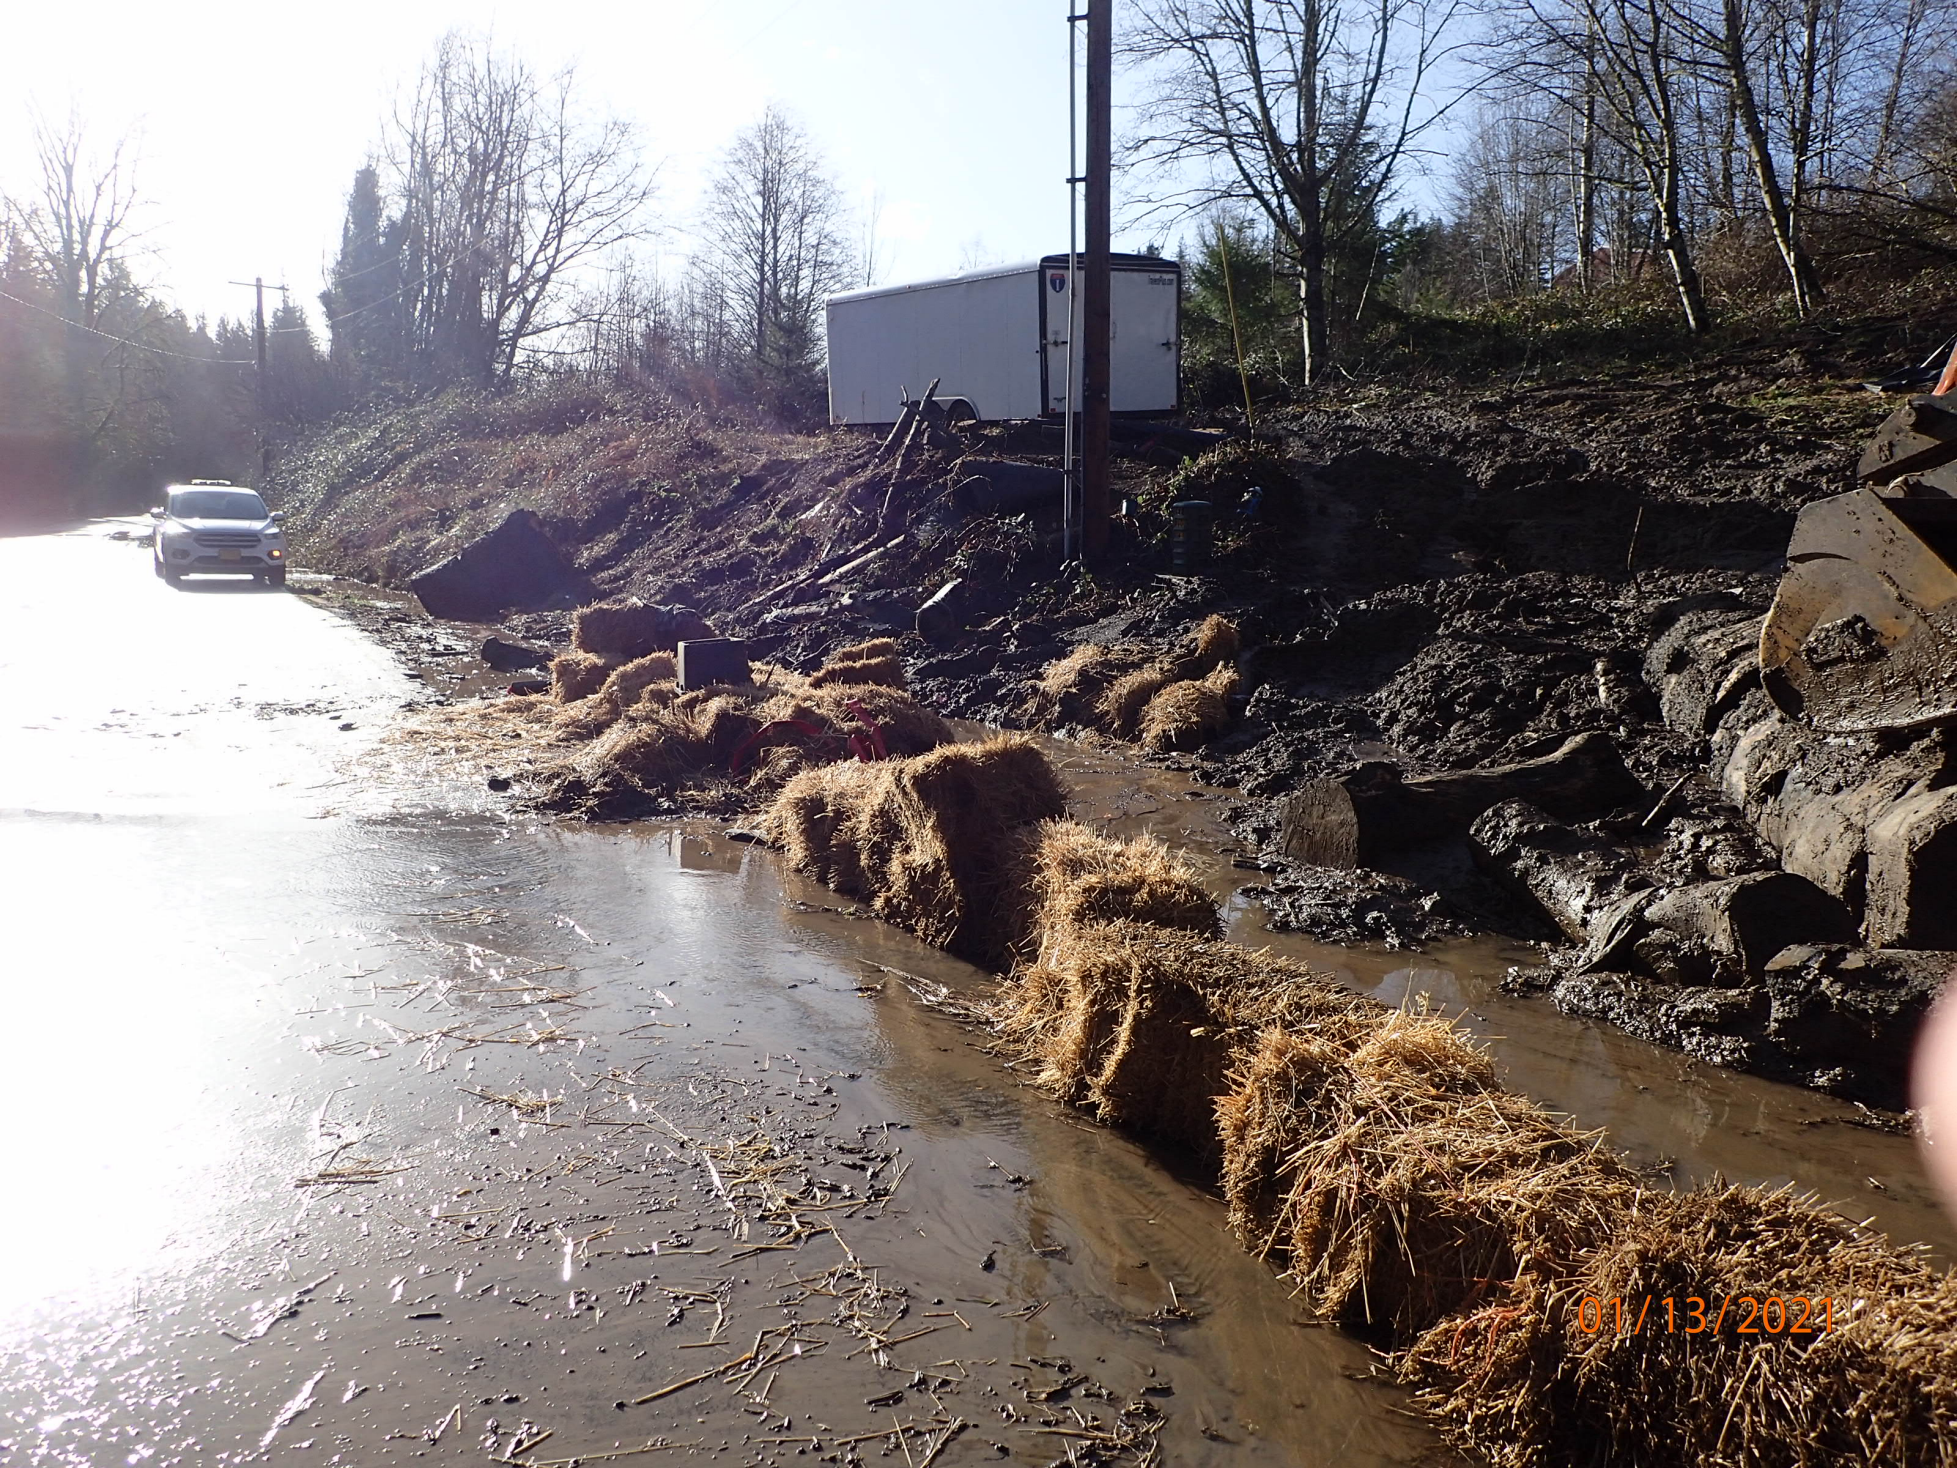
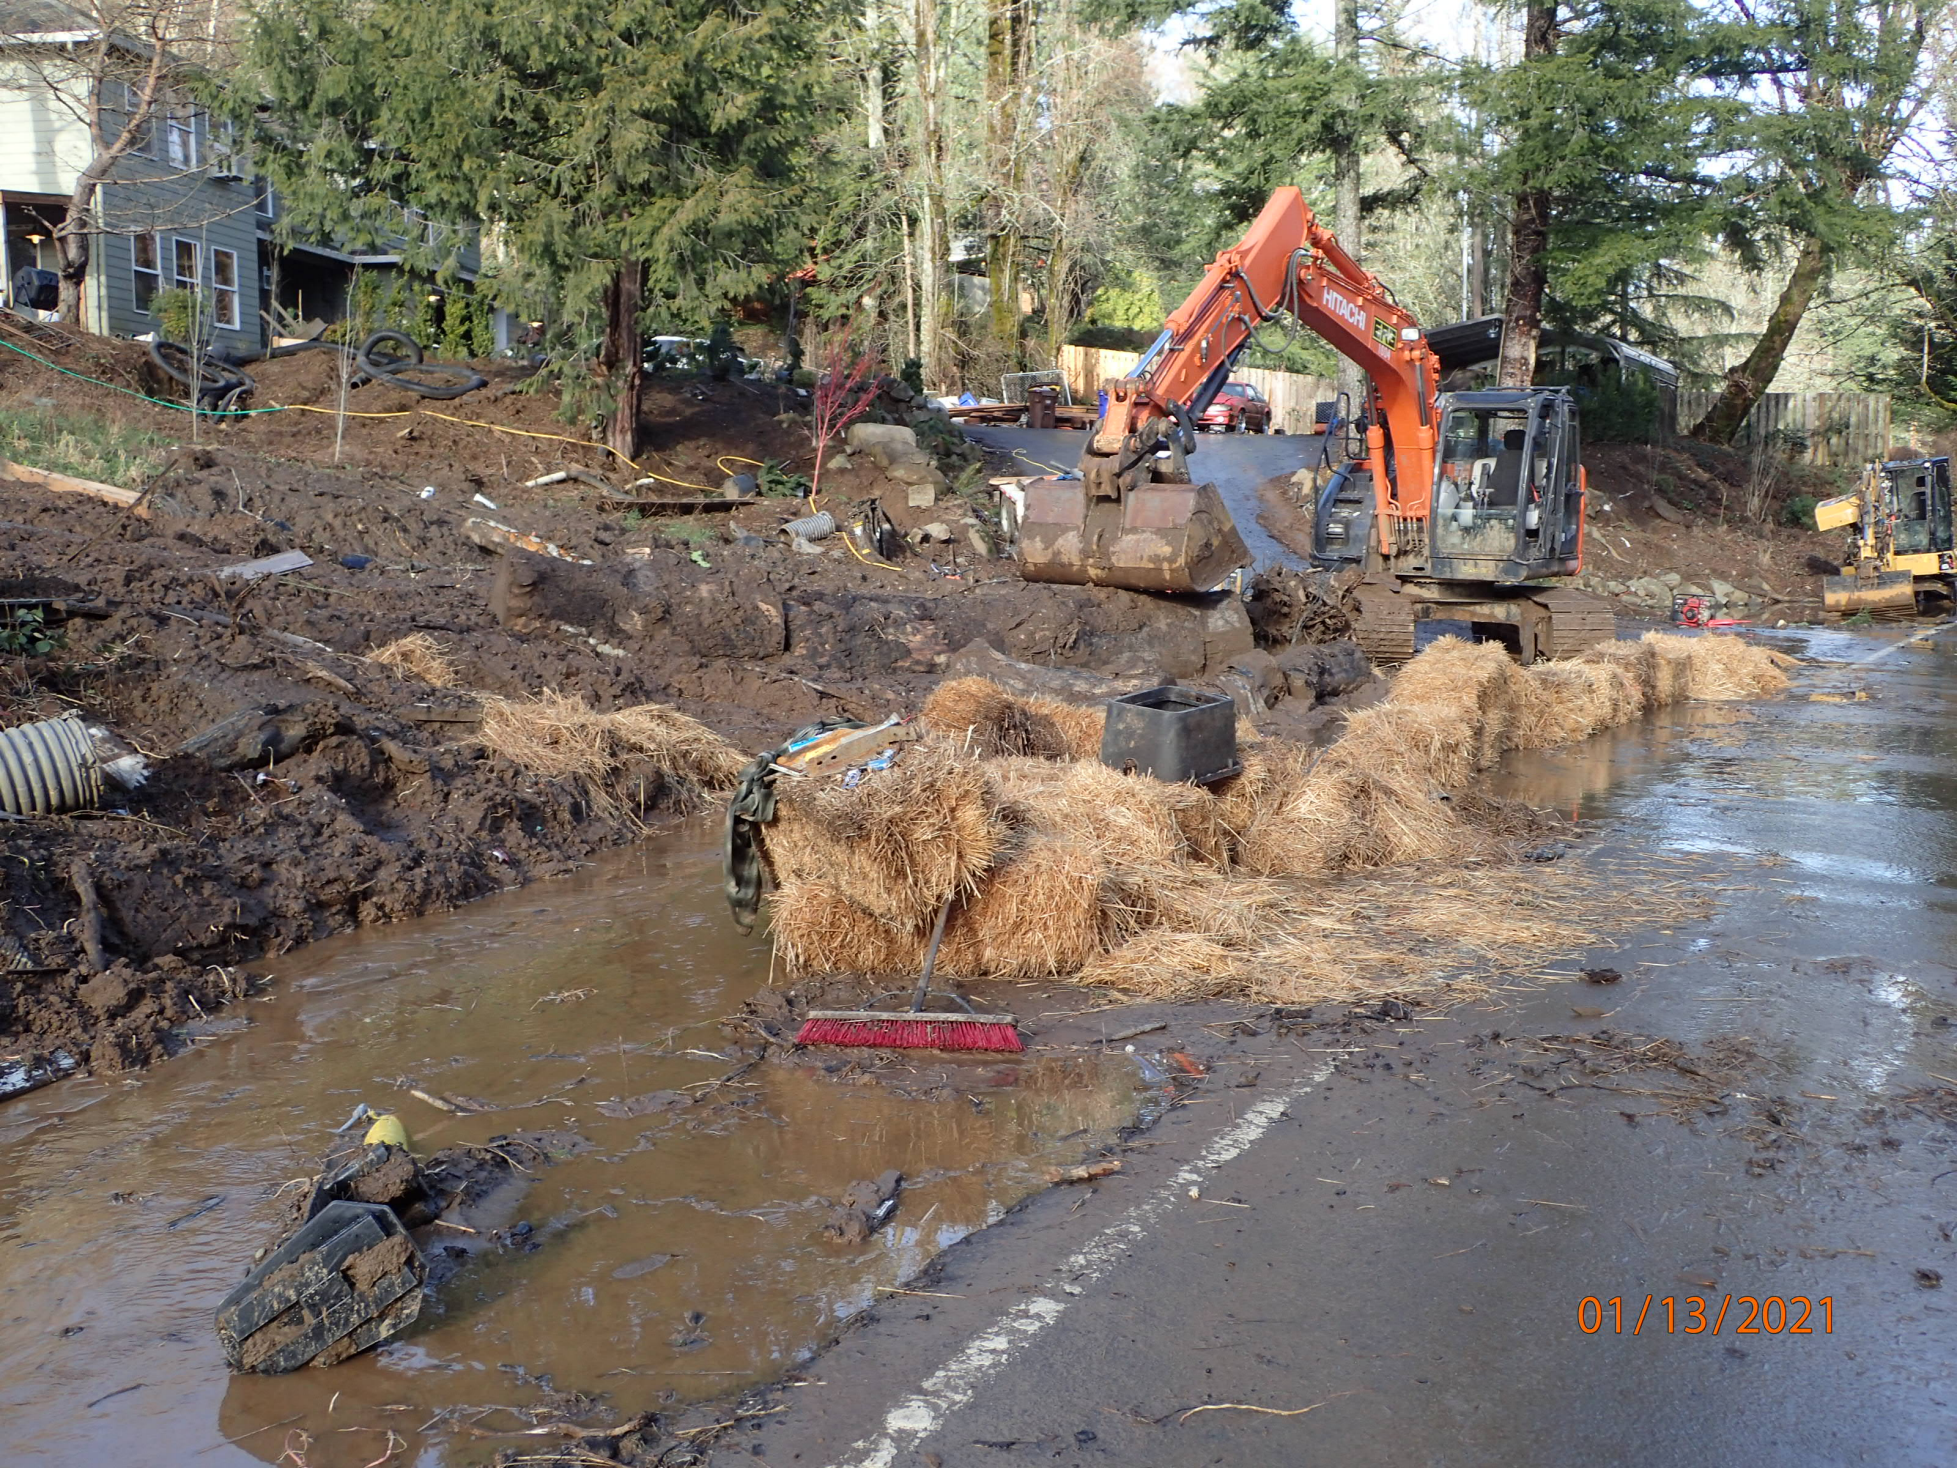
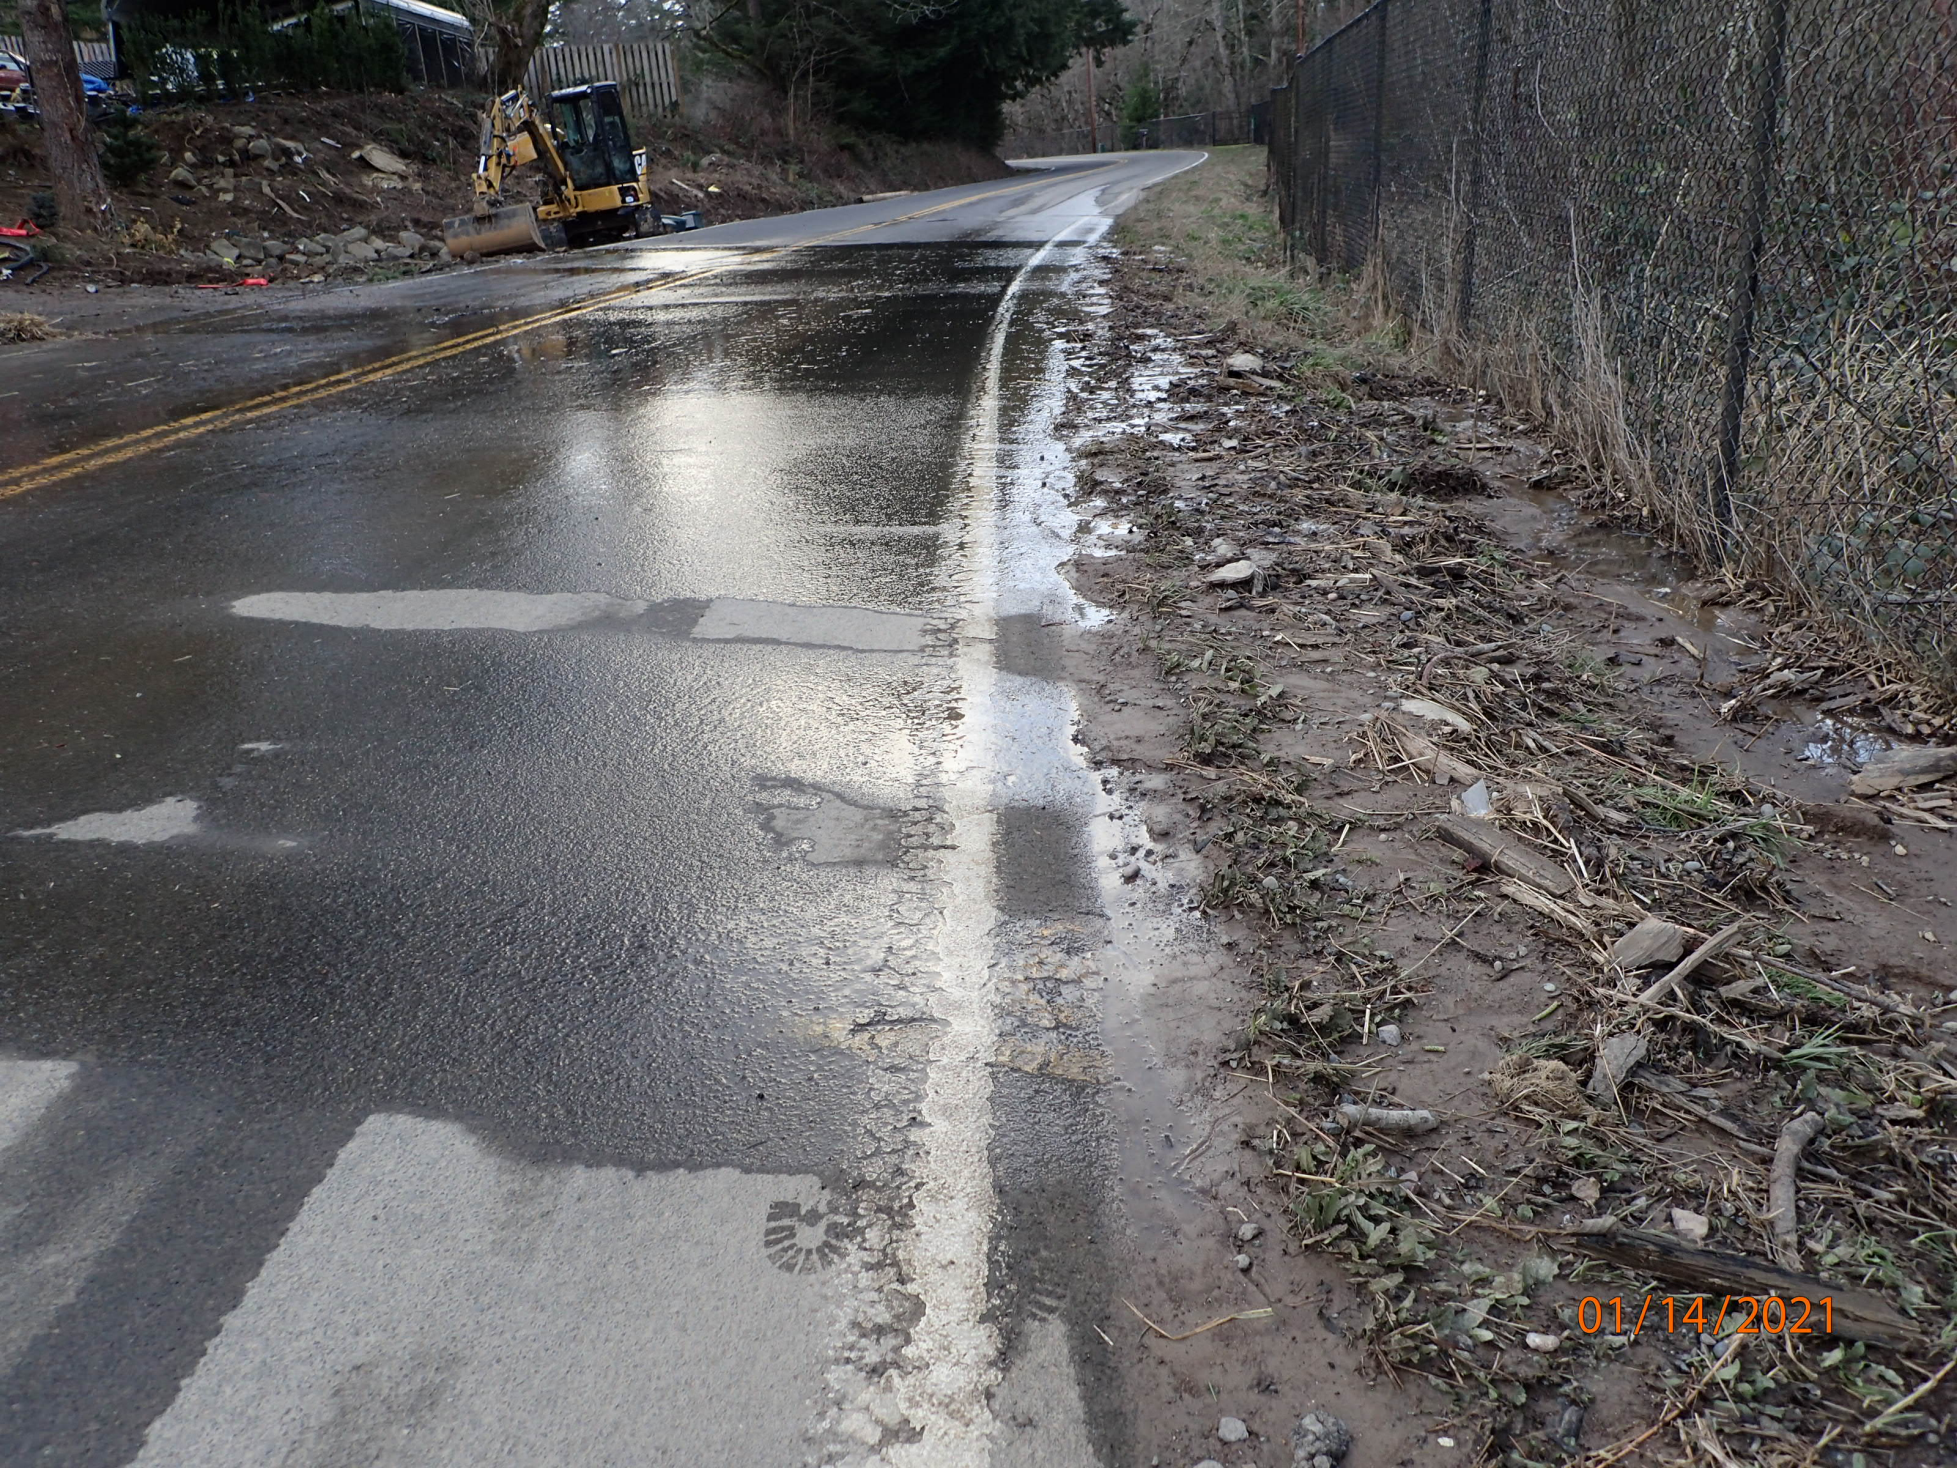
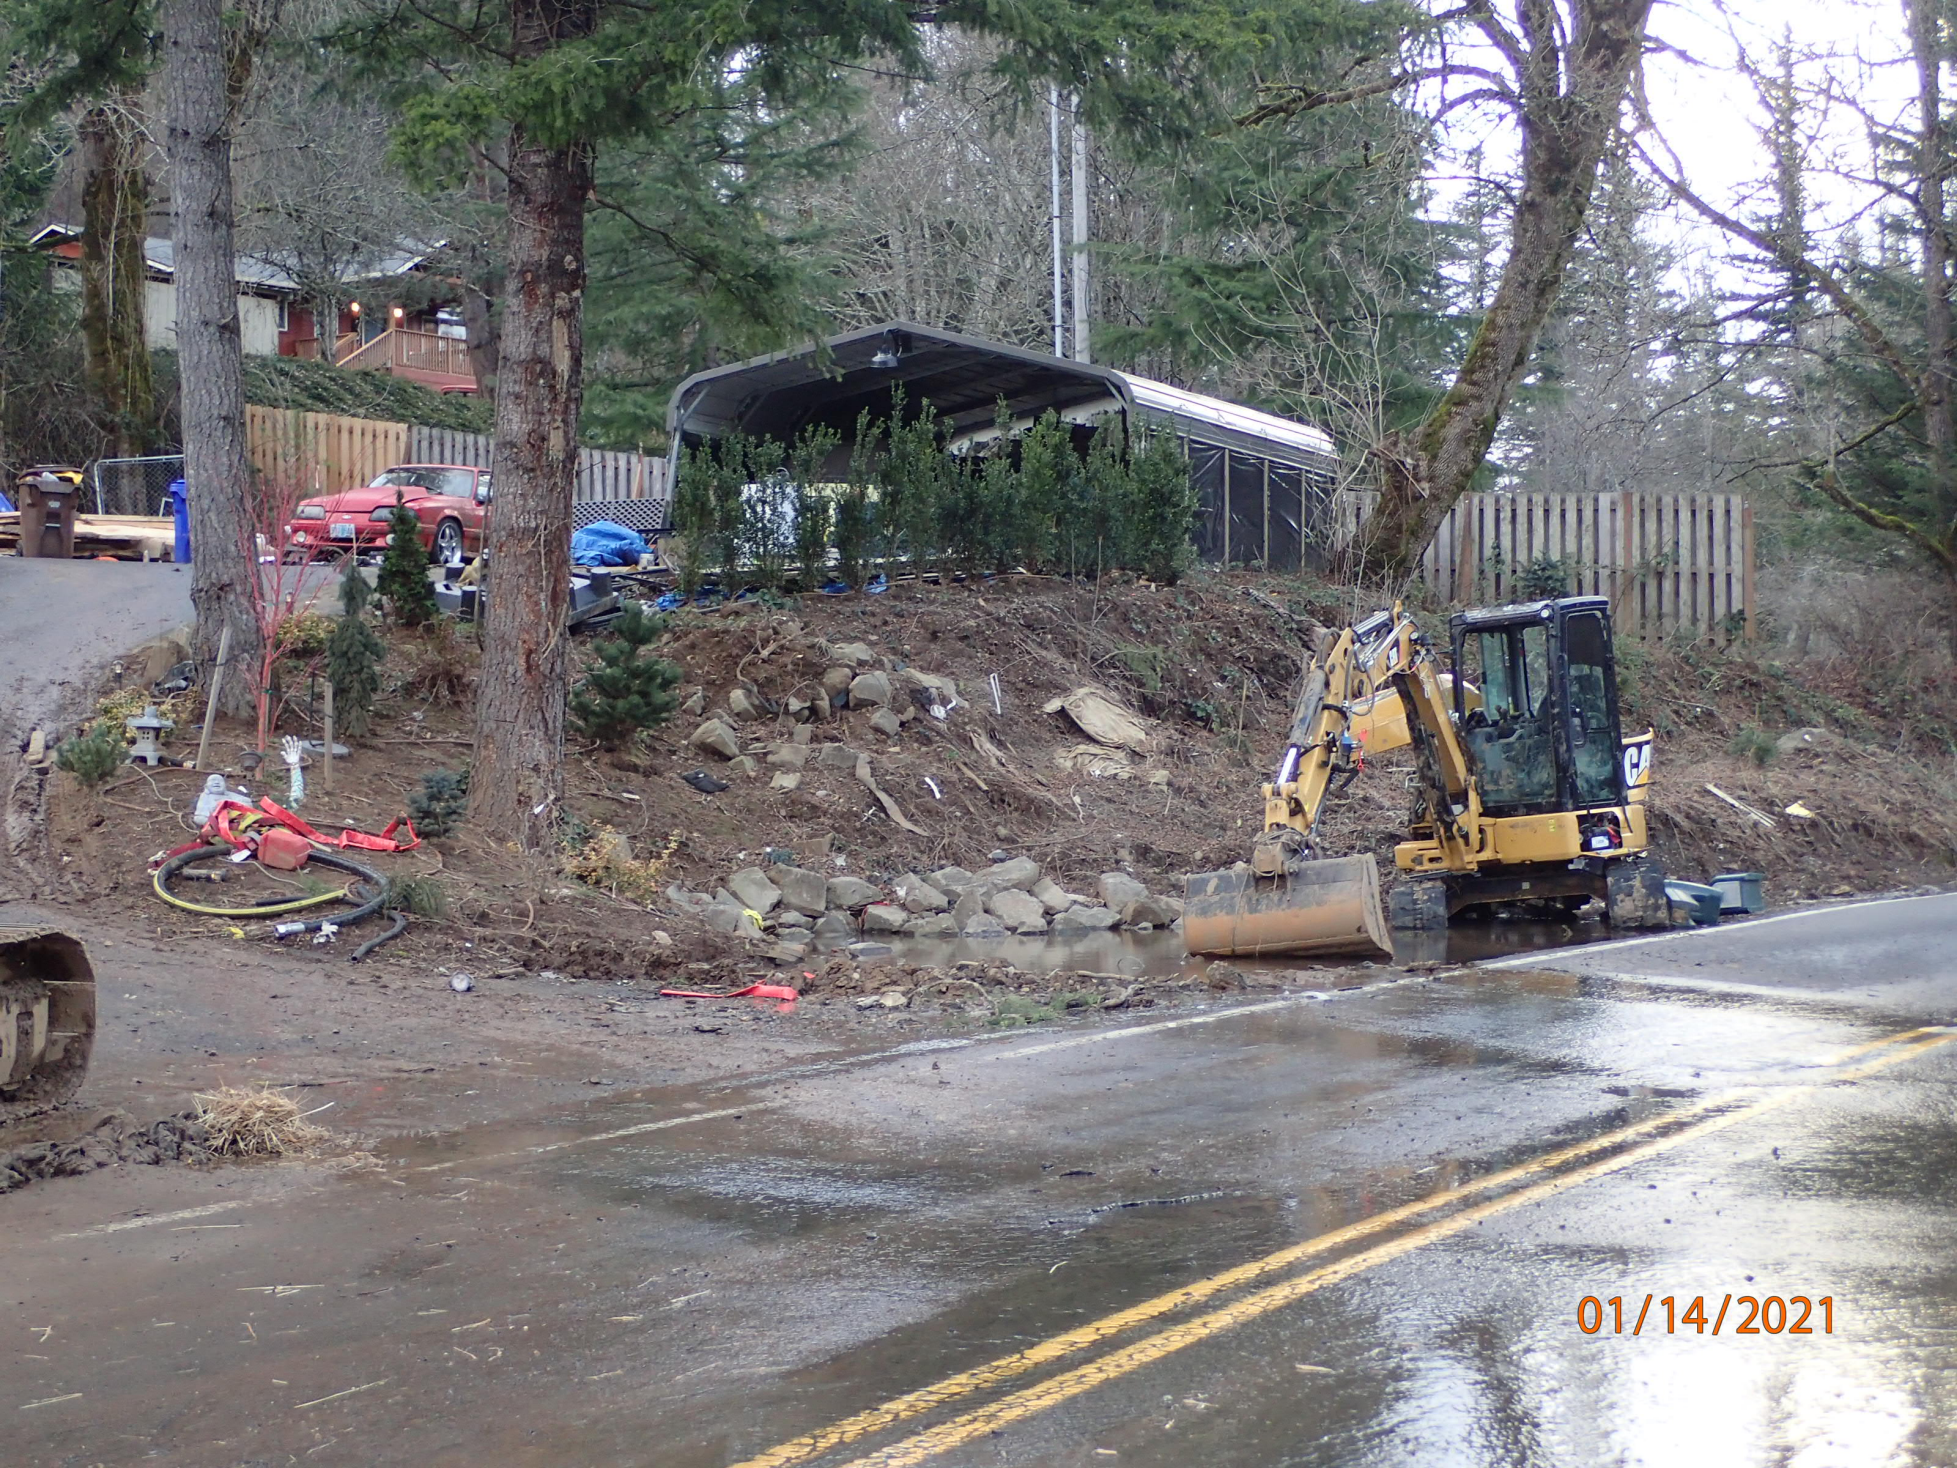
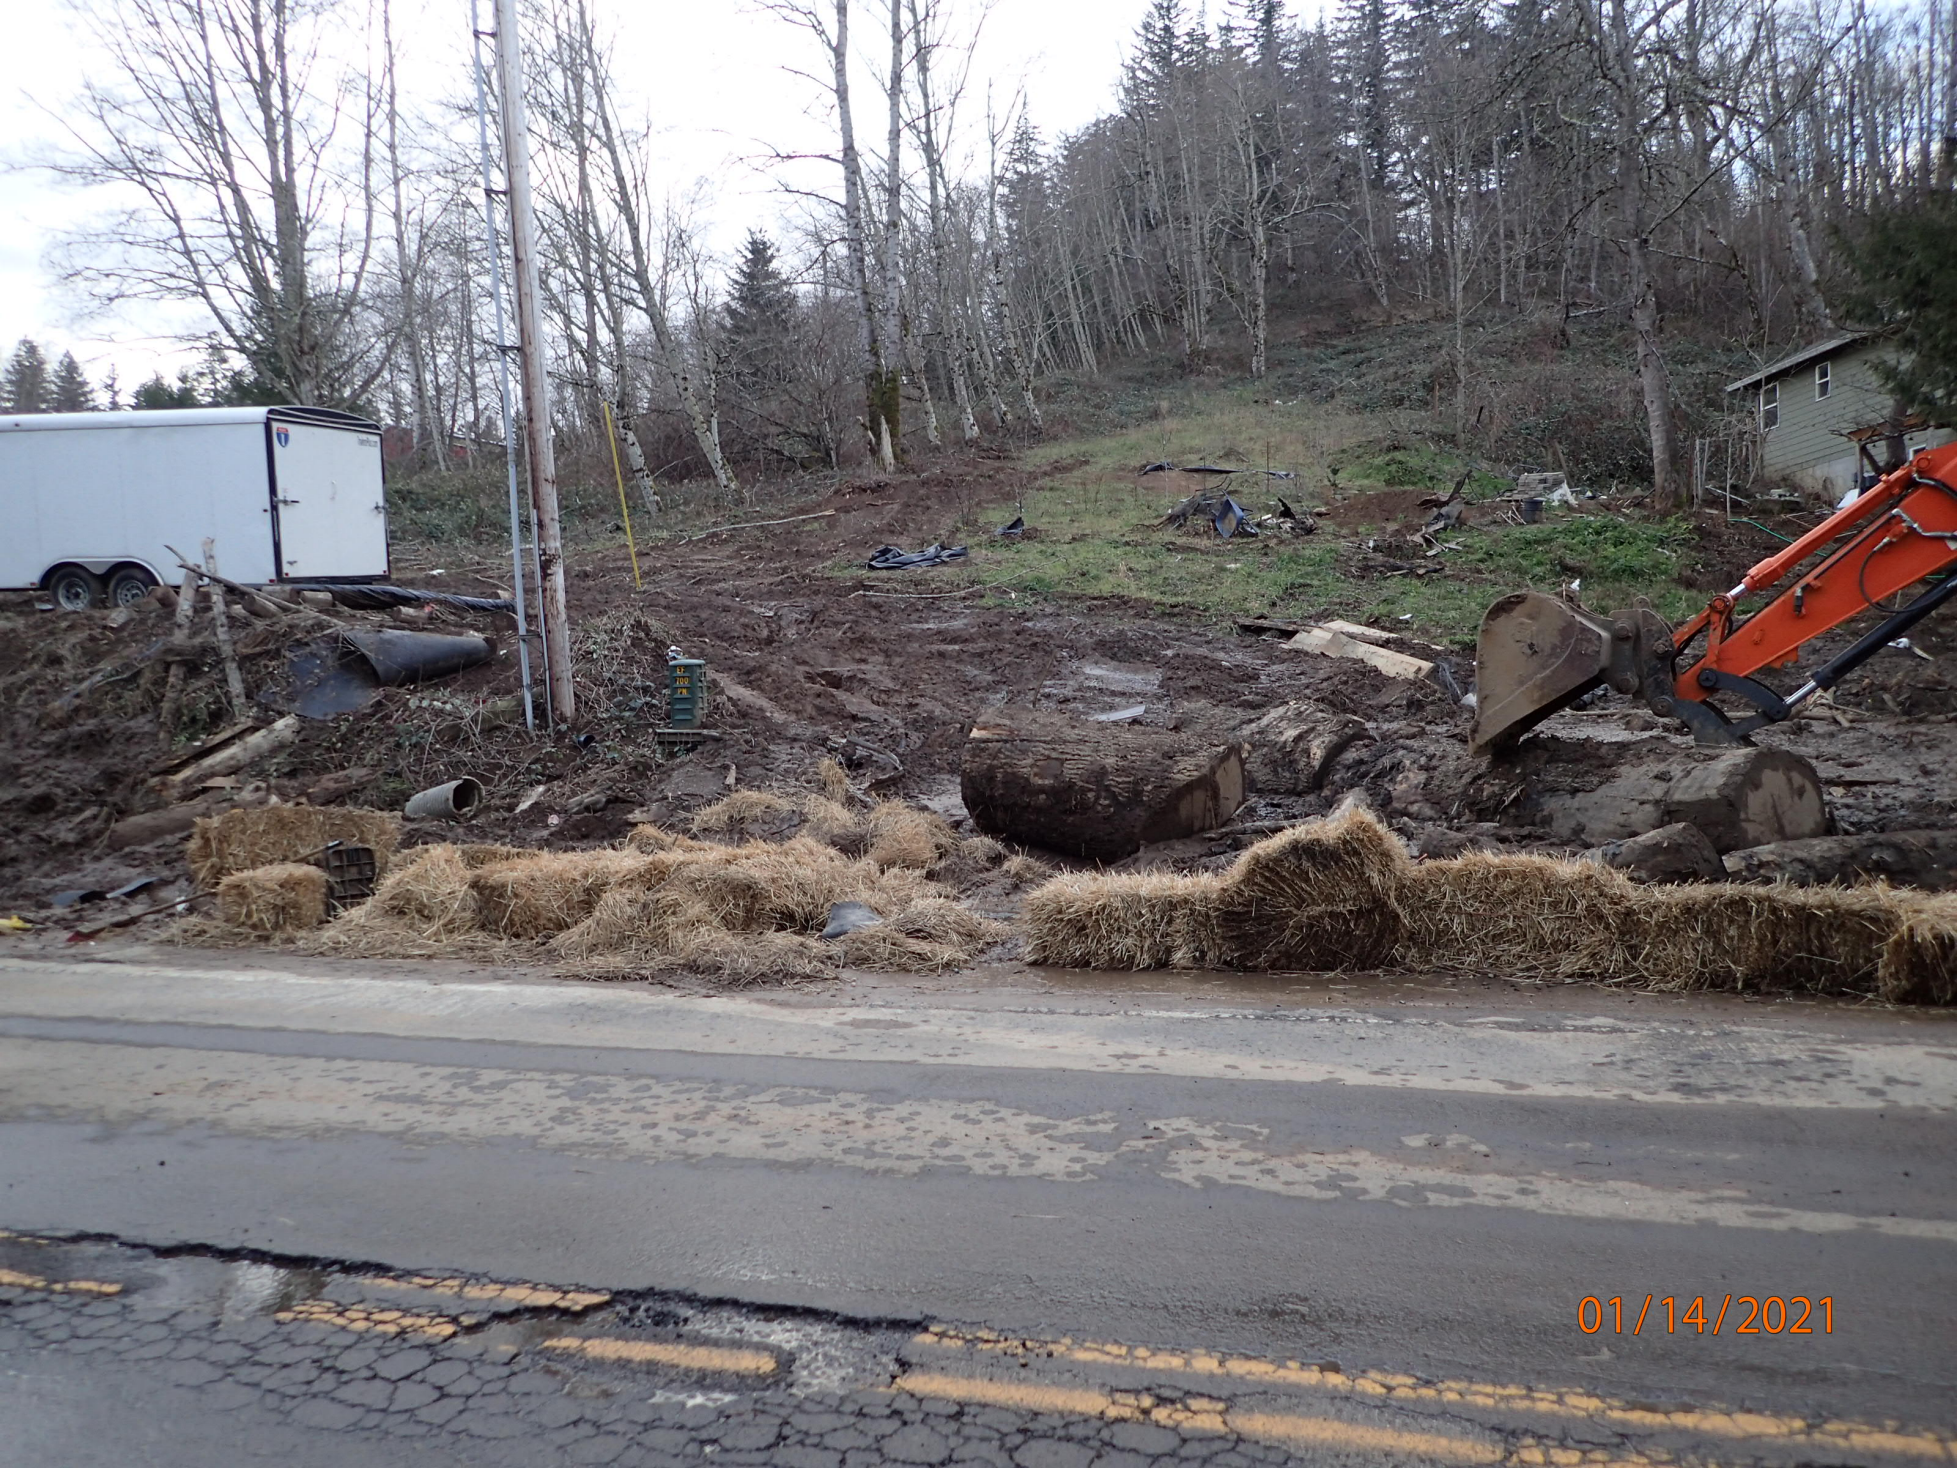
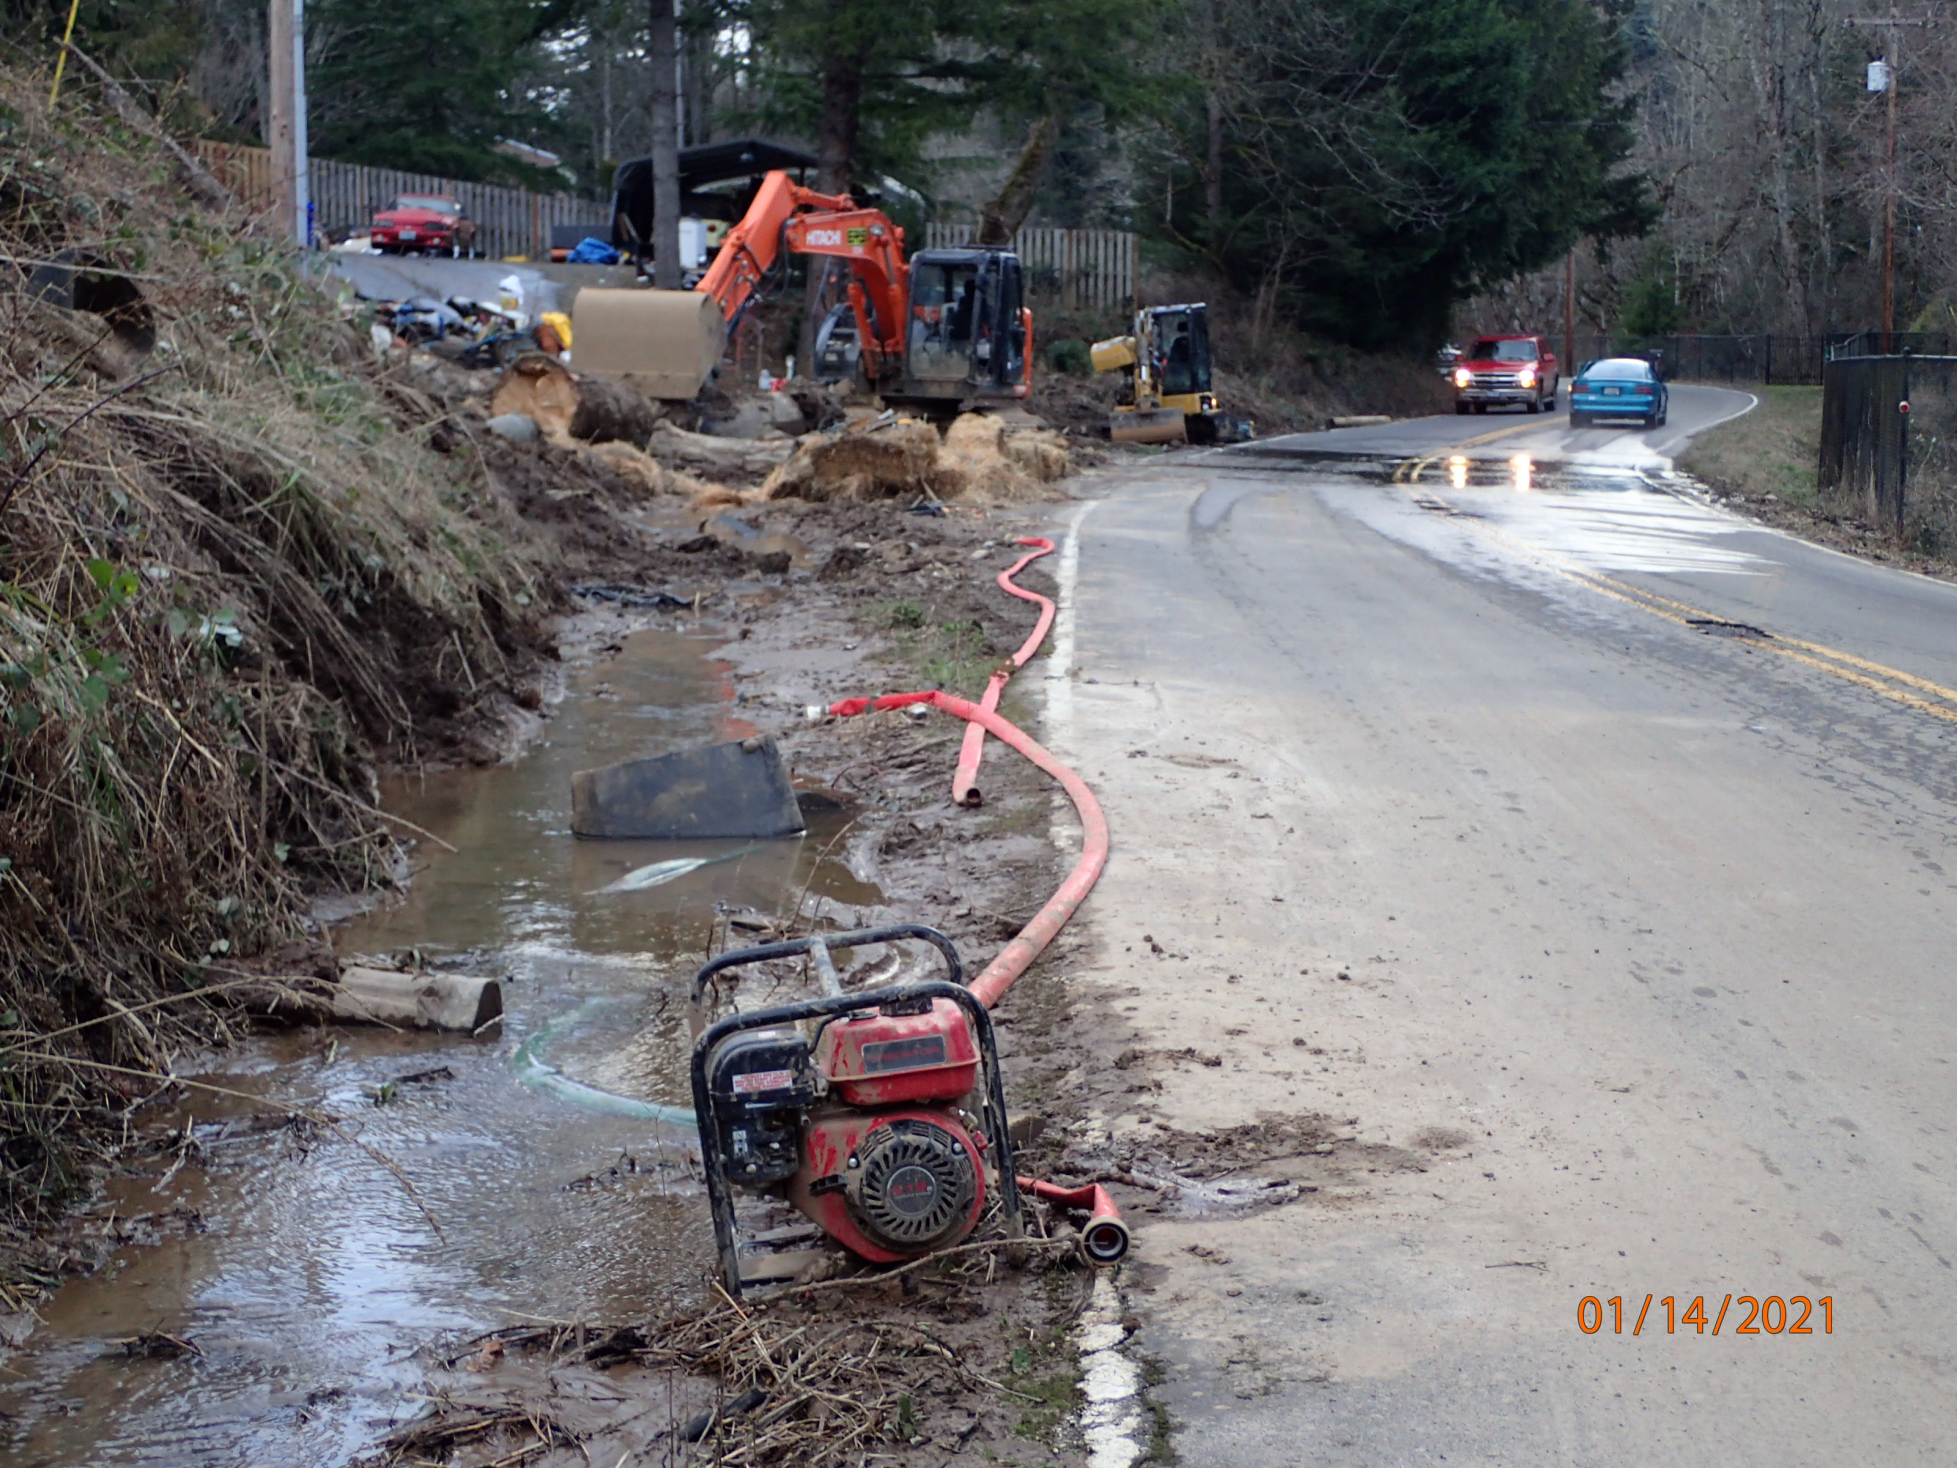
Updated Report: I visited the property for pictures. There are 2 excavators on the shoulder (see pics) of the roadway. The culvert is still plugged as water and silt continue to spill over the roadway. Hay bales line the shoulder for attempted erosion control. Logs placed in the way of mudslide to prevent it from going into the roadway.
