Land Use and Right-of-Way Complaint Form

Case #: ZV-2021-14224

FIELD INSPECTION REPORT

Property Address:	645 SE Pounder Rd		
Property Owner:	Heather Moon		
Tax Account #:	R994020700	Zone:	CFU4
Case File: UR-2020-13222			
Permits on File for property: None			
Other agencies/departments to notify: Mult Co. Sheriff			
Site Visit REMARKS			
Date/Time:	__1__ / __11__ / __2021__	Inspected By:	Robert Hyde
Permits on Location: None			
Measurements Taken:			
Witnesses Interviewed:

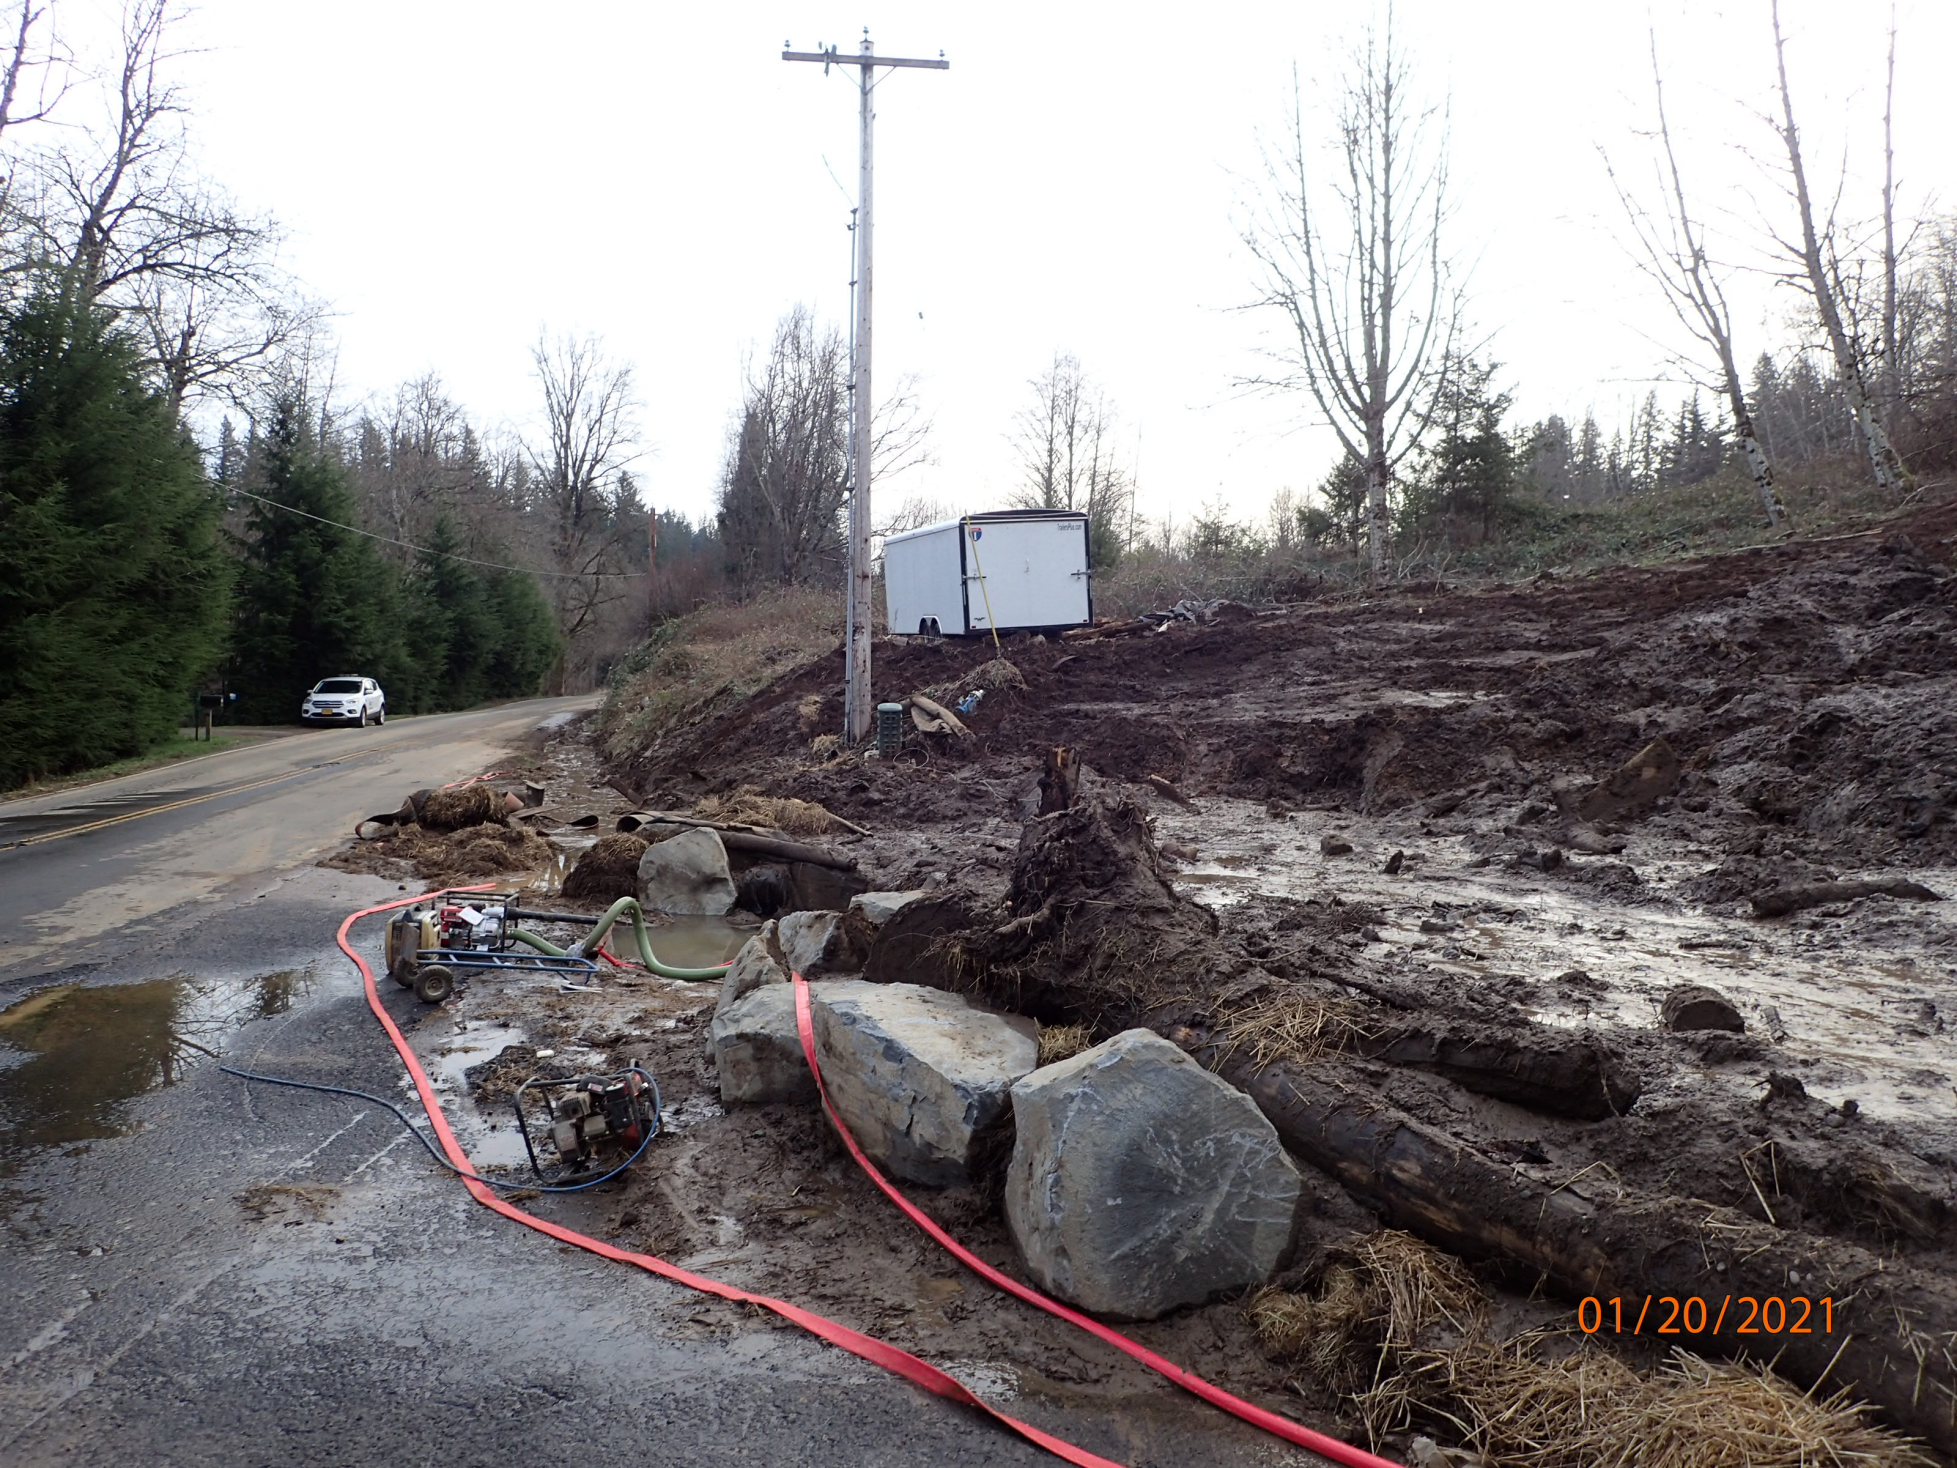
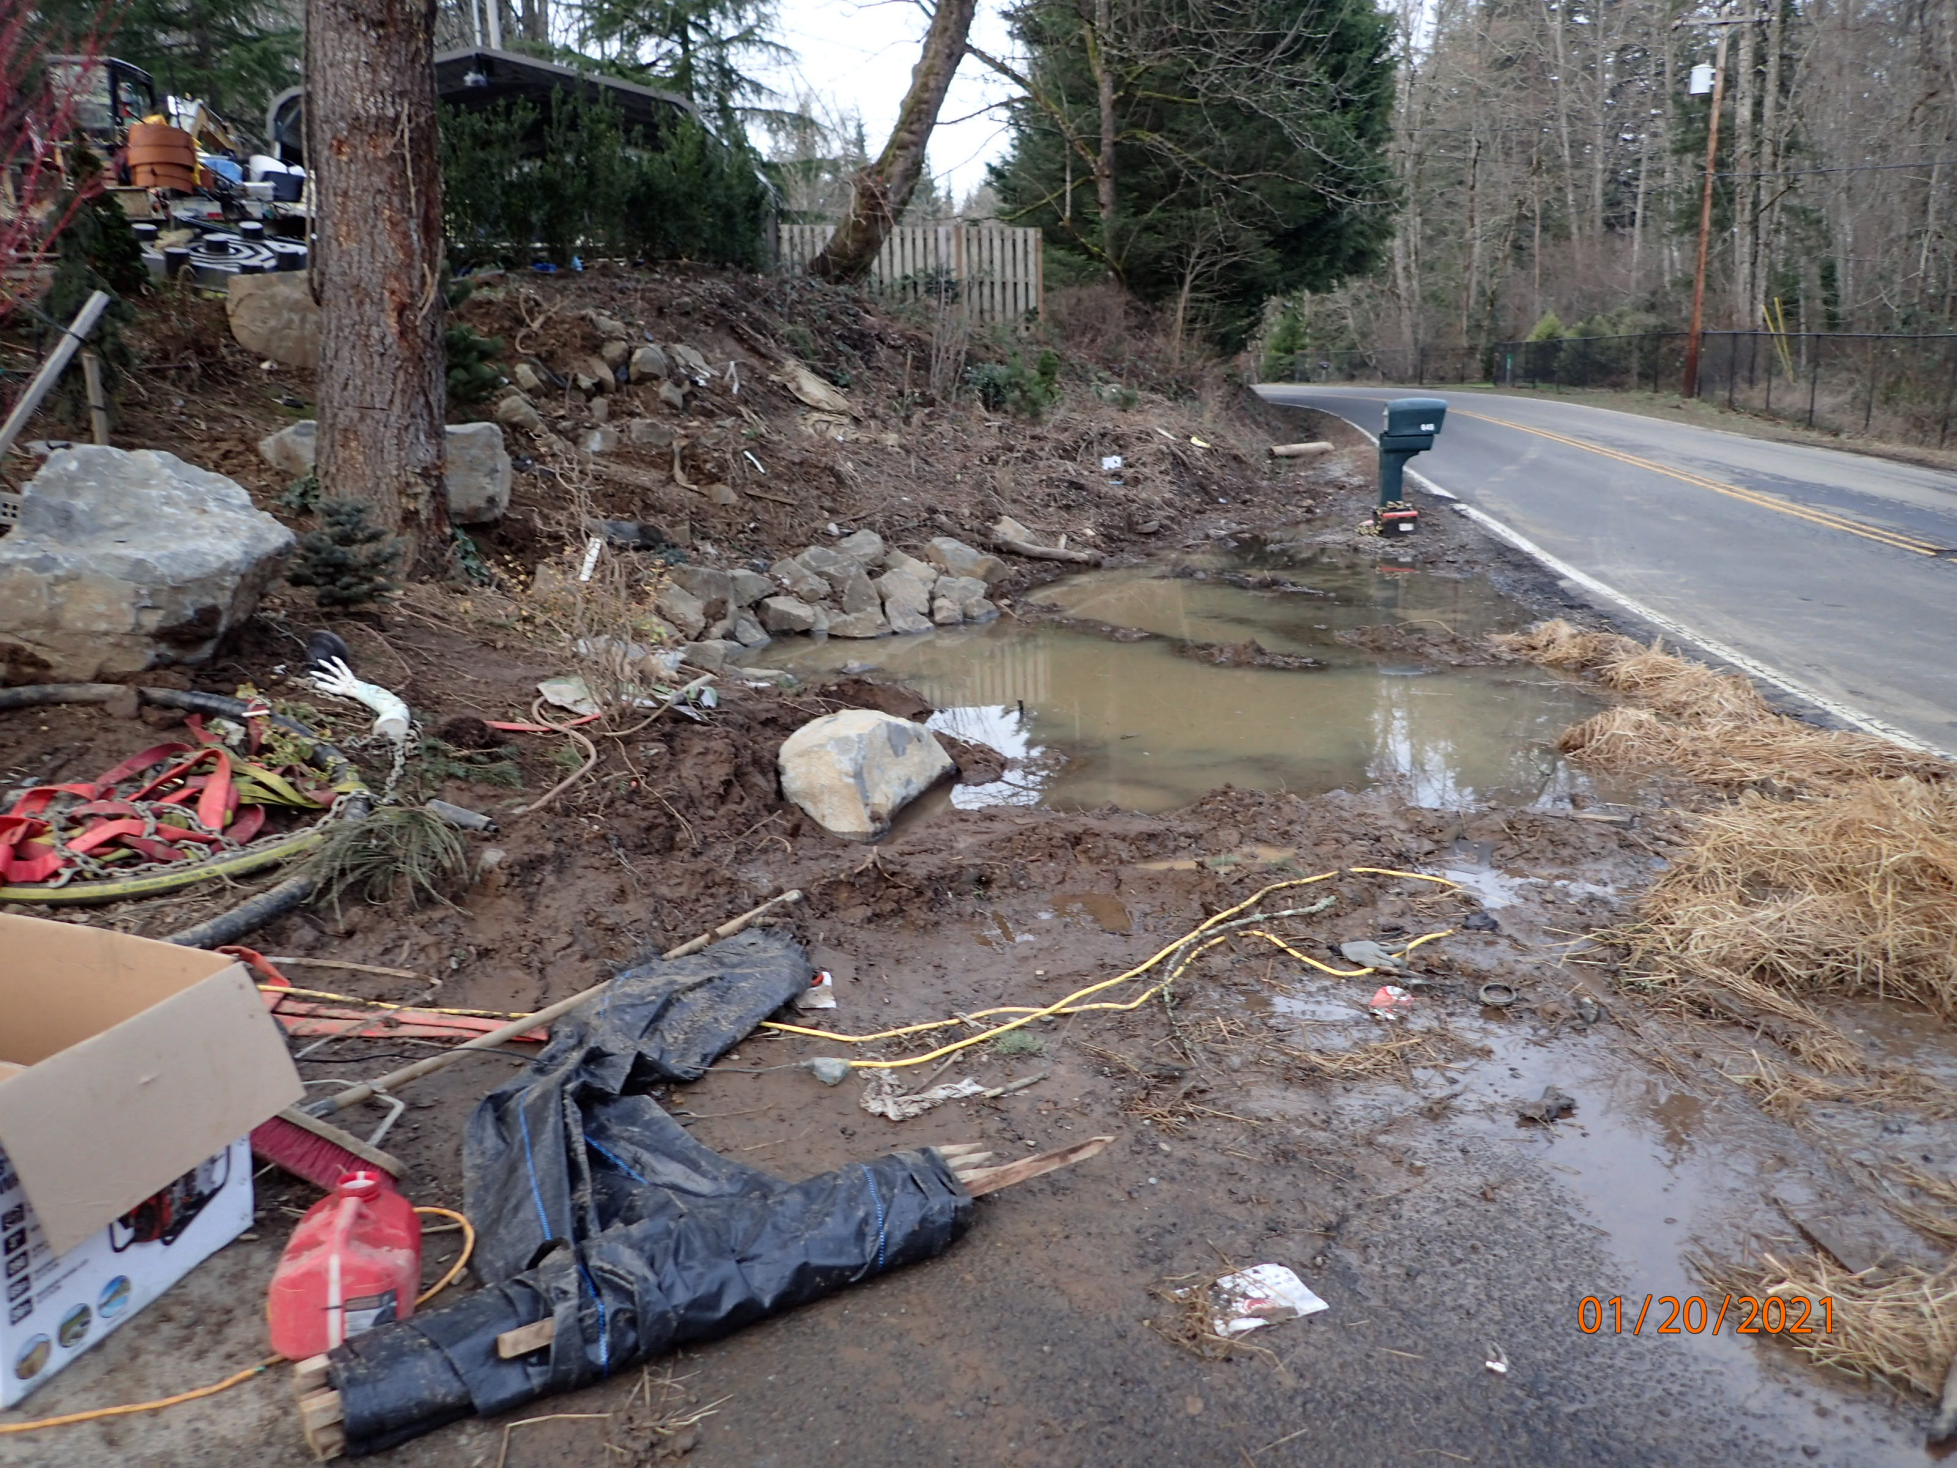
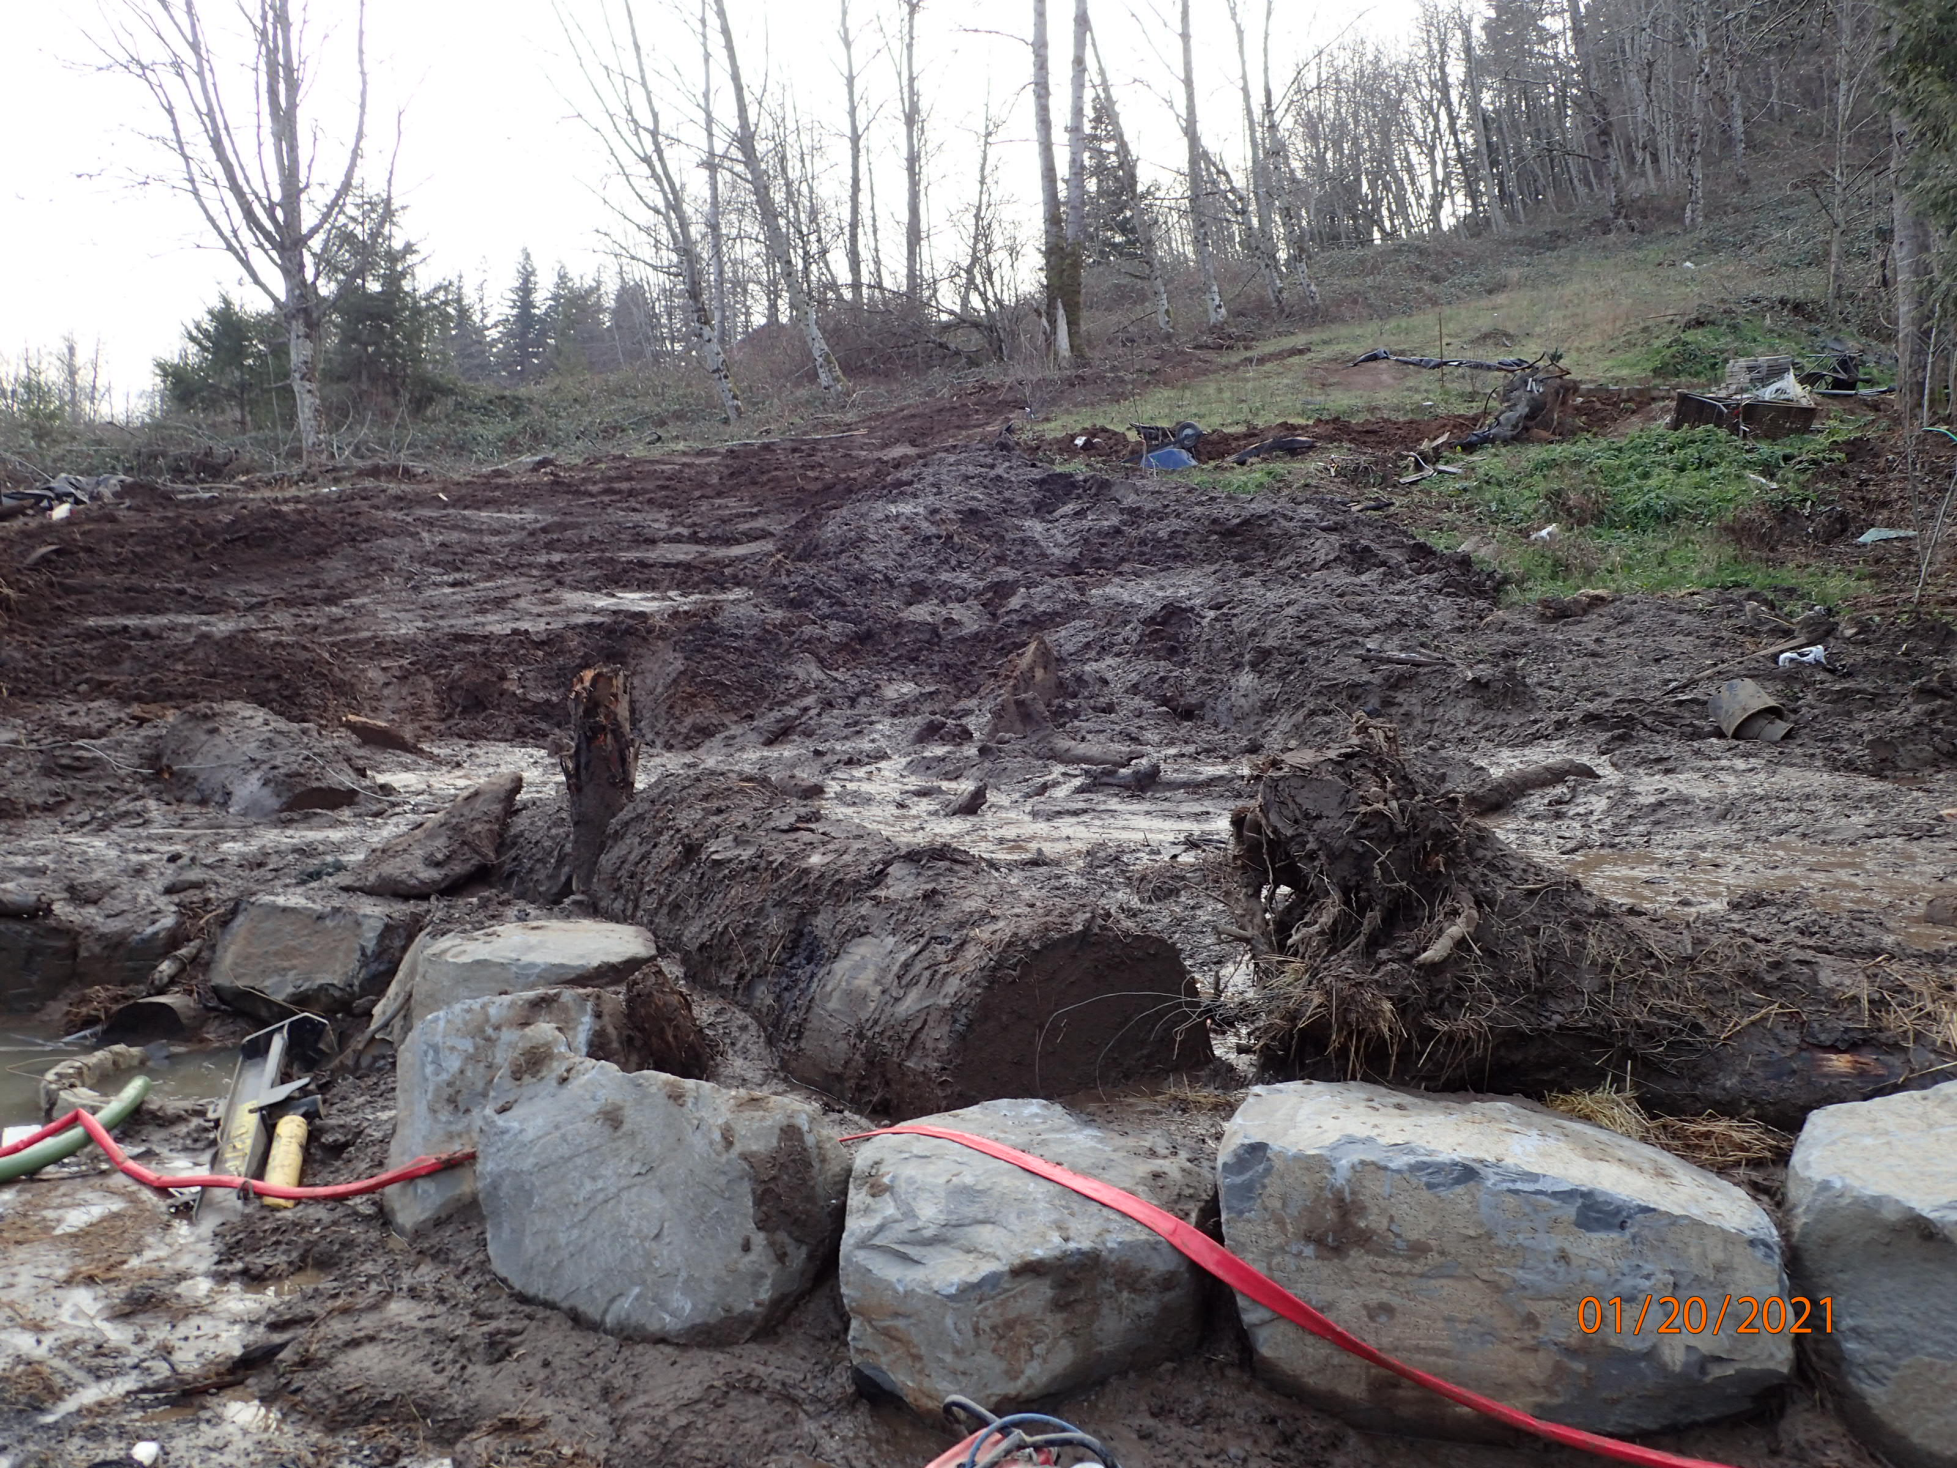
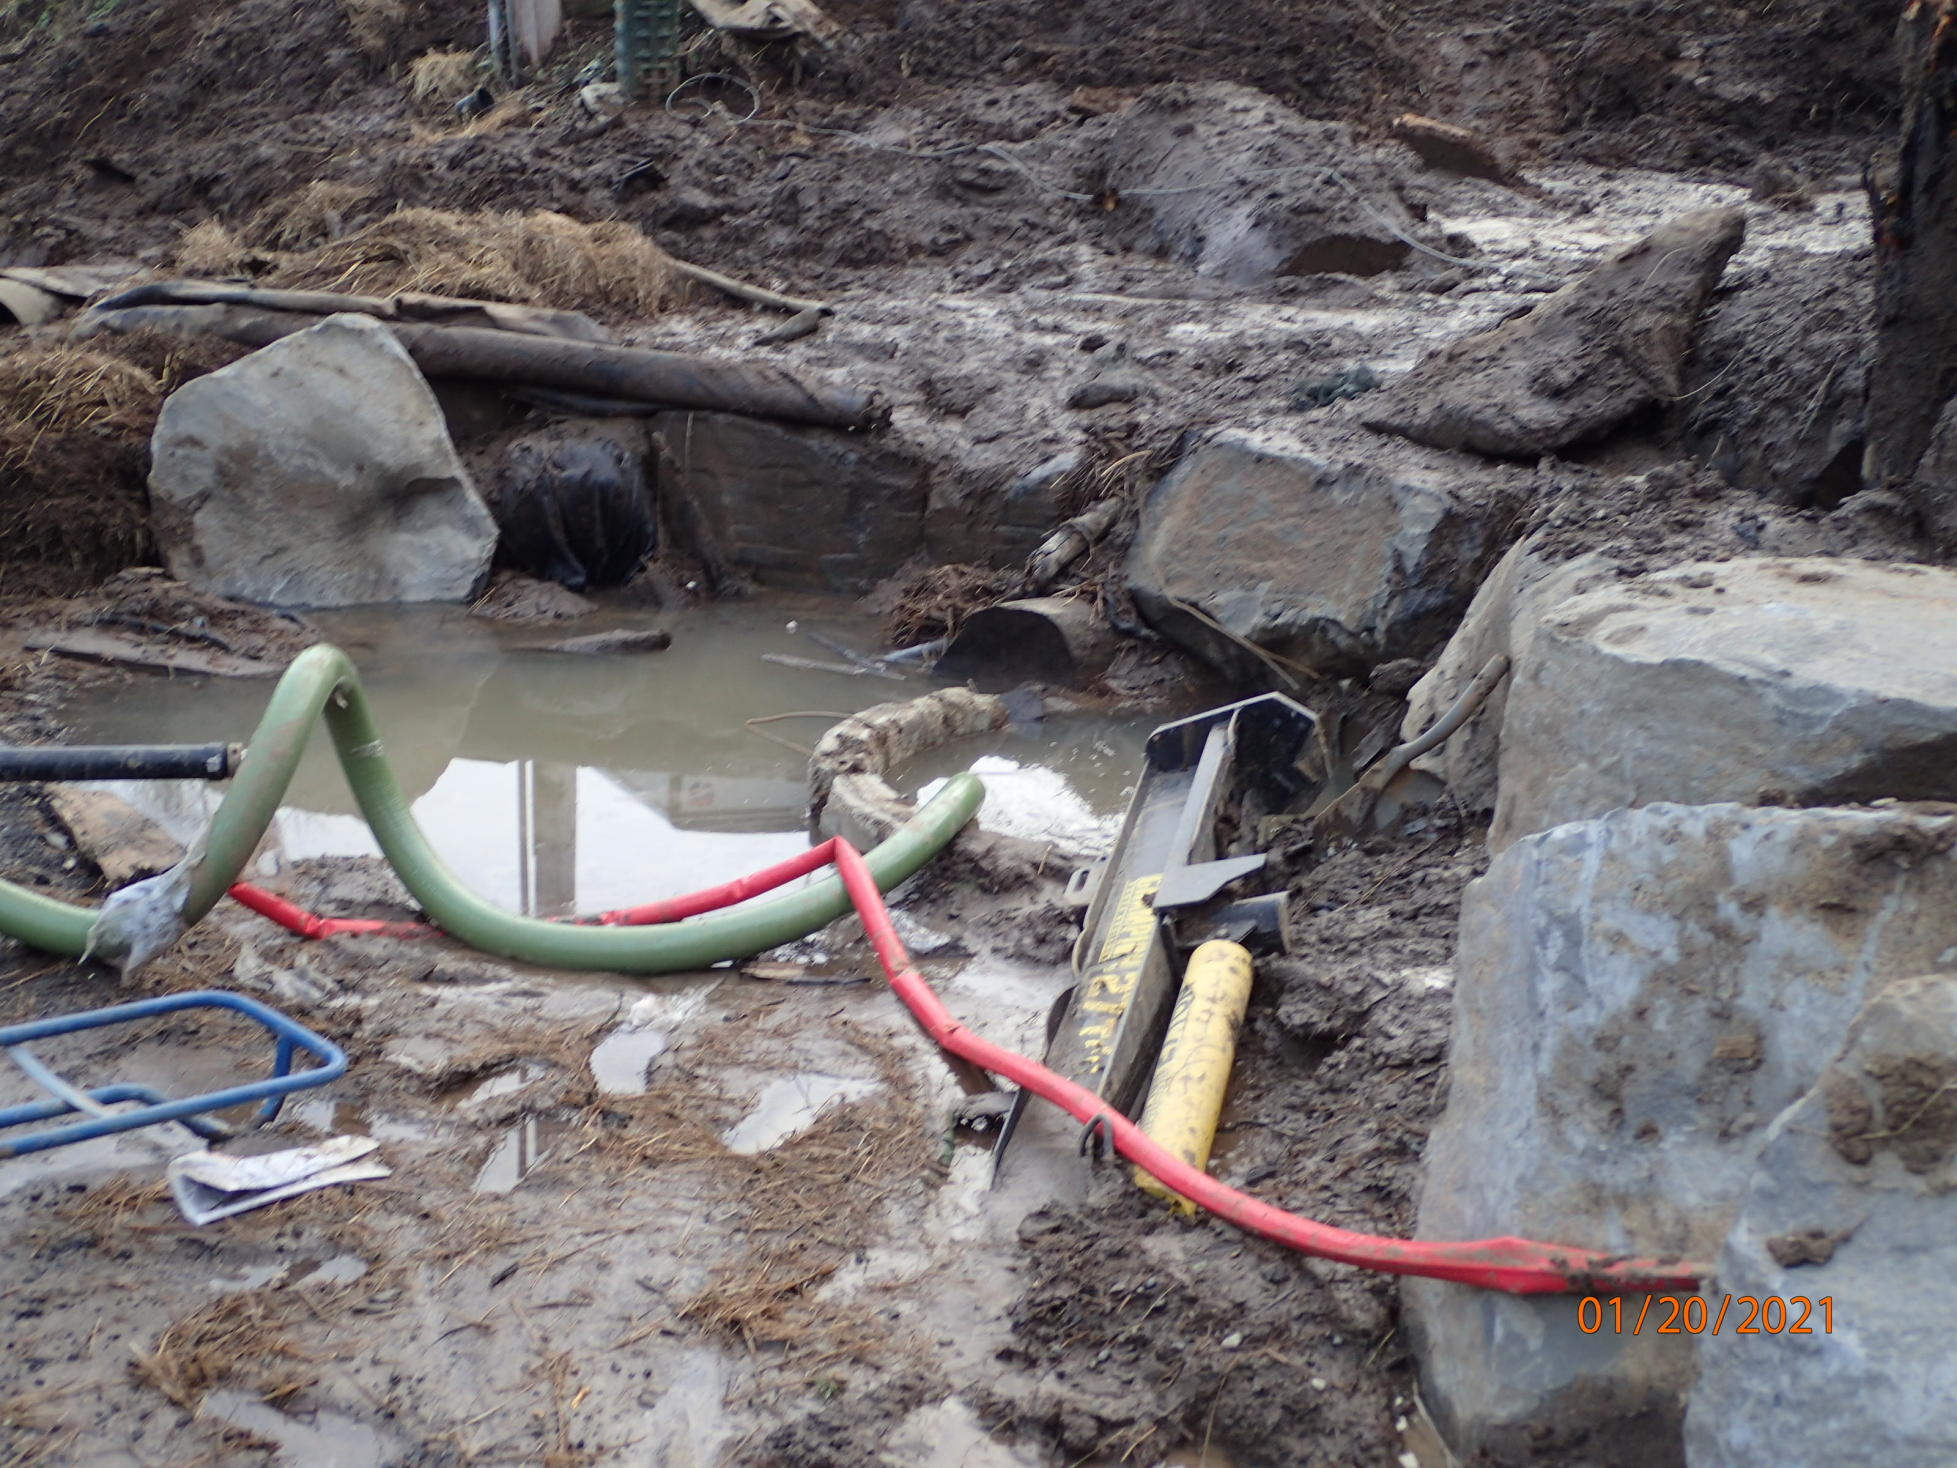
Updated Report: I visited the property for pictures. The truck observed on site looks like they delivered large boulders to the work site. The rocks are there to help the landslide from going into the roadway. The culvert is still plugged and silt and mud continues to cover the road. Other vehicles are tracking mud up and down the road.

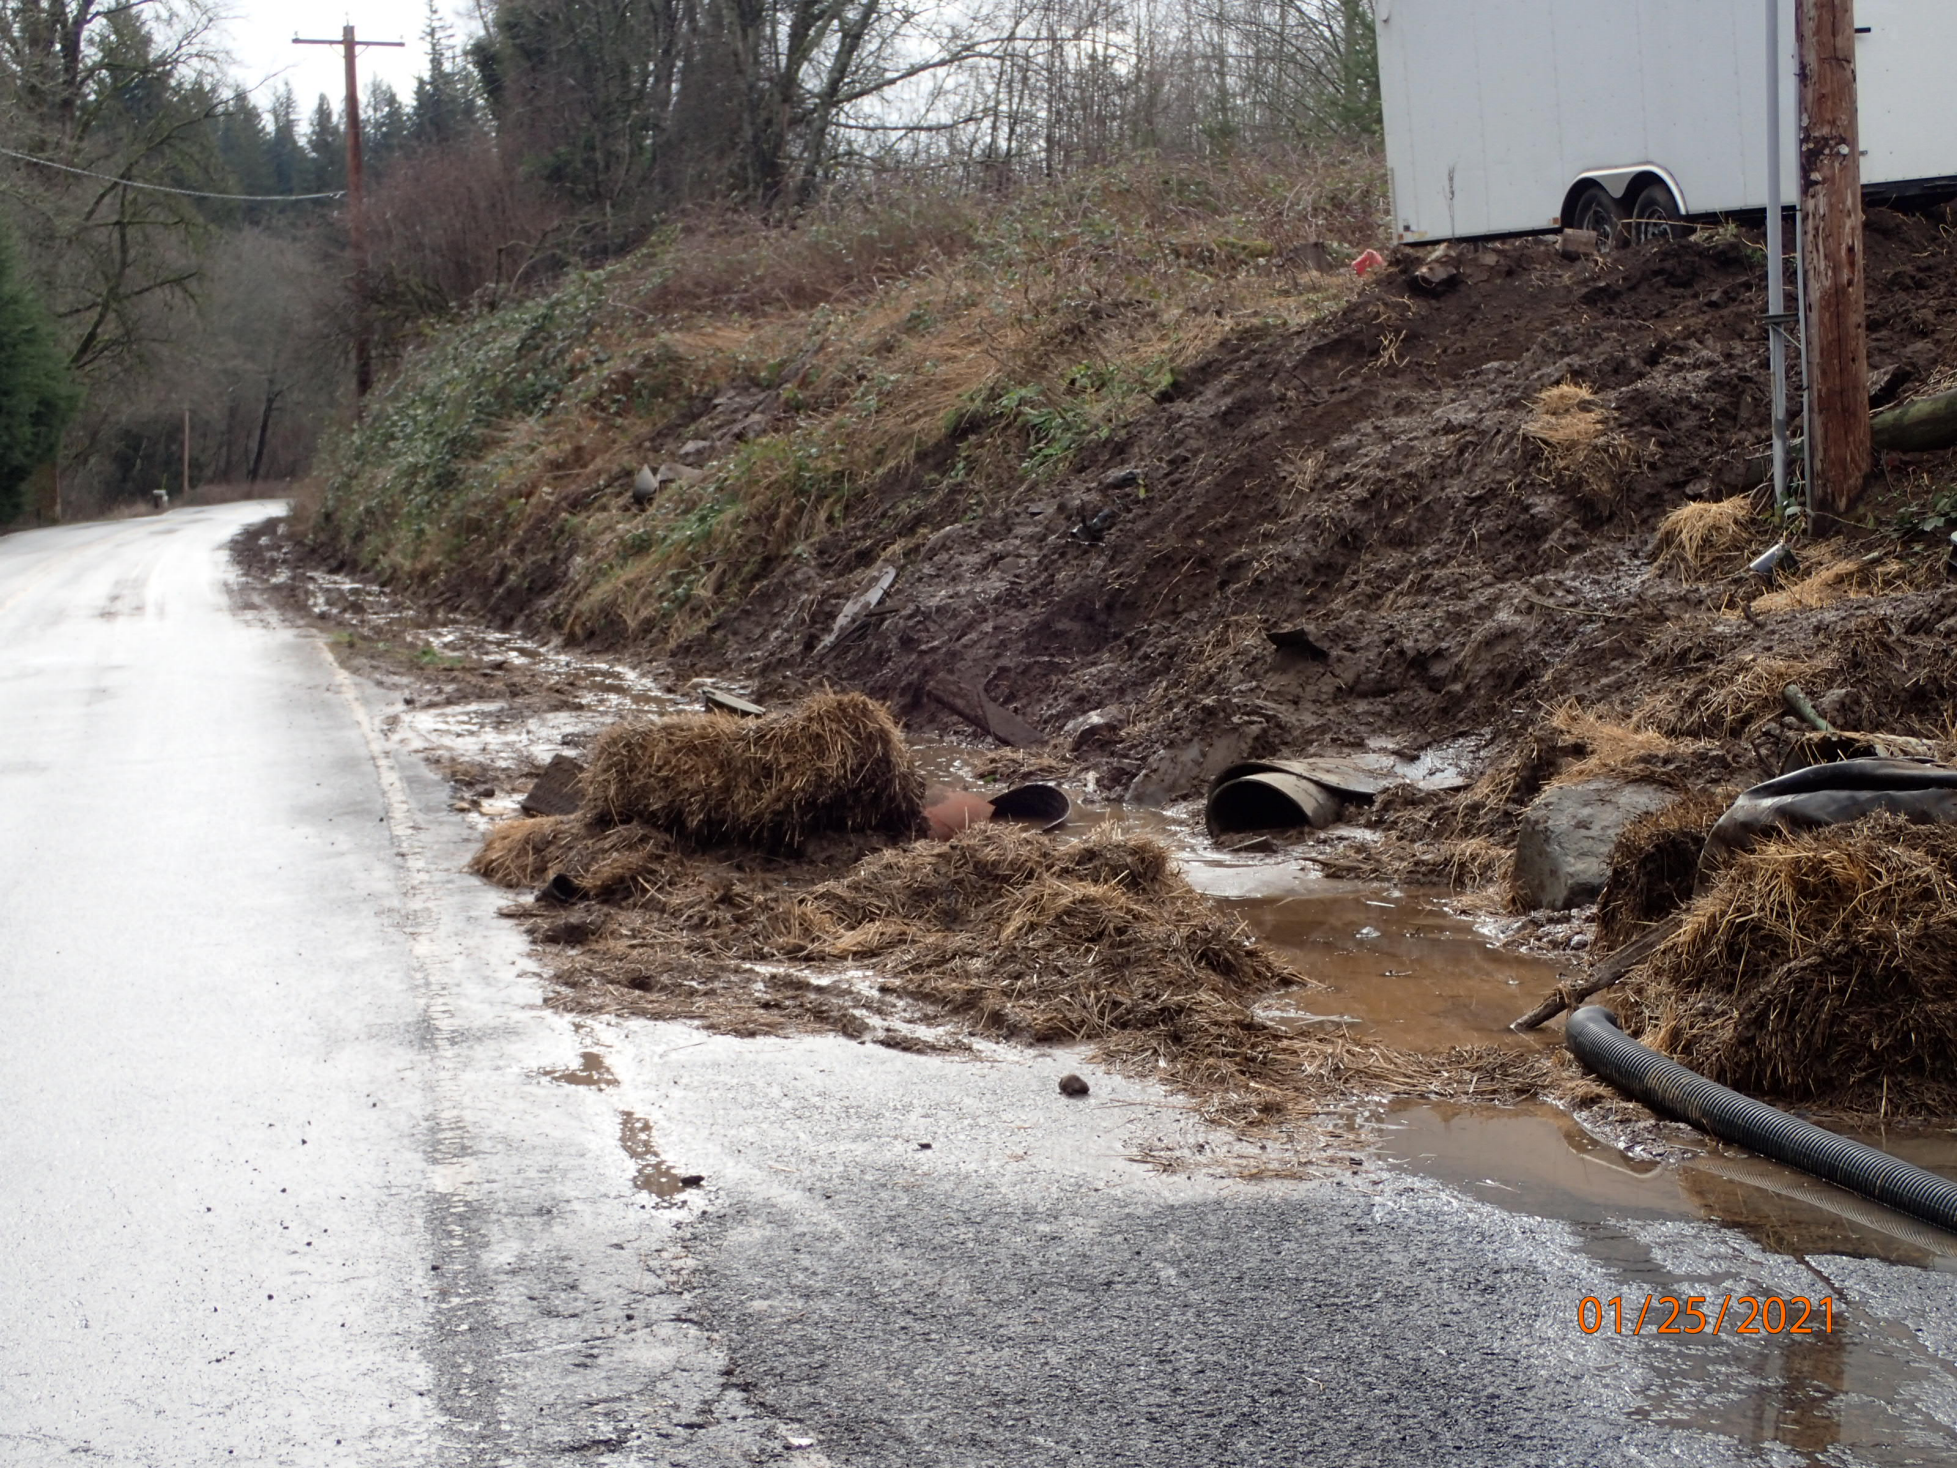
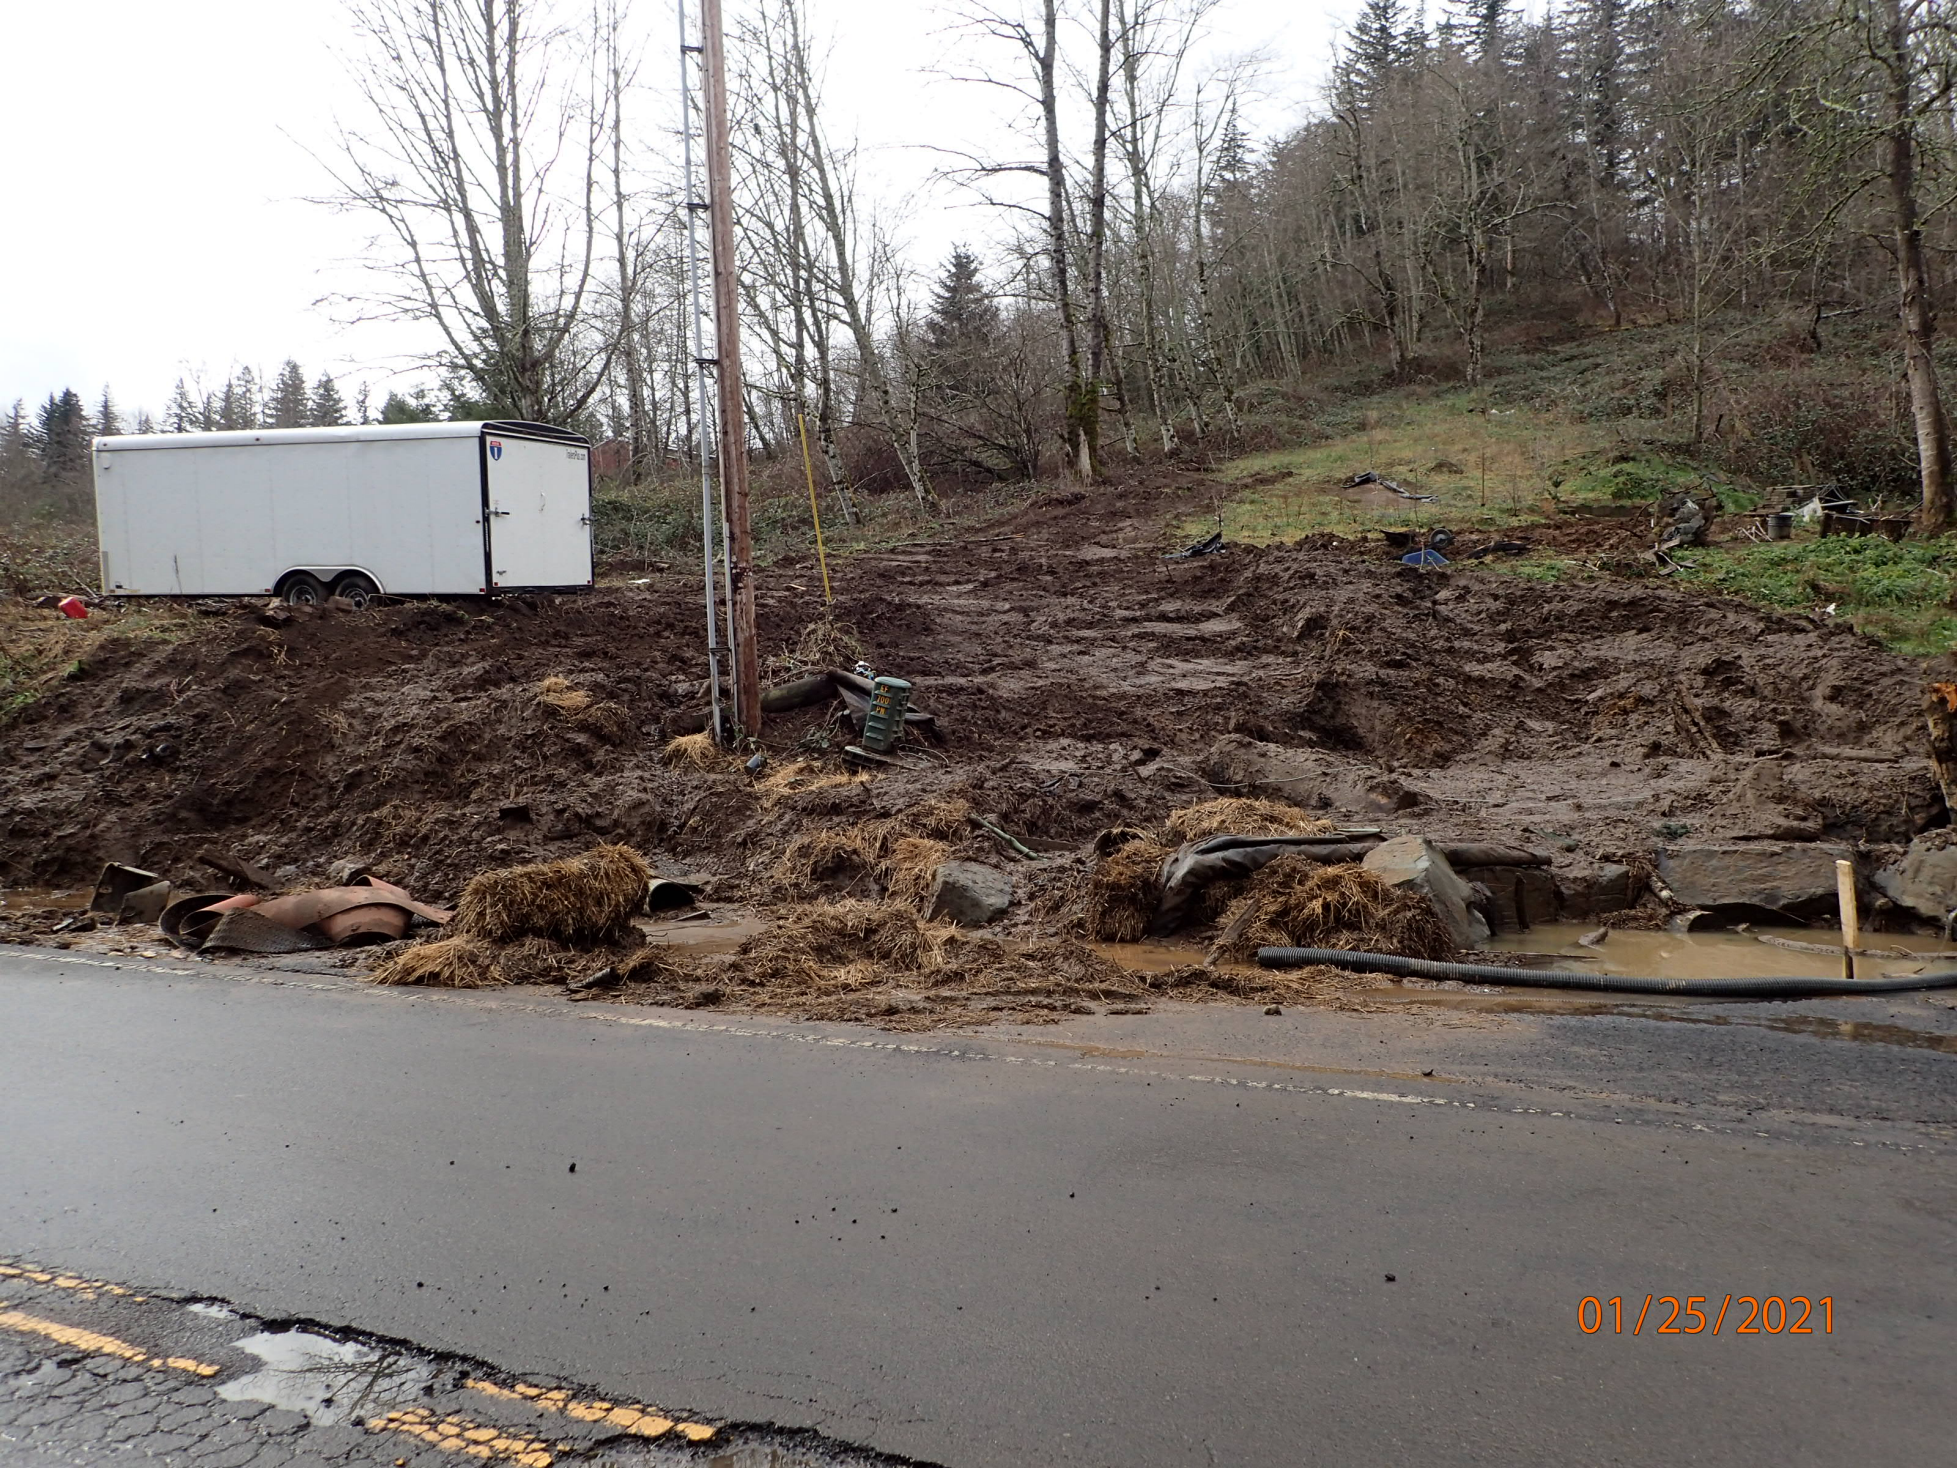
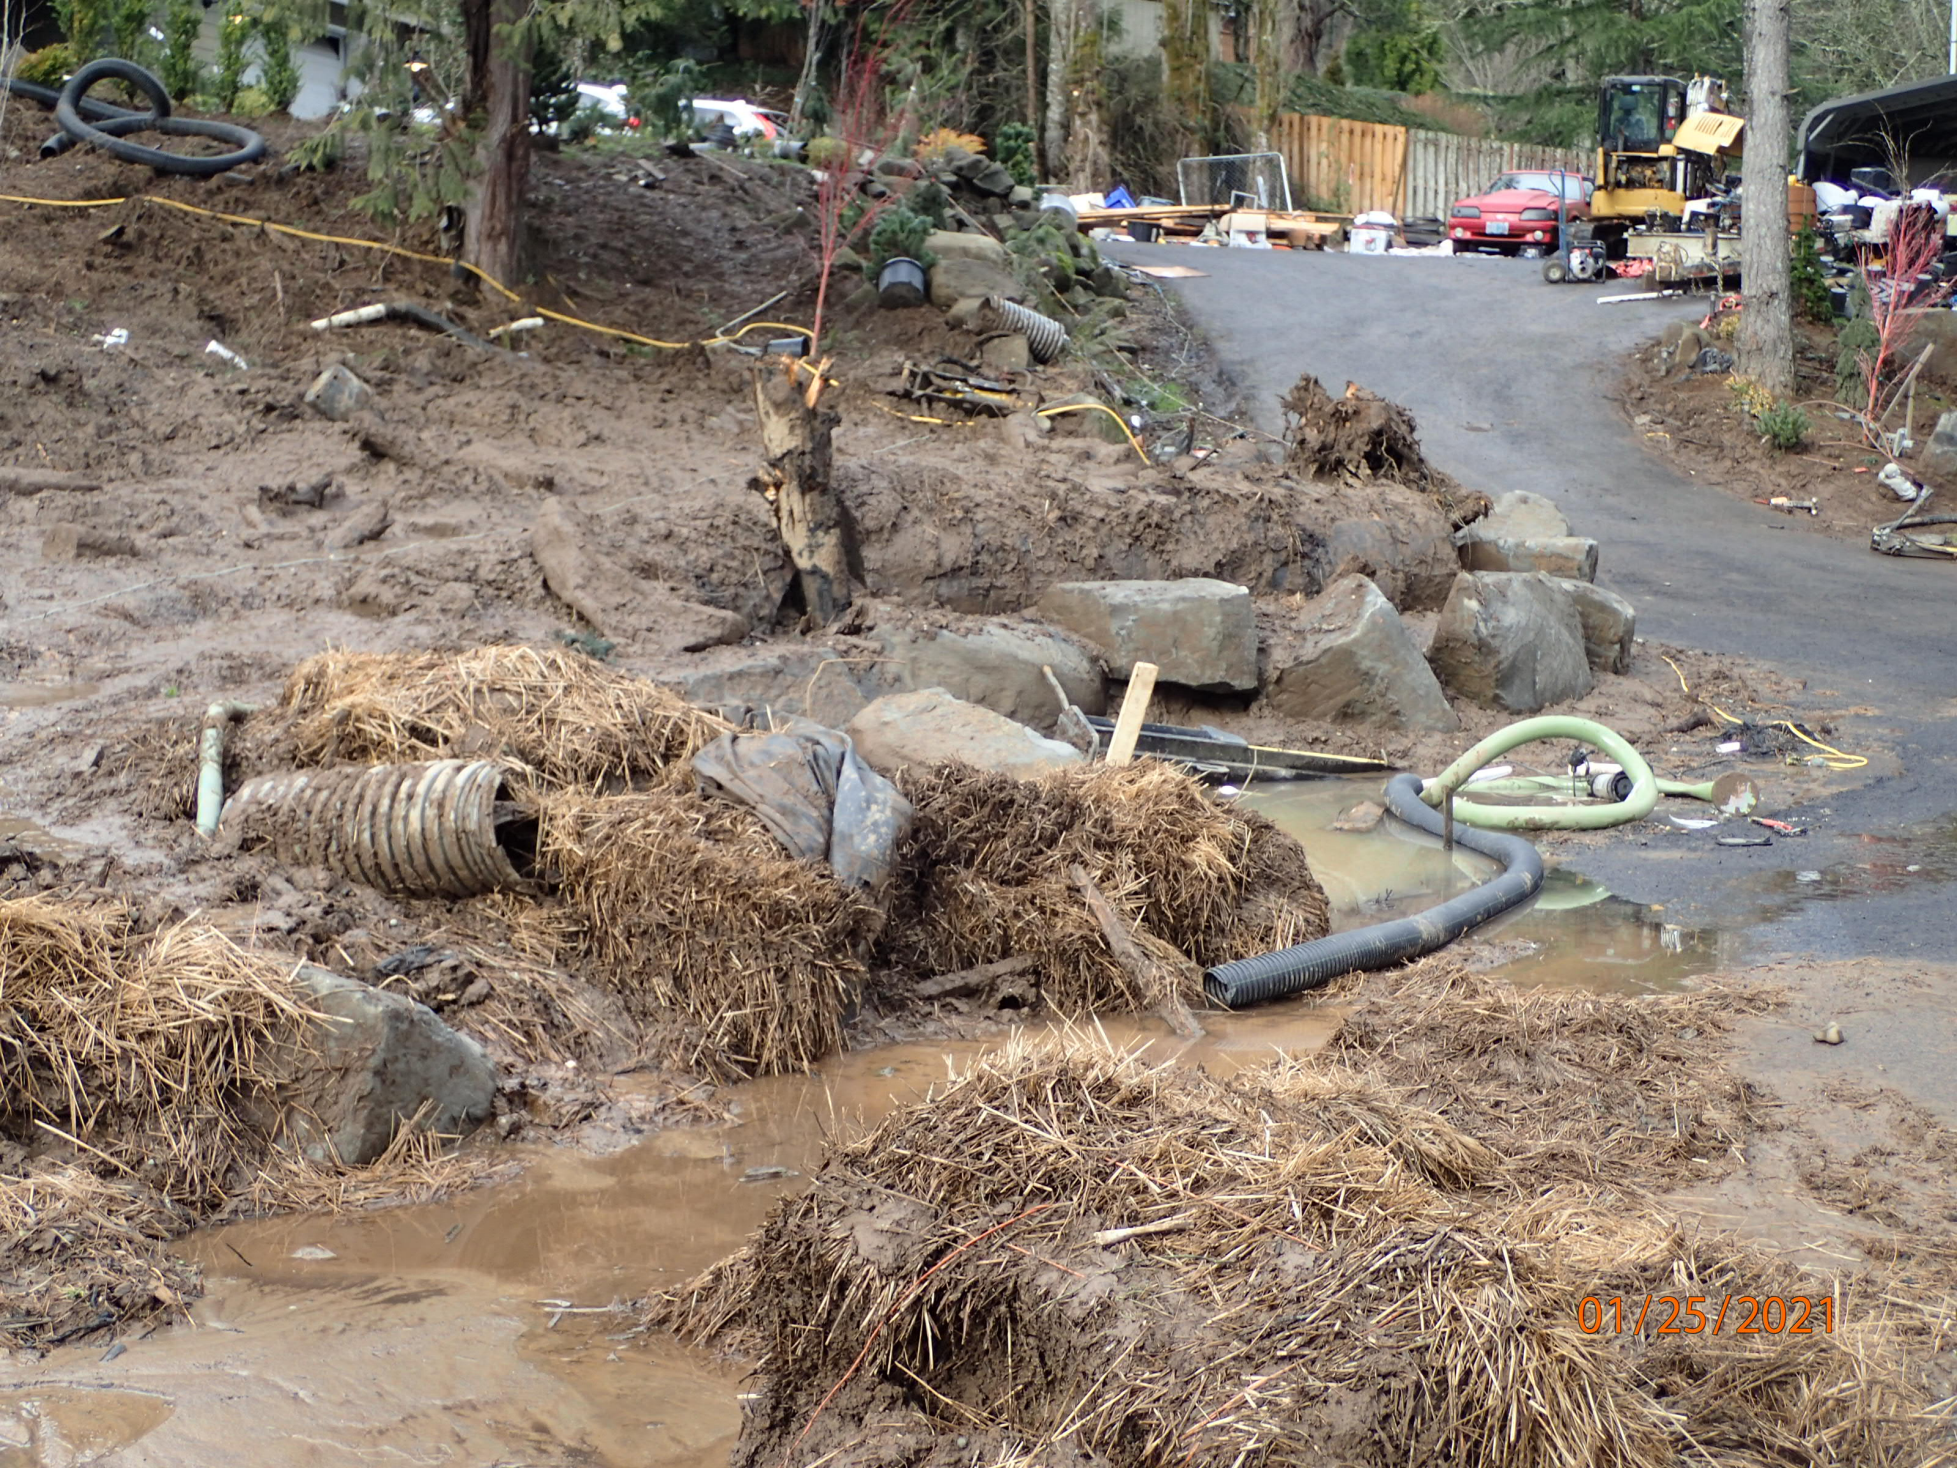
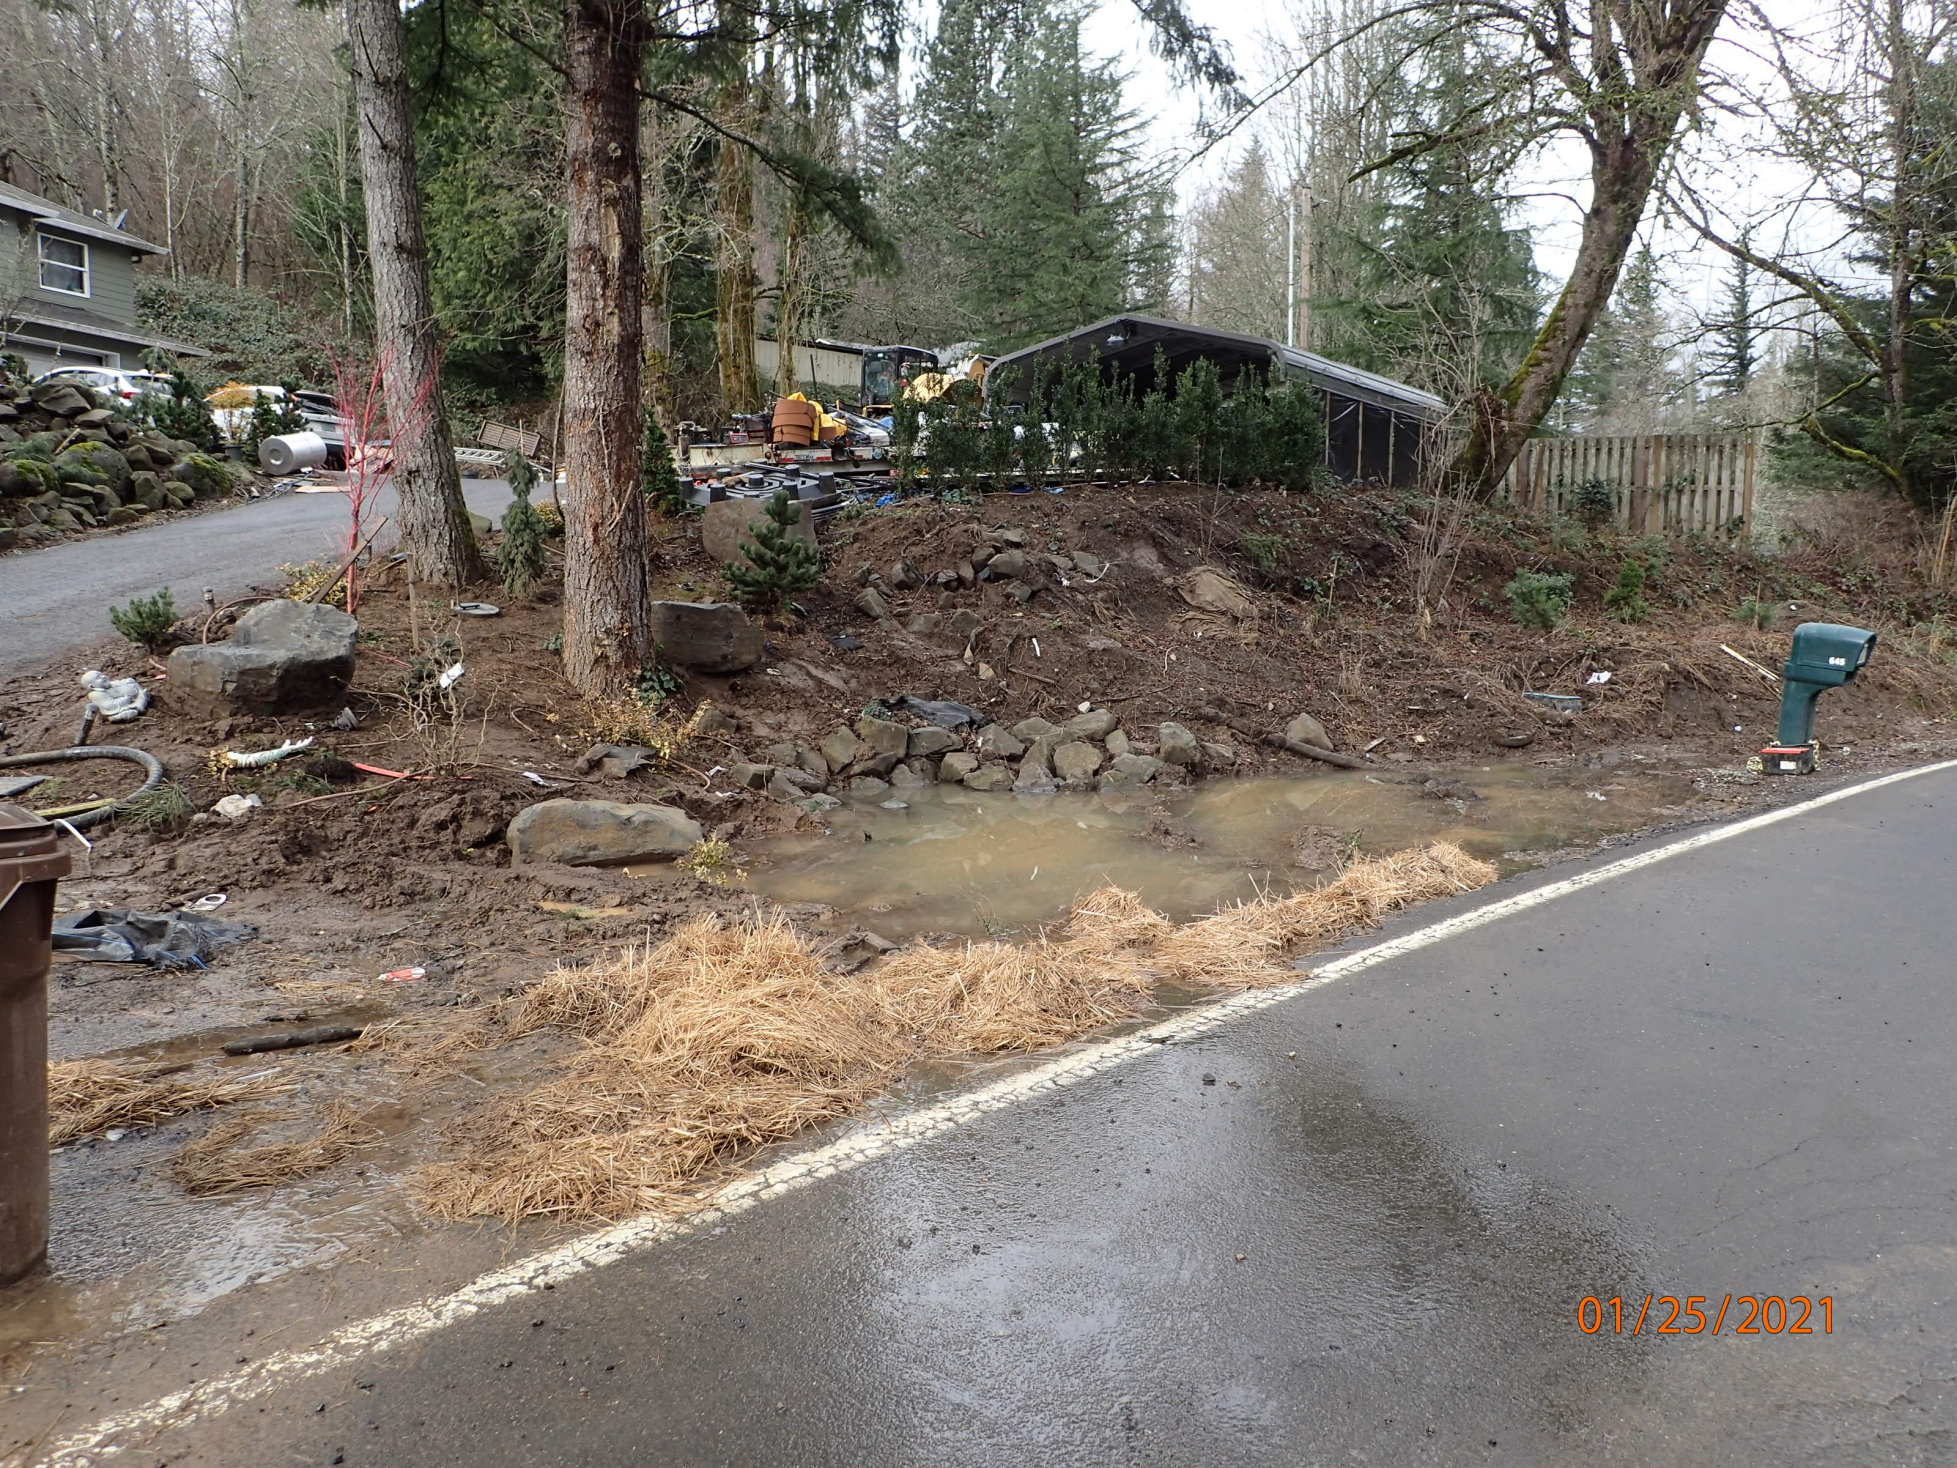
Updated Report: I visited the property for pictures. Culvert is still plugged. Silt is still spilling over the roadway. There is still a big mud pit on site. It appears work has subsided for now. Site is a little bit cleaner. Boulders still in place preventing landslides on the road. The excavators are off site.
