Land Use and Right-of-Way Complaint Form

Case #: ZV-2021-14224

FIELD INSPECTION REPORT

Property Address:	645 SE Pounder Rd		
Property Owner:	Heather Moon		
Tax Account #:	R994020700	Zone:	CFU4
Case File: UR-2020-13222			
Permits on File for property: None			
Other agencies/departments to notify: Mult Co. Sheriff			
Site Visit REMARKS			
Date/Time:	__1__ / __11__ / __2021__	Inspected By:	Robert Hyde
Permits on Location: None			
Measurements Taken:			
Witnesses Interviewed:

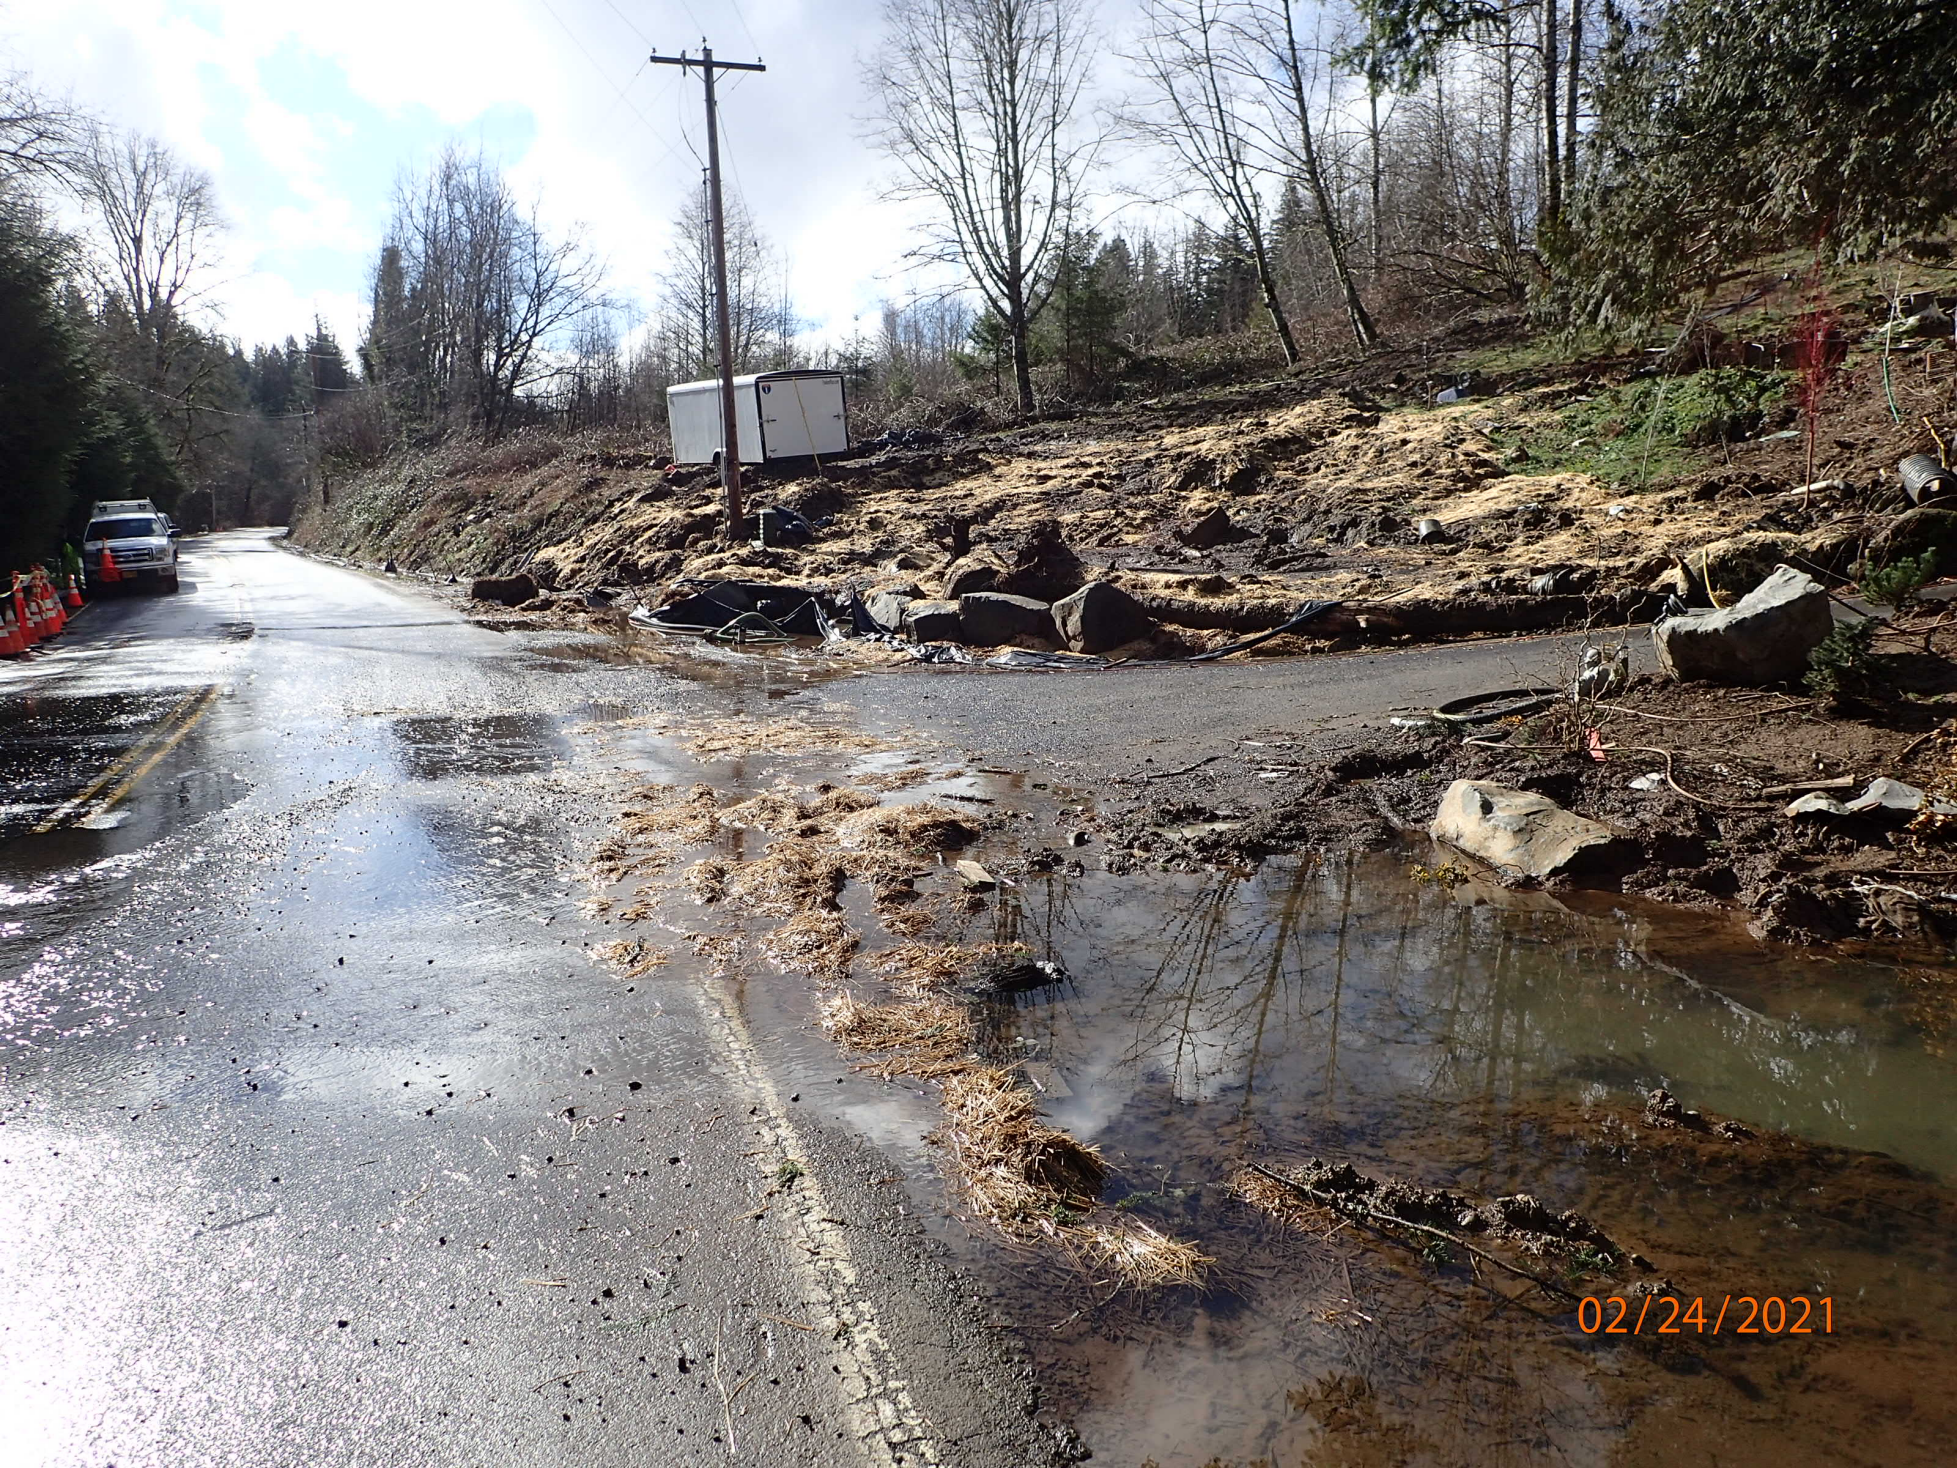
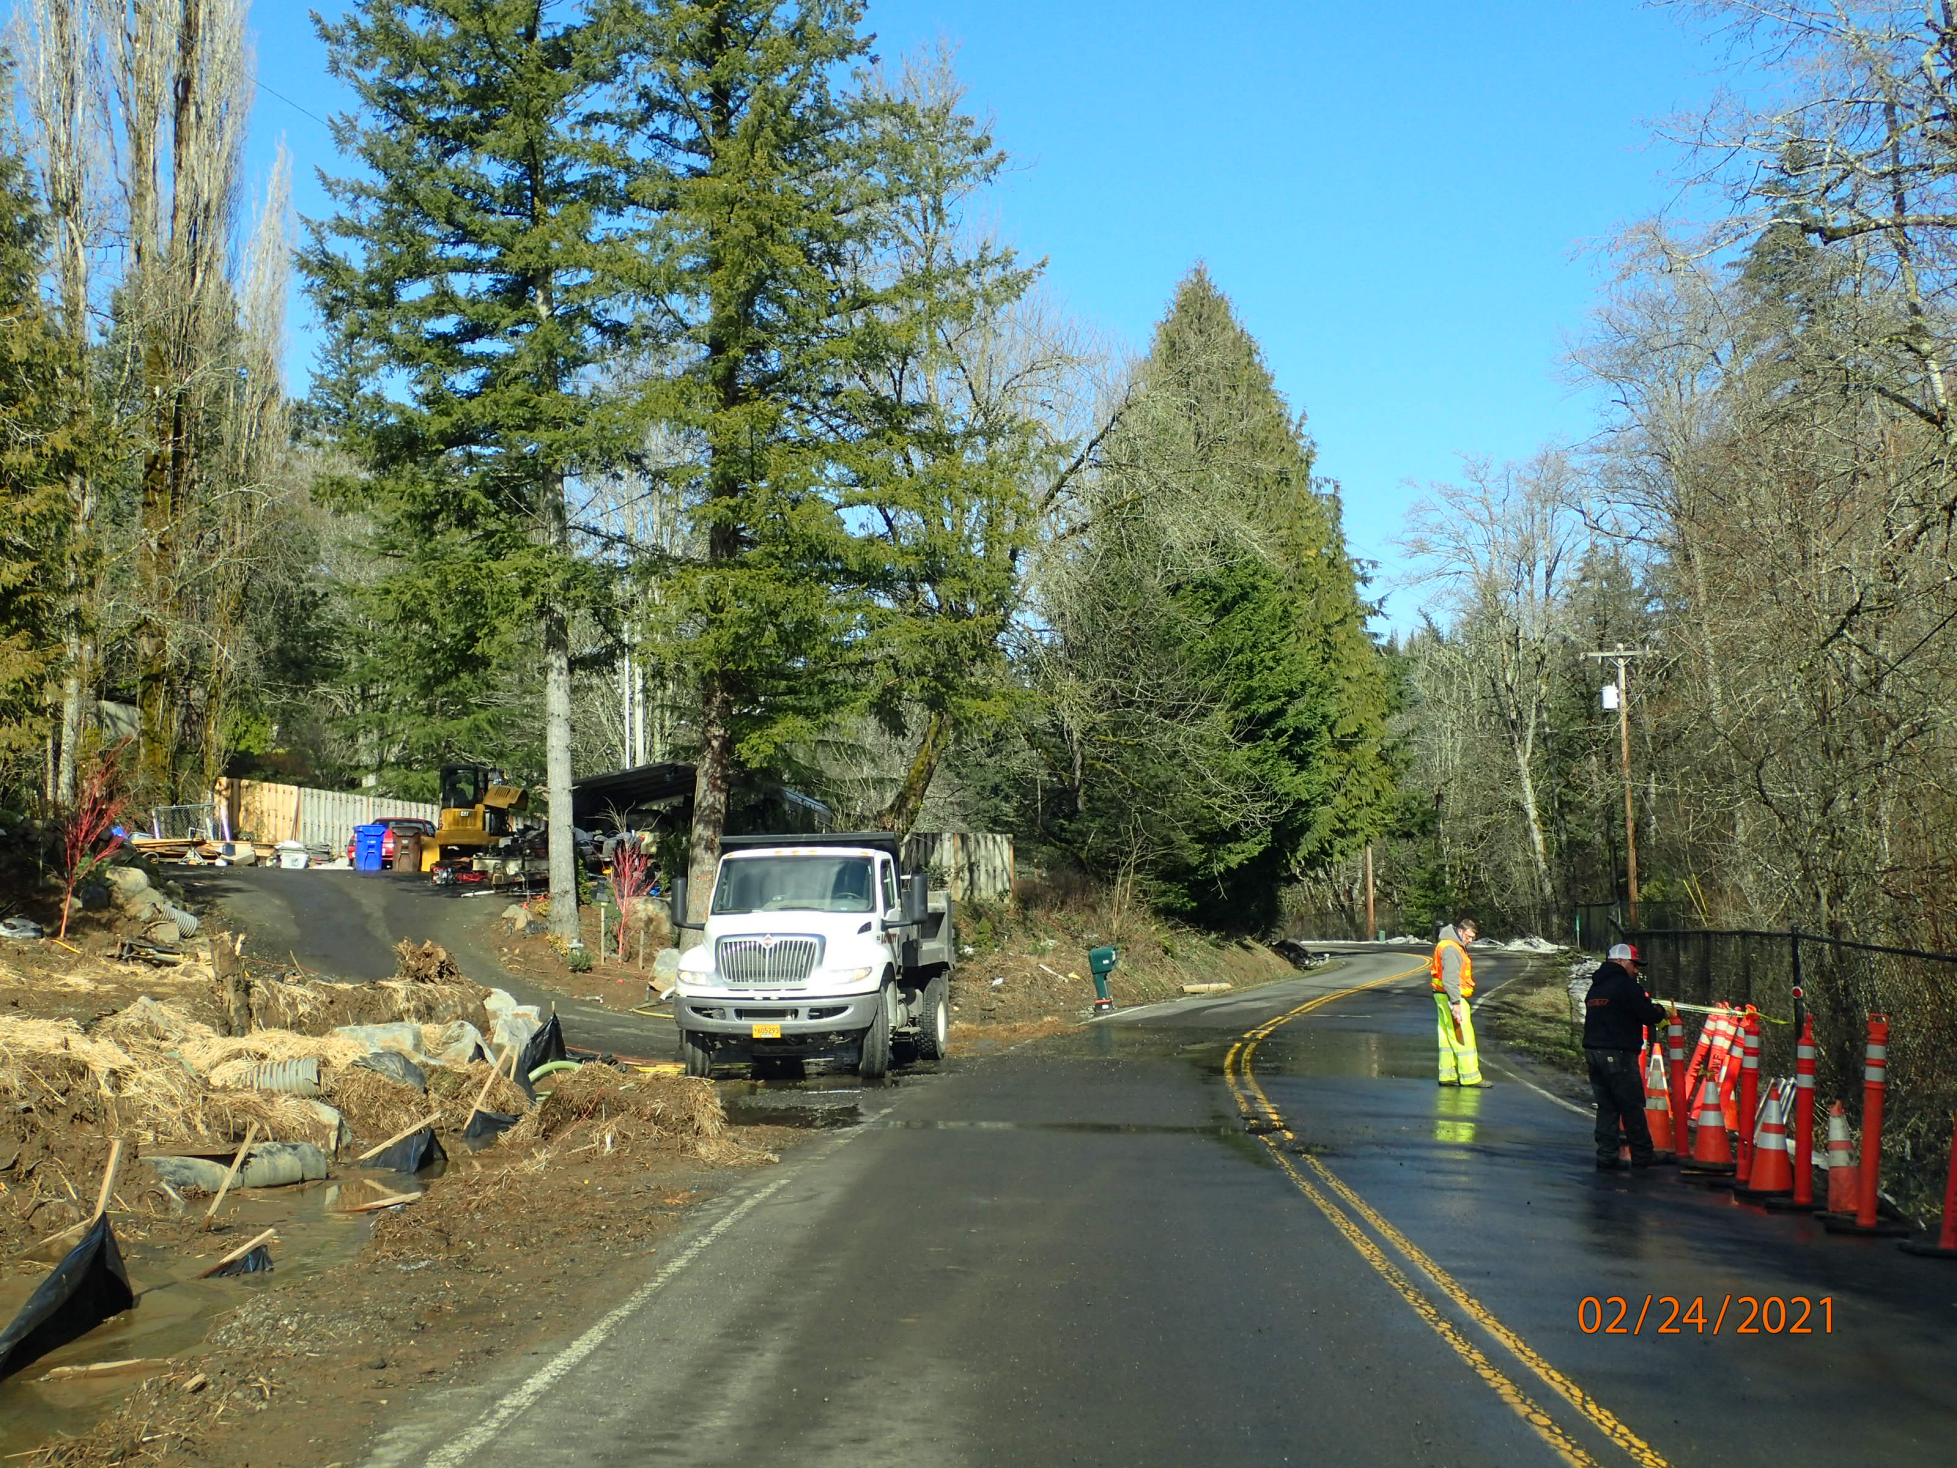
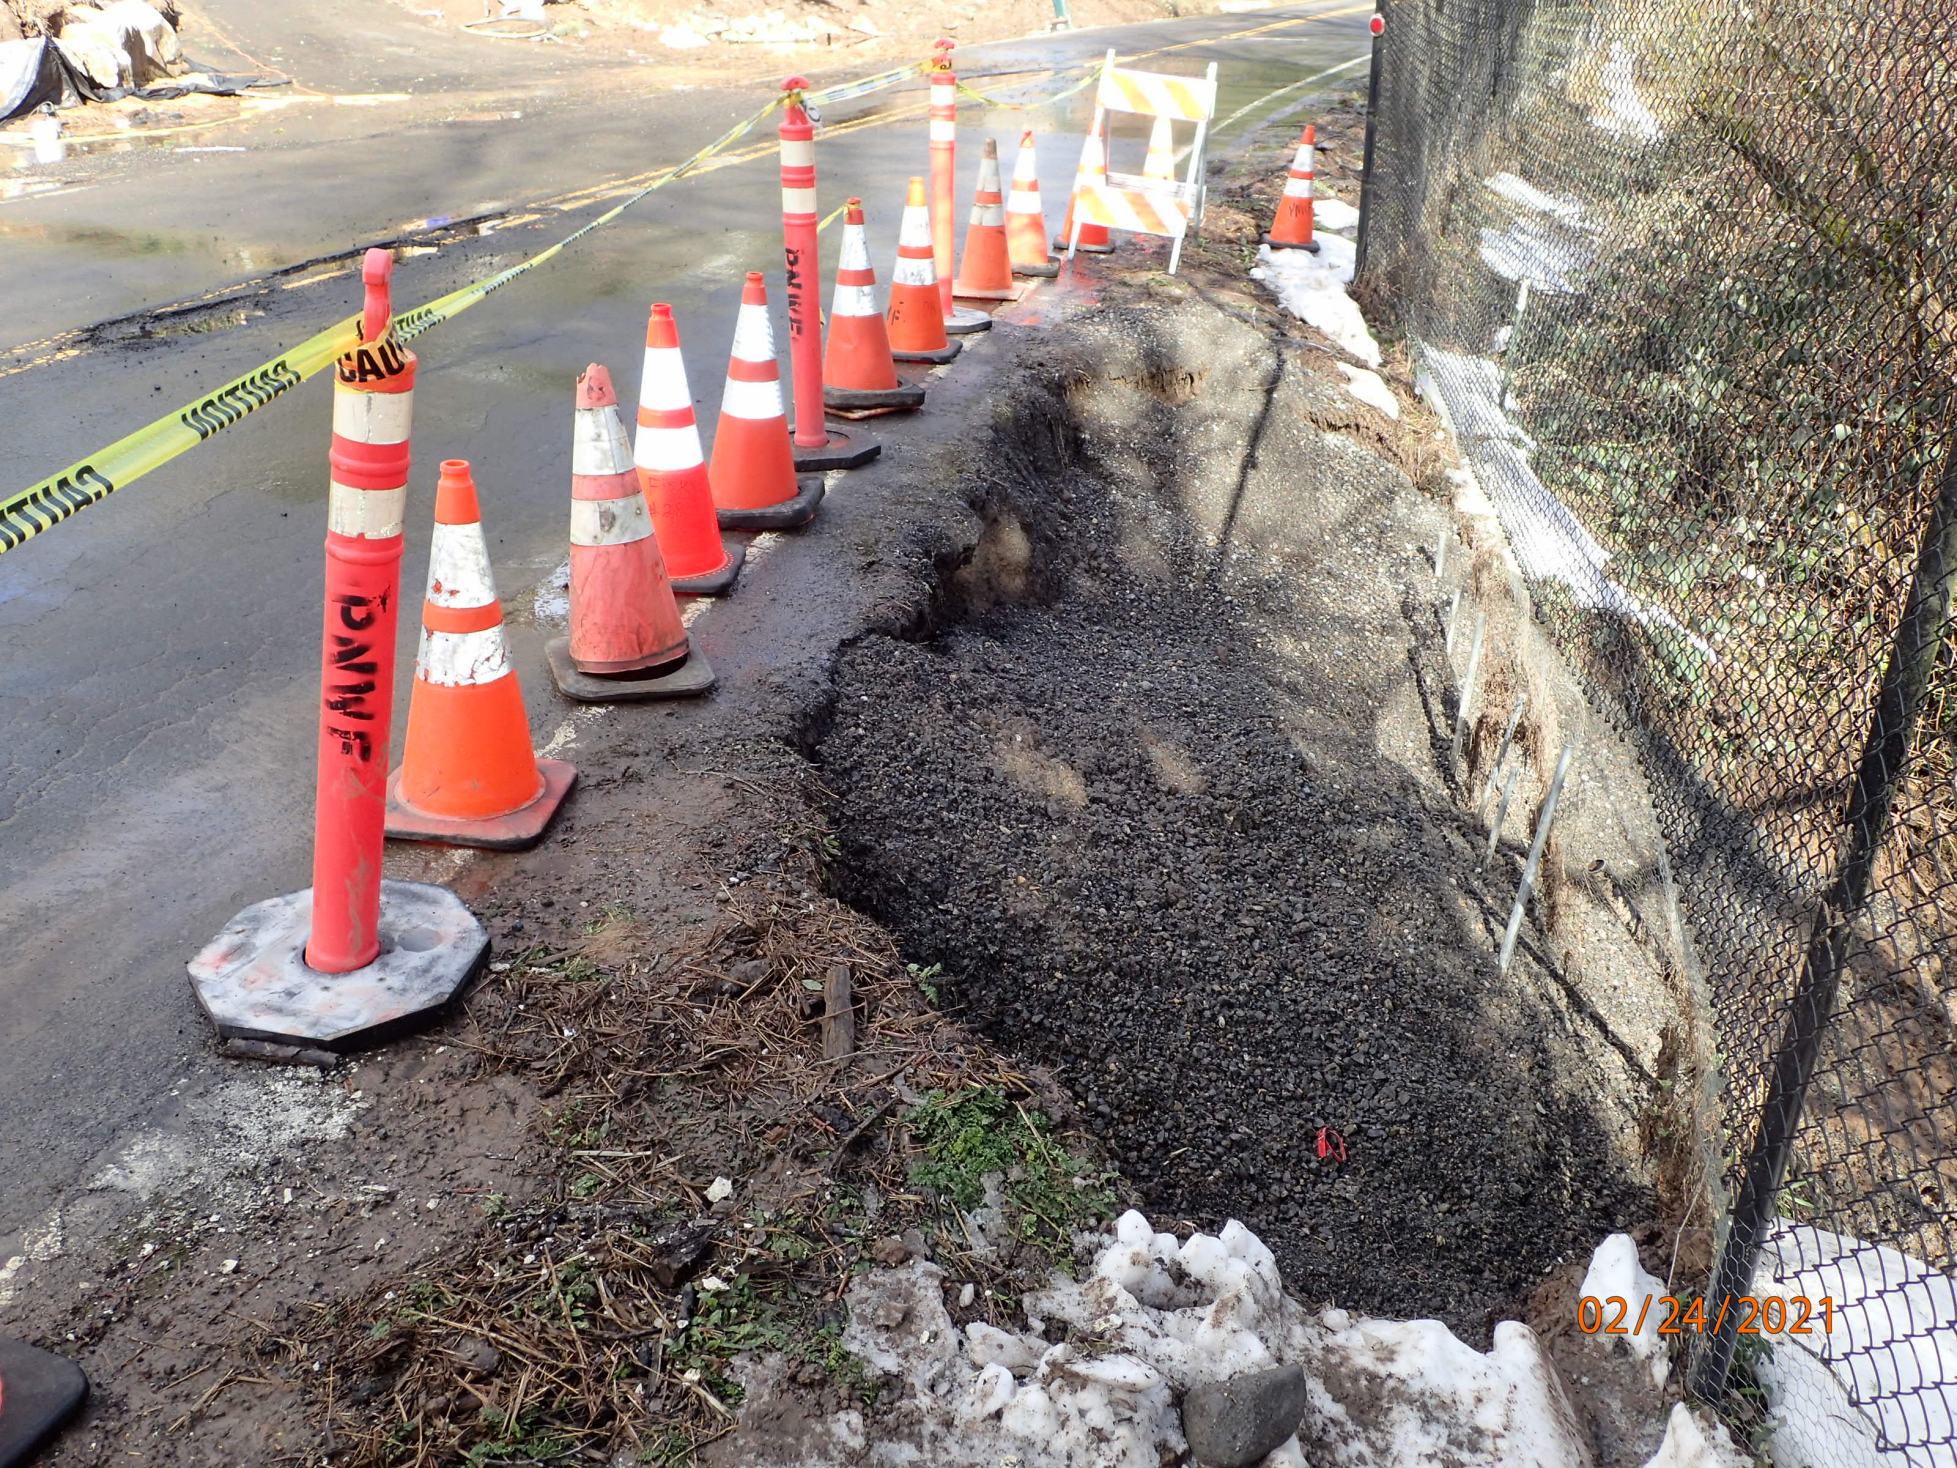
Updated Report: The road shoulder collapsed probably due to the plugged culvert and on going water over the roadway. The water department set out cones on edge of collapse to prevent vehicles from driving into the broken road. And they added pea gravel fill to prevent further collapse. Lovett is the sub contractor hired by the city doing the work. Culvert is still plugged and silt is running over the road. Mult Co. survey crew is on site to establish ROW so crews can work on culvert.
