STORM WATER REPORT

To
Multnomah County

For
Oregon Department of Transportation
Skyline Road Stockpile Facility
Tax lot 2500, Map 2N-1W-31C

Project Number
2200357.00

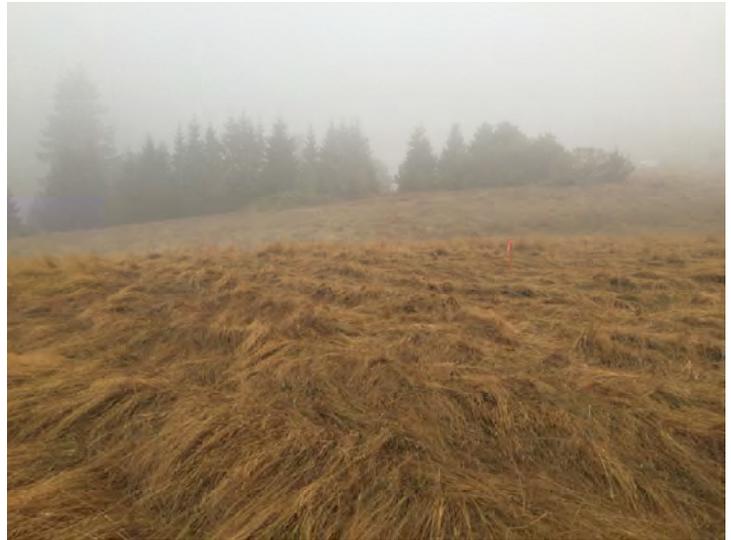
Photograph 1

South of the cut slope, the site generally descended gently to the west at gradients up to about 9H:1V. The majority of the site was vegetated with grasses (Figure C10, Photograph 1). No signs of slope instability or erosion were noted on the site.

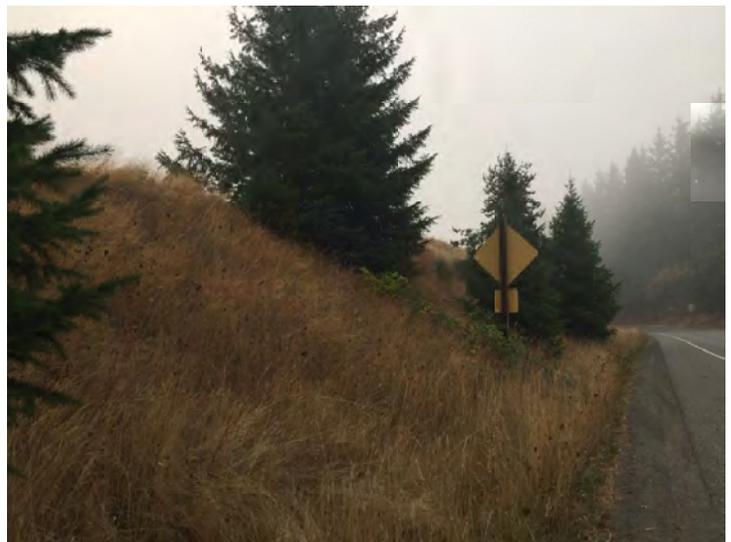
Photograph 3

West of the western property boundary, the topography descended to the west at a generally even gradient of 2H:1V. This slope (Figure C10, Photograph 3) was up to about 25 feet in height, and consisted of a cut slope associated with grading for NW Cornelius Pass Road. This slope was vegetated with grasses and scattered coniferous trees. Basalt bedrock was exposed at the base of the cut slope, as indicated on Figure C8. No signs of instability were noted on this cut slope.
