Adverse Effects of Portland Water Bureau's Proposed Water Treatment Plant on Natural Resources

Failure to Satisfy Conditional Use Criteria MCC 39.7515(B)

April 15, 2025

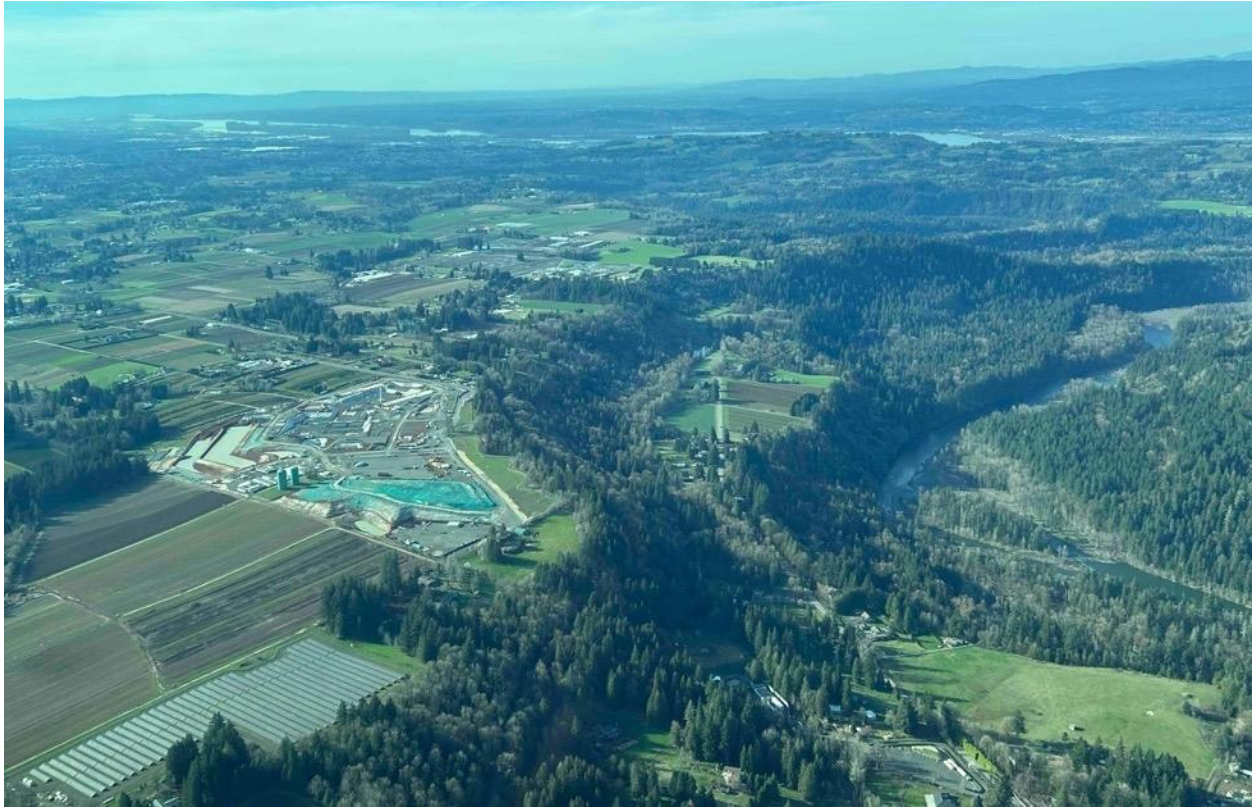
Figure 1. Aerial photo (March 2025) of the 90-acre water treatment plant construction site (looking north) showing its proximity to the Sandy River just 750 feet to the east of the designated “Natural River Area” boundary under the Wild and Scenic Rivers Act.

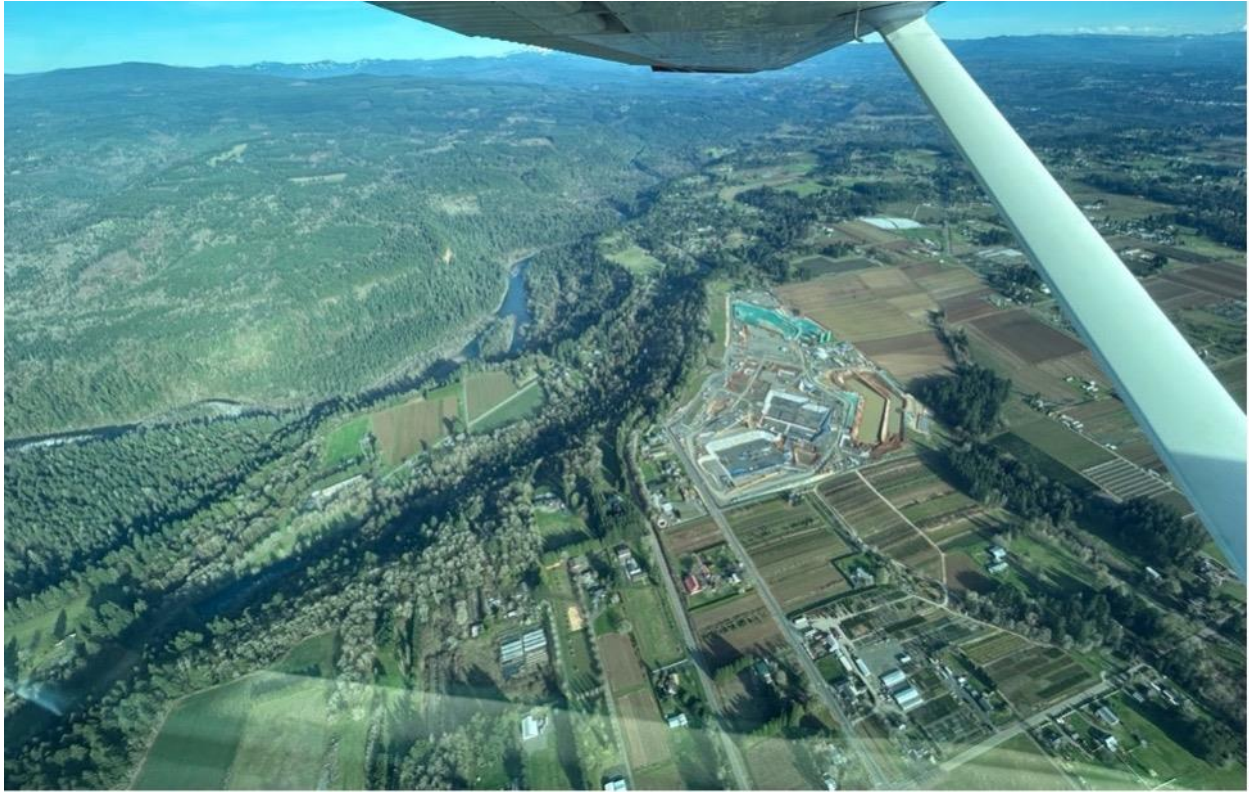
Figure 2. Aerial photo (March 2025) of the 90-acre water treatment plant construction site (looking east) showing its proximity to the Sandy River, designated “Natural River Area” under the Wild and Scenic Rivers Act.

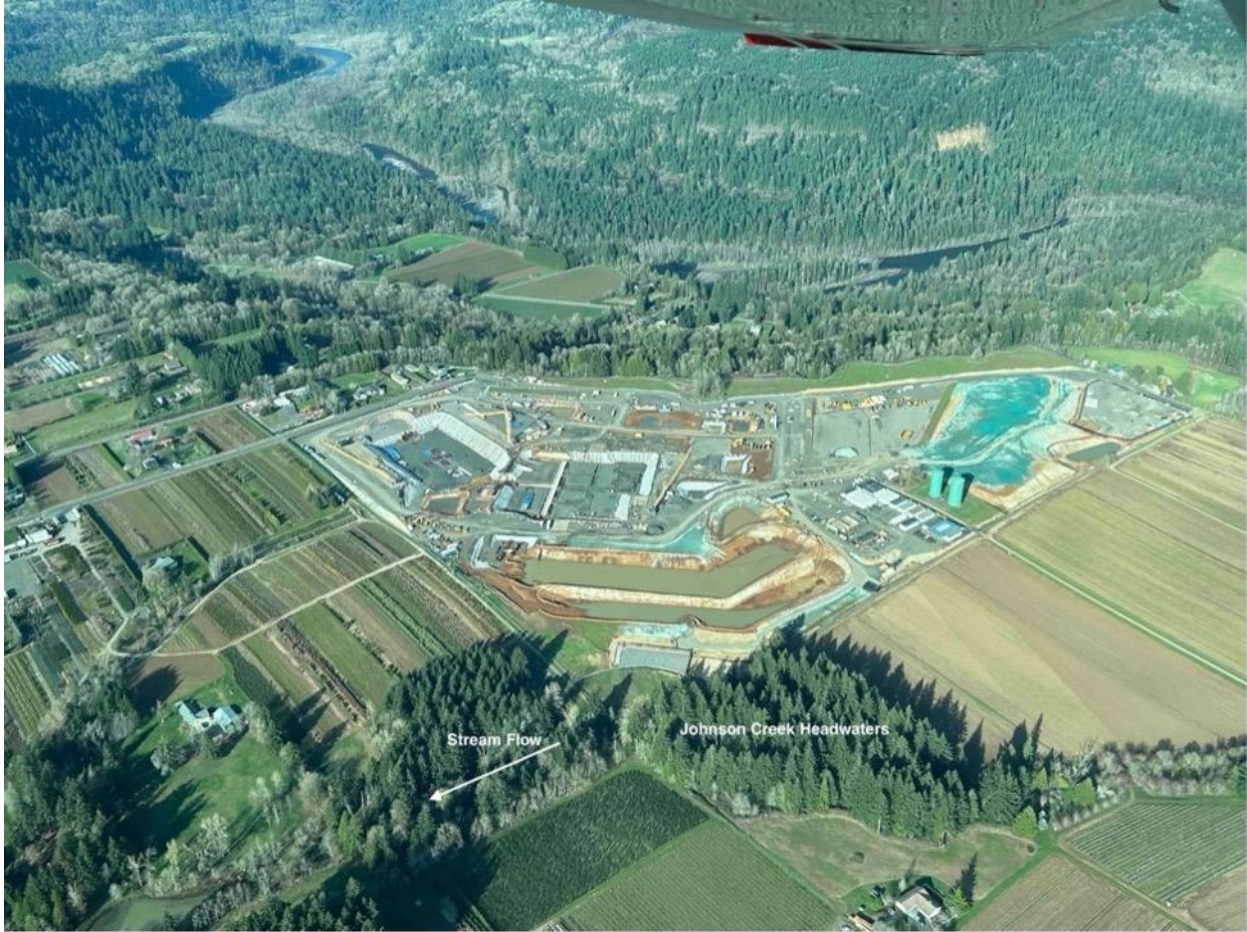
The filtration facility is sited approximately 300 ft from the headwaters of Johnson Creek (Figure 3). To construct the filtration facility, PWB has excavated and relocated significant volumes of soil (~1.25 million cubic yards), leveled the natural topography of ~90 acres, filled in two natural draws, and has discharged all stormwater effluent and emerging groundwater solely into Johnson Creek. Overland flow patterns and the natural characteristics of Johnson Creek have been permanently changed from significant site preparations for the construction of the filtration facility.

Figure 3. Aerial photo of the 90+ acre water treatment plant construction site (looking northeast) showing its proximity to Johnson Creek and the federally designated Wild and Scenic Sandy River. Stormwater collection and facility retention basins were intentionally sited 200 ft from the creek to facilitate discharge of excess storm water into the creek, away from the site. The creek is also currently being used to convey pumped groundwater from the local aquifer out from the construction site.

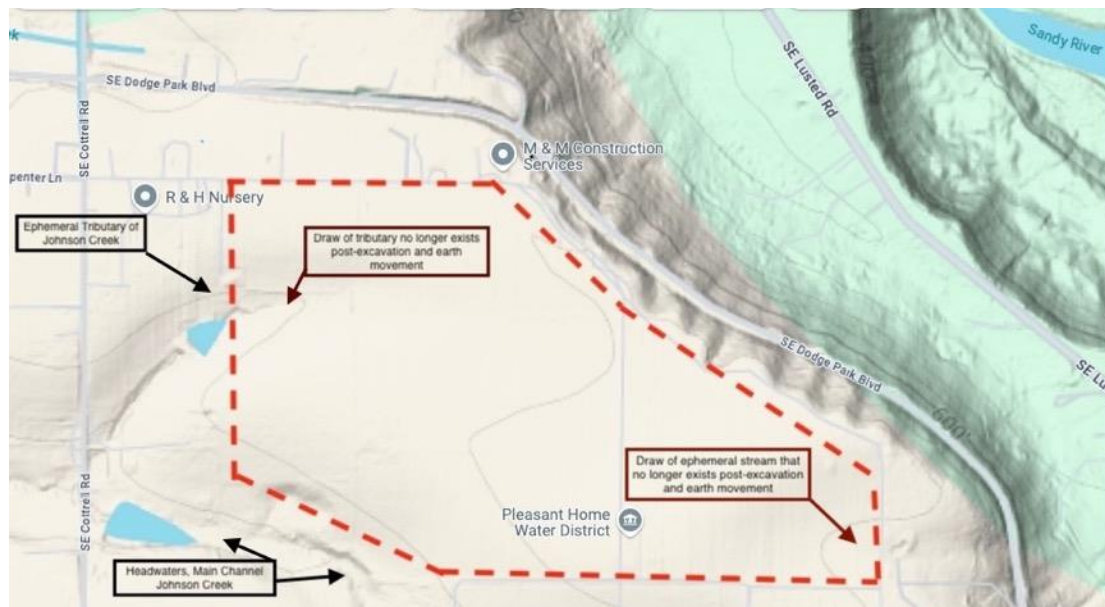
infiltrate into the farmland soil naturally mobilized toward portions of the property with the lowest elevation. These portions were the SW corner toward Johnson Creek's riparian area, the western edge of the property, and at the SE corner. At the western edge of the property, overland flow previously ran off into a small draw that led into an ephemeral tributary of Johnson Creek (Figure 4). Extensive earthwork during site preparations has permanently filled in this draw and it no longer exists. As a result, overland flow and runoff patterns have permanently changed from its previous existence (Exhibit H.1, pg. 24, demonstrates elevation and overland flow prior to construction). Stormwater from the construction site and groundwater being pumped out of extensive 20-30 foot deep excavations (estimated 1,600 gallons per minute at 11 hours per work day; *personal communication* MWH-Kiewit foreman Mr. Goldschmidt January 30, 2025) are solely directed to the southwest corner of the property. Aerial imagery and engineering site plans indicate that Johnson Creek was deliberately selected to channel stormwater and facility overflow (Figure 3, Figure 5, and Exhibit H.1). At the SE corner of the property, near the raw water pipeline portal, a shallow draw existed. During the winter and spring months, overland flow mobilized from the PWB's property and into the neighboring residential property to the east via the draw. The topographical lines in Figure 4 show the natural contour that previously favored drainage at the SE corner of the property prior to construction. Following PWB's excavations, mounding of excess spoils, and the leveling of the property, this drainage no longer exists.

Figure 4. Pre-construction topography of the filtration site (*GoogleMaps*). Dotted red lines are the approximate outline of the filtration project. Arrows indicate water conveyances permanently removed or impacted by the project.

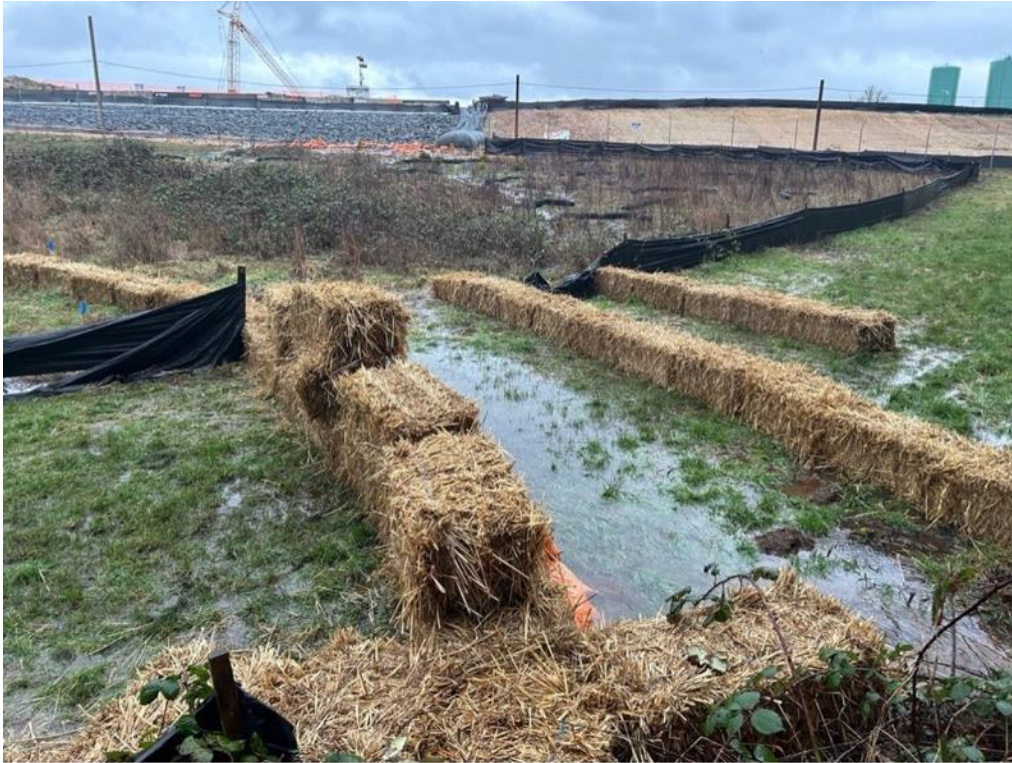
Figure 5. Stormwater discharge from PWB’s construction site directed into Johnson Creek and its associated riparian area through the use of hay bales and silt fencing (February 2025). Hay bales were installed as a form of erosion control after formal complaint made by community members to Oregon Water Resources Department and the Oregon Department of Environmental Quality in January 2025. Hay bales did not alleviate erosion, channelization, or increased sedimentation of Johnson Creek.

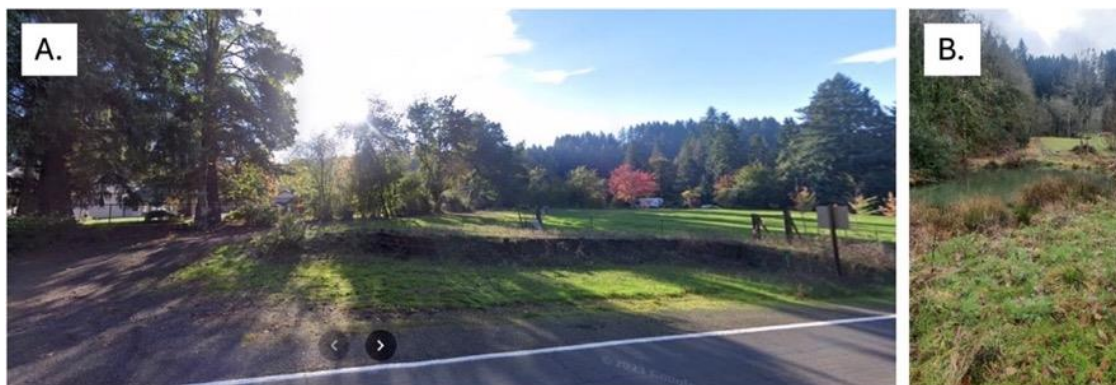
Figure 6. Property associated with raw water portal near 37077 SE Lusted Rd. before raw water portal staging construction (A) Street view of the entrance of impacted property (October 2023, *GoogleMaps*); (B) Existing wetland, associated wetland grasses, pasture and surrounding trees (February 2024).

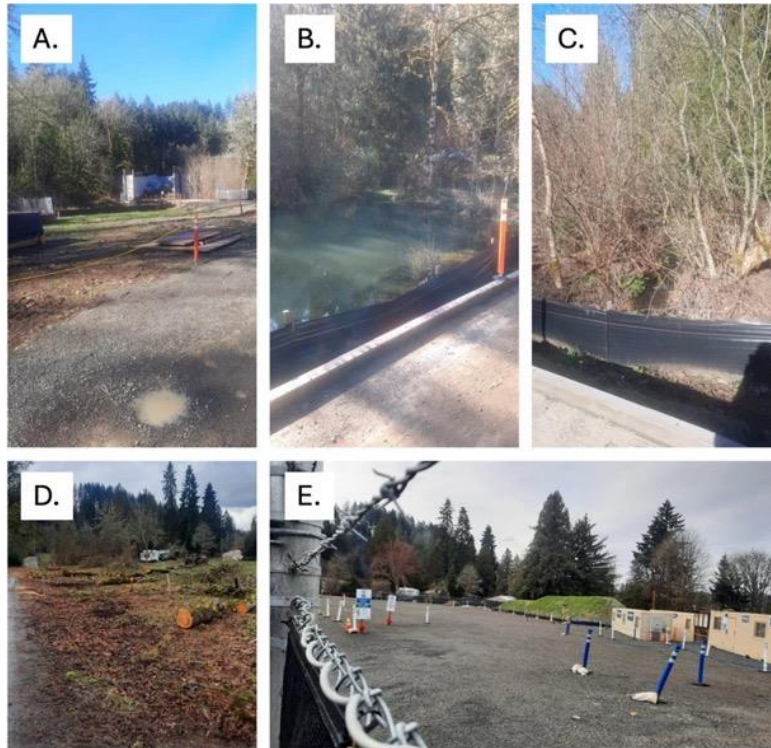
Construction and site preparation of the raw water portal has caused long-term damage to the wetland and forest habitat at the site that abuts the county’s designated SEC-h overlay (Figure 7). Negative impacts are widespread and include (but are not limited to):

- (i) An unknown quantity of trees have been cleared, including decades old Douglas fir, Western red cedar, and bigleaf maple;
- (ii) Contractors have filled, leveled, and the graveled over of the property for vehicle access and construction material staging, thereby changing natural drainage patterns and infiltration;
- (iii) Erosion control materials have modified natural flow into and out of the pond and surrounding wetlands
- (iv) Newly constructed bridge over existing pond and wetlands for traffic access, potentially limiting breeding sites for amphibians and access for waterfowl

Figure 7. Impacts at property associated with raw water portal near 37077 SE Lusted Rd. after raw water portal staging construction (photos taken February 2025) (A) Approaching pond with access bridge and concrete sound barrier; (B) Pond with erosion control material viewing from constructed bridge; (C) Pond-associated wetland with stream on other side of bridge; (D) Cleared deciduous trees prior to grading and gravel (Winter 2024/2025); and, (E) Current state of construction site entrance.

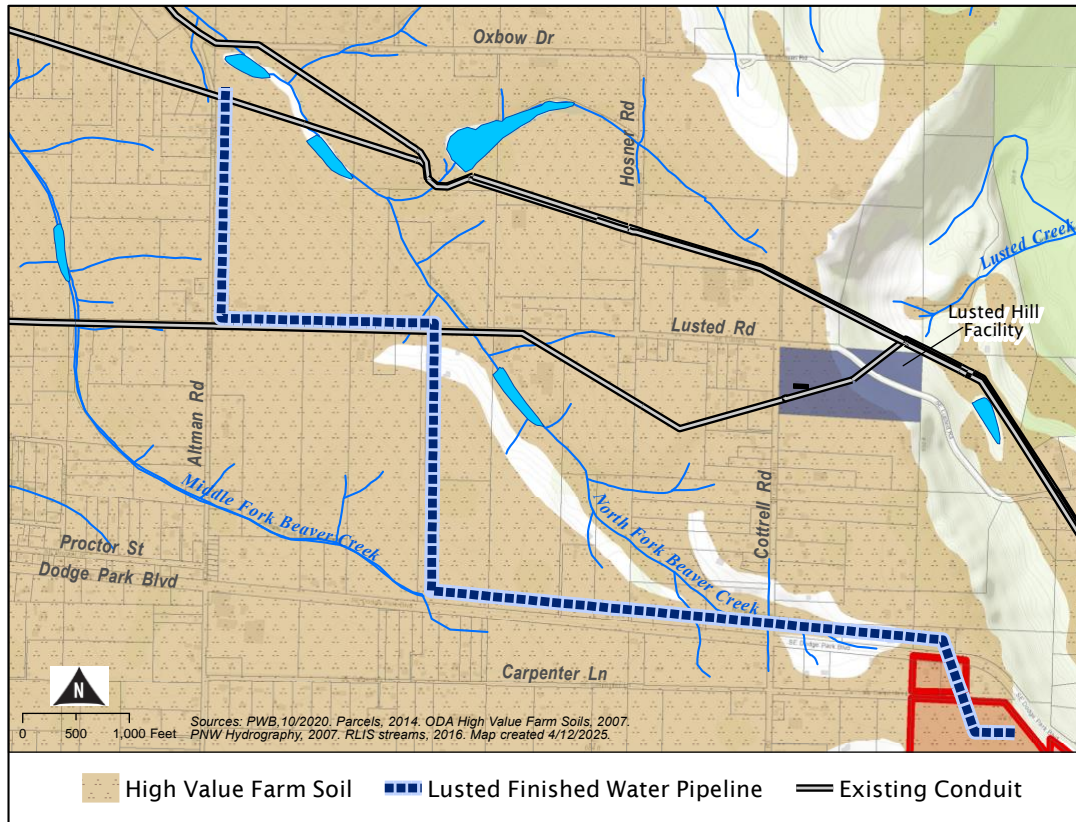
The filtration site is located less than a quarter mile from the north fork of Beaver Creek and approximately 1 mile from the middle fork of Beaver Creek. The finished pipeline route crosses existing farmland, crosses the middle fork of Beaver Creek, and also impacts the north fork of Beaver Creek (Figure 8). Beaver Creek is a tributary of the Sandy River (Figure 9), a federally designated Wild and Scenic River. Site preparations for the finished pipeline have included tree removal, soil movement and excavation, and grading. It is unknown to what extent PWB has implemented culverts or drainage control systems to direct overland flow and erosion. Figure 10 provides evidence that current systems are inadequate and inefficient. Therefore, overland flow is leaving the site, east flowing and downhill on SE Lusted Road, subsequently entering the north fork of Beaver Creek. Uncontrolled runoff is thereby adding increased sedimentation into Beaver Creek.

Figure 8. Finished pipeline route (*blue hashed line*) crosses existing high value farmland from SE Dodge Park Blvd northerly to SE Lusted Road. Pipeline route impacts both the middle fork and north fork of Beaver Creek.

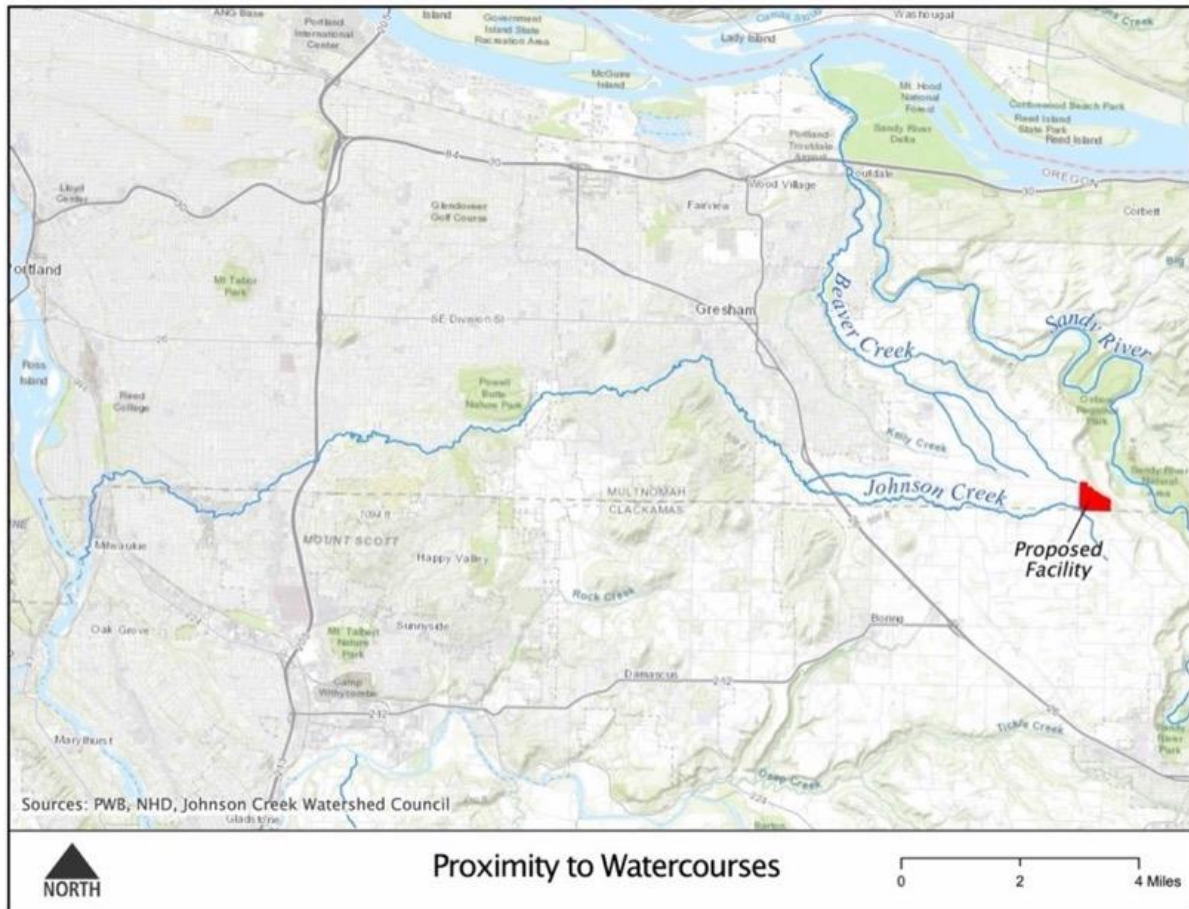
Figure 9. Proposed filtration facility location in relation to the nearby waterways of Beaver Creek, Johnson Creek, and the Sandy River.

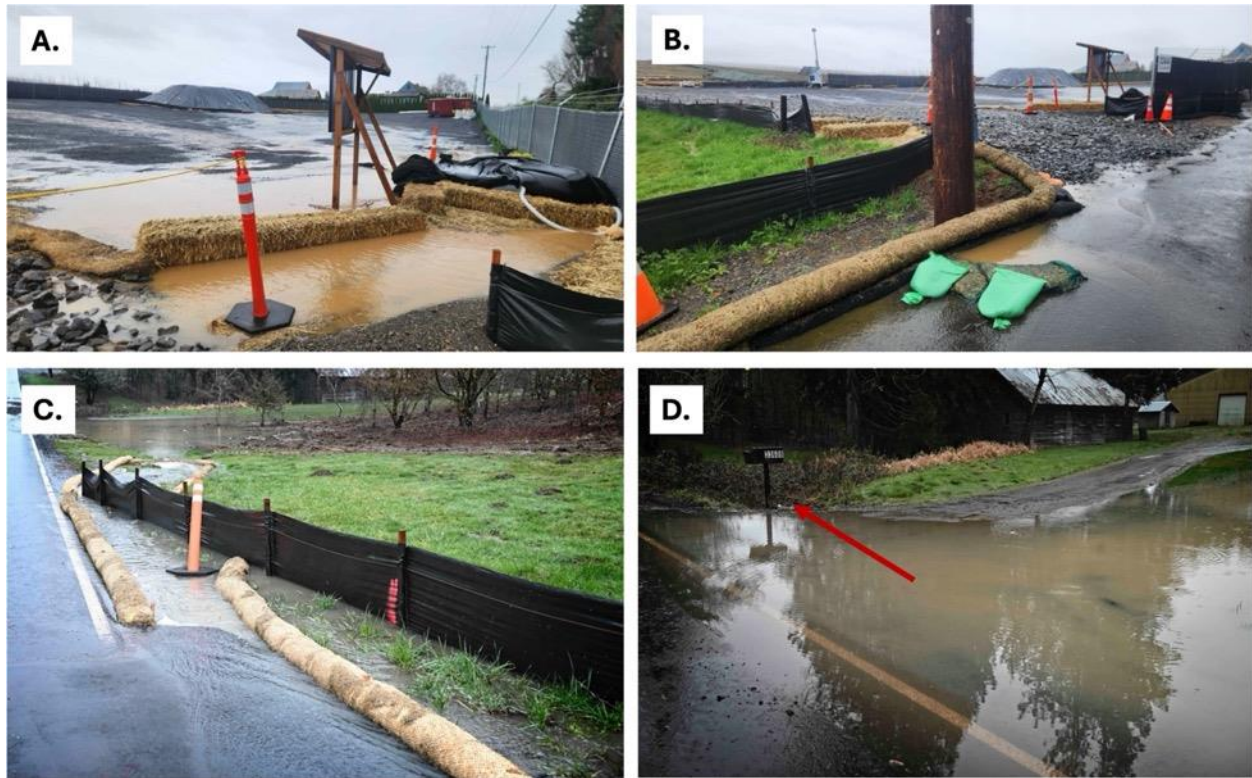
Figure 10. Area's lack of stormwater drainage infrastructure results in poorly controlled overland runoff and drainage negatively impacting residences and farms on SE Lusted Rd and the north fork of Beaver Creek (*photo credit: Guy Meacham*)². (A) Muddy runoff with ineffective storm water control (i.e., hay bales) at the construction staging for the finished water pipe route at 33444 SE Lusted Rd; (B) Runoff draining and directed from staging area, headed east and downhill toward Beaver Creek; (C) Runoff directed into residence (33608 SE Lusted Rd) adjacent to Beaver Creek, and downhill from staging area; and, (D) Runoff entering north fork Beaver Creek (*red arrow*) from residence at 33608 SE Lusted Rd.

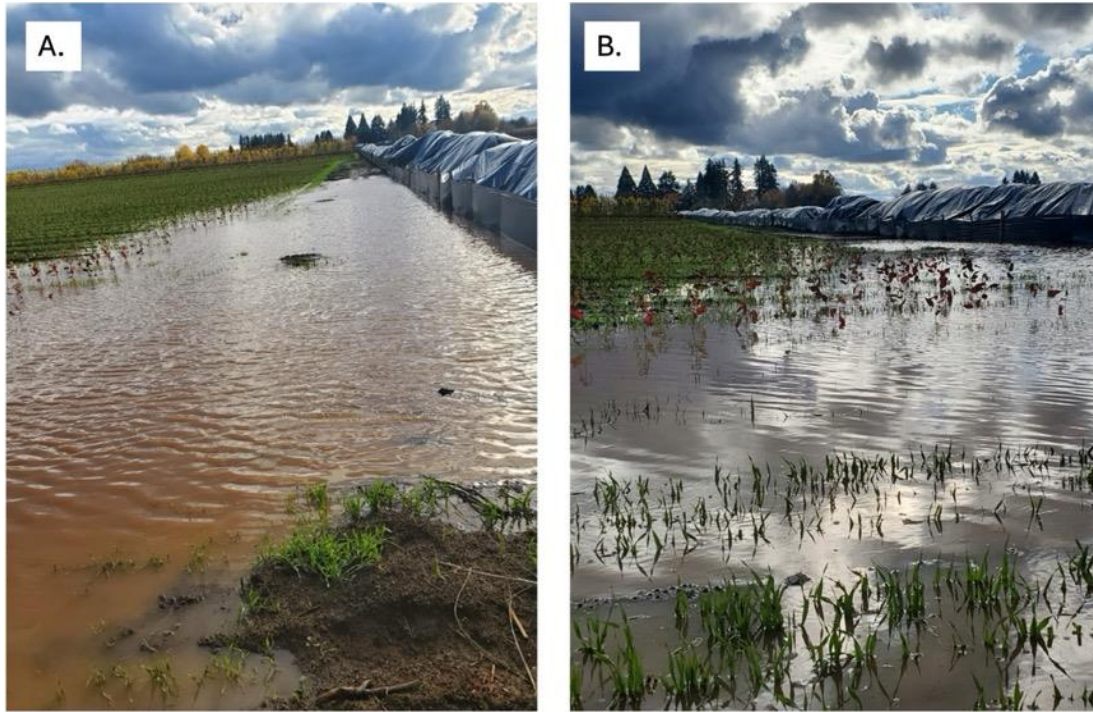
Figure 11. Significant negative impacts of altered landscape and erosion control measures on agricultural resources and existing farmland in fall of 2024 (*photo credit: Surface Nursery*). The location captured in the photos are along the finished pipeline route between SE Dodge Park Blvd and SE Lusted Road. (A) Excessive flooding of Surface Nursery property following fall rain events causing inaccessibility for farm operators; and (B) Flooded field of newly planted nursery stock saplings.

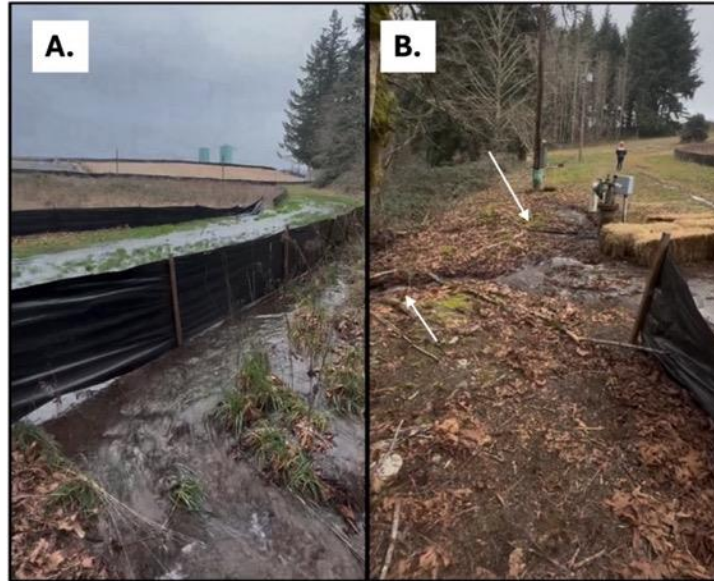
In the winter of 2025, residents observed a substantial volume of water being discharged into Johnson Creek following several days of dry weather (Figure 12). Upon inquiry, the onsite foreman for Kiewit, Mr. Goldschmidt, explained that groundwater was being pumped from the construction site into the creek at a rate of approximately 1 million gallons per day, or 3-4 cubic feet per second (cfs) over a typical 11-hour workday. This operation was occurring daily and was expected to continue as long as groundwater infiltrated excavated sections of the construction site. In short, PWB is using Johnson Creek like a canal instead of respecting it as a natural waterway. It should be noted that this section of Johnson Creek is designated by the County as an area of Significant Environmental Concern.

The headwaters of Johnson Creek typically experience flows ranging from 1-10 cfs. Rapid fluctuations in stream flow, such as those caused by PWB's groundwater pumping activities, can have significant ecological consequences for fish, macroinvertebrates, and amphibians. These impacts stem from changes in flow dynamics, water temperature, dissolved oxygen levels, and potential shifts in water chemistry. Unfortunately, PWB and its contractors appeared to be unaware of these effects. When neighbors raised concerns with foreman Goldschmidt, he

Figure 12. Overland flow of groundwater pumped from the filtration construction site and directed into Johnson Creek. (*Photo credit: Jennifer Hart; January 30, 2025*). (A) Approximately 1,600 gallons per minute, or 3-4 cfs, is being pumped into Johnson Creek on workdays (6 days per week), 10-11 hours per day, suddenly increasing and decreasing stream flow on a regular basis. (B) Excessive discharge of significant volumes of water creates channelization and sediment transport into Johnson Creek (*see white arrows*) negatively impacting the riparian habitat and the naturally occurring water quality conditions of the creek.

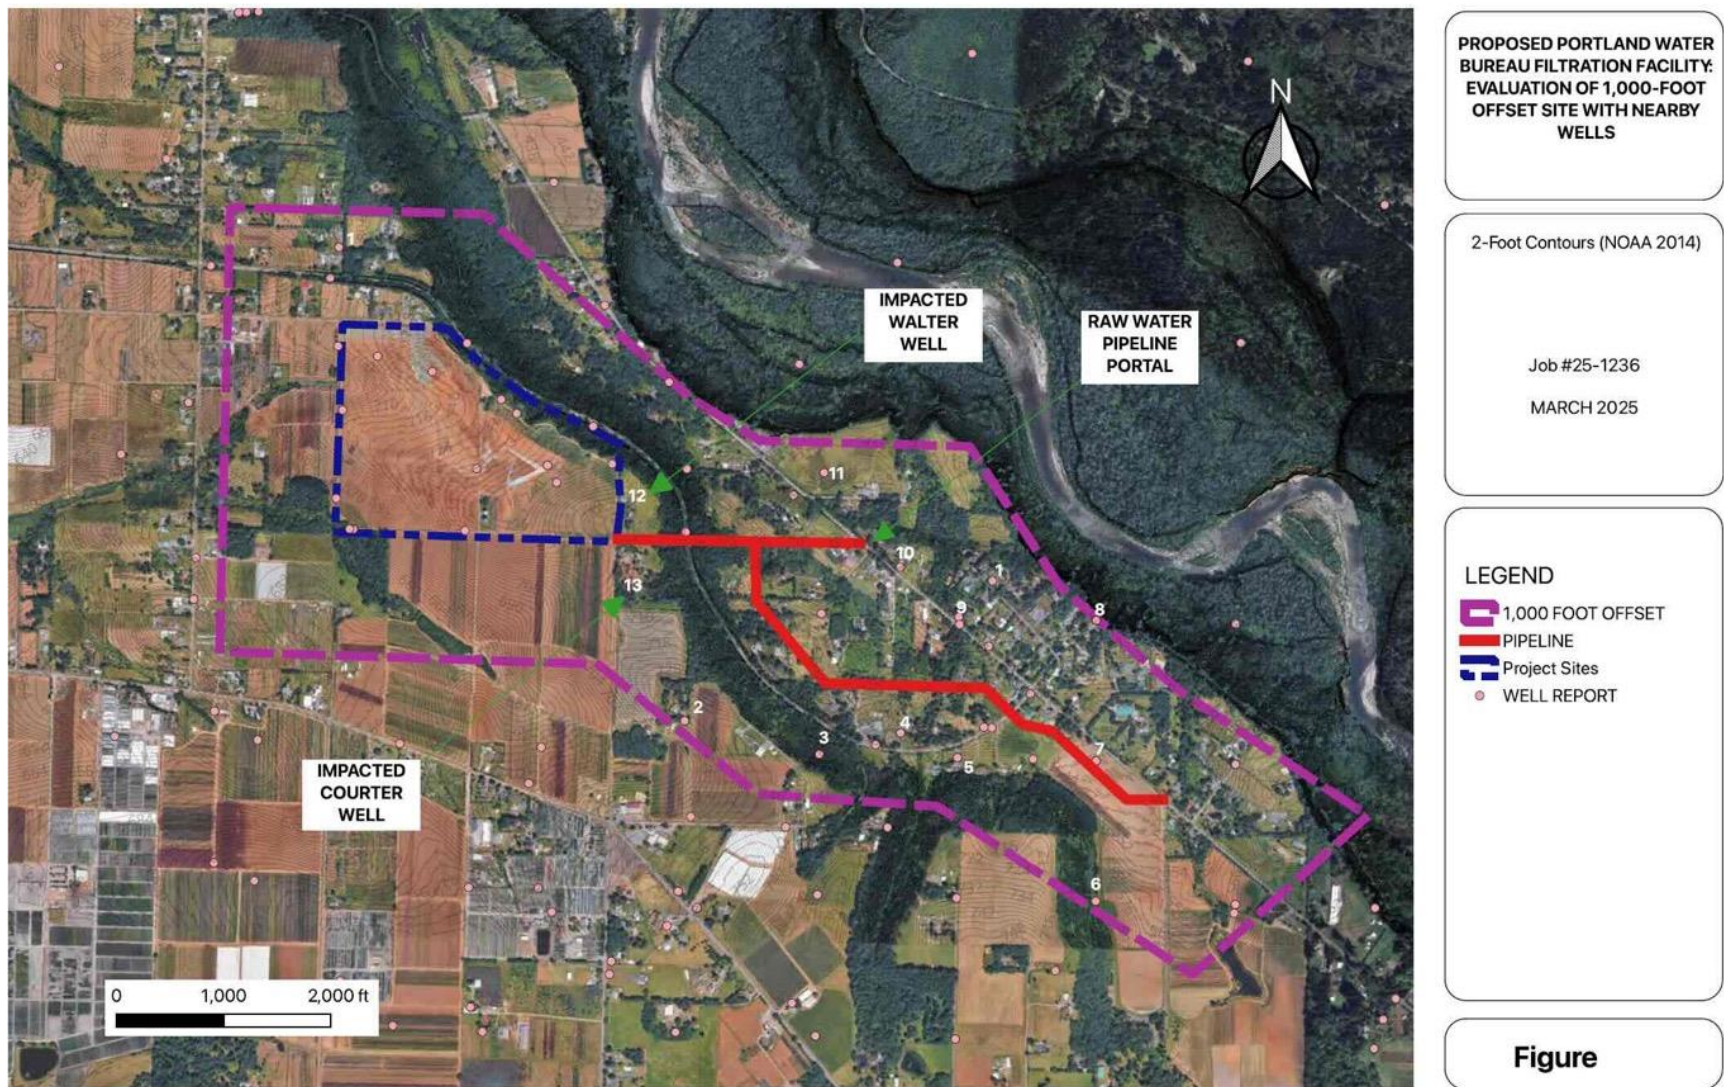
Figure 13. Map of domestic wells proximate to the proposed facility.

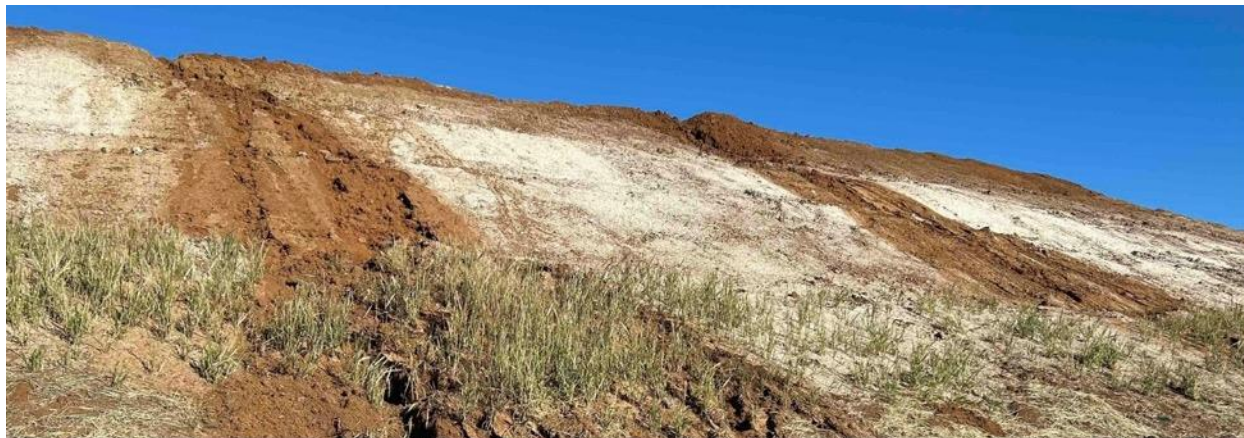
Given the soil type, there is a high potential for erosion. During construction, there have been multiple observations of channelization and erosion proximal to Johnson Creek. Erosion has also been observed on the mound of the ~600,000 CY of excavated soil at the southeastern portion of the property (Figure 12), which is likely attributed to the high volume of excavated loess and Cazadero silty clay loam concentrated in one location.

Figure 14. Example of erosion occurring at PWB's construction site.

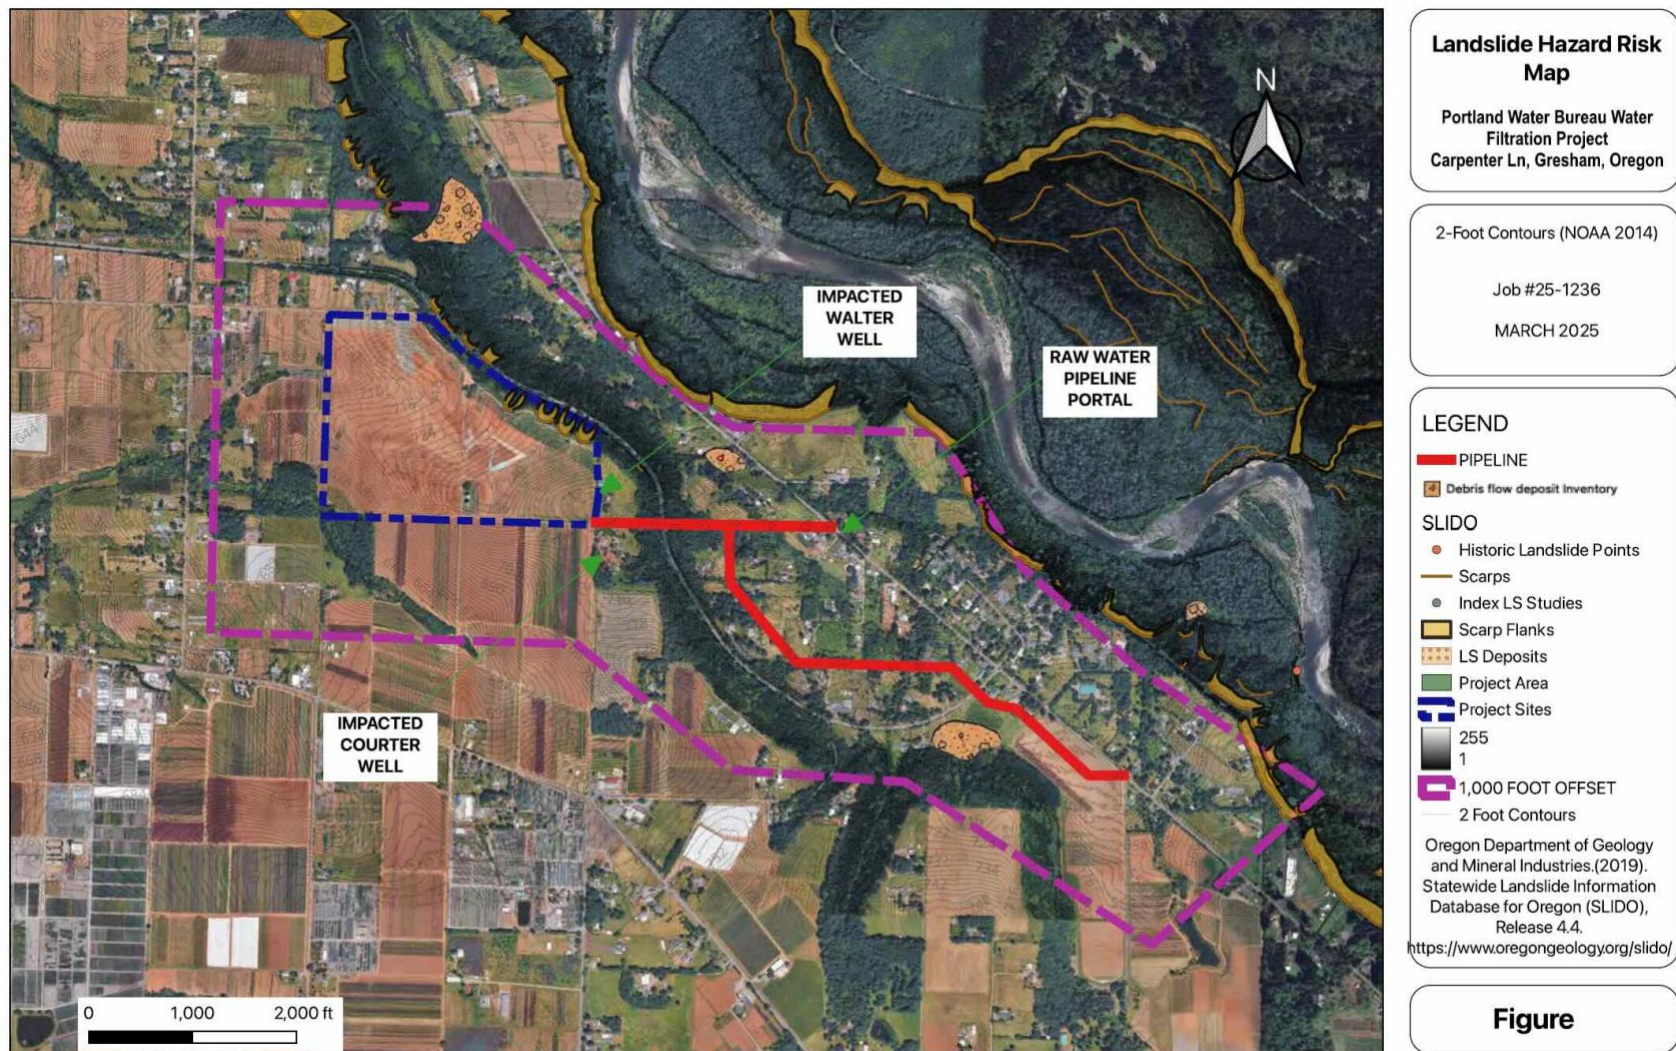
Sandy River—either historically or during high-flow events—can remove support at the base of the slope, leading to retrogressive failure. The risk is further elevated under seismic loading, particularly from the Cascadia Subduction Zone, which could rapidly reduce slope stability.

To our knowledge, PWB has not conducted a detailed slope stability analysis, including field borings, shear strength testing, and groundwater monitoring. Long-term stormwater management is also a concern, as uncontrolled surface water may exacerbate instability or initiate shallow slides.

Figure 15. Map of proposed facility and local geologic features, including historic landslides.

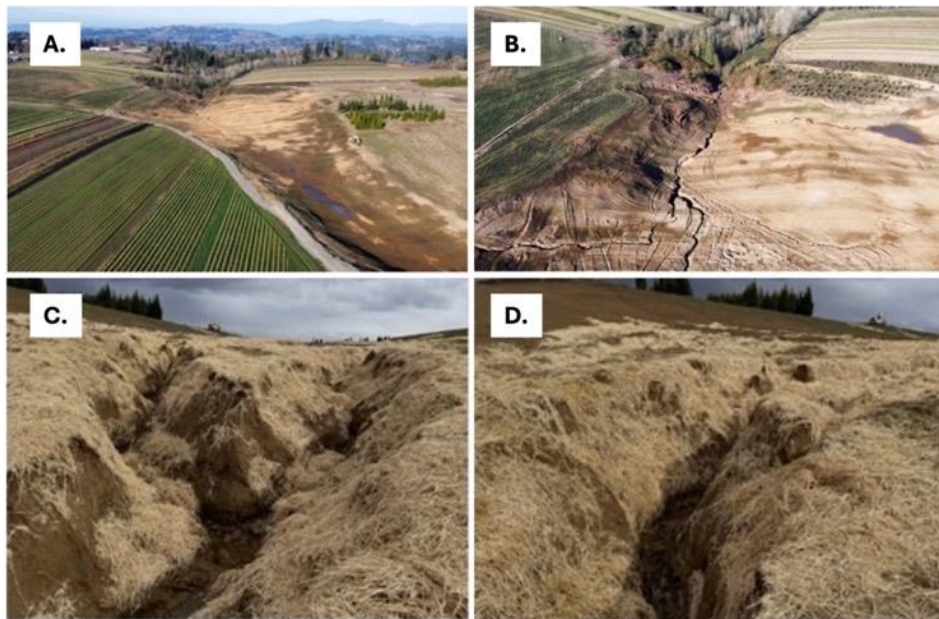
Figure 16. Photos taken in November 2022 at the Oxbow property documenting erosion at the site and mobilizing directly into the Wild and Scenic Sandy River. (A, B) Extensive erosion and channelization; (C, D) Bare loose soils surrounding extreme channel incision that is 4 feet deep and 3 feet wide⁶.

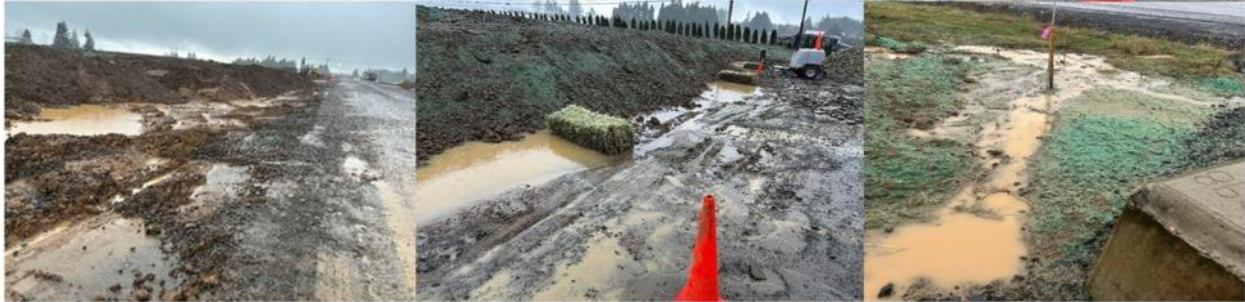
Figure 17. Photos taken by DEQ on 12/27/24 at the Gramor property on SE Highway 212 documenting uncontrolled runoff from contaminated soils deposited at the site.

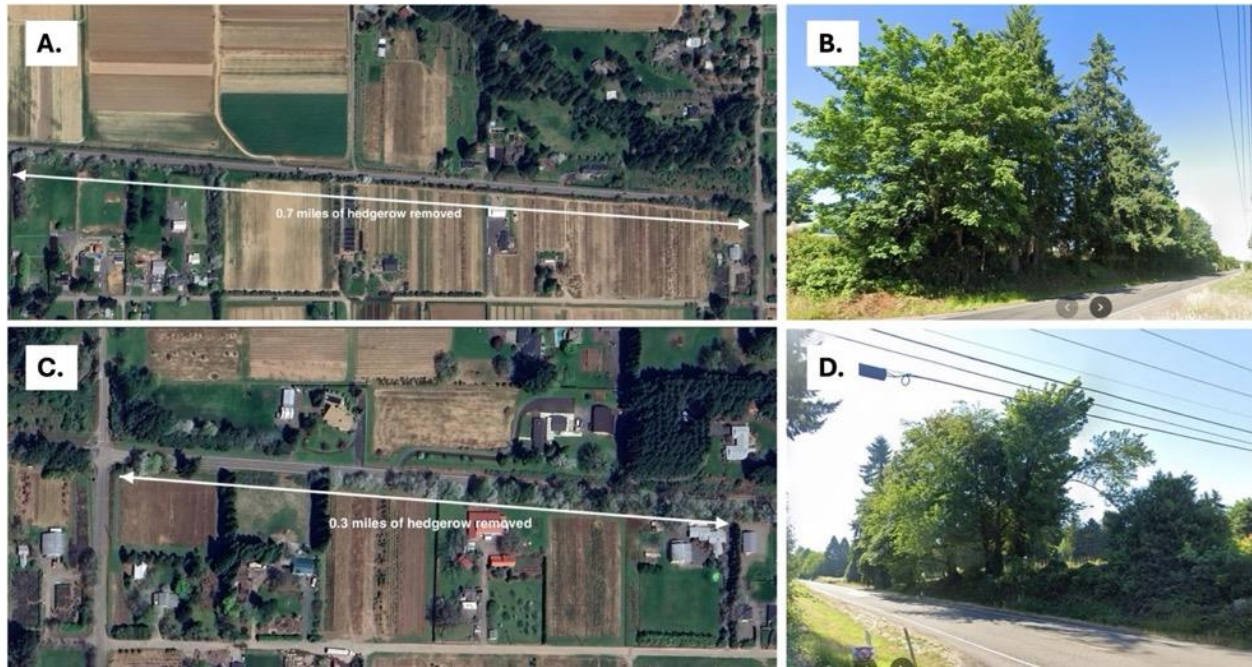
Approximately 0.7 contiguous miles along SE Dodge Park Blvd west of SE Cottrell Rd and 0.3 miles of SE Dodge Park Blvd east of SE Cottrell Rd was fully cleared (Figure 22, Figure 25), and that ecosystem no longer exists. Nearby on SE Carpenter Lane – the entering roadway to the filtration site – the mature trees and shrubbery along the roadside was also cleared (Figure 26).

Figure 22. Before tree removal along SE Dodge Park Blvd (*GoogleEarth, accessed April 10, 2025*). Hedgerow was a mix of mature deciduous and coniferous/evergreen trees and shrubbery. (A) Approximately 0.7 miles of continuous hedgerow existed to the west of SE Cottrell Rd (*imagery from April 2023*); (B) Corner of SE Cottrell Rd and SE Dodge Park Blvd and looking at hedgerow looking west along SE Dodge Park Blvd (*imagery from June 2023*); (C) Approximately 0.3 miles of hedgerow was present east of SE Cottrell Rd. (*imagery from April 2023*); (D) Corner of SE Cottrell Rd and SE Dodge Park Blvd and looking at hedgerow looking east along SE Dodge Park Blvd (*imagery from June 2023*).

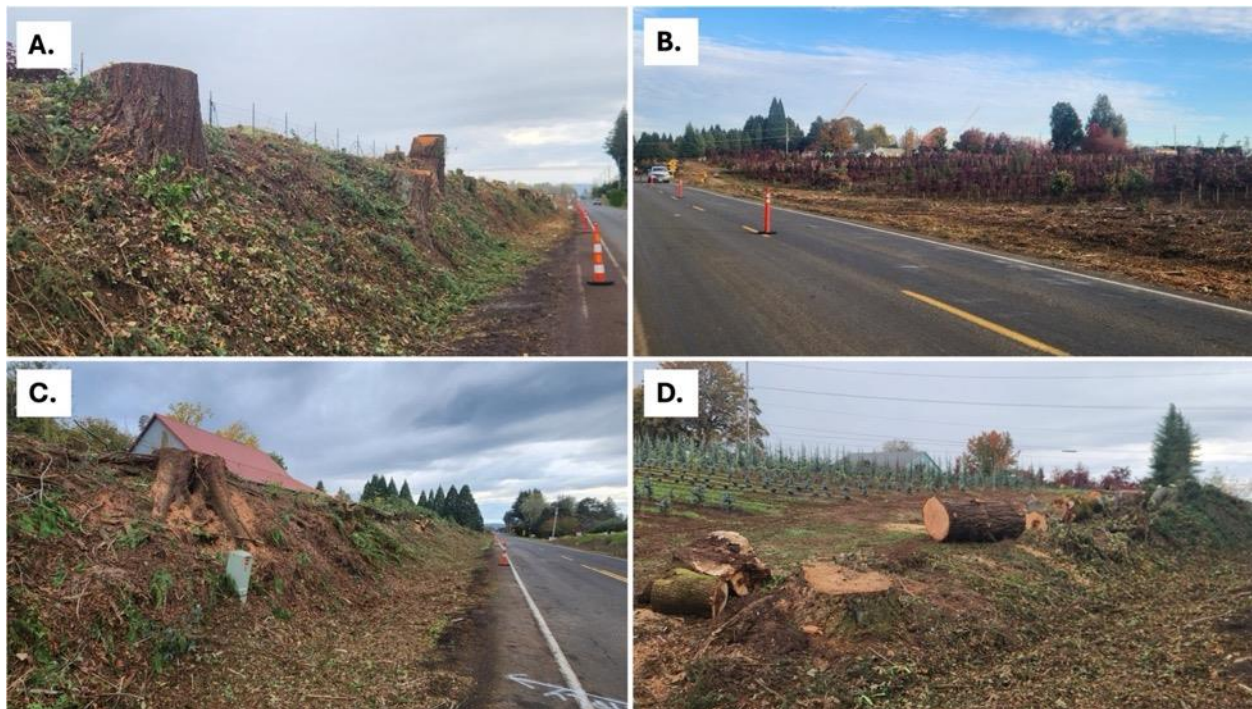
Figure 25. Following hedgerow tree and habitat removal on SE Dodge Park Blvd, October 2024 (*photo credit: Guy Meacham*). Between 320-400 trees ($> \frac{1}{2}$ foot in diameter) and countless shrubs were removed across one contiguous mile. (A) Stumps of old conifers (Douglas fir, multiple aged at ~80 years old) at the corner of SE Cottrell Rd and SE Dodge Park Blvd, looking west; (B) Cleared portion of SE Dodge Park Blvd where hedgerow existed, looking east to SE Cottrell Rd; (C) Stump of old red cedar (~100 years old, foreground) and stumps of big leaf maple, cherry, and Douglas fir trees, looking west toward SE Cottrell Rd; (D) Stumps of Douglas fir, including one that was aged at 80+ years old, near the intersection of SE Cottrell Rd and SE Dodge Park Blvd looking west.

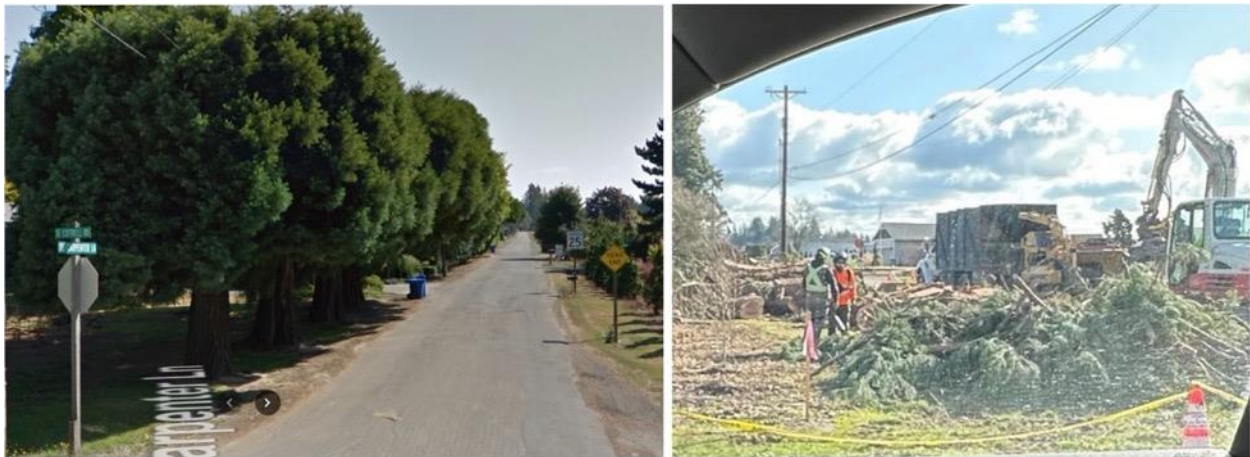
Figure 26. Row of four mature, 60+ year old red cedars (left) on SE Carpenter Lane near hedgerow on SE Dodge Park Blvd that were harvested in fall of 2024. All trees and shrubbery along SE Carpenter has been cleared (right) to double the width of the lane to accommodate filtration project traffic.

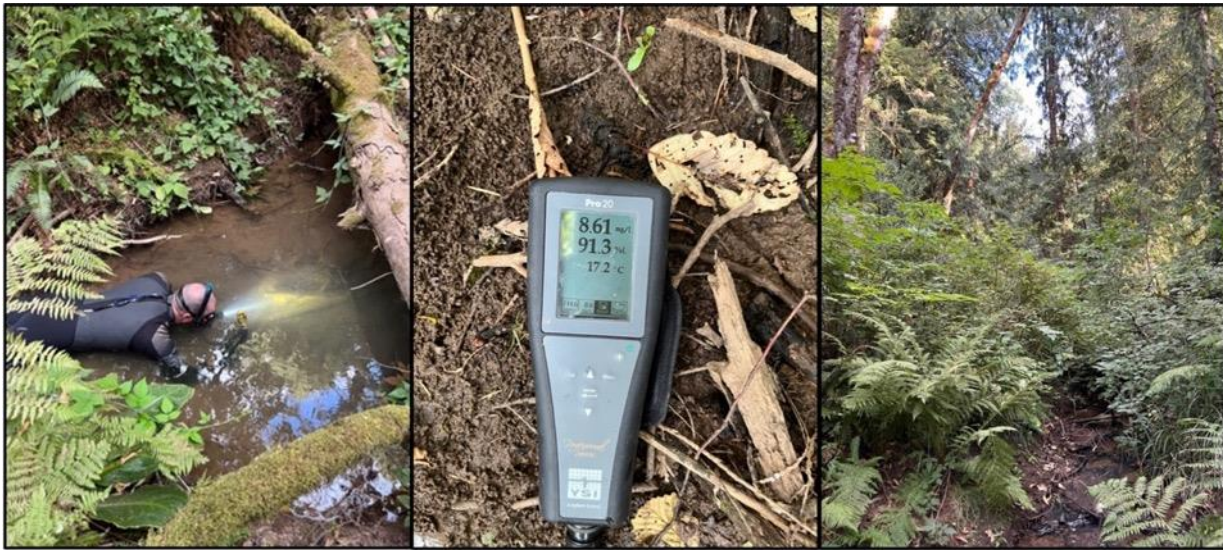
Figure 28. Pictures from a stream survey conducted on August 22, 2023 in Johnson Creek directly adjacent to PWB's proposed development site at Carpenter Lane. (left) Snorkel survey to confirm fish presence (center). Water quality measurements indicating suitable dissolved oxygen (>8 mg/L) and summer temperature (<18 °C) conditions for native cold-water fish species. Measurements taken at 17:00 PDT when stream temperature was at its daily peak. (right) Dense riparian vegetation surrounding the creek.
