Adverse Effects of Portland Water Bureau's Proposed Water Treatment Plant on Natural Resources

Failure to Satisfy Conditional Use Criteria MCC 39.7515(B)

April 15, 2025

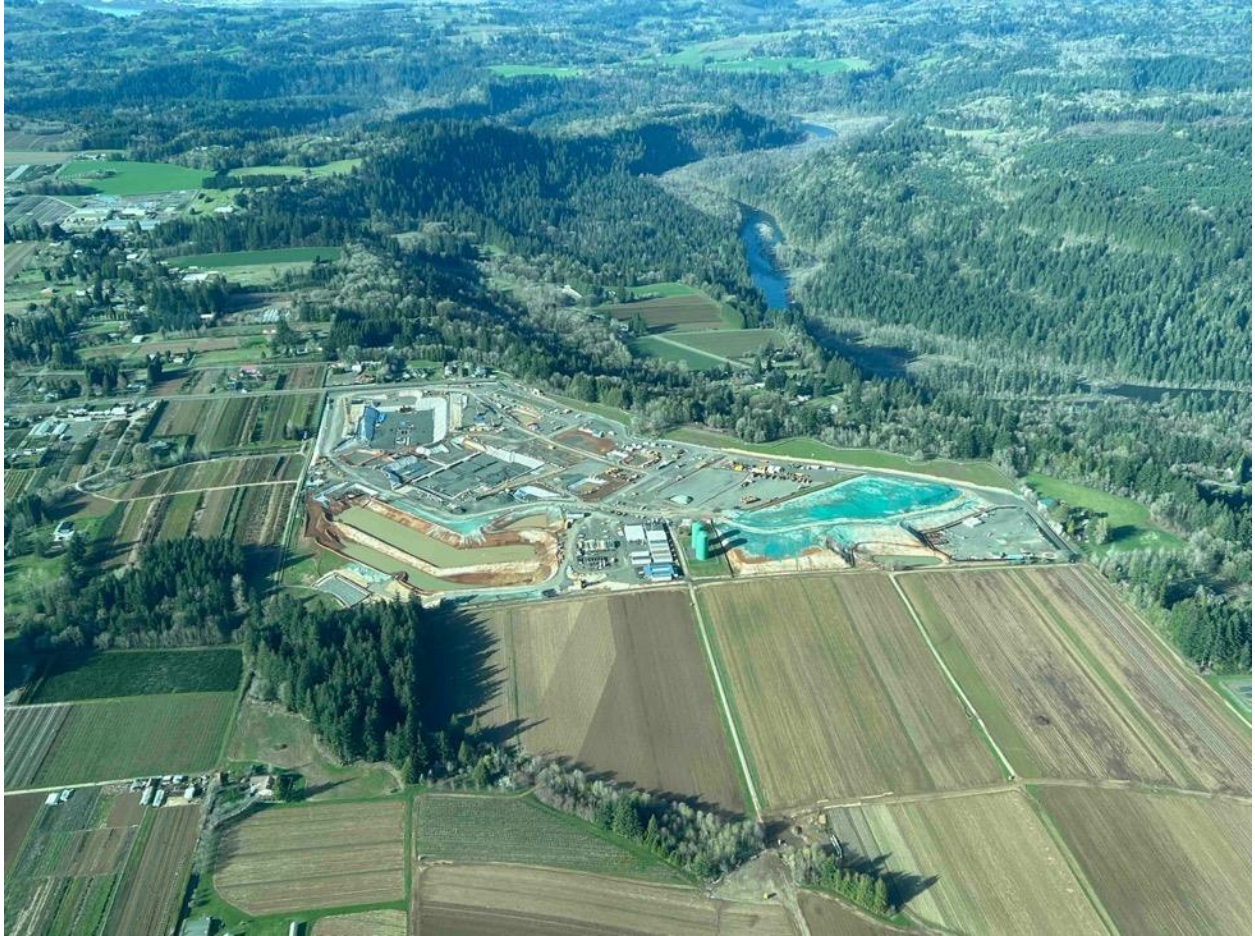
Figure 30. Aerial picture of the water treatment plant showing its contrast to the surrounding environment. There are no facilities as large or remotely similar to Portland's proposed treatment plant anywhere within a 5-mile radius. All the industrial buildings in the region are agricultural businesses. PWB often cites to the existence of their Lusted Hill facility as a comparable site about 1-mile north of the proposed development area, but the Lusted Hill facility is tiny by comparison, barely visible from the air and hidden in the trees.

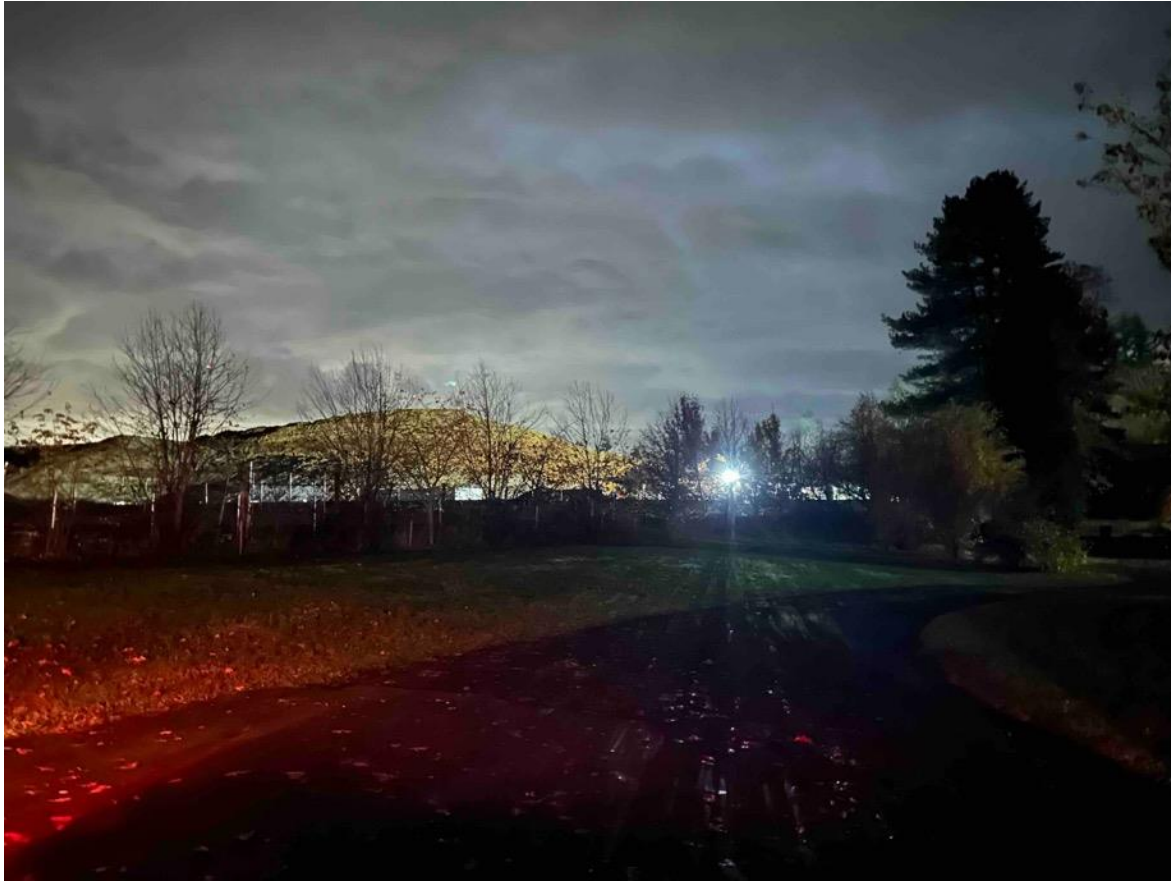
Figure 32. This photo, taken from a property adjacent to the water treatment plant construction site, illustrates light intrusion and its impact on night-sky conditions. 24-hour lighting at the completed facility is expected to be of similar intensity.
