3.3 Landslide

3.3.1 Landslide Impacts, Location and Extent

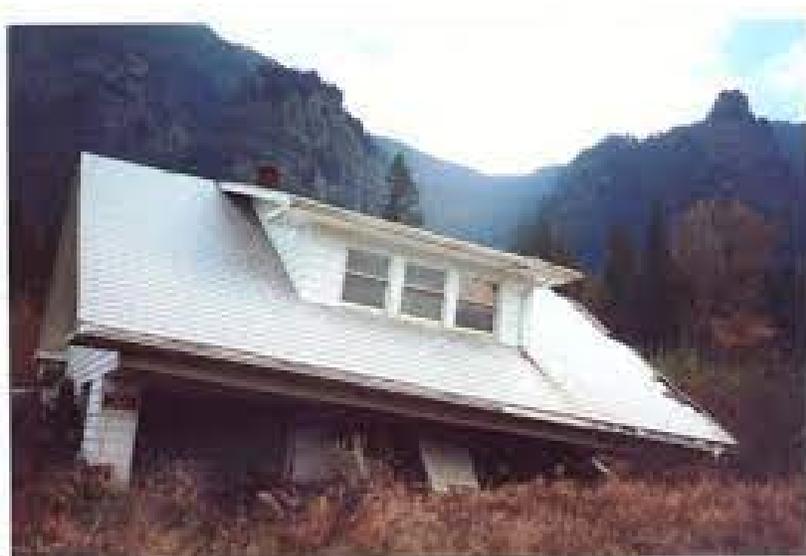
Figure 62 - A home in Dodson, in eastern unincorporated Multnomah County, damaged by landslide in 1996. The house later burned down during the 2017 Eagle Creek Fire.

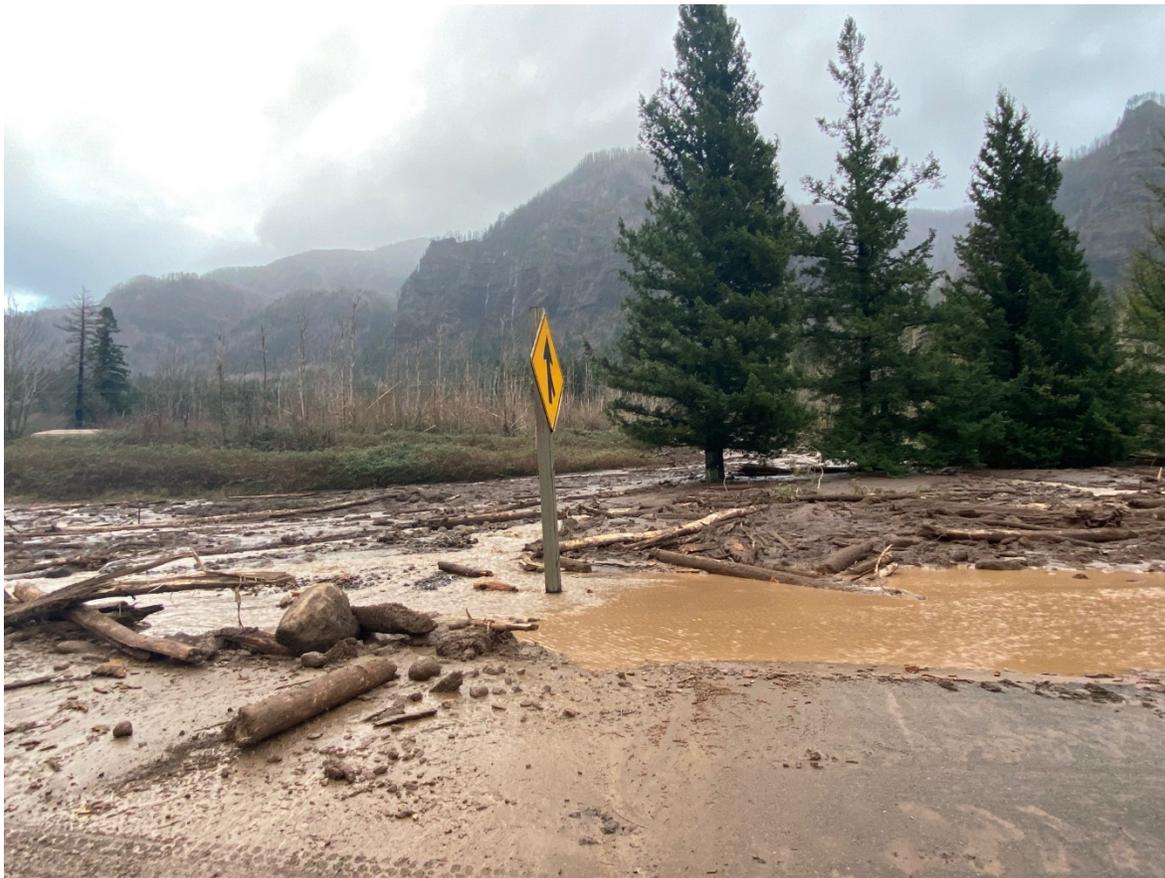
Figure 64 – Aftermath of the 2021 Dodson landslide. Photo Multnomah County Sheriff's Office

Minor landslides were a common event during extremely rainy periods over the last five years, causing brief interruptions to transit routes. However, a major landslide occurred near the unincorporated Multnomah County community of Dodson on January 13, 2021, killing one person.

This tragedy occurred when a car was swept from the Interstate Highway 84 Frontage Road during the night of a heavy rain event. This stretch of highway runs through extremely steep portions of the Columbia River Gorge that had seen extreme landslides in the 1996 flood season and have a long geological record of slides. The slopes above the site also contained burned over areas from the 2017 Eagle Creek Fire, further increasing the probability and potential severity of a land movement event.

This event was a 15-foot high flow of mud, rocks and logs. After the slide, Dodson was evacuated for three days until it was determined by geologists that there was no imminent risk of another debris flow event. No homes were damaged by this event.

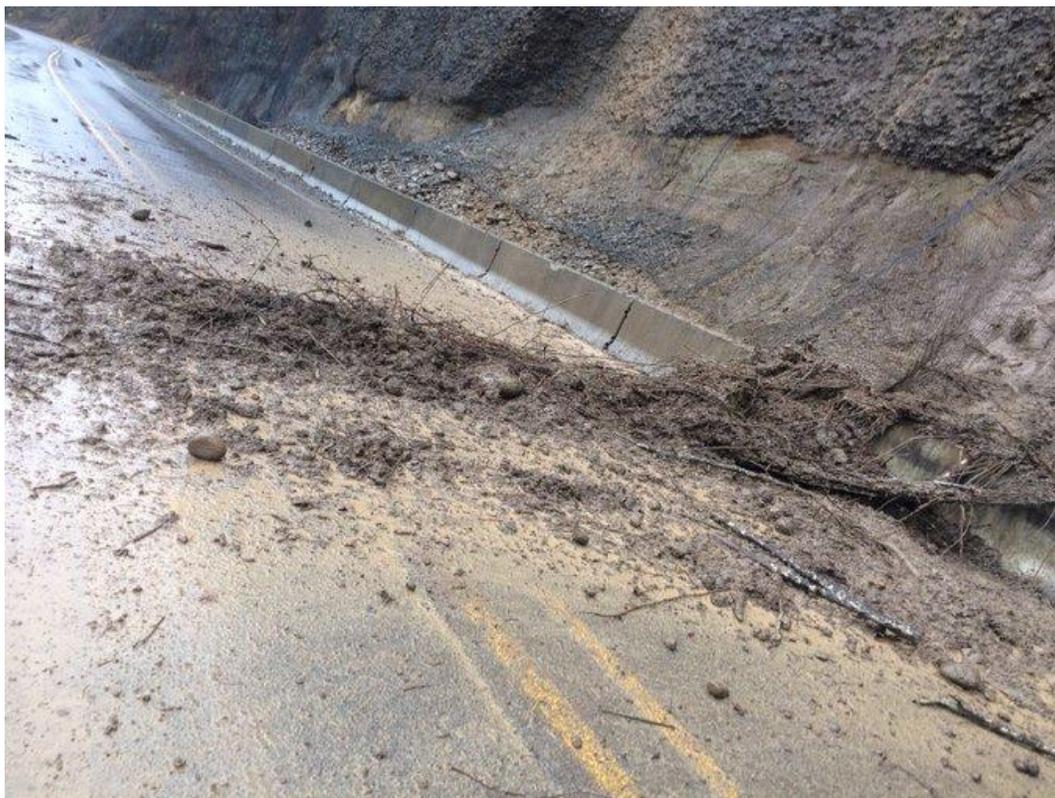
Figure 65 - Minor 2017 winter landslide on the East Historic Columbia River Highway. Photo Multnomah County Sheriff's Office

The effects of smaller slides were primarily to city or county roads in areas with identified steep slopes. These smaller slides also coincided with periods of high rain.

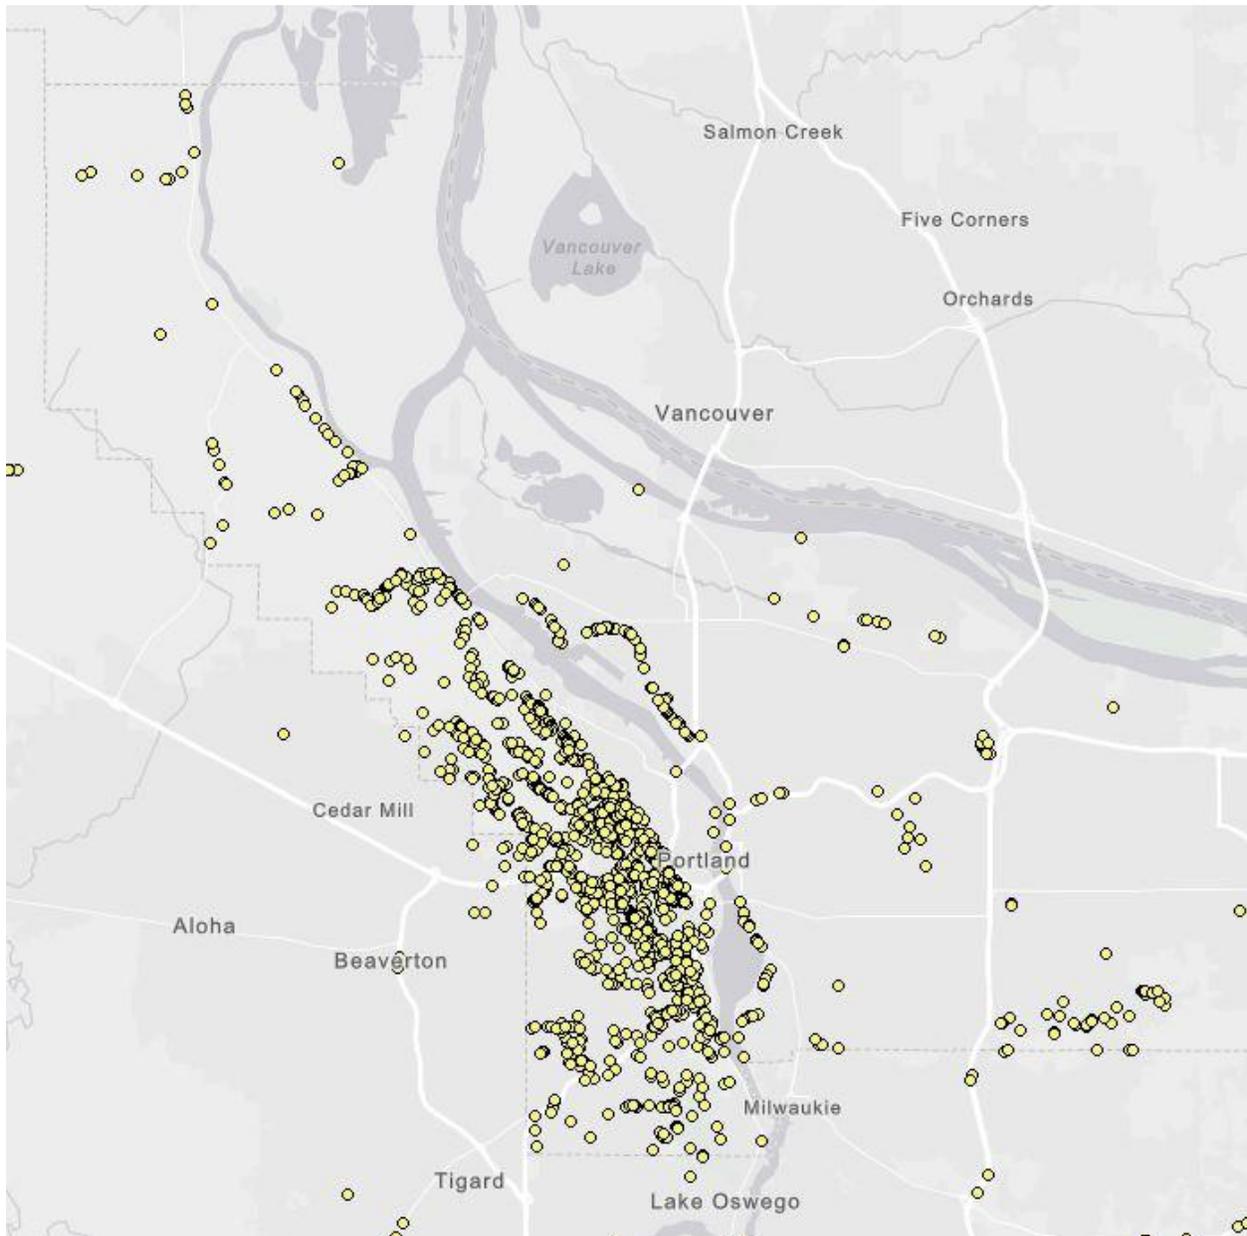
Figure 66 - Map showing locations of landslides over the last 150 years in Western and Central Multnomah County. Map from DOGAMI SLIDO site.

The historical points shown below are records from a 150-year period and are primarily shallow landslide events.

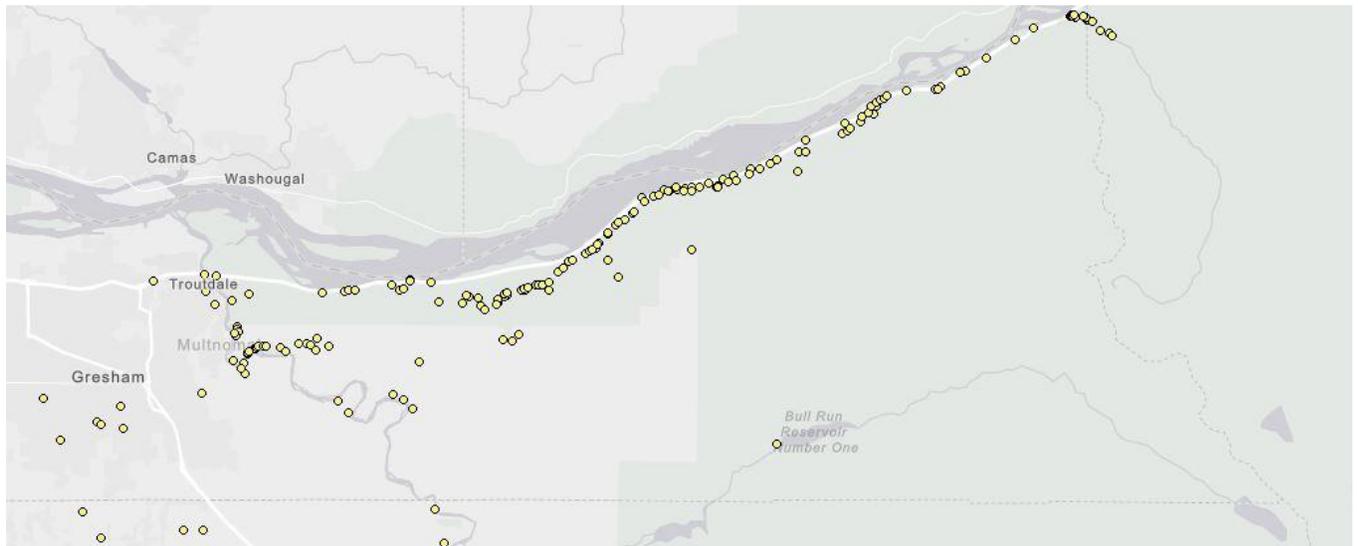
Figure 67 - Map showing locations of landslides over the last 150 years in Eastern Multnomah County. Map from DOGAMI SLIDO site.

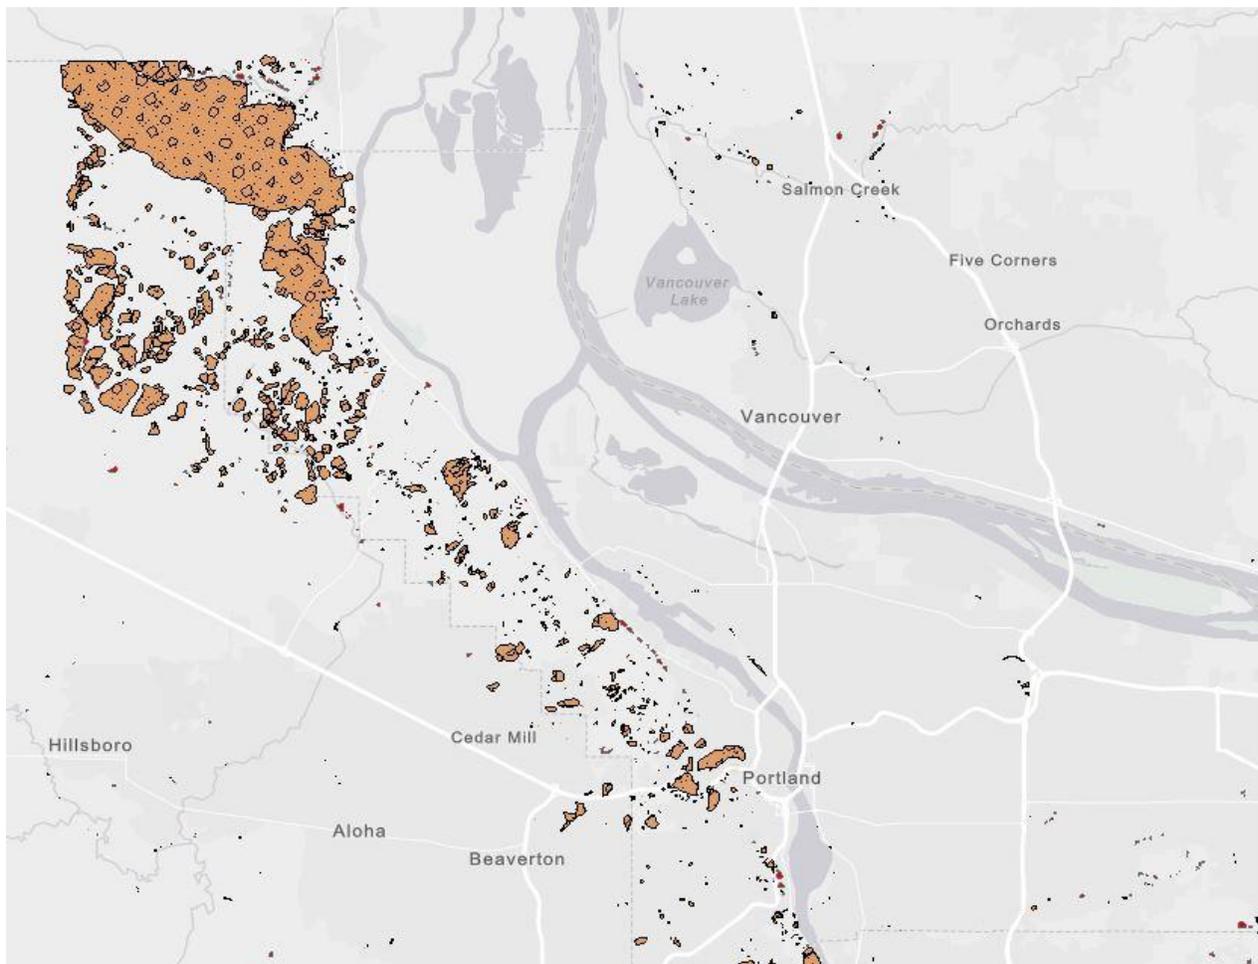
Figure 68 - Map showing locations of historic deep landslide deposits in Western and Central Multnomah County.
DOGAMI SLIDO Map

Through the use of LIDAR, geologists can also see evidence in ground formations where deep landslides have previously occurred, even from thousands of years ago. Areas shown to have deep landslide deposits from past slides are the areas at the highest risk of future deep landslides. The largest areas of these landslide deposits are in the northwestern most corner of the county, the Columbia River Gorge, and steep slopes above the Sandy River.

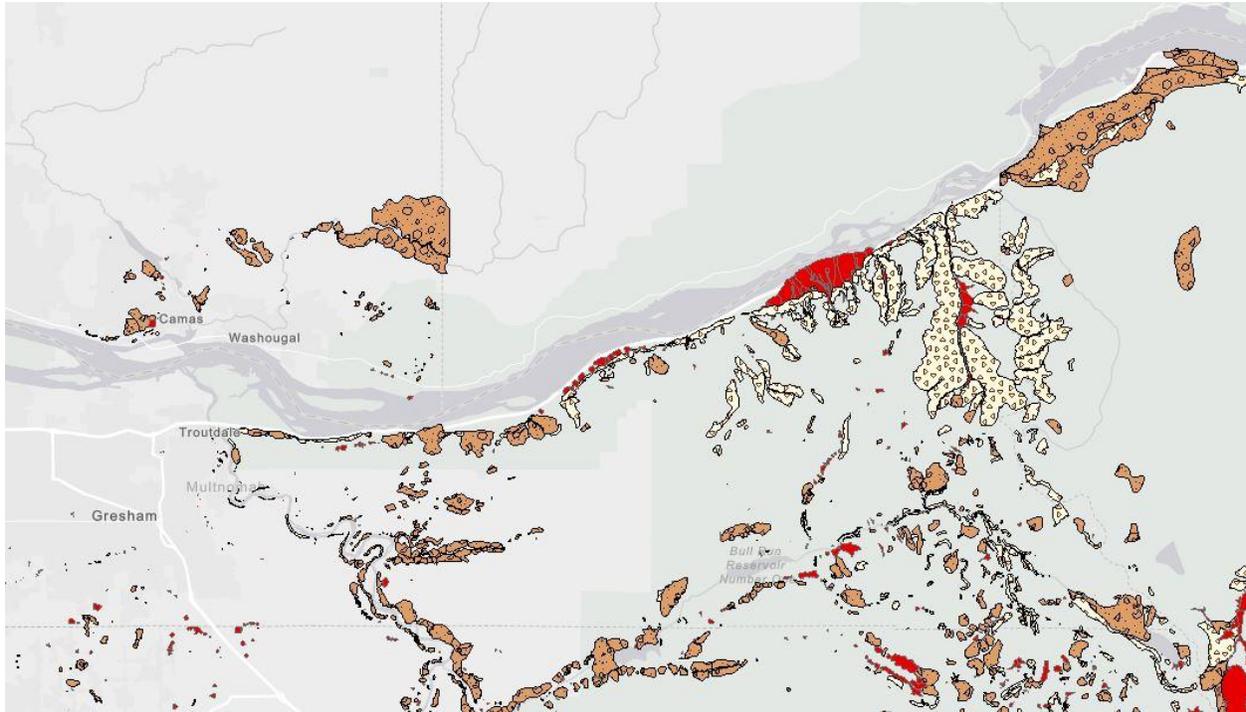
Figure 69 - Map showing historic deep landslide deposits in Eastern Multnomah County. The red areas are alluvial fans, where debris spreads out at the confluence with rivers, lakes and streams. The lightest colored areas are Talus-Colluvium deposits, which are rocky. DOGAMI SLIDO map

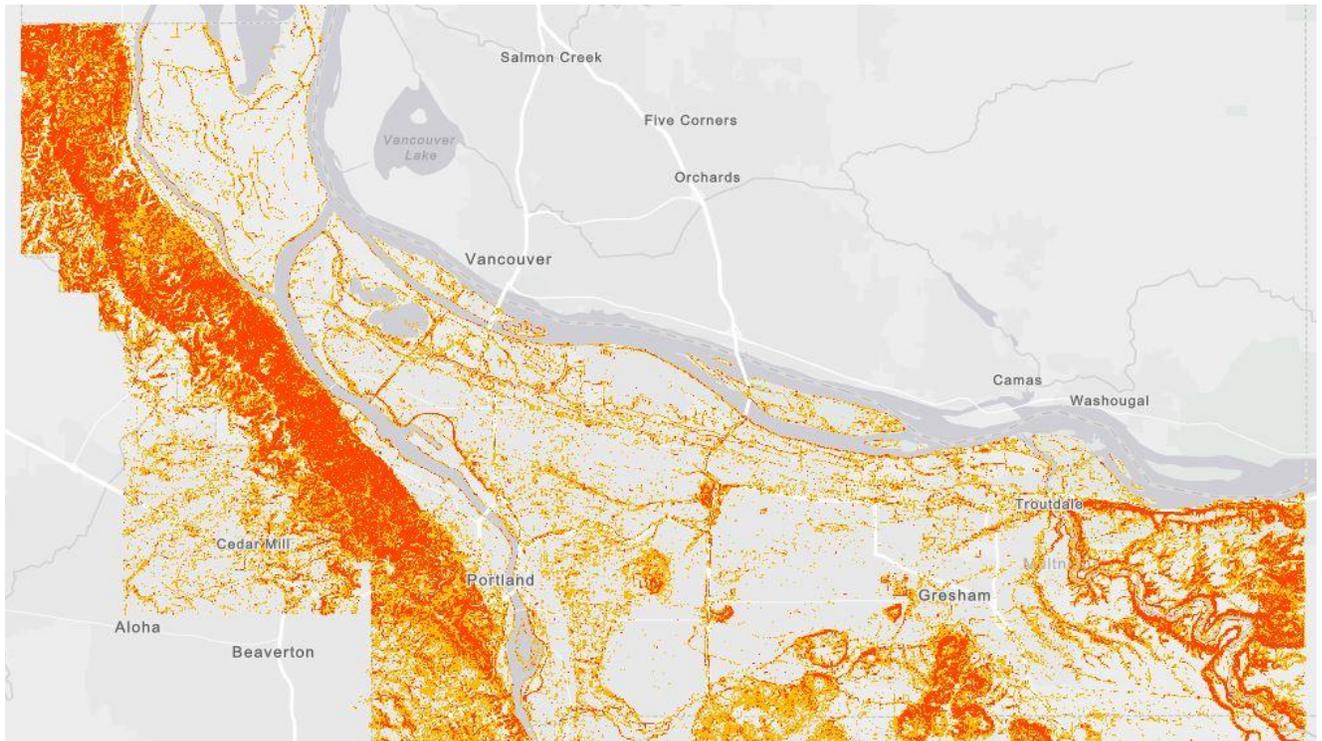
Figure 70 - Map showing location of shallow landslide risk across Western and Central Multnomah County. Dark orange indicates high susceptibility, orange is moderate susceptibility and light orange is low susceptibility. Areas with no color were determined to have no shallow landslide risk. Map DOGAMI SLIDO site.

Planning Area	Percentage of Area by Risk Zone		
	Low	Moderate	High
Airport	92%	7%	2%
Fairview	74%	20%	6%
Gresham	70%	19%	11%
Troutdale	71%	20%	9%
Wood Village	77%	18%	5%
Unincorporated Multnomah County (West/Central)	56%	22%	22%

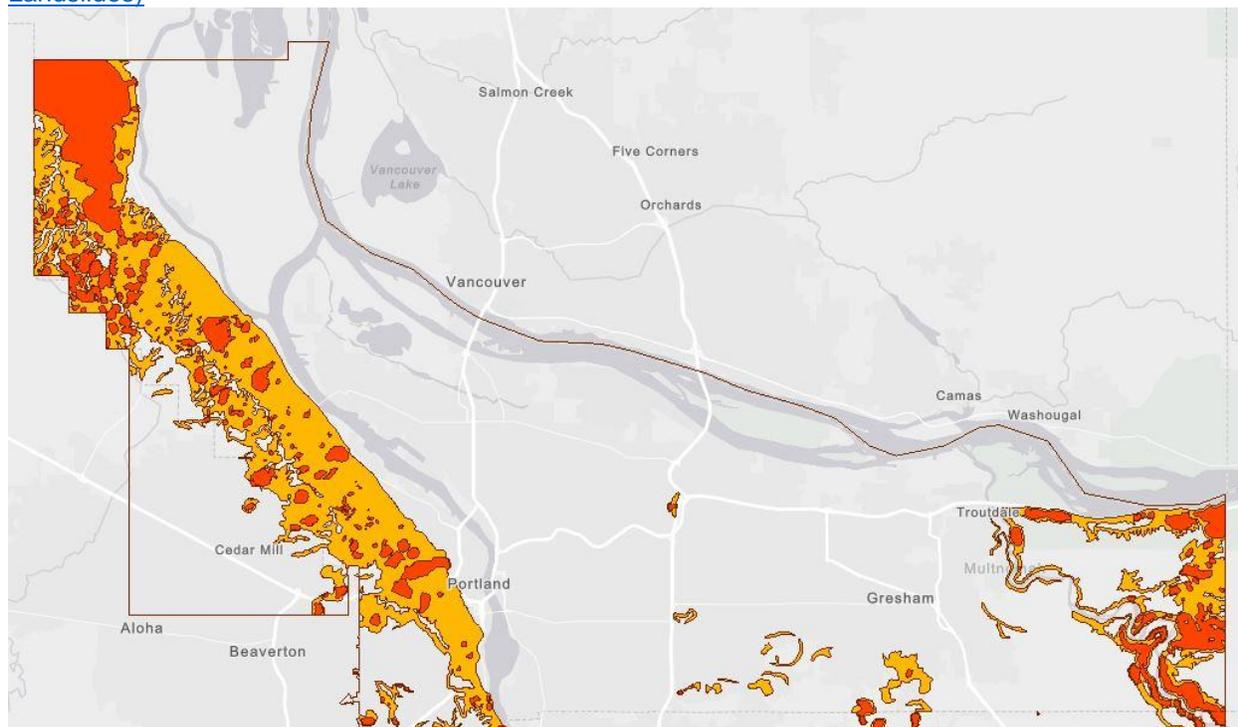
Figure 71 -- Map showing location of deep landslide risk across Western and Central Multnomah County. Red indicates high susceptibility and orange is moderate susceptibility. Areas with no color have low deep shallow landslide risk. Map DOGAMI SLIDO site.

Planning Area	Percentage by Zone		
	Low	Moderate	High
Airport	100%	0%	0%
Fairview	100%	0%	0%
Gresham	95%	4.5%	0.5%
Troutdale	96%	2.5%	1.5%
Wood Village	100%	0%	0%
Unincorporated Multnomah County (West/Central)	65%	21%	14%

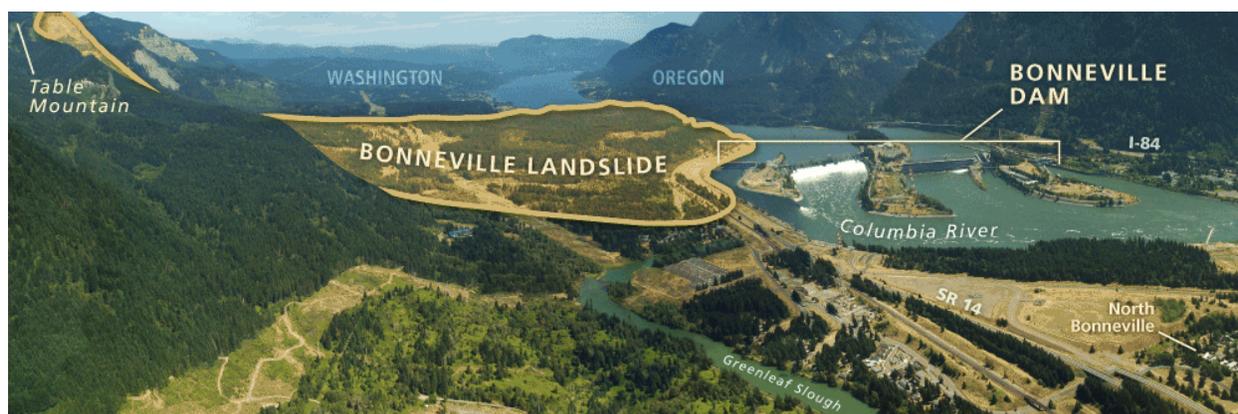
Figure 72 - Columbia River Gorge photo overlaid with an outline of the Bonneville Landslide. [Image](#) by Dan Coe, Washington Geological Survey/Washington Department of Natural Resources.

Landslides have occurred for millennia in this region and are a natural part of long-term geological processes in the region. A huge landslide occurred on the Washington side of the Columbia River Gorge over 500 years ago near where the City of Cascade Locks lies now in Hood River County. The Bonneville Dam in Eastern Multnomah County sits within the location of the slide.

The Bonneville Landslide was so large, it dammed the Columbia River, forming a temporary lake, and covered an area of six square miles with slide deposits while overlapping three other previous landslide deposits. It is unknown if deaths were caused by this slide, but it profoundly altered the landscape, creating a miles-long stretch of rapids when the river flow was naturally restored and causing the formation of sandy beaches downstream⁵⁸.

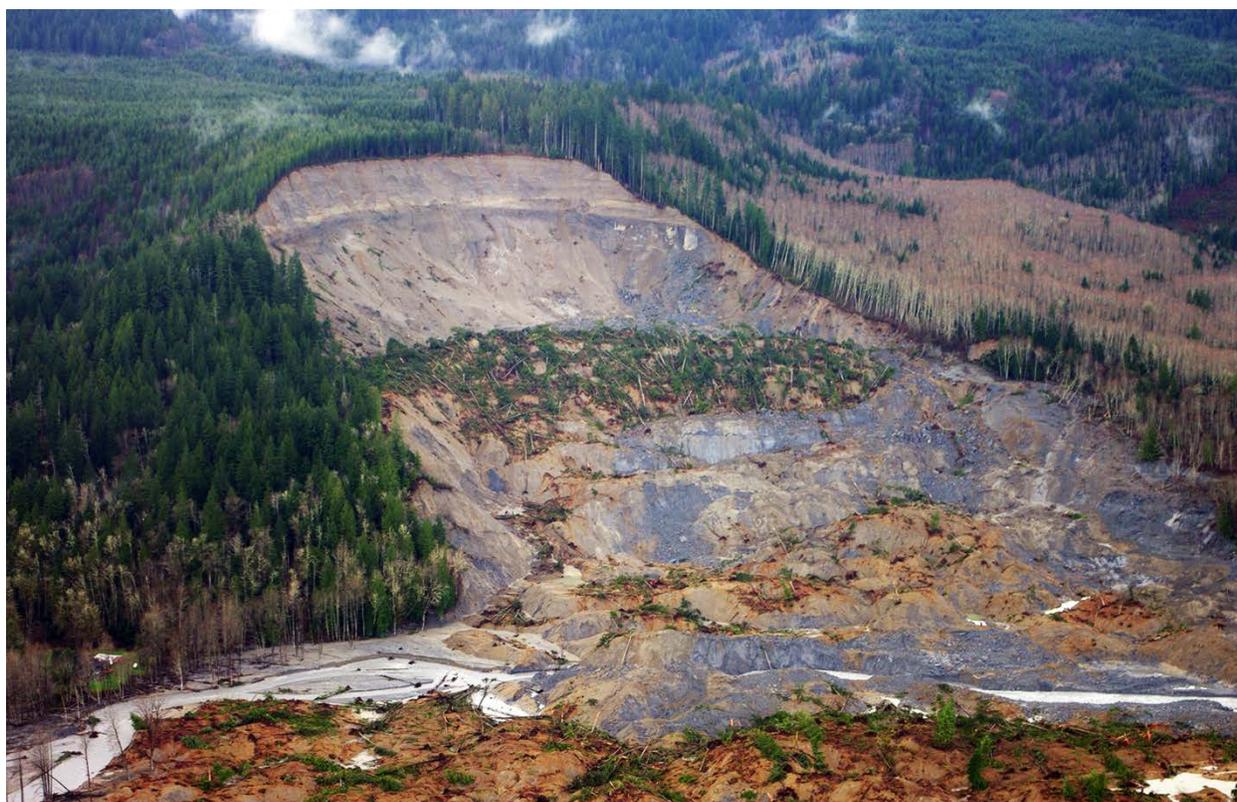
Figure 73 - 2014 Oso Landslide photo. Photo Jonathan Godt, US Geological Survey

The March 2014 Oso Landslide in northern Washington was a catastrophic example of the threat of deep landslides when development occurs in locations below areas with landslide characteristics and evidence of previous deep slides. The slide killed 43 people, destroyed about 40 structures and buried about a mile of state highway. The slide occurred during a period of extreme rainfall (150-200 percent of normal) when the ground was already saturated. As with the Bonneville Landslide, the sheer amount of debris – about 19 million tons – dammed the local river, and created a temporary lake that flooded homes upstream. Research after the slide revealed evidence of similar past slides ranging from 500-6,000 years old⁵⁹.
