Multnomah County NPDES MS4 Phase I Permit  
Stormwater Management Program

## **Hydromodification Assessment**

**Submitted November 1, 2014**

**Road Services - Water Quality Program  
Department of Community Services  
Multnomah County**

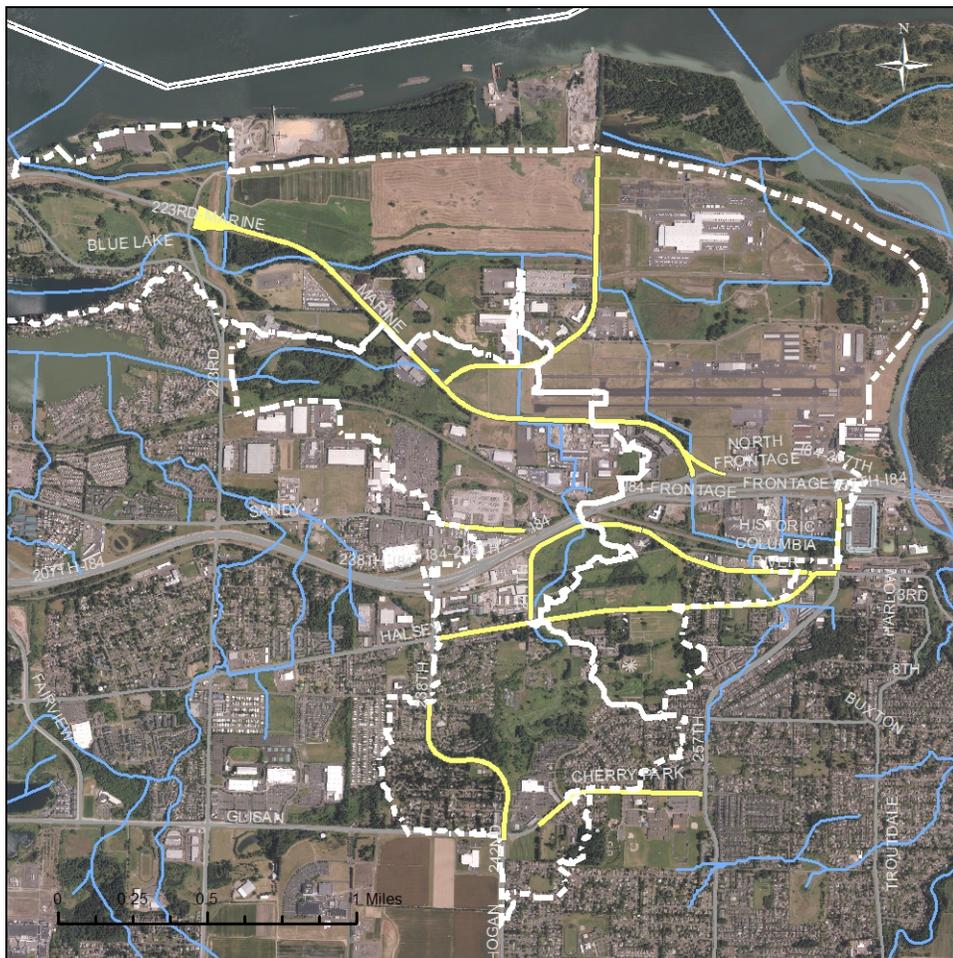
Figure 6. County right-of-way areas in the Salmon Creek watershed are highlighted in yellow. Watershed boundary is shown as a white dashed line.
