Cornelius Pass Road Safety Improvements

January 5, 2017
CAC Meeting

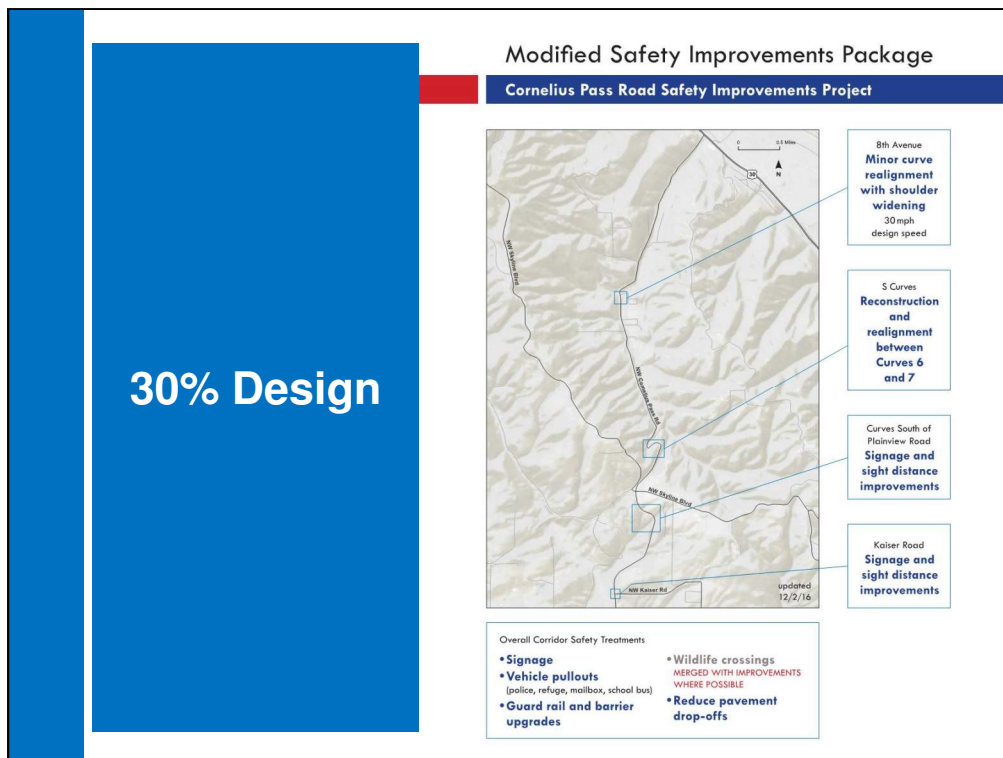
This is the adjusted list of improvements the team is suggesting be moved towards final design.

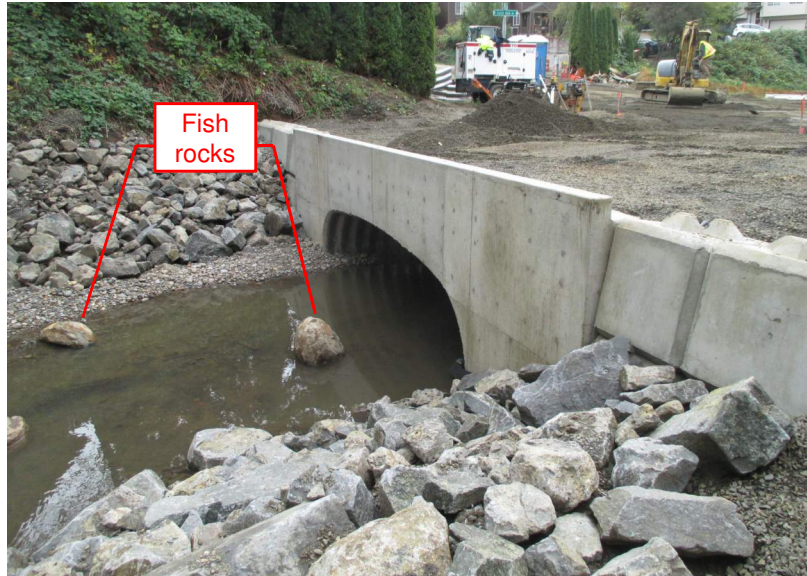
8th Avenue Example Culvert for Fish Passage

This picture is an example of what the stream and culvert could look like to accommodate fish passage, however, we will likely end up with a box culvert instead of the steel arch shown.

The design will likely include large rocks like those shown as “fish rocks” to create shadows, rip rap for armoring of sharp corners, rounded streambed material, etc.

Much of this work will need to be completed within federally mandated in-water work periods likely in June/July of 2018.

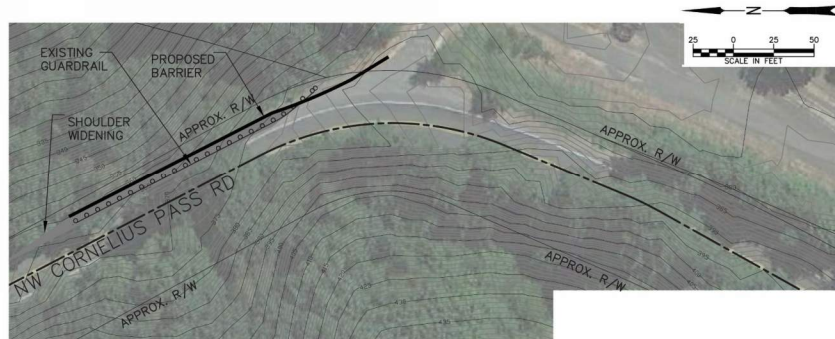
Boyd's Lower Driveway Barrier and Shoulder Widening Detail from Alternative Analysis

This is the concept last shown at CAC Meeting #5 for the improvement at Boyd's Lower Driveway.

The goal was to widen the shoulder on the outside of the curve to provide more recovery area for vehicles to avoid hitting the guardrail.

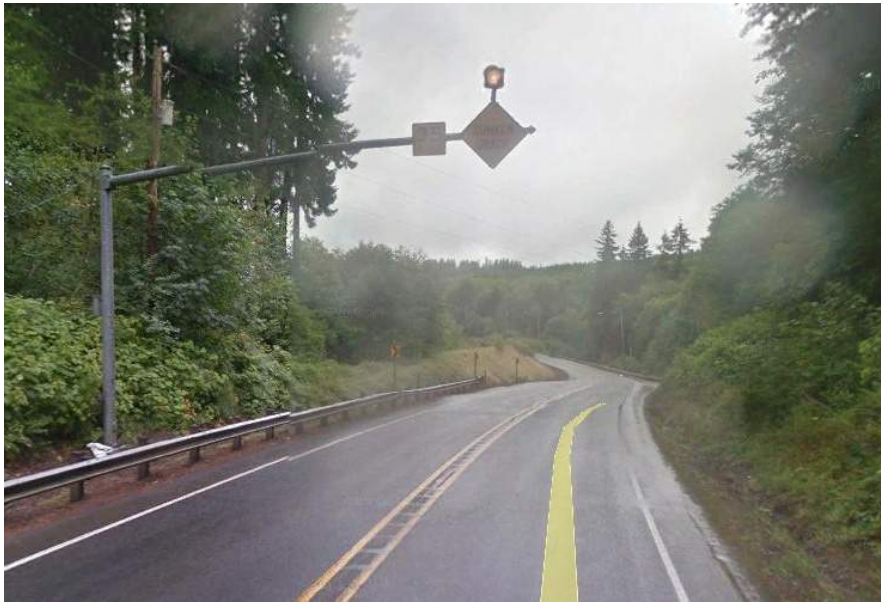
S-curves - Example Overhead Curve Warning Beacon

This is an example of an overhead flashing beacon and warning sign which we plan to construct on the uphill and downhill sides of the S-curves for better awareness of these being the most constrained curves in the corridor.

This particular picture is on US26 going towards the coast. For the case of the S-curves, the "SUNKEN GRADE" sign would be replaced with a curve symbol.

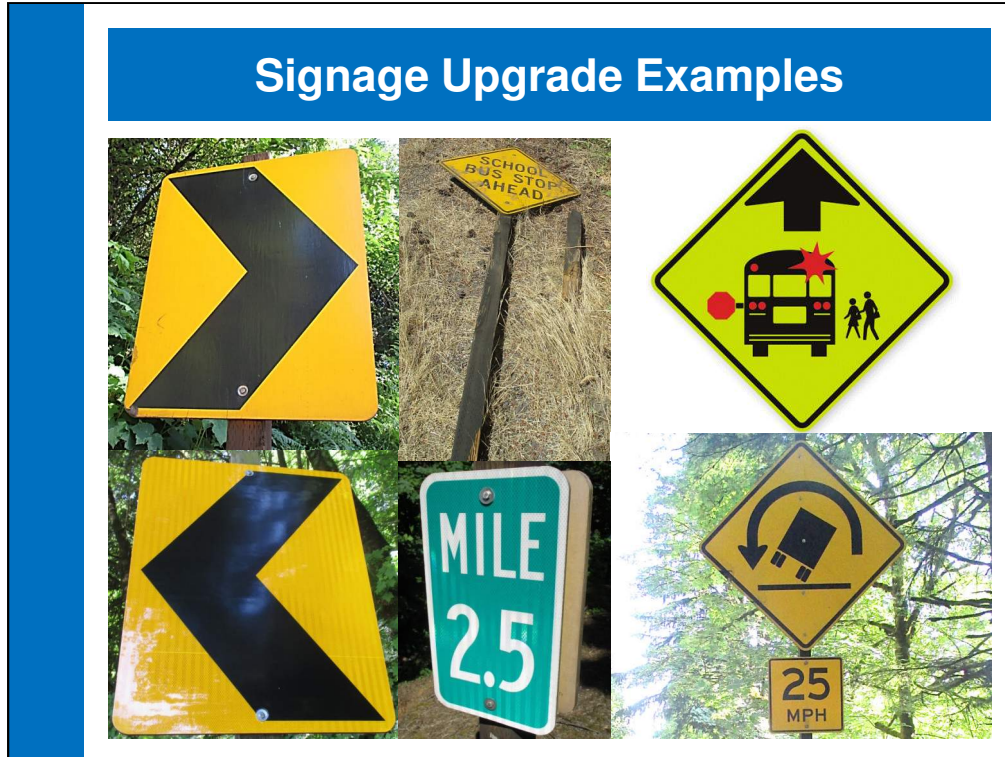
All signs in the corridor will be upgraded with this project to current standards and to provide better overall visibility. This slide shows just a few of the planned upgrades.

The top chevron sign is non-reflective and will be replaced with the reflective version as shown on the bottom. The school bus sign standard was updated in 2012 per the sign shown in the top right and will be upgraded as well. The milepost sign standard has also changed, so milepost signs every half mile will be added. Advisory speed signs like that in the bottom right will also be upgraded based on the measured safe speed for each curve.

Many other sign upgrades will be completed as well.

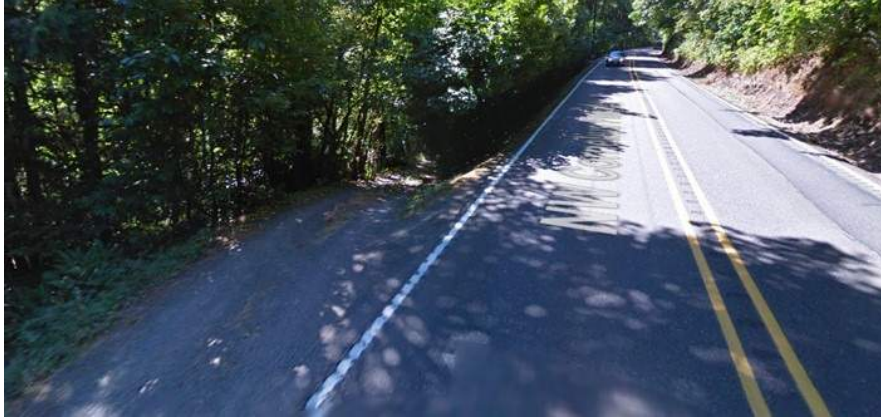
Guardrail – Example of Constraints

This a picture of just one location on Cornelius Pass where the design team will have a challenge with guardrail installation. This location is a steep driveway where a break in the guardrail is needed and where it may be challenging to provide acceptable end treatments for the guardrail.
