**Date:** May 19, 2025

**To:** Ms. Liz Fancher, Multnomah County Hearings Officer

**From:** Bruce Prenguber, M.S., Agricultural Economist

**Subject:** Second Open Record Period Response to Public Comments on Agriculture and Agricultural Lands

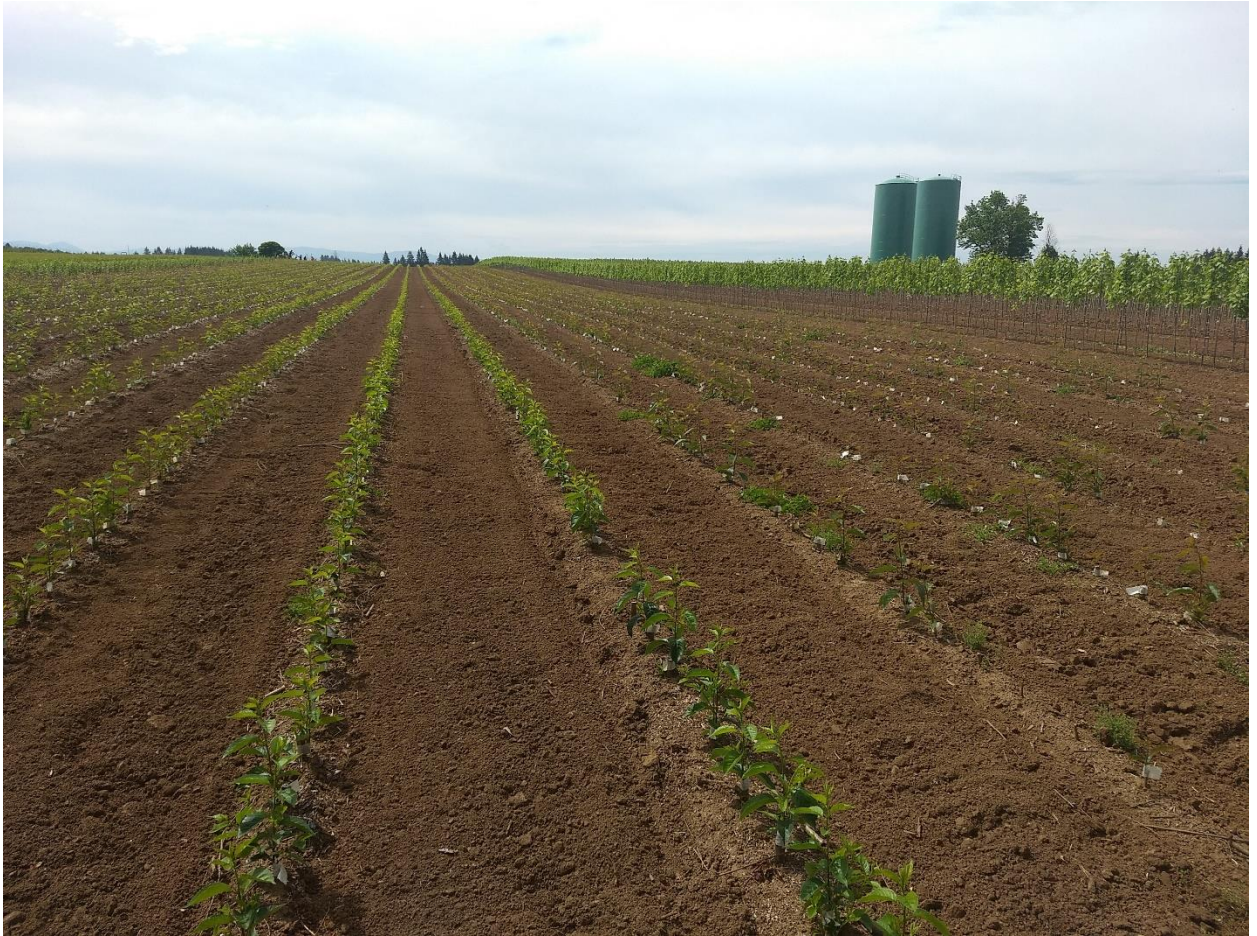
Again, I personally was on the filtration facility site when Surface Nursery and R&H were leasing and managing the land for their crop production. I took the photo below on May 11, 2020, showing a recently planted section of Surface Nursery. Notably, the area between plant rows has been rotavated, not planted to a cover crop.

The practice of rotavating (mechanically breaking up and loosening the soil) and leaving the soil bare increases sedimentation in stormwater runoff and increases dust and wind erosion for a number of reasons. Rotavating breaks up soil structure, making particles finer and less cohesive. Without plant roots or surface cover to hold the soil together, it becomes highly susceptible to being picked up and carried away by rain or sprinkler irrigation or even moderate winds. Vegetation also slows wind at the ground level – so when soil is bare, it is easier for wind to lift and carry away fine soil particles. Bare soil is exposed to direct raindrop or irrigation water impact, which breaks up soil aggregates and detaches particles. This process is called splash erosion, and it is one of the first steps in sediment transport. Vegetation slows down water flow and allows more of it to infiltrate into the ground. Without it, water moves faster over the surface, increasing its ability to carry sediment. Overall, both water and wind erosion are made worse by rotavating and leaving soil bare, as was the practice at the filtration facility site.

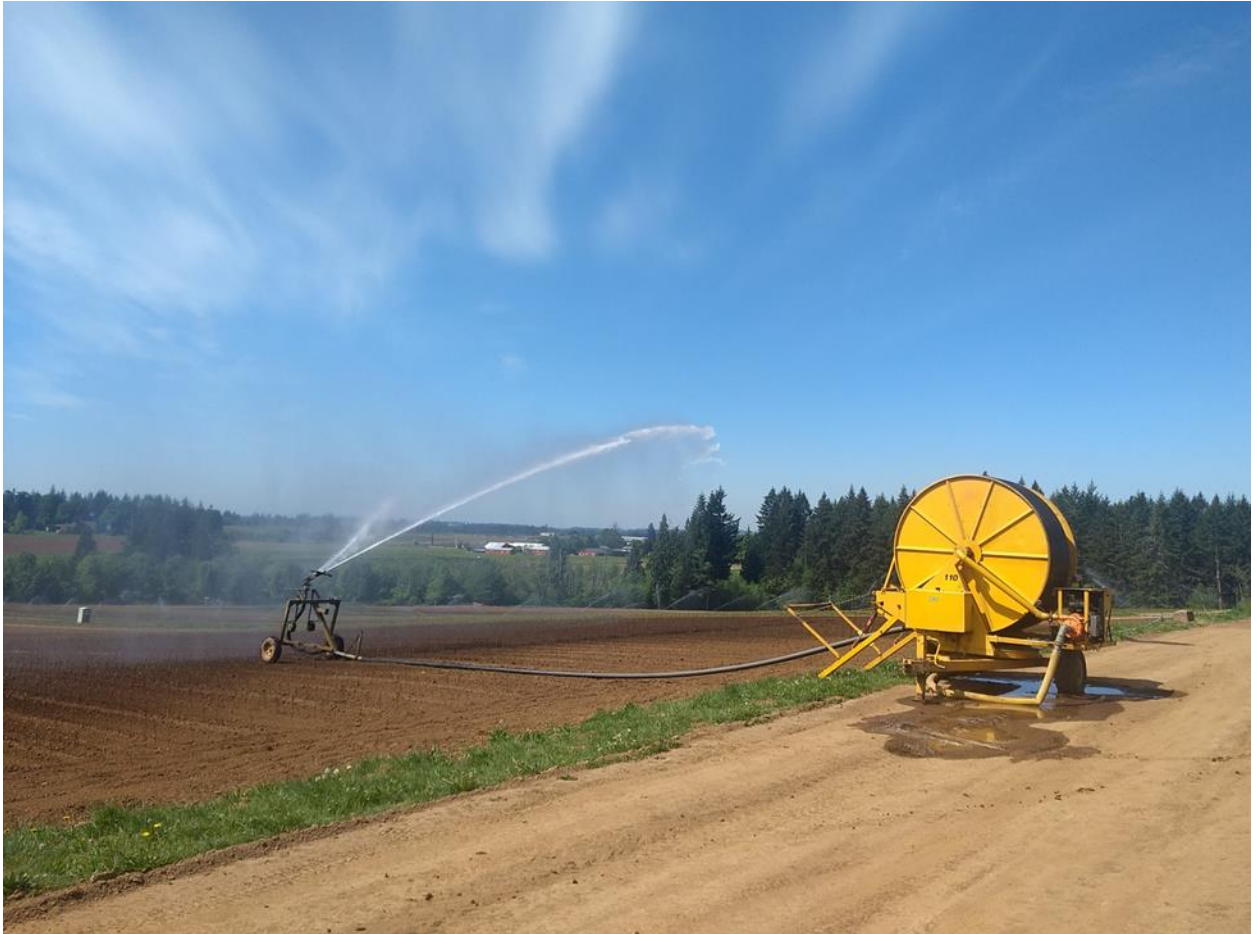
The photo below shows one of the sprinkler irrigation systems used by Surface Nursery to irrigate its field immediately south of the filtration facility site. This photo was taken by me on May 14, 2021. This is referred to as a “big gun” sprinkler that more rapidly applies water than smaller, inline sprinklers. The big gun applies more water to plants due to its higher pressure and larger nozzle size, in comparison to the smaller sprinklers. However, especially when used on sloped ground with no cover crop between plant rows – as shown in this photo – it also has greater potential to result in soil erosion and water runoff. This is another example of the emphasis by the farmers at the PWB site to manage the farmland and soil in favor of efficient crop production over soil protection.

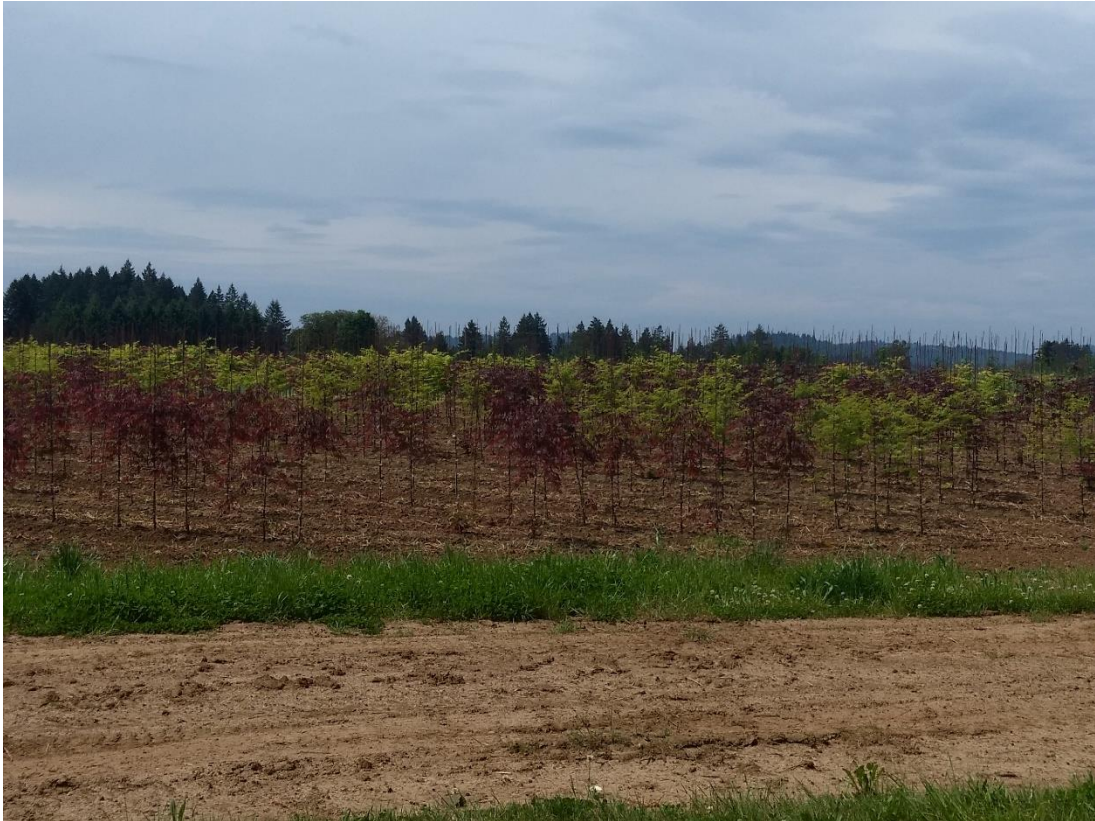
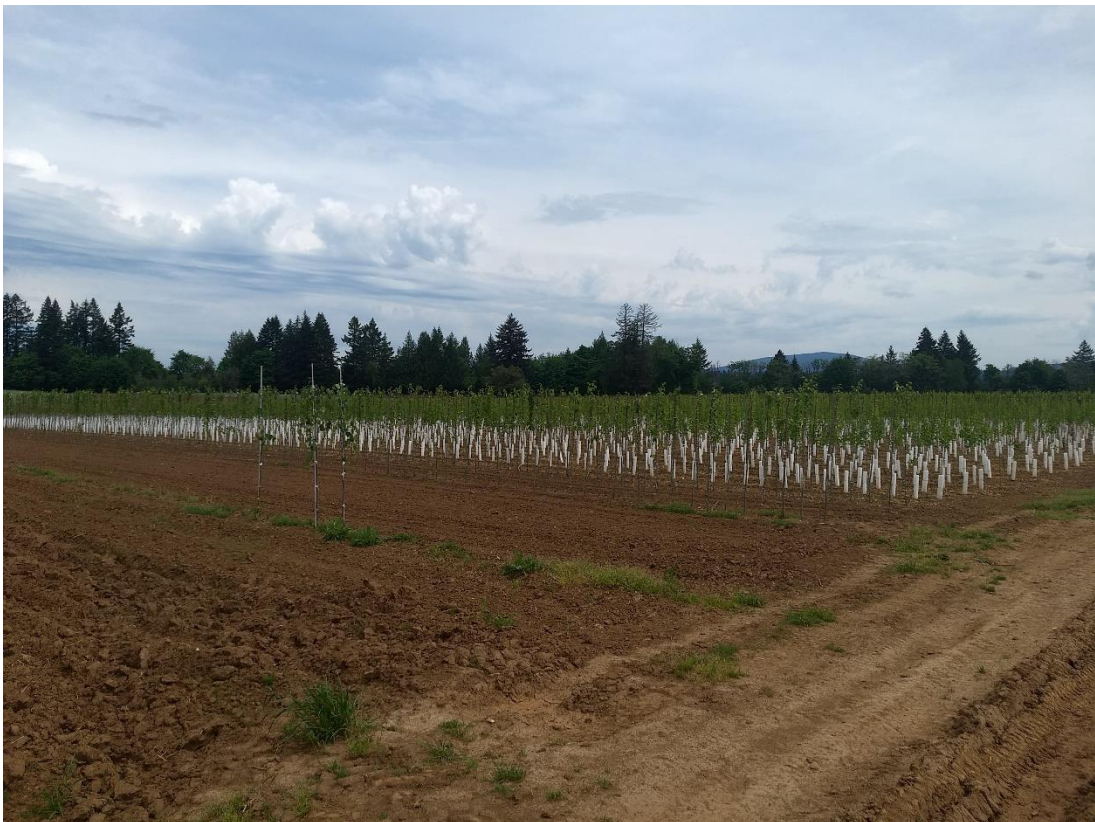
The two photos side by side at the bottom of page 3 of Exhibit S.25 show cover-crop planting between rows at a location “on ... property ... adjacent to,” but not on, the filtration facility site. There may be times where Surface Nursery uses cover crops between rows on this adjacent property, but the overwhelming evidence is that, in most cases, both Surface Nursery and other area bareroot nurseries do not use cover crops between rows, for the reasons explained above. I personally did not see any use of cover crops on the Surface Nursery field between rows when evaluating the filtration facility site. Two additional photos I took on May 11, 2020, of the Surface Nursery field on the filtration facility site are below and illustrate this point.
