Hazardous Building Material Survey Report

MULTNOMAH COUNTY

Wikman Juvenile/MCCAA Weatherization

Property # 465

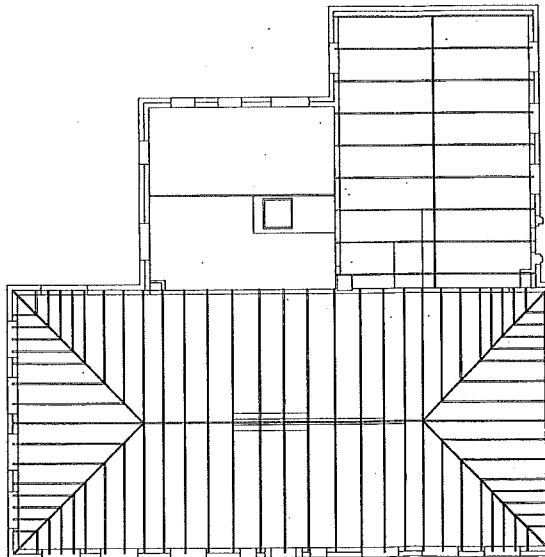
1. BULK SAMPLES OF SUSPECT ASBESTOS-CONTAINING BUILDING MATERIALS WERE NOT COLLECTED FROM THE ATTIC SPACE DURING THE PREVIOUS SURVEY. ASBESTOS-CONTAINING MATERIALS MAY BE PRESENT IN THIS AREA. SAMPLE ALL SUSPECT MATERIALS LOCATED IN THIS SPACE PRIOR TO IMPACT.

1. ROOFING MATERIALS LOCATED ON THIS STRUCTURE PRESUMED TO CONTAIN ASBESTOS.
