Wikman Building Renovation

October 2, 2012

THA ARCHITECTURE
INC

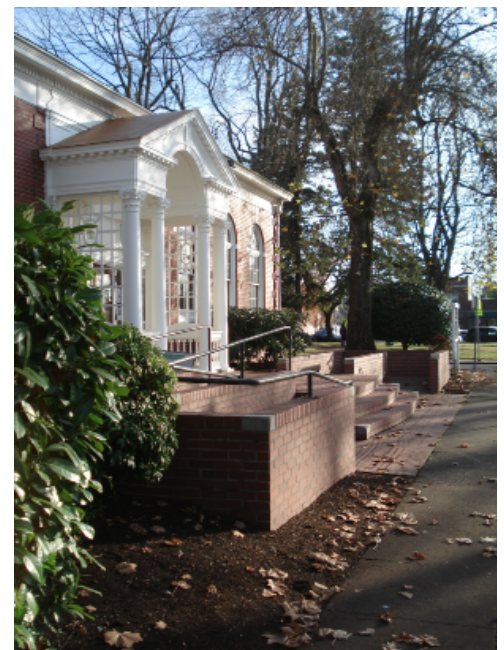
West ramps

- Remove and repair concrete at east entry
- Revise north ramp at front to be correct slope. As the ramps were constructed under a building permit, it is not required that they be upgraded. However, it is recommended that the main entrance be brought up to current code for accessibility to meet the intent of Universal Access.
- Add new ramp and stair on the south side of the building.
- Clean and re-point exterior brick
- Exterior concrete pads for bike racks

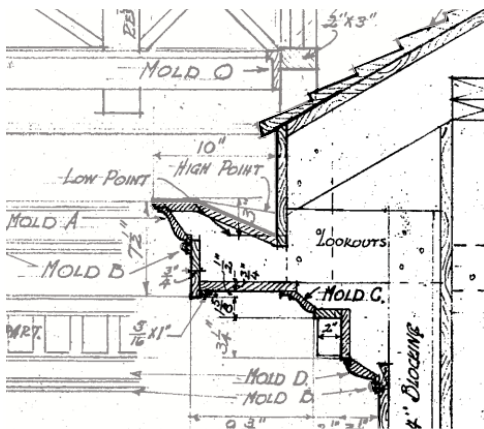
Original integral gutter detail

- Repair/Replace gutter liner.
- Repair leaking scupper at northeast corner.
- Check all downspouts and rain drains for proper operation
- Painted steel bike racks
- Exterior ramp and stair railings

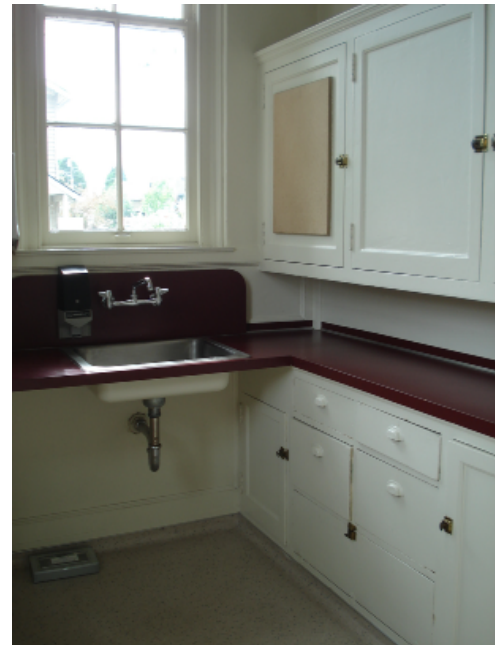
The kitchen still has the original cabinets but the sink was replaced with a contemporary stainless steel sink.

Kitchen

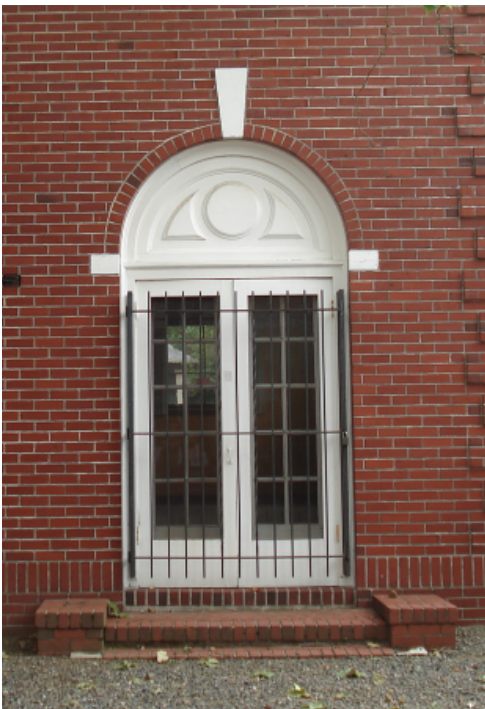
Detail of east door into Meeting Room 003

- Replace exterior Door X011 with a new steel door with lites and panic hardware. Replace Door X007 with existing Door X011.
- Replace glazing in side lite at Door X007.
- Add weather stripping at east door of Conference Room 003. Adjust hardware.
- Re-key locks and make repairs adjustments to all existing hardware to remain.
- Two new doors and hardware for new restrooms.
- Add tempered interior storm windows at mezzanine
- Flip Door 001B to exit from Reading Room and upgrade door hardware.

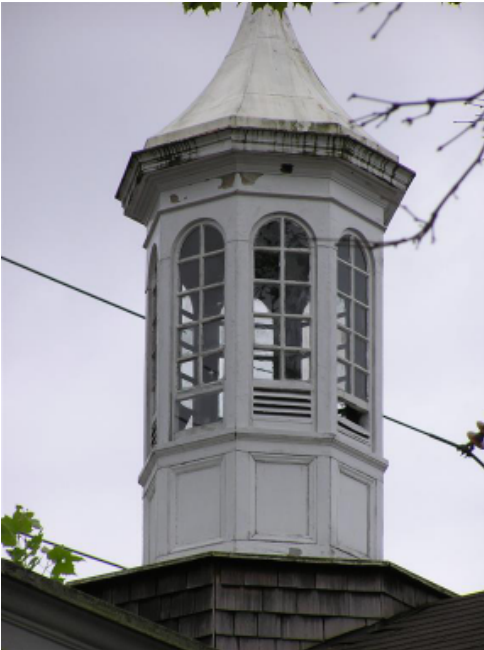
The lantern at the top of the roof is in fair condition. The glazing compound of the lites needs to be repaired. Some of the wood elements need to be repaired or replaced in-kind.

Lantern

- Fix glazing in lantern.
 - Repair flashing at lantern/ roof intersection.

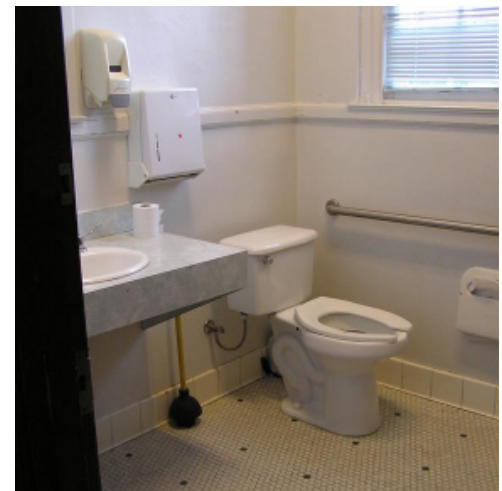
The restroom was remodeled to be accessible to 1981 standards and does not meet current code. The kitchen sink will need to be retrofit to be accessible.

WC on main floor

- Replace/repair damaged wood sill at east stair.
- Revise threshold at main floor restroom
- New framing and blocking for new restrooms
- Add Simpson straps at the ridge and at the top plates above office wing.

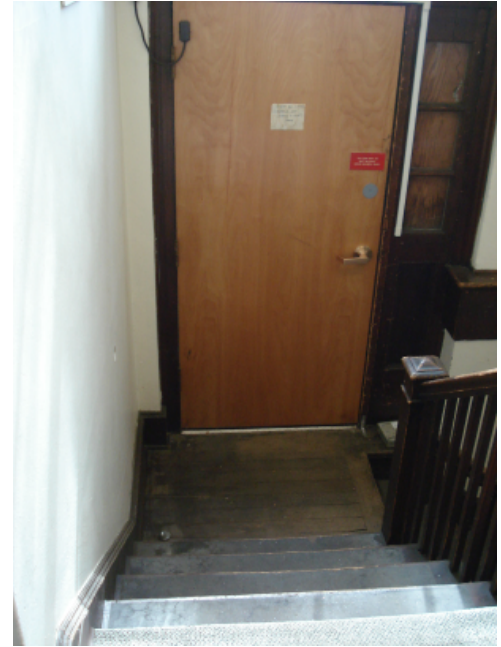
East stair and Door X007
