ROAD SAFETY AUDIT

Cornelius Pass Road Multnomah County, Oregon July 1-3, 2008

Primary Author:
Nicholas Fortey, P.E
Safety Engineer
Federal Highway Administration, Oregon Division

December 2008

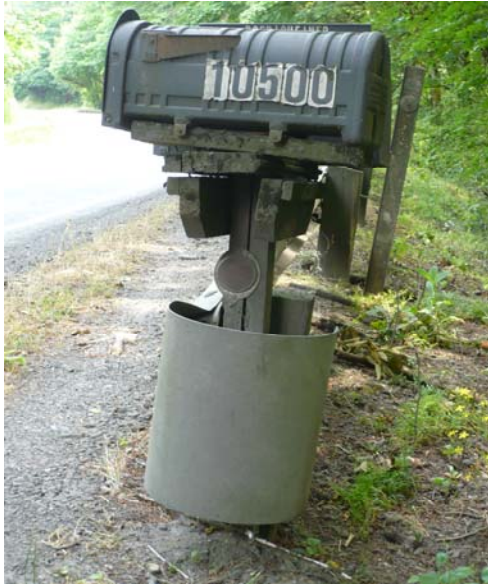
Due to the number and variety of potentially hazardous objects close to the traveled

way, additional treatment approaches should be considered. Due to low cost, object hazard markers should be considered more widely; however, due to the large number of objects this could result in a high number of delineators. Long term maintenance, relatively high initial cost, and consistency among routes in the County needs to be considered; thus, the sites should be considered strategically. Removal, or relocation of, or making point fixed objects breakaway (where possible) also needs to be considered programmatically. This audit has attempted to address a few locations but should not take the place of a thorough hazard assessment process. The County should thus develop a policy to determine where guardrail is warranted along Cornelius Pass Road. Finally, the County should develop a policy for the control of

devices on or adjacent to roadside safety features; although specific instances were noted with mailboxes located within the end terminal of a guardrail, the policy should be broad enough to extend to all devices that might be installed to prevent interference with sight lines, or the proper visibility of signs.¹¹

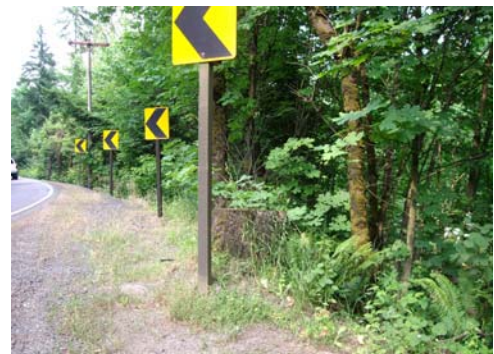
- Advance warning signs should be consistent in the type of arrow and advisory speed plaque.
- In-curve delineation (delineators and/or chevrons) needs to be consistent within the curve (and among similar curves). For example, for some curves the chevrons were at an inconsistent height and inconsistent horizontal spacing making the path alignment through the curve difficult to discern. In some cases chevrons were present in one direction for a curve but were not present for the opposing direction.

- There needs to be consistency in the differential use of chevrons and arrow boards (i.e., W1-6, “One Direction Large Arrow sign”). Arrow boards should be restricted to those cases where the turn is very sharp.
