Enhanced Seismic Retrofit Technical Report

Multnomah County | Earthquake Ready
Burnside Bridge

January 29, 2021

Earthquake Ready Burnside Bridge Enhanced Seismic Retrofit Technical Report

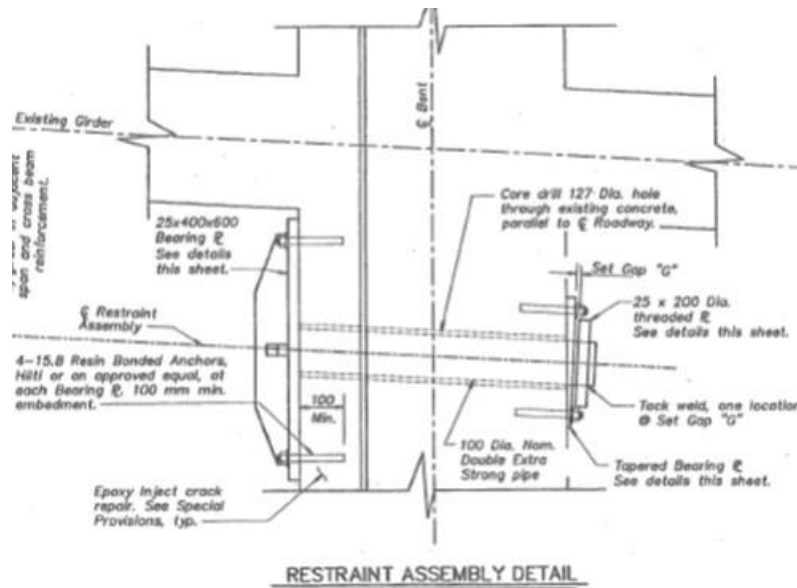
Figure 5-1. Seismic Restrainer Vulnerability

Seismic Restrainer – Insufficient strength. The existing restrainers at expansion bents are inadequate due to increased seismic loading demand requirements that have been developed in the years since the original Phase I seismic retrofit. Modification of the restrainers would also be required due to the floor-beam strengthening that is described below; therefore, analysis of the demands and capacities of the existing restrainers was not required (see Figure 5-1).

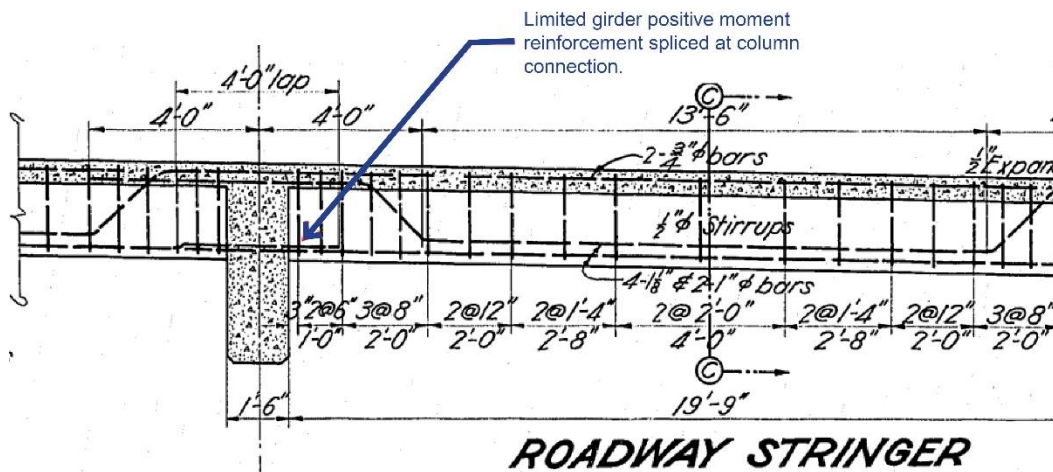
Figure 5-2. Superstructure Vulnerability

Superstructure Flexural or Shear Strength – Insufficient strength. The girder’s positive moment reinforcement is spliced at the column connection, limiting moment capacity due to inadequate development length. Analysis of the existing structure for the CSZ event shows the C/D ratios are less than 1.0 at multiple locations (see Figure 5-2). In addition, load rating analysis results indicated that the stringers do not have sufficient strength to meet the load rating requirements per current design standards.

Superstructure Flexural or Shear Strength – Poor seismic detail. Girder positive moment reinforcement spliced at column connection thus limiting moment capacity due to inadequate development length. Analysis of the existing structure for the CSZ event shows the C/D ratios for superstructure flexure at the bents to be less than 1.0 (see Figure 5-2). In addition, load rating analysis results indicated that the stringers do not

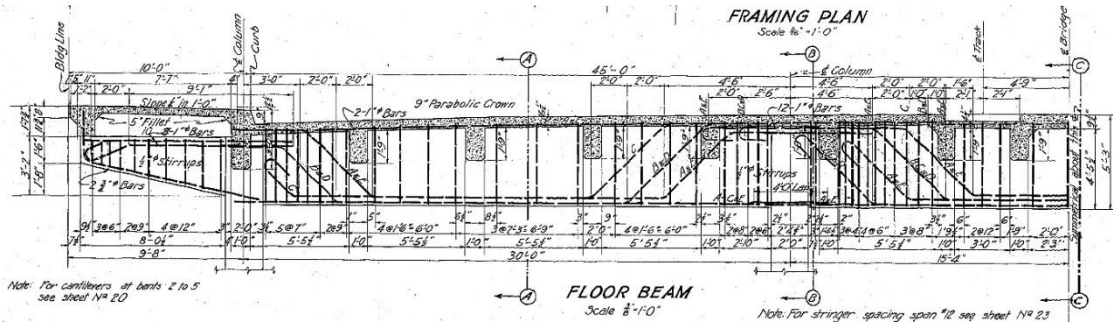
Figure 5-3. Floor-Beam Vulnerability

Floor-Beam Flexural or Shear Strength – Poor seismic detailing. The floor-beam positive moment reinforcement is spliced and/or has limited embedment at column connection, limiting its moment capacity due to inadequate development length. The

negative moment capacities at supports are inadequate to maintain elastic behavior for a design-level seismic event. Analysis of the existing structure for the CSZ event shows the C/D ratios at multiple locations are less than 1.0 (see Figure 5-3). In addition, load rating analysis results indicated that the floor beams do not have sufficient strength to meet the load rating requirements per current design standards.

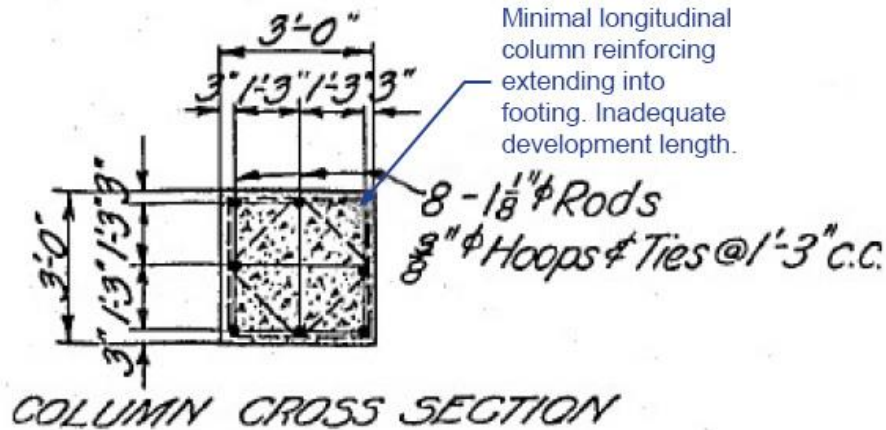
Figure 5-4. Column Vulnerability

Column Flexural or Shear Strength – Insufficient strength. There is very little longitudinal column reinforcing extending into the footing, compounded by inadequate development length. There is poor confinement and a lack of seismic hooks, with ties and hoops at 1-foot 3-inch spacing. C/D ratios for column flexure and shear for the CSZ event are less than 1.0 (see Figure 5-4).

Column Flexural or Shear Strength, Poor Confinement Detailing – Minimal longitudinal column reinforcing extending into footing with inadequate development length. Poor confinement and lack of seismic hooks, with ties and hoops at 1-foot 3-inch spacing. C/D ratios for columns are less than 1.0 (see Figure 5-4).

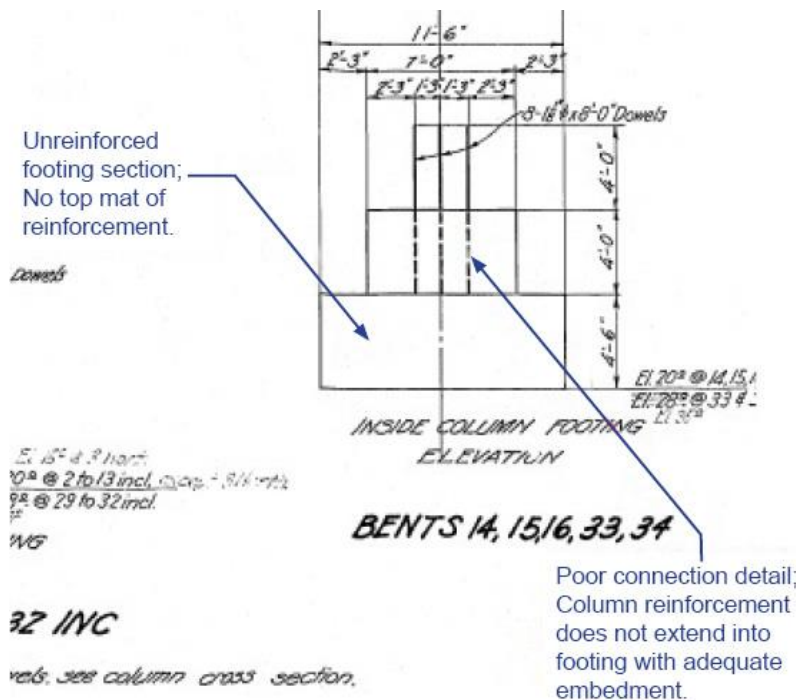
Figure 5-5. Spread Footing Vulnerability

Footing Size and Strength – Unreinforced Footings. The small footing size is inadequate to resist overturning and to limit settlement from liquefaction to a desirable level. Further, the unreinforced footing section has no top mat of reinforcement. The connection detail does not meet current design standards because column reinforcement does not extend into the footing with adequate embedment. Due to the lack of reinforcing in the footing, and liquefaction effects, a foundation retrofit is required because a reasonable load path for seismic forces in these elements does not exist (see Figure 5-5).

Footing Size and Strength, Unreinforced Footings – Bents 28 to 35 are on small spread footings with limited bearing capacity to resist overturning. Unreinforced footing section with no top mat of reinforcement. Poor connection detail as column reinforcement does not extend into the footing with adequate embedment. Due to the lack of reinforcing in the footing, foundation retrofit is required because a reasonable load path for seismic forces in these elements could not be found, and structural analysis of the demands and capacities of the footings was not required (see Figure 5-5).

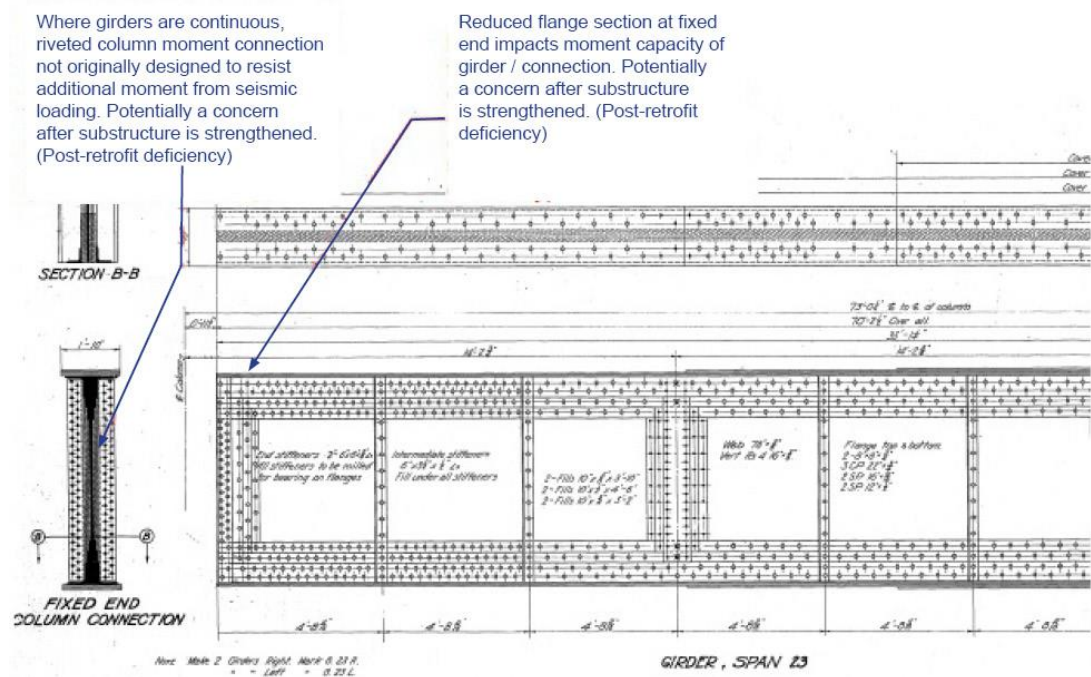
Figure 5-8. Superstructure to Column Connection Vulnerability

Superstructure Flexural or Shear Strength – The strength of the superstructure is a concern. Where girders are continuous, the riveted column moment connection was not originally designed to resist additional moment from seismic loading. The reduced flange section at the fixed end impacts the moment capacity of the girder/floor-beam connection. Analysis of the existing structure for the CSZ event resulted in a minimum C/D ratio less than 1.0 (see Figure 5-8). In addition, load rating analysis results indicated that the stringers do not have sufficient strength to meet the load rating requirements per current design standards.

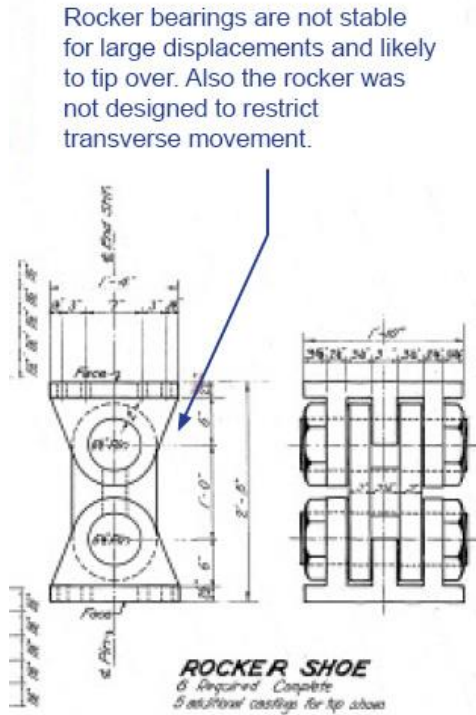
Figure 5-9. Rocker Bearing Vulnerability

Steel Rocker Bearings – Rocker bearings are not stable for larger displacements and are likely to tip over. Also, the rocker was not designed to restrict transverse movement. Longitudinal restrainers installed in the early 2000s tied the superstructure together near deck level and do not restrict transverse movement of the superstructure. Retrofit of the steel rocker bearings is required based on the lack of a reasonable load path for seismic

loading; therefore, a detailed analysis of the demands and capacities of the existing rocker bearings was not required (see Figure 5-9).

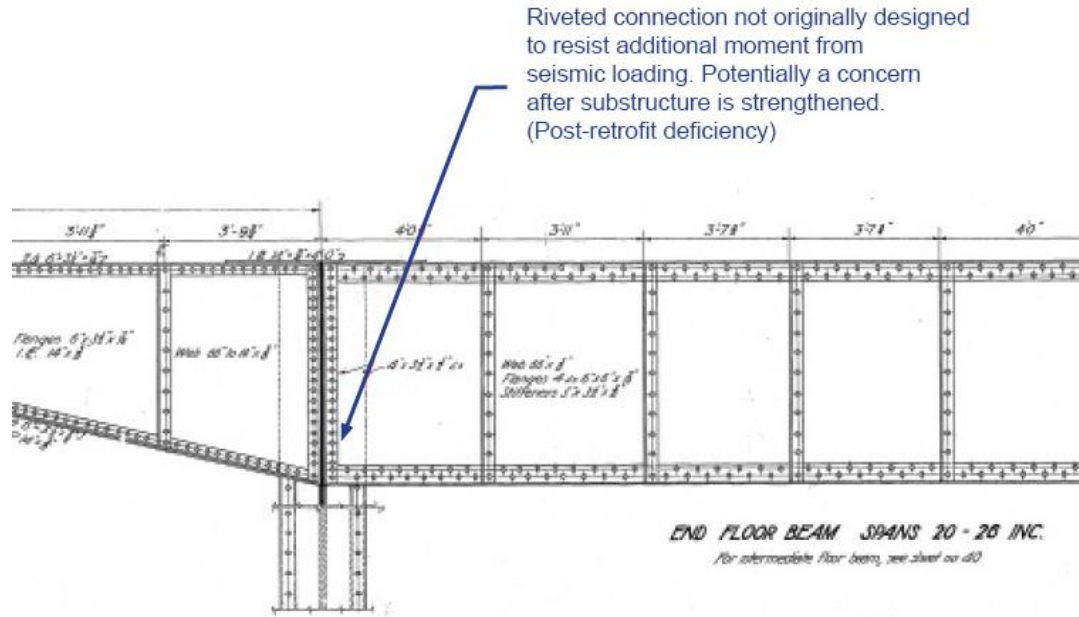
Figure 5-10. Steel Floor-Beam Connection Vulnerability

End Floor-Beam Flexural or Shear Strength – The superstructure strength becomes deficient after the substructure columns is strengthened. The riveted connection was not originally designed to resist additional moment from seismic loading, and this is exacerbated by needing to be capacity-protected against the column. There is a relatively long cantilever supporting a portion of the roadway. Analysis of the existing structure for the CSZ event resulted in C/D ratios for all end floor beams of less than 1.0 at the columns (see Figure 5-10). In addition, load rating analysis results indicated that

the floor beams do not have sufficient strength to meet the load rating requirements per current design standards.

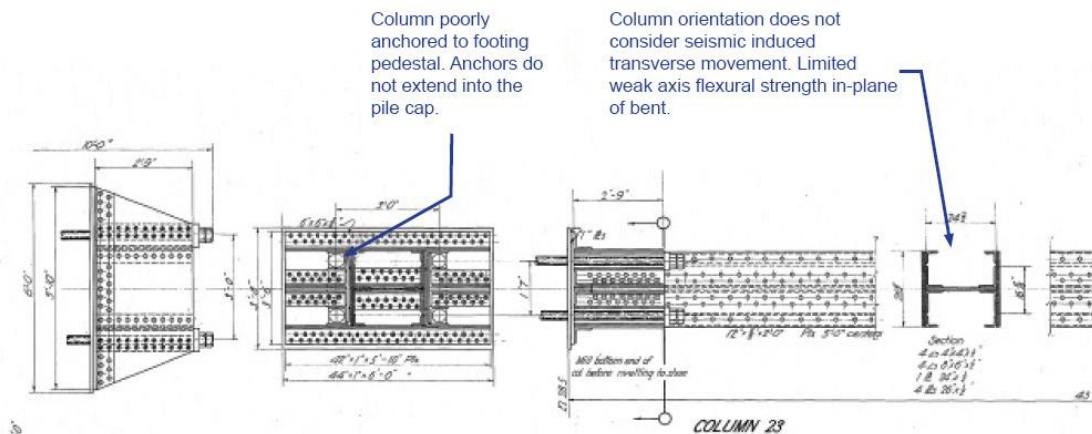
Figure 5-11. Steel Column Vulnerability

Column Flexural or Shear Strength – Columns are poorly anchored to footing pedestals. Anchors do not extend into the pile caps. Column orientations do not accommodate seismic-induced transverse movement. Weak axis flexural strength in the plane of the bent. Analysis of the existing structure for the CSZ event resulted in C/D ratios for all steel columns of less than 1.0 when evaluating axial-flexure interaction in the columns and tension in the anchor bolts (see Figure 5-11).

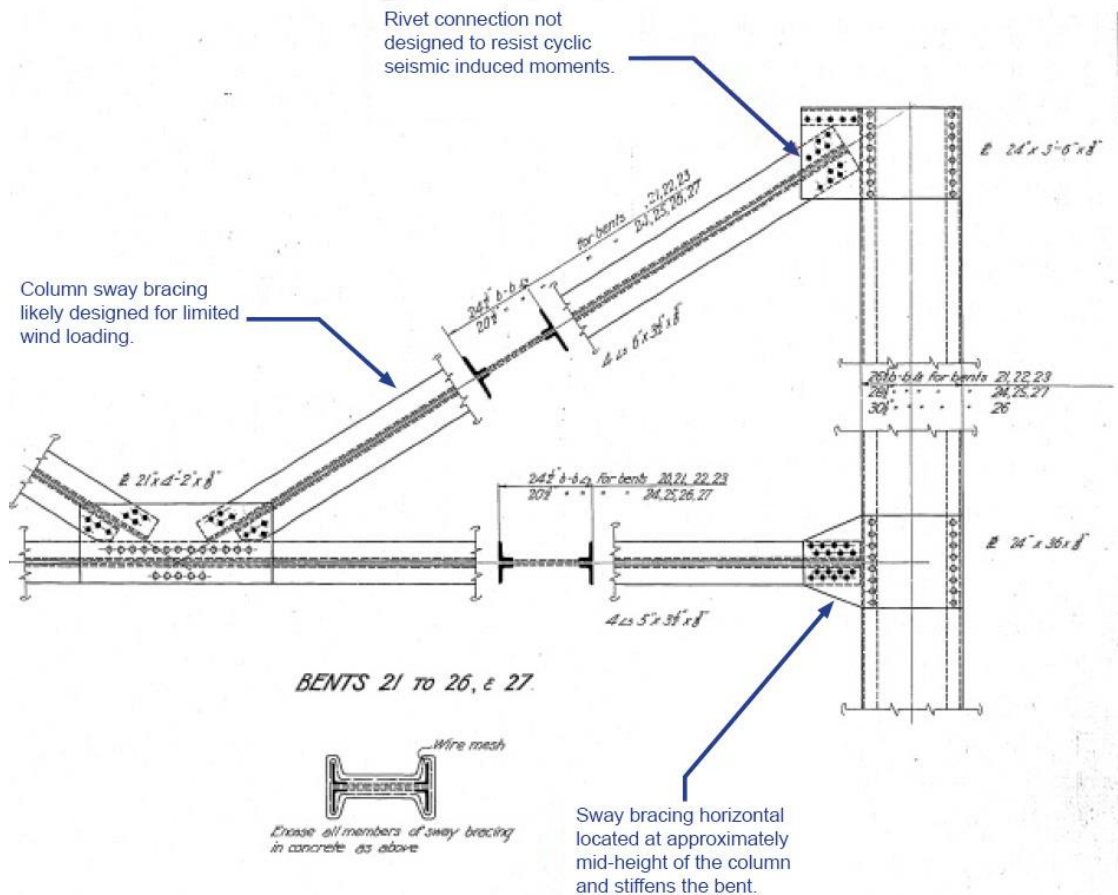
Figure 5-12. Column Bracing Vulnerability

Column Sway Bracing Strength – Column sway bracing was likely designed for limited wind loading. The rivet connections were not designed to resist cyclic seismic-induced moments. The sway bracing horizontal is located at approximately mid-height of the column and stiffens the bent. Analysis of the existing structure for the CSZ event resulted in C/D ratios less than 1.0 for the steel column bracing (see Figure 5-12).

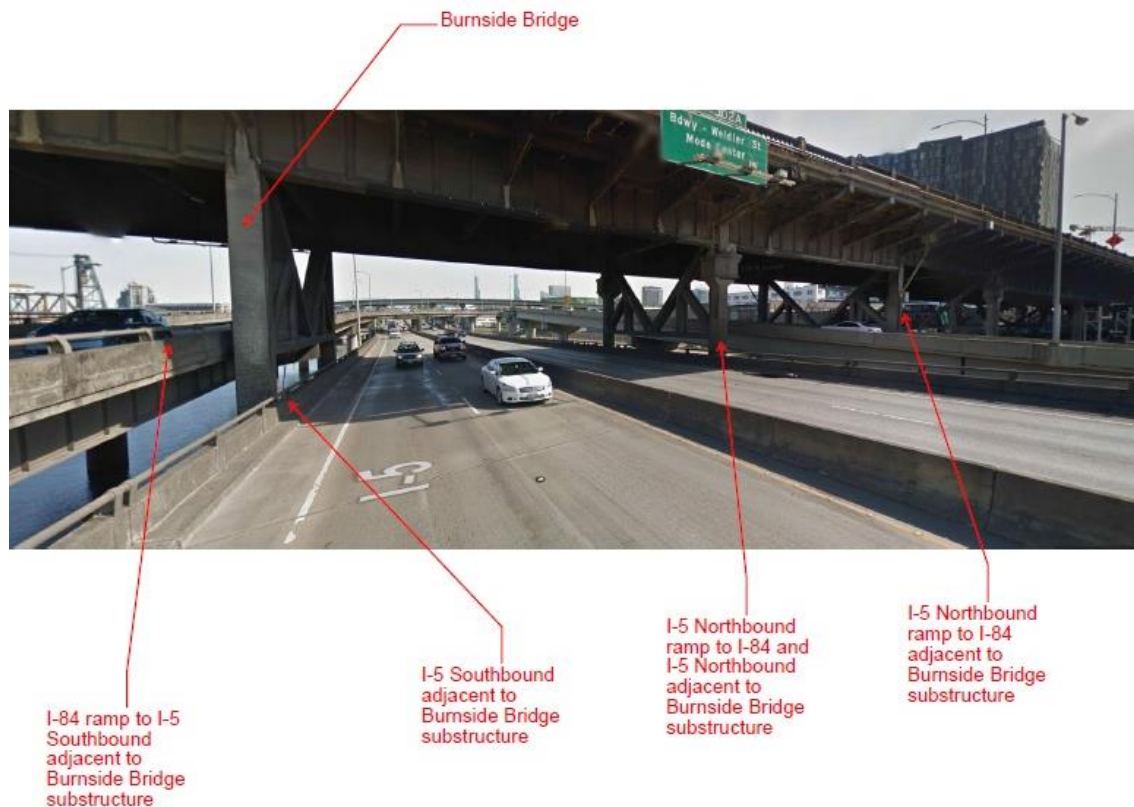
Figure 5-13. Vulnerability to Impact from Adjacent Structures

Damage from Adjacent Structure – Bents 21 to 23 are adjacent to various highway structures (on-ramp from I-84 westbound to I-5 southbound, I-5 north- and southbound, and I-5 northbound to I-84 eastbound), which could impact each other during a seismic event resulting in catastrophic damage to the columns of Bents 21 to 23 (see Figure 5-13).

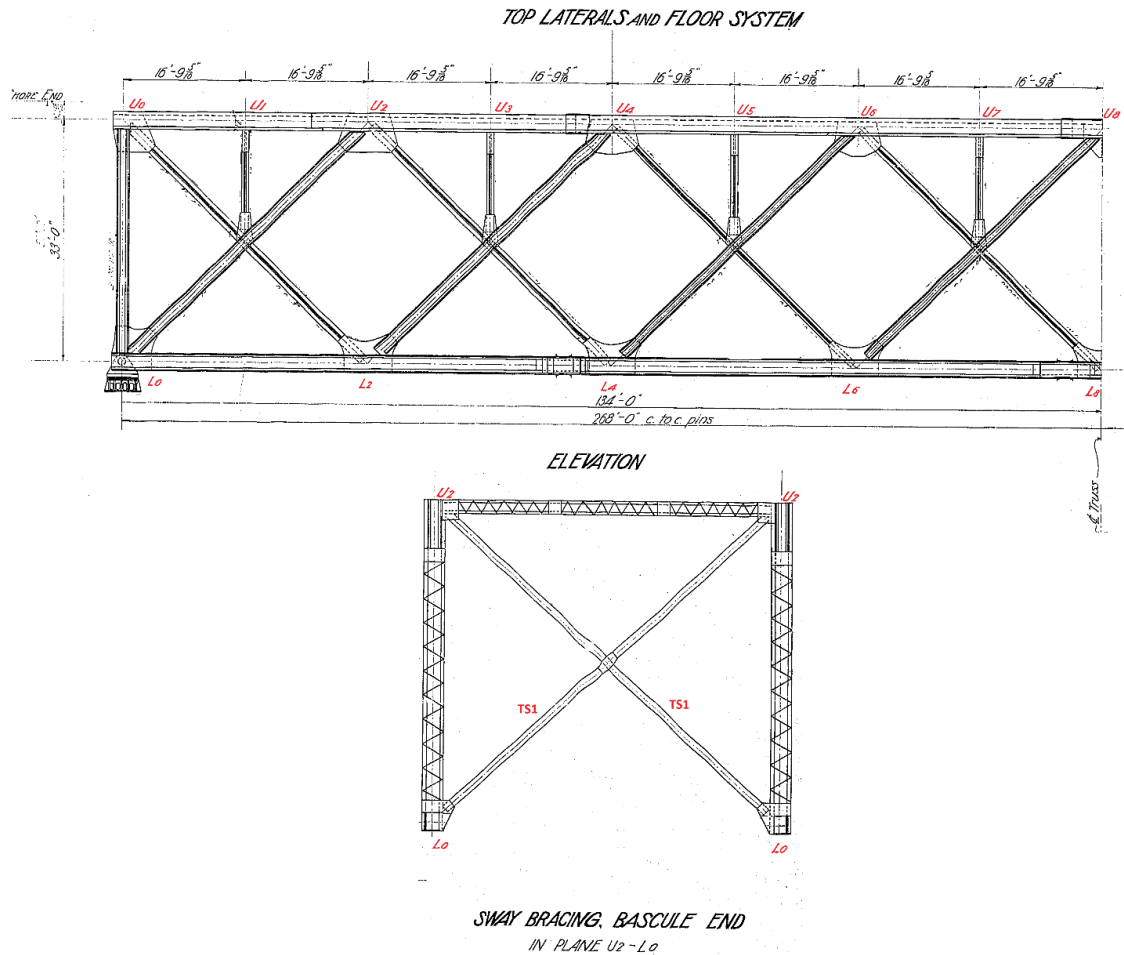
Figure 5-14. Steel Truss Span Elevation and Sway Bracing

The analysis was conducted step by step to identify the required retrofit. Table 5-1 below indicates representative members that have C/D ratios less than 1.0 under a CSZ event; therefore, those members need to be strengthened.

Drawing Member #	Member Location	Failure Mode	C/D Ratio
U8U9	Top chord at midspan	Compression	2.04
L8L9	Bottom chord at midspan	Tension yield	2.12
L8L9	Bottom chord at midspan	Tension fracture	3.28
U8L9	Diagonal near midspan	Compression	1.99
TS1	Out-of-plane bracing near bascule	Compression	0.08
TS1	Out-of-plane bracing near bascule	Tension yield	0.40
TS1	Out-of-plane bracing near bascule	Tension fracture	0.61
U16L16	End post near bascule	Compression	3.37
	Fixed End Support Anchor Bolts	Shear	0.22

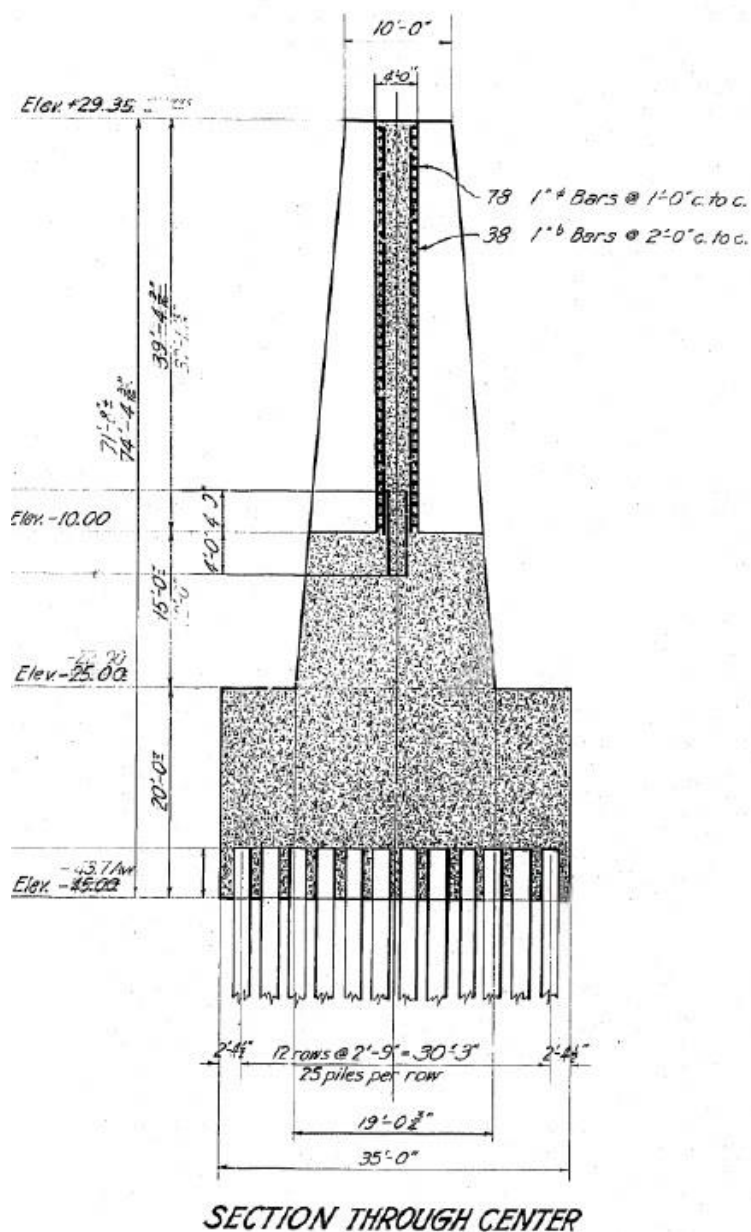
Figure 5-15. Piers 1 and 4 Walls and Foundations

Existing Pier 1 and Pier 4 foundations consist of unreinforced pile caps and groups of timber piles (see Figure 5-15). These foundations were neither designed nor constructed according to current seismic design requirements and detailing practices. During a design-level earthquake, these foundations can have multiple failure modes.

Concrete pile caps at Pier 1 and Pier 4 are unreinforced. This limits flexural capacity to the cracking strength of the concrete. Shear capacity is also limited to the concrete shear capacity, V_c . Because the unreinforced concrete has low capacities in both flexure and shear, the pile caps are predicted to have fracture and shear failures during the design-level earthquakes.

Liquefaction-induced ground displacement at the west and east riverbanks during and/or after an earthquake will apply pressure on the Pier 1 and Pier 4 foundations, pushing the pier foundations toward the river. Since the existing timber piles have low lateral resistance capacities, the lateral soil movement, if not mitigated, will result in the collapse of the existing pier foundations. This concern is even more critical for Pier 4 because the liquefiable soil layer is much deeper.

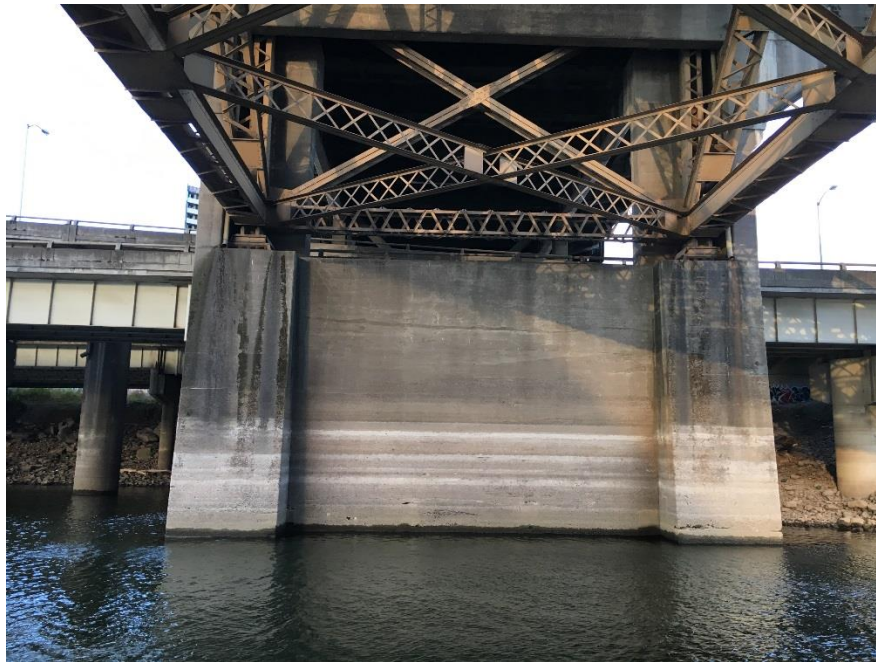
Figure 5-16. Pier 4

Each pier consists of two concrete columns supported on pile foundations (see Figure 5-16). The columns are connected by a reinforced concrete shear wall below the fixed truss bearing locations. The columns are reinforced above the top of the shear wall and are unreinforced below. The foundations consist of an unreinforced concrete pile cap supported by timber piles.

The southern column of Pier 1 has experienced significant deterioration. There is cracking, spalling, and delamination on the east face of the column, and existing patch repairs have been performed at the crack location. There is also a large vertical crack on

the south face of the column just behind the interface with the existing Harbor Wall. This deterioration was addressed as part of the Burnside Bridge Maintenance Project.¹ Two vertical steel distribution beams on each side of the shear wall were installed on the south and north faces of the column and are connected by drilled and grouted high-strength threaded rods. Steel cover plates were installed using resin-bonded anchors on the east face of the column.

In examining the as-built plans, the unreinforced or under-reinforced concrete pier column/wall is vulnerable under seismic loads and lateral movement. The pier columns are not properly reinforced to conform to seismic design requirements, and the reinforcing is not detailed for ductile behavior as required per current seismic design standards. The column/wall capacity is limited to the concrete cracking strength and will crack and lose vertical load support capacity during a design-level seismic event. Major deficiencies are listed below:

- Lack of lateral confinement reinforcing in the columns. During an earthquake, the concrete is predicted to crack and fail, and the vertical main reinforcement is predicted to buckle, thus causing the pier columns to lose vertical support capacities.
- Lack of adequate rebar embedment length, lapping splice length, and seismic hook details. During an earthquake, the reinforcement will not be able to develop full strength capacity, will un-bond, and lose the load-carrying capacity. Unreinforced plain concrete is used in the lower portion of the columns and the walls. This

unreinforced concrete will crack and fall apart during an earthquake (C/D ratio of 0.42), causing the piers to collapse.

- Because of the above-identified deficiencies, Pier 1 and Pier 4 are anticipated to fail in both flexure and shear during a design-level earthquake event; therefore, seismic retrofit is required.

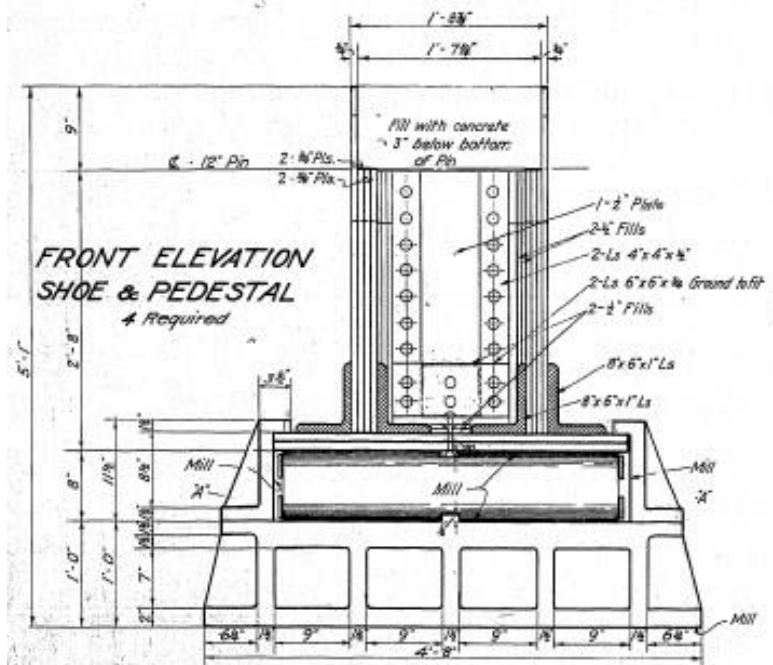
Figure 5-17. Expansion Rocker Bearing

The expansion ends of the steel truss spans are supported on Pier 1 and Pier 4 which also support the concrete approach spans from approach structures. The support bearings under the steel trusses are rocker-type steel bearings (see Figure 5-17). During late 2001, the bridge went through a Phase I seismic retrofit (Multnomah County 2001) that included:

The expansion rocker-type bearings at Piers 1 and 4 are predicted to fail during a CSZ or 1000-year earthquake. Because the piers under the bearings are massive rigid concrete structures that have very low or almost no displacement capacity to accommodate seismic movements, the longitudinal seismic movements are anticipated to be accommodated at the bearing level. The predicted longitudinal movement at the bearing level is 6 inches. However, the existing retrofits using wedges at these bearings were designed for maximum movement of fewer than 4 inches, which is not adequate to accommodate the seismic movement; the rocker may fall due to excessive seismic movement. Currently, the displacement required for seismic motion is 23 degrees which exceeds the 22-degree maximum rotation of the retrofitted bearings.

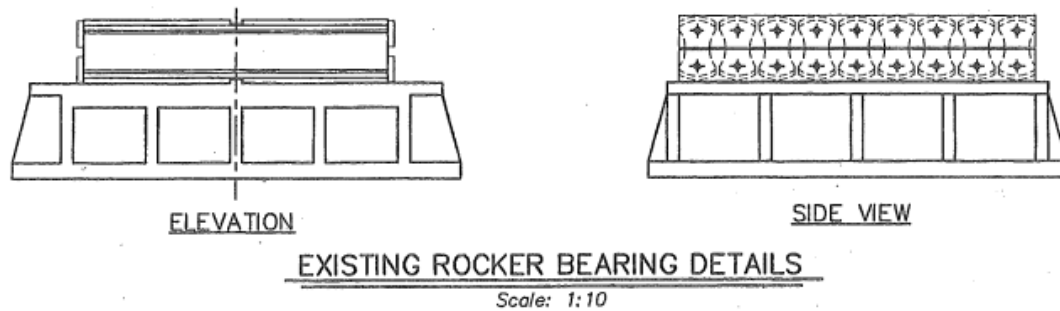
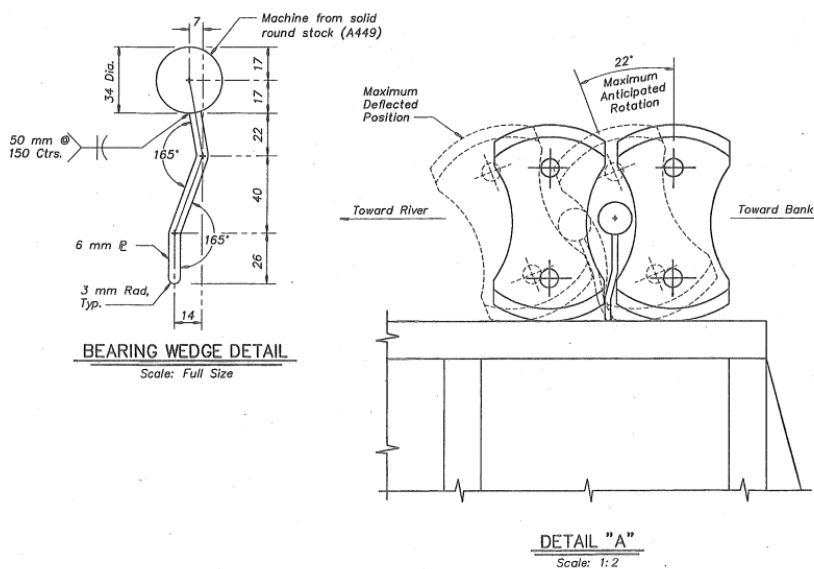
- Installing seismic restrainers connecting the top chords of the steel trusses to the concrete approach spans.
- Retrofitting the rocker-type bearings by inserting bearing wedges (see Figure 5-18 and Figure 5-19).

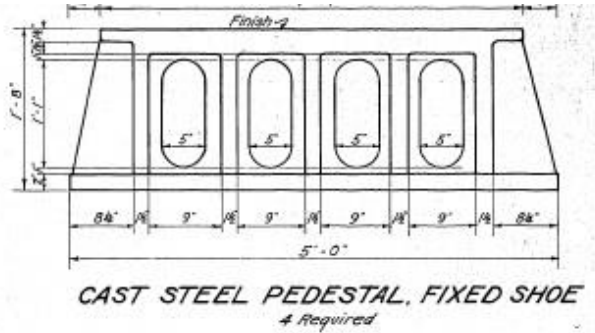
Figure 5-20. Fixed Bearing Shoe

The steel truss spans are supported on fixed bearings (see Figure 5-20) at bascule Pier 2 and Pier 3.

Existing anchor bolts of the fixed bearings are insufficient to resist seismic-induced horizontal forces. The concrete pier wall below the bearing is not reinforced to resist seismic loads; therefore, the concrete surrounding the anchor bolts could crack causing the anchor bolts to lose lateral resistance.

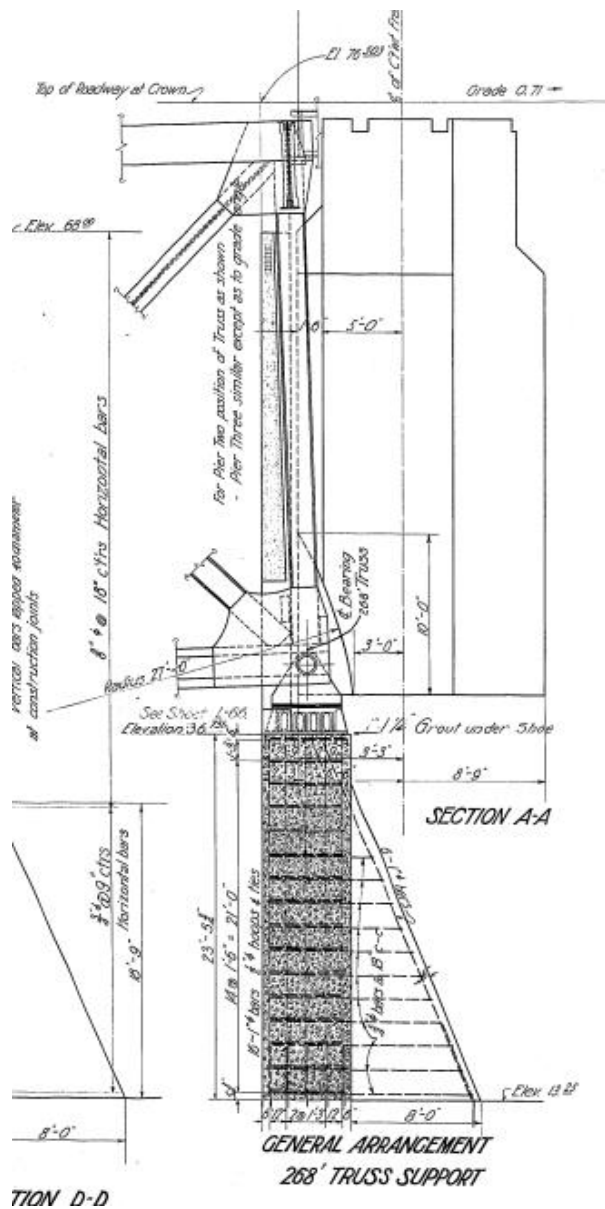
Figure 5-21. Truss Span Support at Piers 2 and 3

On the fixed support ends, the seating lengths do not conform to the current *AASHTO Guide Specifications for LRFD Seismic Bridge Design* (AASHTO 2012) requirements for seismic design. The seating length provided is 33 inches (see Figure 5-21), which is less than the required length per current standards. The truss girders can slip off from the

support at the pier tops due to the bearing anchor bolts being sheared off and unconfined concrete cracking, as indicated in the previous section.

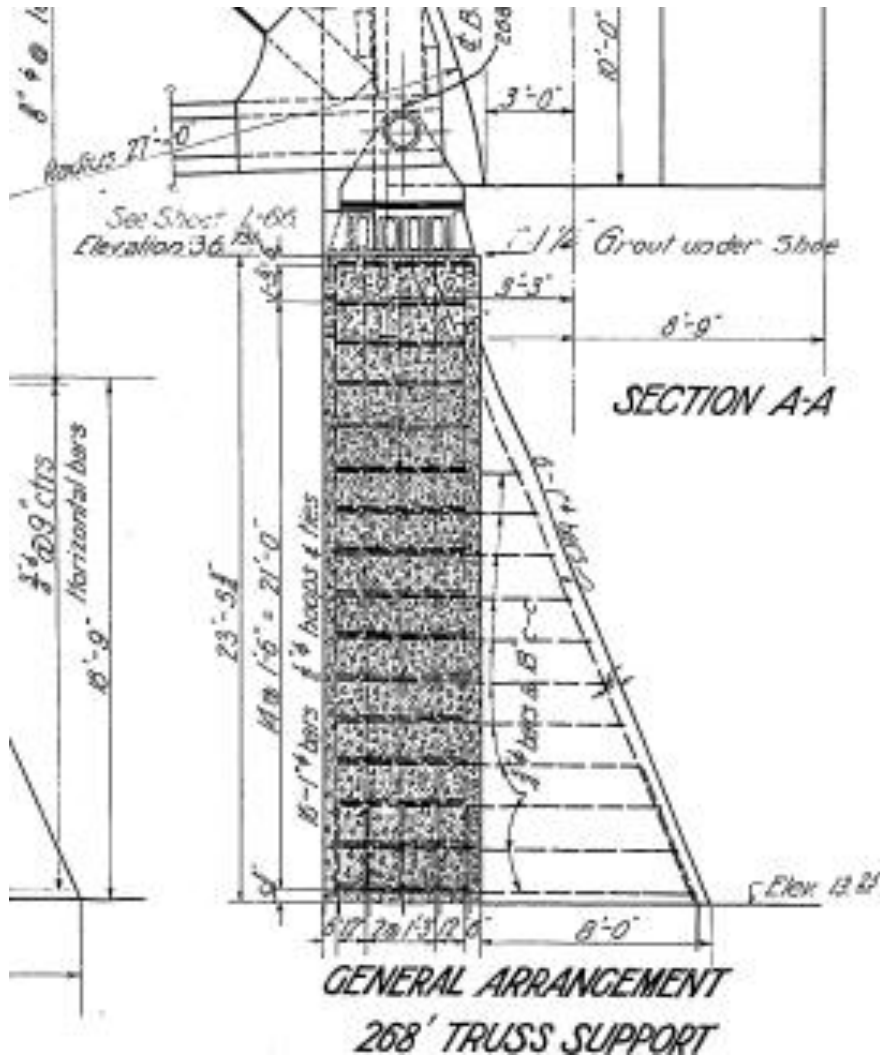
Figure 5-22. Wall Reinforcement under the Bearings at Piers 2 and 3

The pier columns or walls at Piers 1, 2, 3, and 4 are not properly reinforced with seismic reinforcing details; therefore, these columns and walls cannot function effectively as transverse seismic restrainers during a design-level earthquake. Therefore, the truss support will pull free from the existing pier structure. Reinforcement of Piers 1 and 4 can be seen in Figure 5-15. Reinforcement of the wall under the truss supports at Piers 2 and 3 can be seen in Figure 5-22.

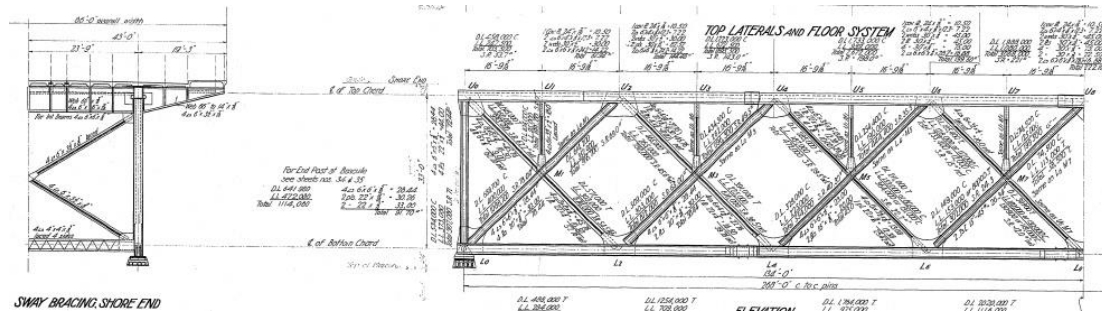
Figure 5-23. Fixed Steel Truss Span

Each of the truss spans is a 268-foot-long constant depth steel deck truss (see Figure 5-23). A reinforced-concrete bridge deck is supported by steel stringers and floor beams that are connected to the main steel trusses. An analysis of the truss member was conducted to determine the seismic deficiencies. The following sections generally describe the analysis results.

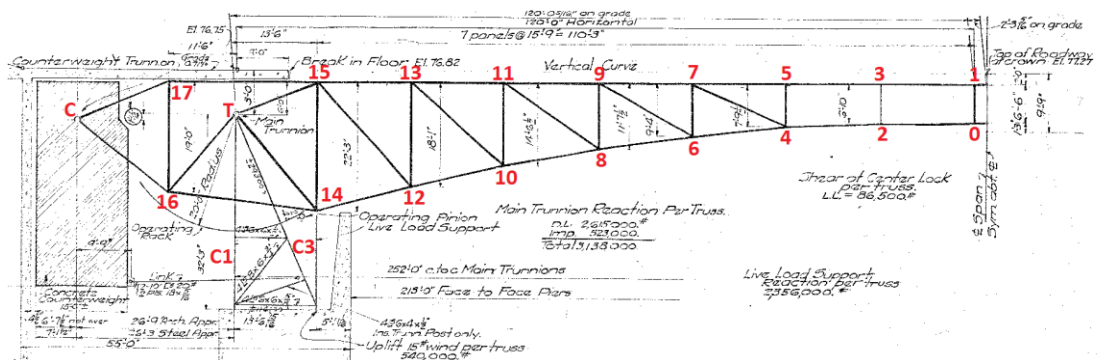
Figure 5-25. Bascule Leaf and Counterweight

Reinforced concrete decks are on top of the variable-depth bascule leaves. Each of the two bascule leaves, including the counterweight (see Figure 5-25), is supported via trunnion support steel frames on concrete pedestals inside the bascule pier. The centerlines of the bascule trunnions are at an elevation of 70.85 (NAVD 88), and the supporting concrete pedestals are at an elevation of 38.6 (NAVD 88).

The analysis was conducted step by step to identify the retrofit required. Table 5-2 shows members with C/D ratios less than 1.0 under a CSZ event. At a minimum, these members need to be strengthened. In Figure 5-25, the joint numbers are shown, and the members are identified in Table 5-2 by their joint-joint connection.

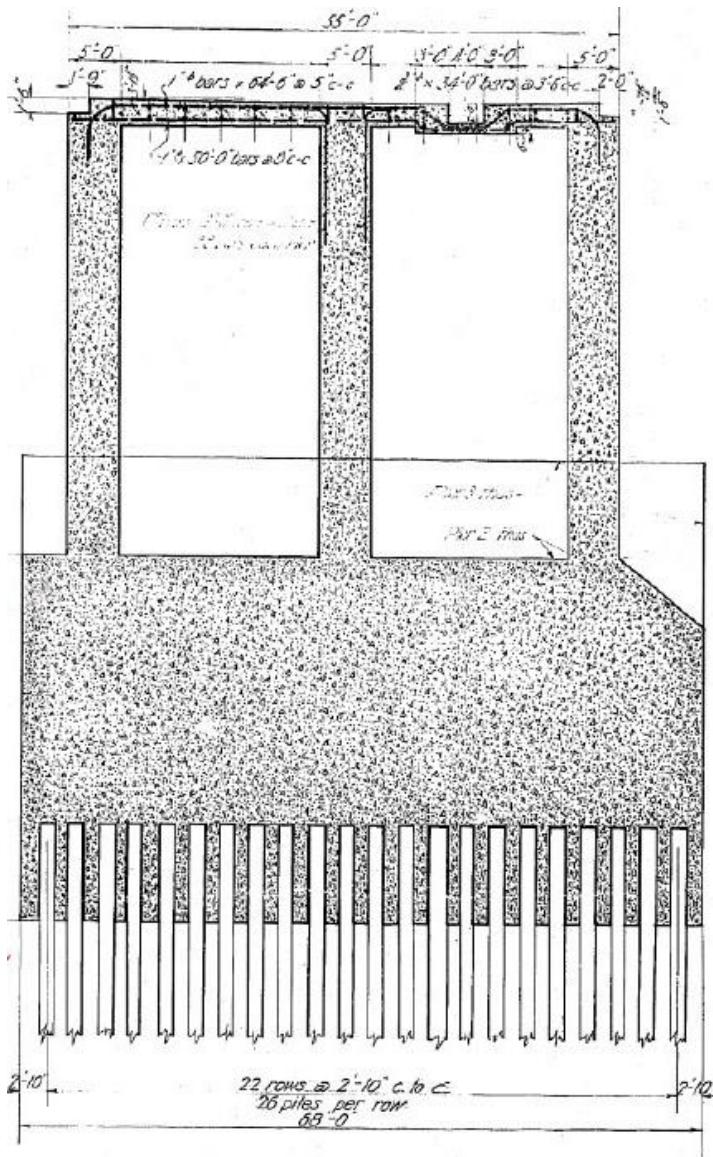
Figure 5-26. Bascule Pier Foundation

Existing bascule Pier 2 and Pier 3 foundations consist of unreinforced pile caps and groups of timber piles (see Figure 5-26). These foundations were neither designed nor constructed according to current seismic design requirements and detailing practices. During a design-level earthquake, these foundations would fail as described below.

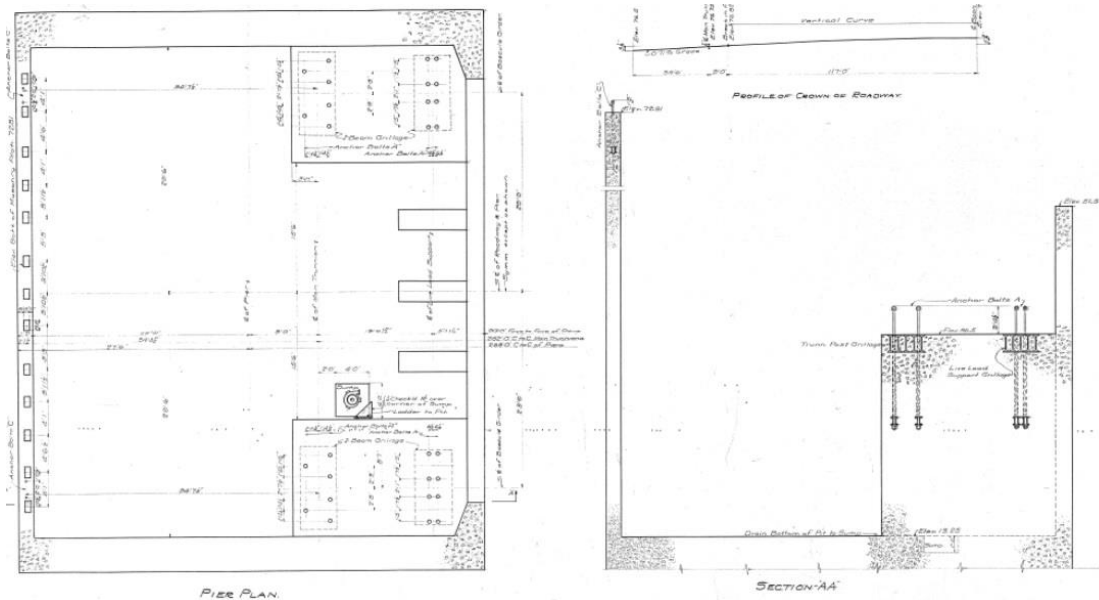
Figure 5-27. Bascule Pier Walls

Pier walls were designed for non-seismic lateral loads such as wind loads and gravity loads only. They are not reinforced and detailed to resist seismic forces (see Figure 5-27).

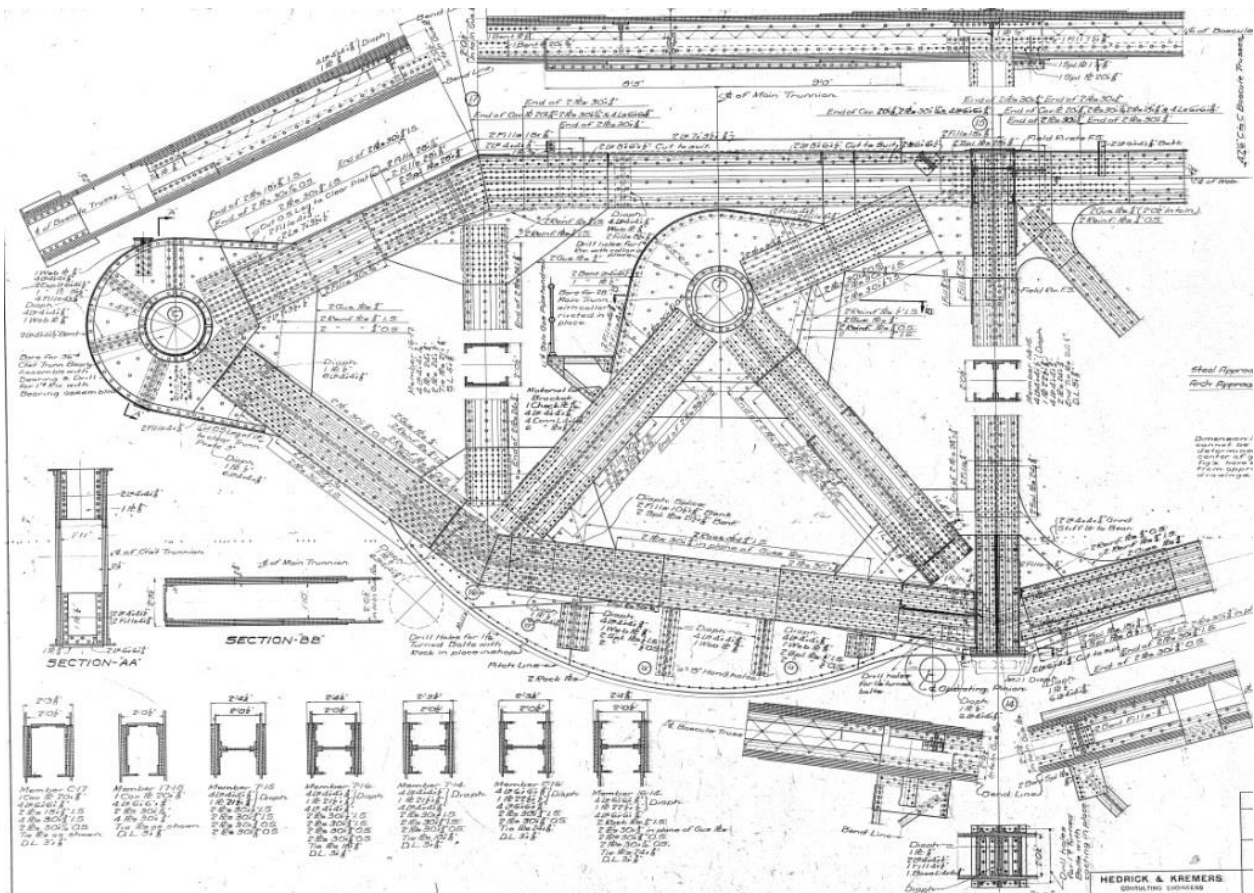
Figure 5-30. Counterweight Support Frame

No lateral supports restrain the counterweight. This exposes the counterweight support frames to buckling (see Figure 5-30). Counterweight support member 16-C has a C/D ratio for shear of 0.21 and a value of 0.40 for the inverse of the compression-moment interaction (see Table 5-2). In addition, unrestrained lateral movement of the counterweight can impact the reinforced concrete walls supporting the sidewalks.

T-15 can be seen in Figure 5-30 as the top right member in the connection to the trunnion.

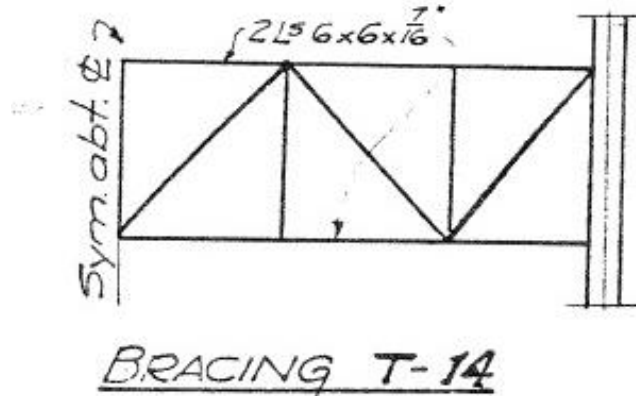
Figure 5-31. Bracing for Trunnion support Frame

Bracing frame T-14 (see Figure 5-31) transmits lateral loads from the entire bascule span to the trunnion tower support frame. These members were not originally designed for transmitting the seismic motion-induced lateral forces, thus are vulnerable to buckling and yielding during a design-level seismic event. For shear, the C/D ratio for T-14 was 0.21. For the inverse of the tension-moment interaction, the resulting value was 0.62. In addition to T-14, member T-15 has a C/D ratio of less than 1.0 (see Table 5-2). Member

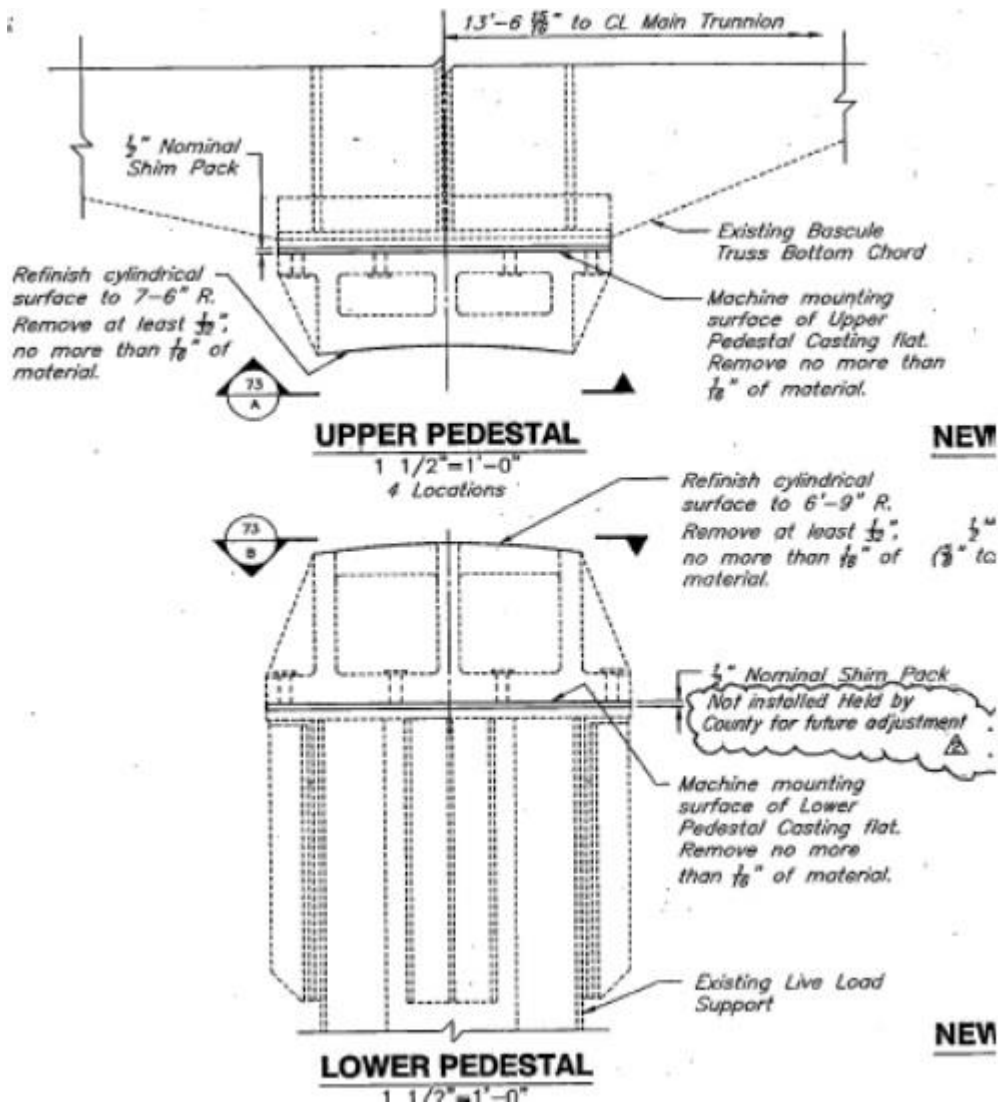
Figure 5-32. Live Load Shoe

The live load support shoes were designed to resist unbalanced vertical loads and live loads (see Figure 5-32). Because it is a simple bearing plate, the live load support cannot resist lateral or upward (tension) loads present in a seismic event. During a design-level seismic event, the bascule leaves will move horizontally and rotate around approximately the intersection of the centerline of the trunnion and the centerline of the bridge. Without the live load shoes' help in resisting vertical and horizontal rotational movement of the bascule leaf, the bascule trunnion support frames (member T-C3) will be exposed to large forces causing buckling or tension failures of the trunnion support frames.
