Enhanced Seismic Retrofit Technical Report

Multnomah County | Earthquake Ready
Burnside Bridge

January 29, 2021

Earthquake Ready Burnside Bridge Enhanced Seismic Retrofit Technical Report

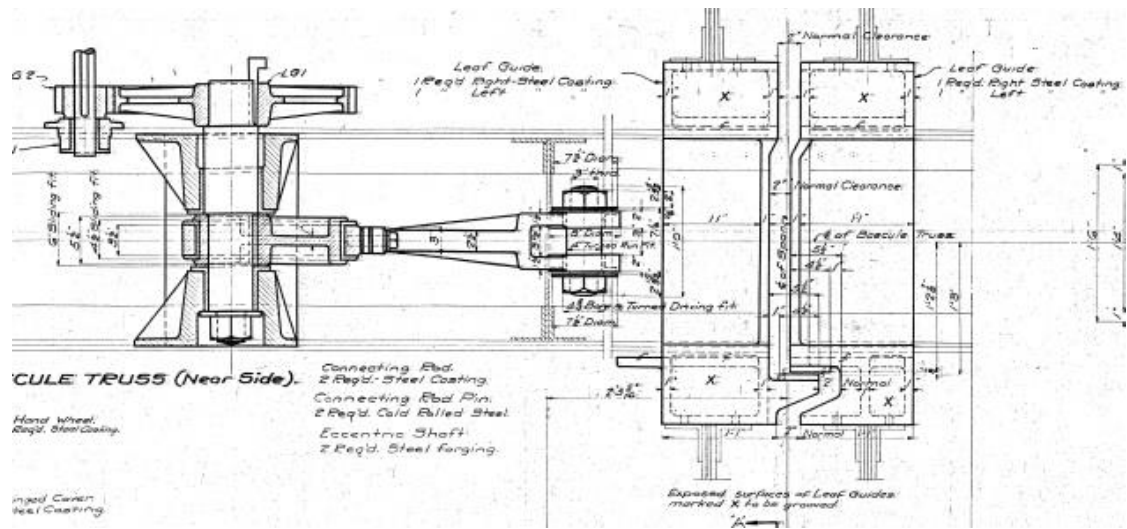
Figure 5-33. Bascule Span Center Lock

A typical bascule leaf center-span lock, such as the one on the Burnside Bridge, is not designed to transmit forces caused by the relative transverse displacement of the two bascule spans and can be severely damaged in a significant seismic event (see Figure 5-33). When the center lock is damaged during a seismic event, bascule leaves without the center lock can sway in different directions, causing large horizontal forces on the trunnion support frame.

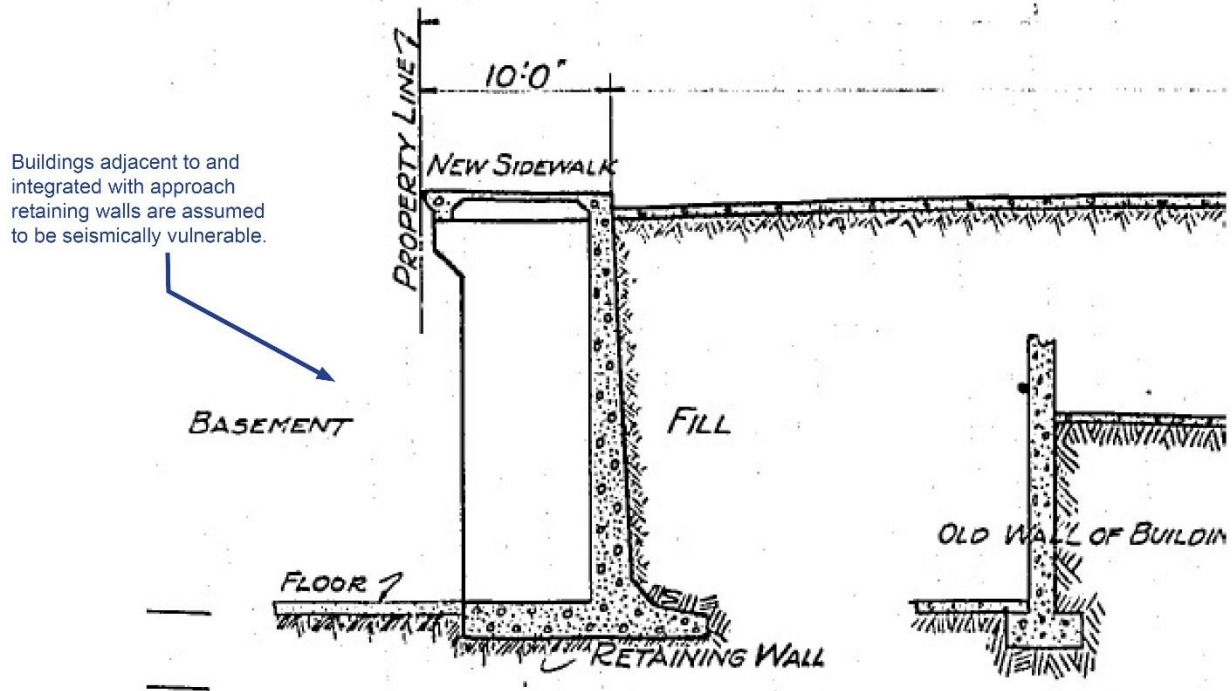
Figure 5-34. Retaining Walls at Approach

Approach retaining walls at both the west and east ends of the bridge consist of a mix of reinforced semi-gravity cantilever walls and counterfort walls. As discussed previously, in many cases, these retaining walls are integrated with the adjacent buildings (see Figure 5-34).

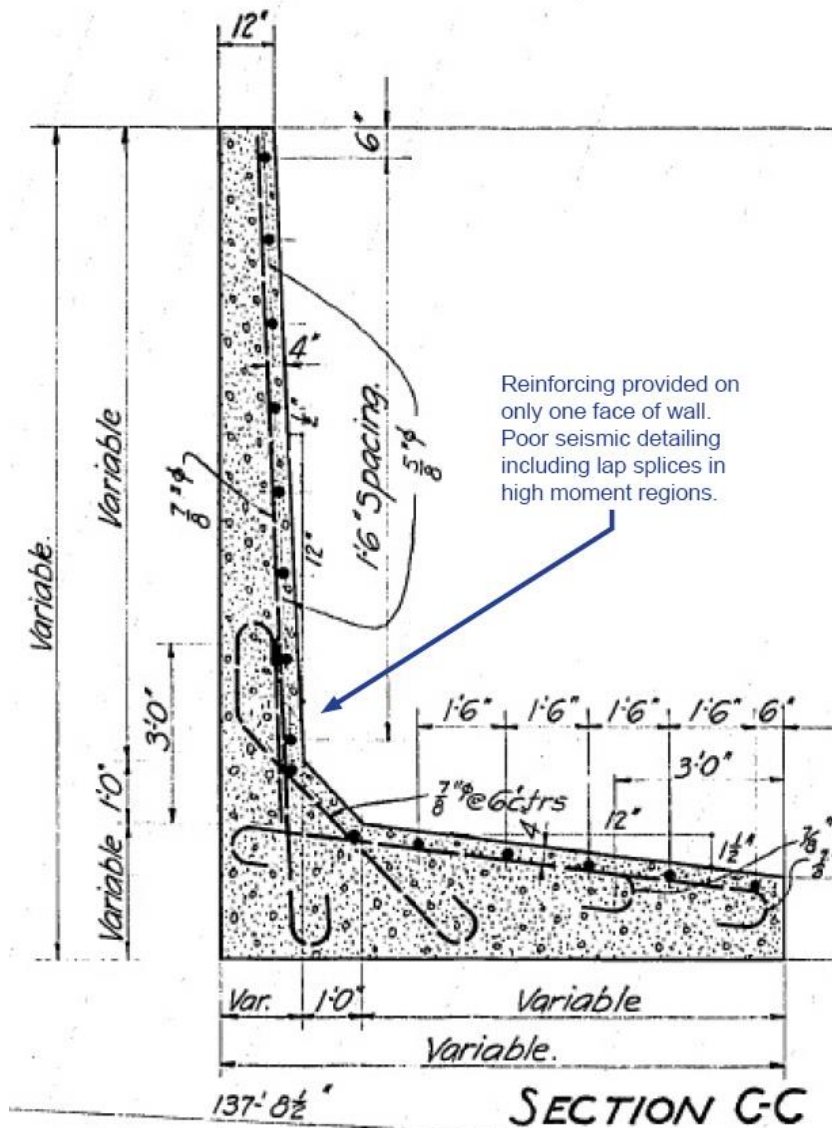
Figure 5-35. Retaining Wall Reinforcement

Vulnerabilities identified in these approach retaining walls include poor seismic detailing with lap splices in high moment regions, and buildings adjacent to and integrated with approach retaining walls (see Figure 5-35).

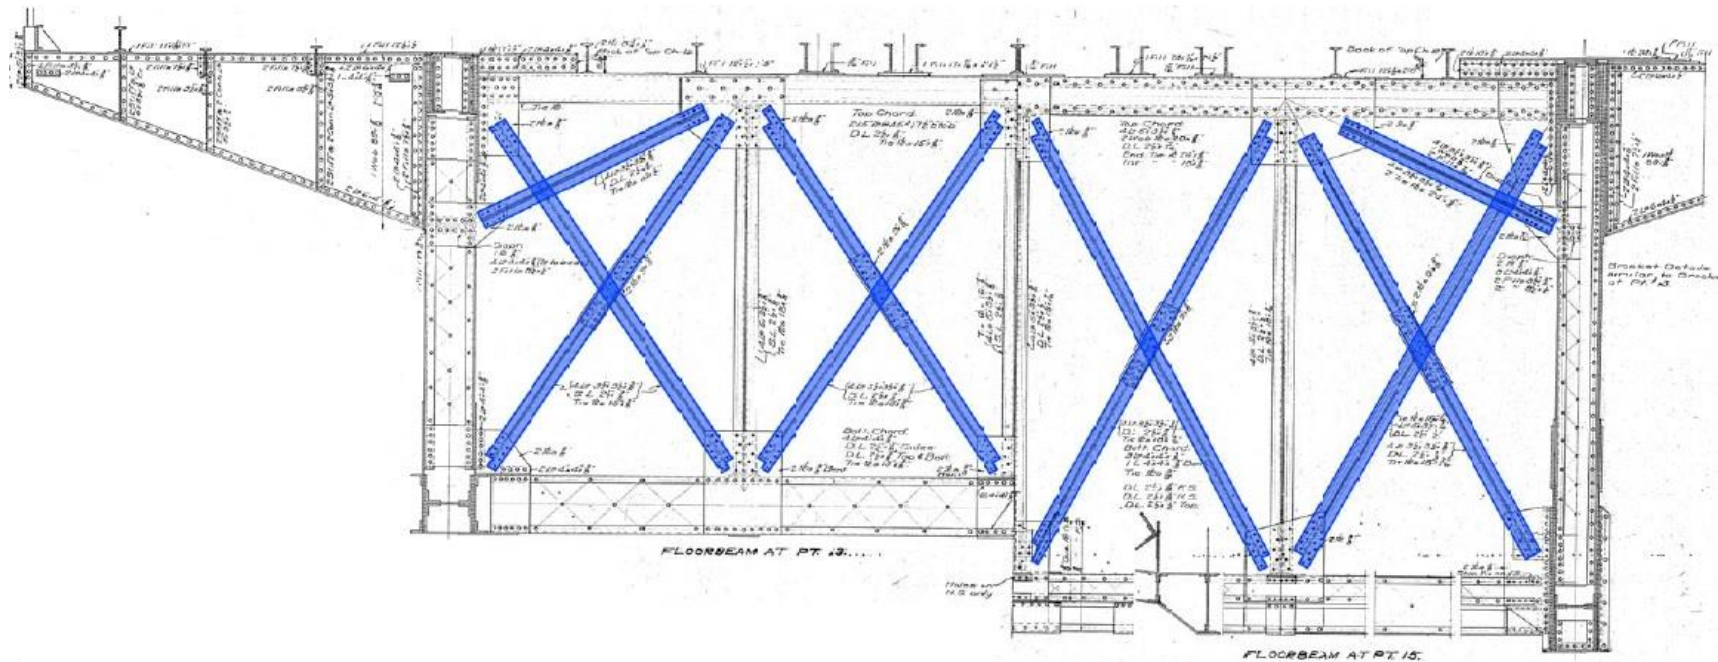
Figure 8-19. Strengthening of Bascule Leaf Lateral Bracings

The bascule leaf trusses were not designed for seismic loads and movement; adding or strengthening the lateral load-carrying members is required. These members include diagonal sway bracings and connected vertical members, as well as bottom lateral bracings (see Figure 8-19). The bracing members at truss member connections 13, 14, and 15 would have the highest priority for strengthening.

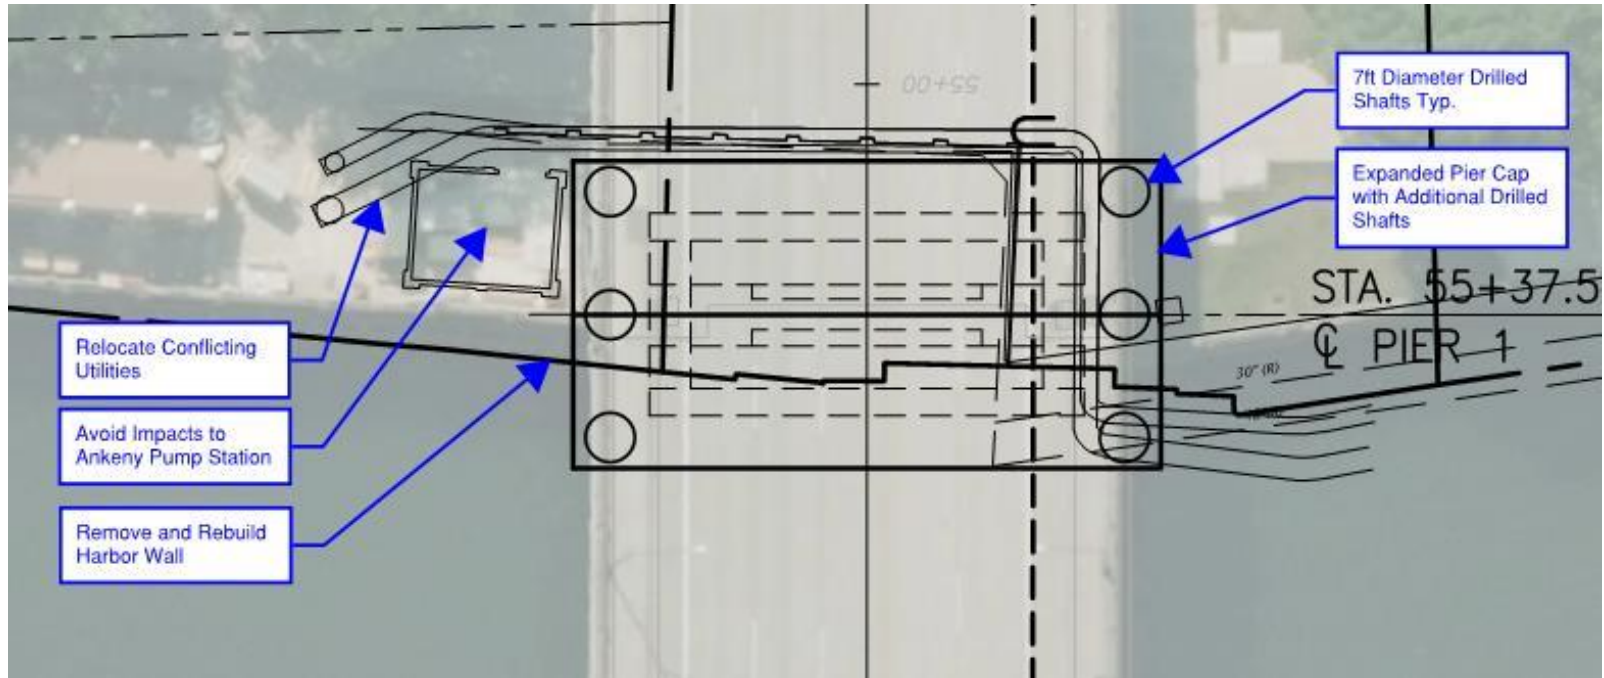
Figure 12-1. Site Restraints at Pier 1

At Pier 1, there are major underground utility lines, a pump station, and a seawall adjacent to the pier foundation. The foundation retrofit would need to be coordinated with potential utility line relocations and reconstruction of the seawall, and would need to avoid impacting the pump station (see Figure 12-1). These requirements would increase construction costs.

Given that the Ankeny Pump Station is adjacent to Pier 1, transverse post-tensioning on the enlarged new shaft cap would be limited for jacking operation from the north side only. One end jacking would not be an issue because the relatively short tendon length.

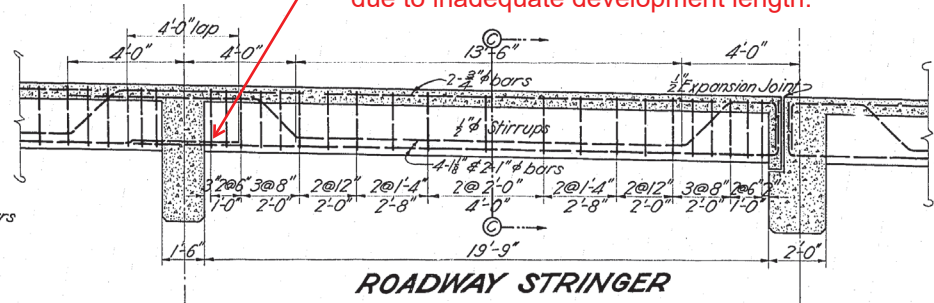
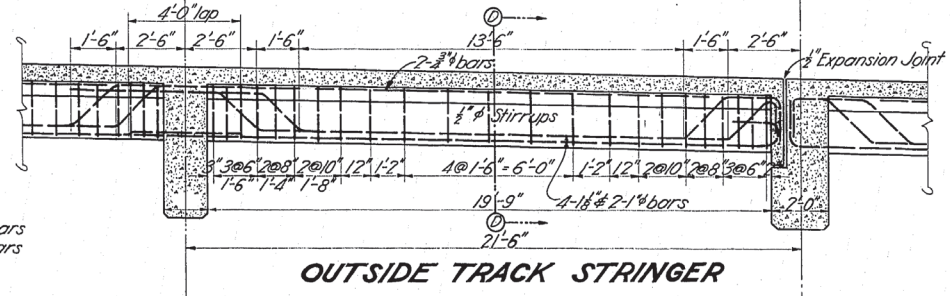
W1

Poor seismic detail. Girder positive moment reinforcement spliced at column connection thus limiting moment capacity due to inadequate development length.

At isolated locations, inadequate negative moment capacity at midspan to maintain elastic behavior for CSZ event.

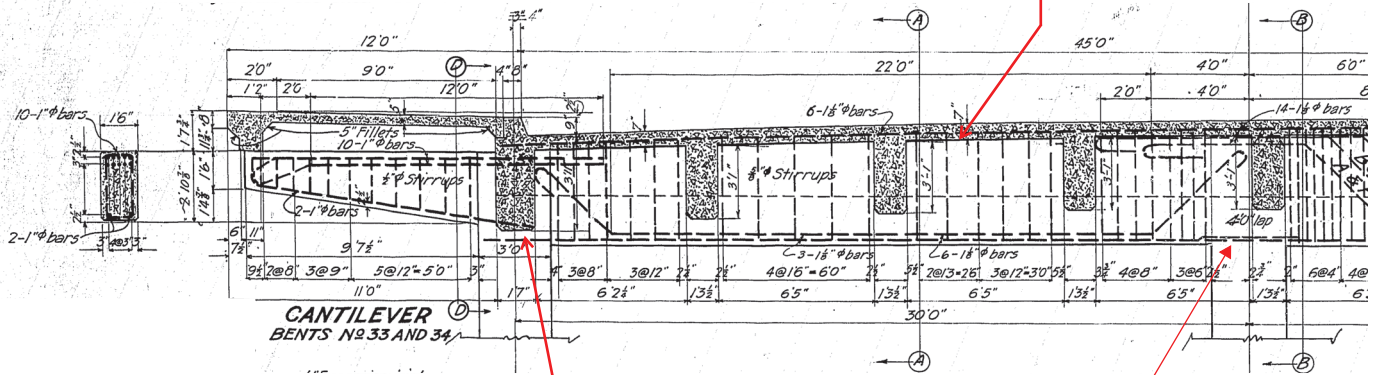
W2

Poor seismic detail. Floorbeam positive moment reinforcement spliced or has limited embedment at column connection thus limiting moment capacity due to inadequate development length.

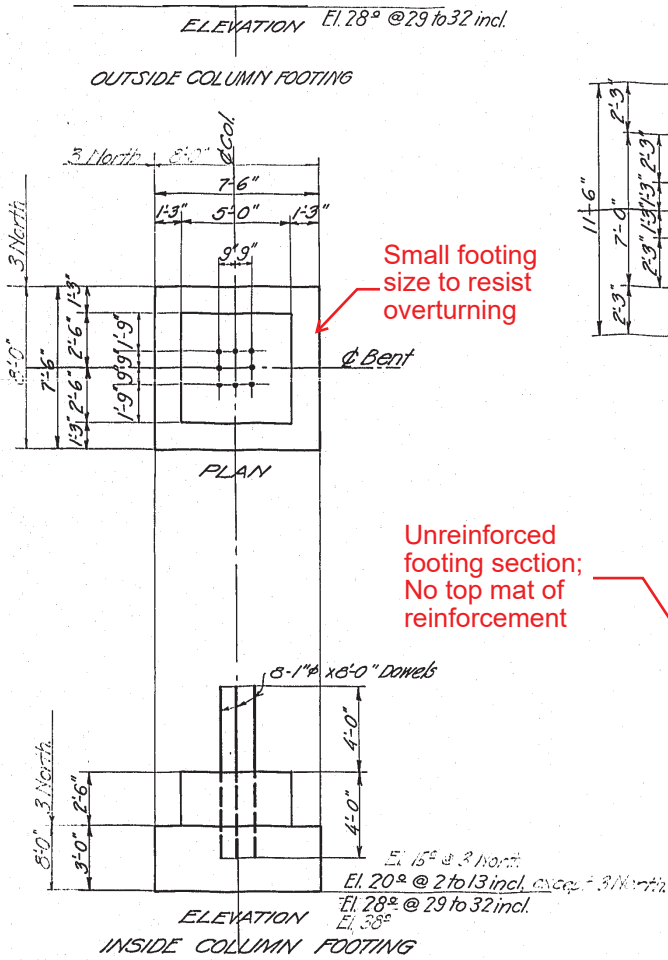
Small footing size to resist overturning

Unreinforced footing section; No top mat of reinforcement

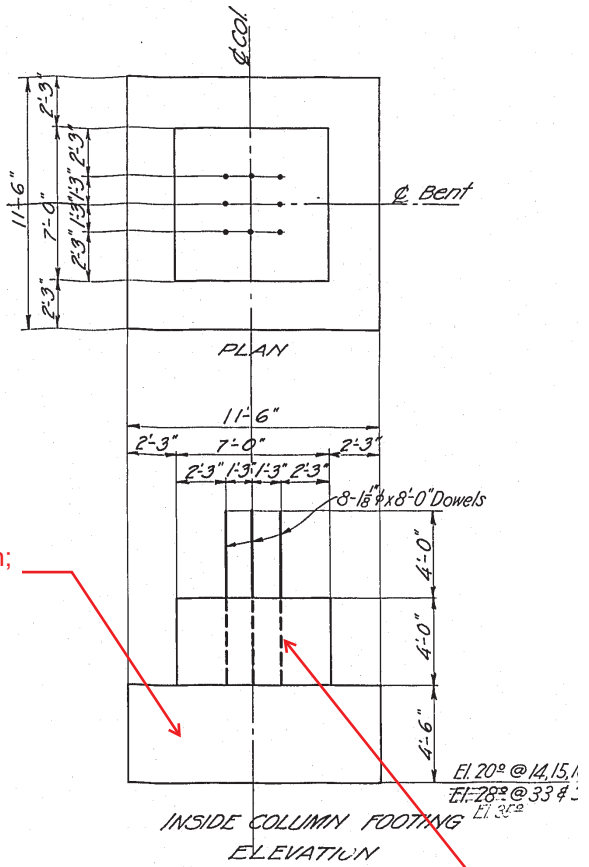
BENTS 14, 15, 16, 33, 34

Poor connection detail; Column reinforcement does not extend into footing with adequate embedment.

Soil Structure Interaction:
 Spread footing inadequate to limit settlement from liquefaction to a desirable level.

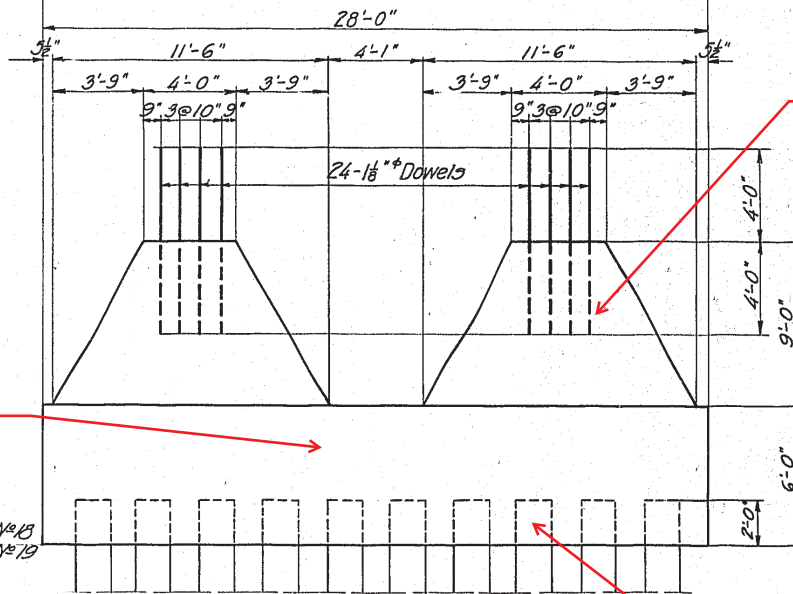
BENTS 18-19

Embedment of piles into pile caps inadequate to resist seismic uplift forces.

Soil Structure Interaction:
 Pile group capacity inadequate to limit settlement from liquefaction to a desirable level, resist uplift and downdrag forces, and to resist displacements and forces from lateral spreading.

Bents 18 & 19 on timber piles with limited capacity to resist liquefaction induced settlement, and lateral forces and displacements due to lateral spreading.

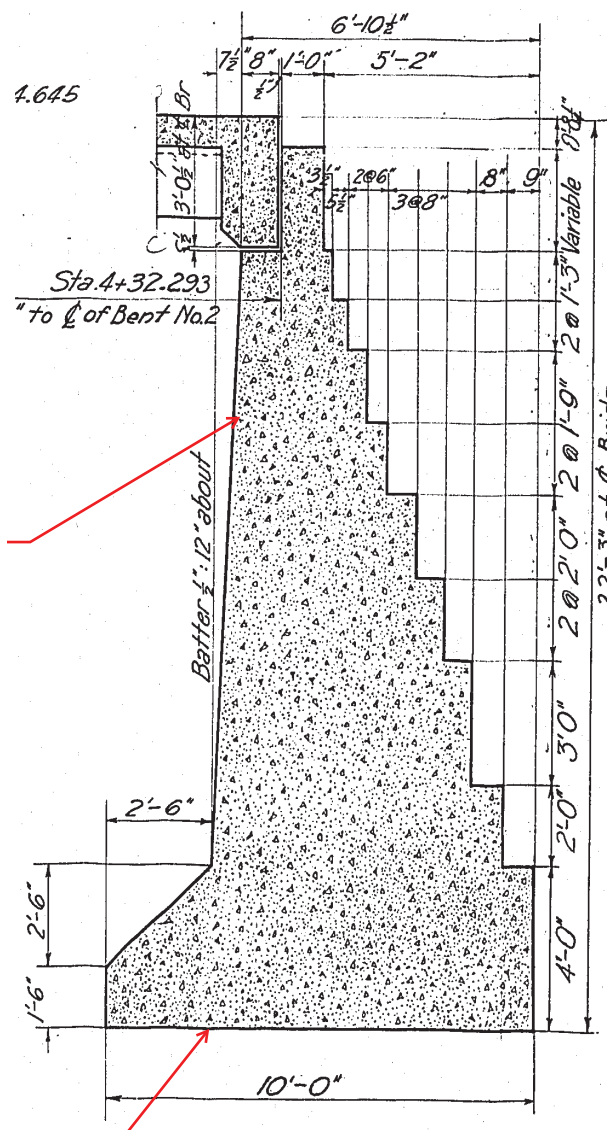
SECTION B-B

Unreinforced abutment wall.

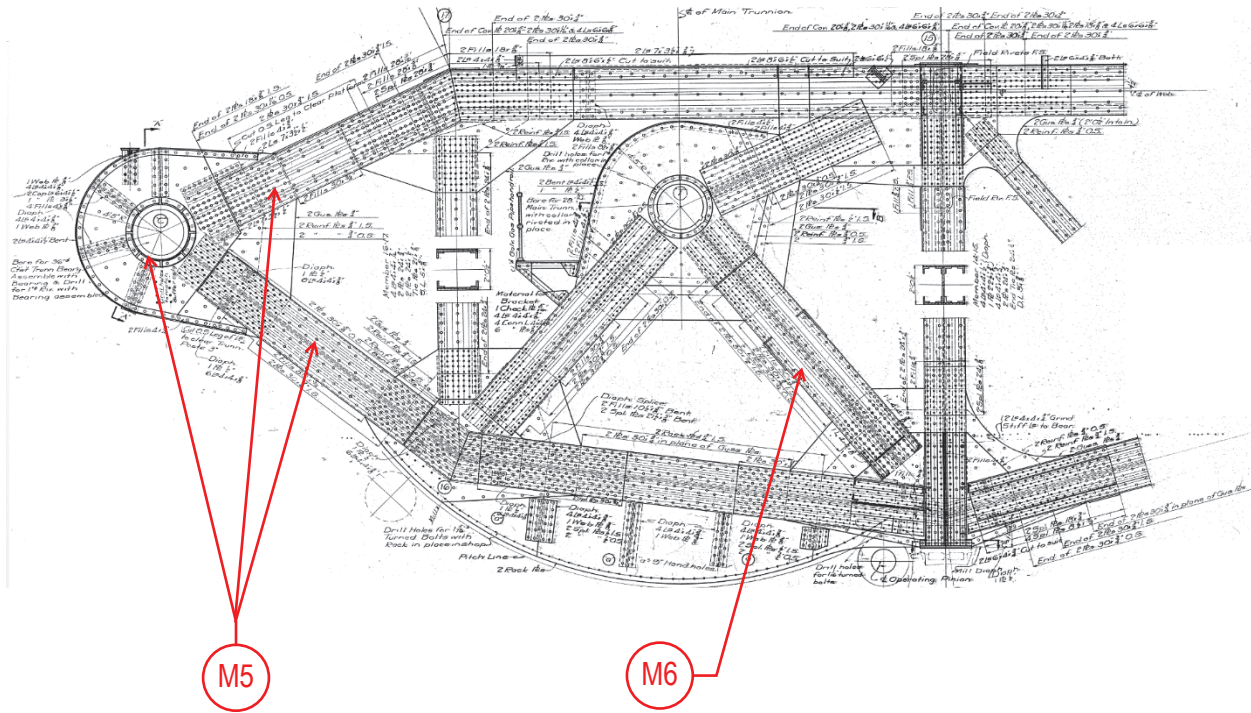
M5

No lateral supports restrain the counterweight. This exposes the counterweight supports to buckling. In addition, unrestrained lateral movement of the counterweight can impact the reinforced concrete walls supporting the sidewalks. See Note M9

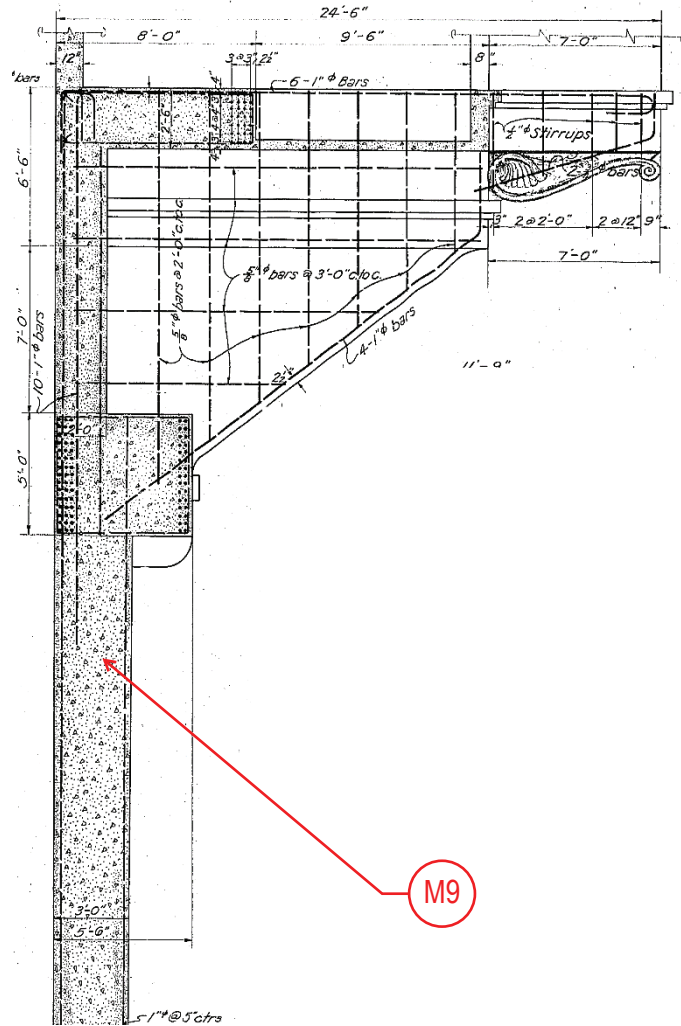
M9

Pier walls were designed for wind loads and dead loads only, and not detailed to resist seismic forces.

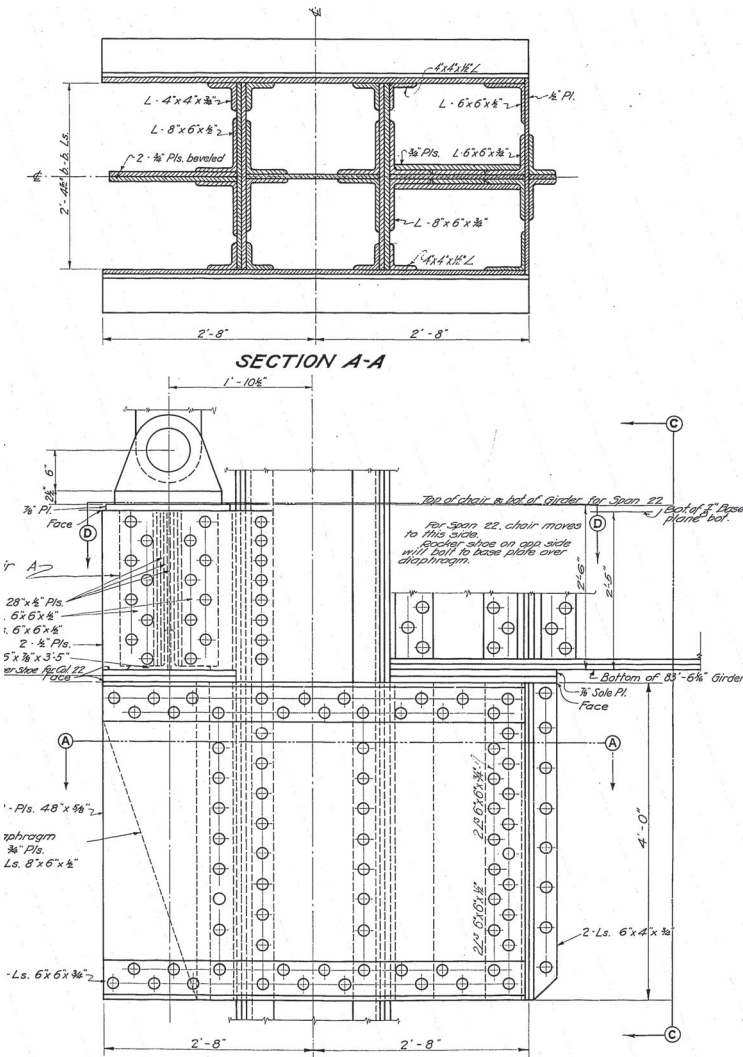
ELEVATIONS COL. 24

Rocker bearings are not stable for large displacements and likely to tip over. Also the rocker was not designed to restrict transverse movement.

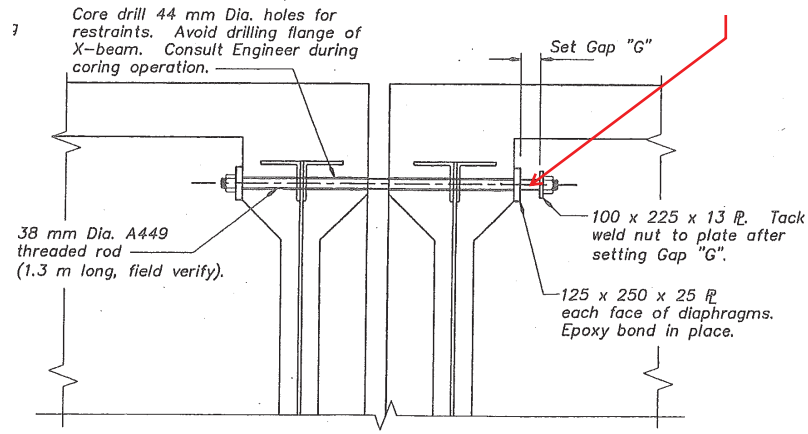
LONGITUDINAL RESTRAINT DETAIL

Longitudinal restrainers installed in the early 2000s tied the superstructure together near deck level and do not restrict transverse movement of the superstructure.

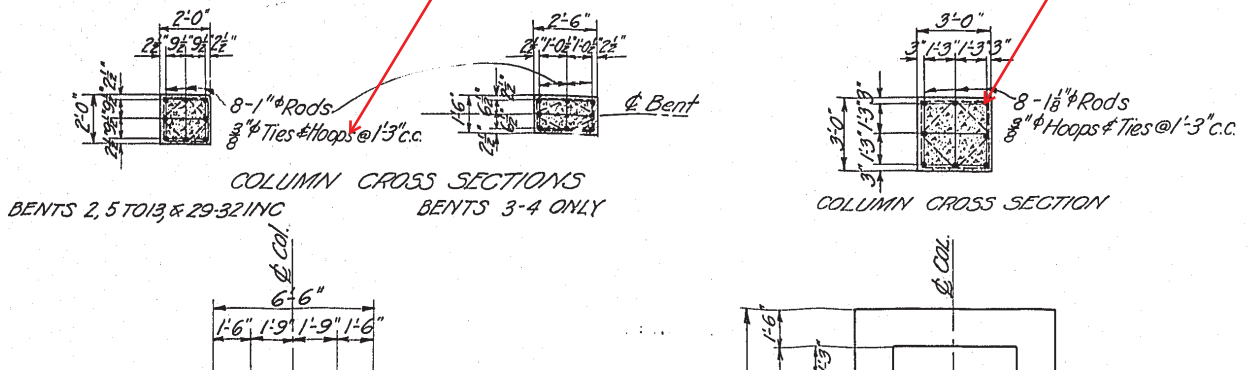
E4

Poor confinement; Lack of seismic hooks; Ties and hoops @ 1'-3"

Minimal longitudinal column reinforcing extending into footing. Inadequate development length.

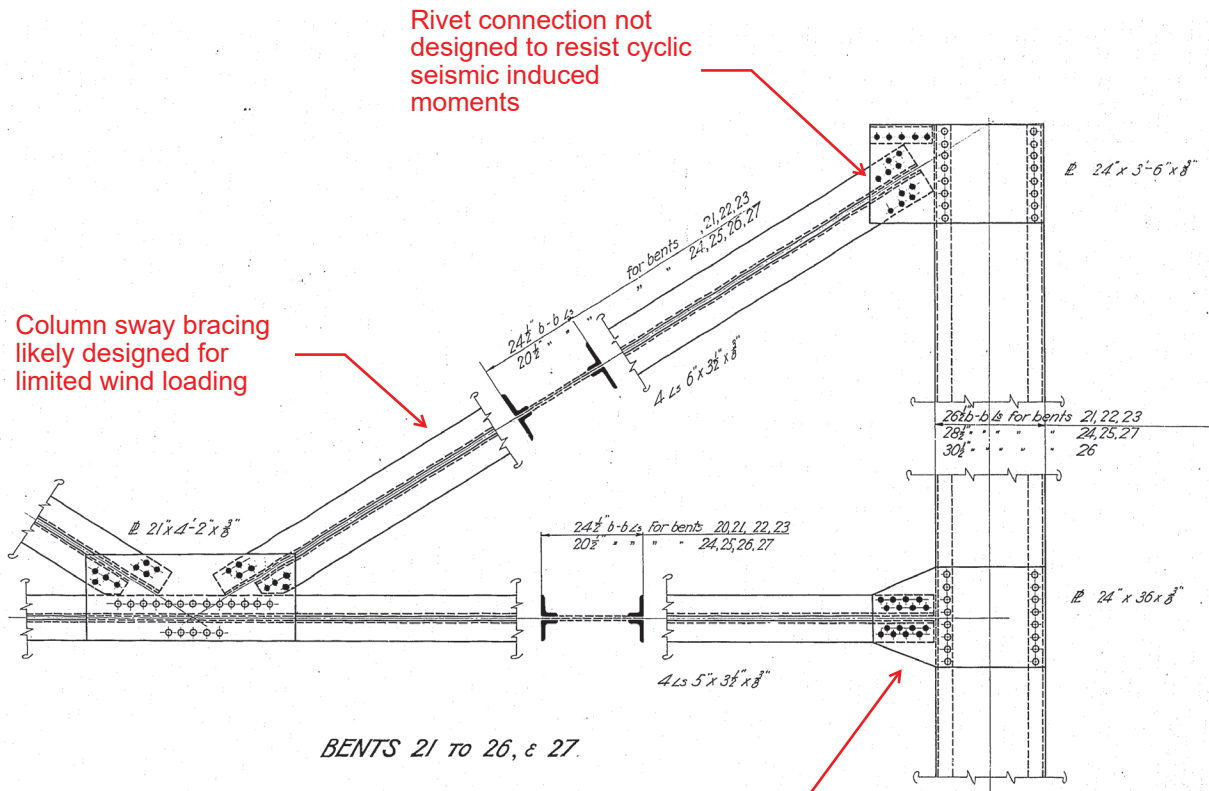
Rivet connection not designed to resist cyclic seismic induced moments

Column sway bracing likely designed for limited wind loading

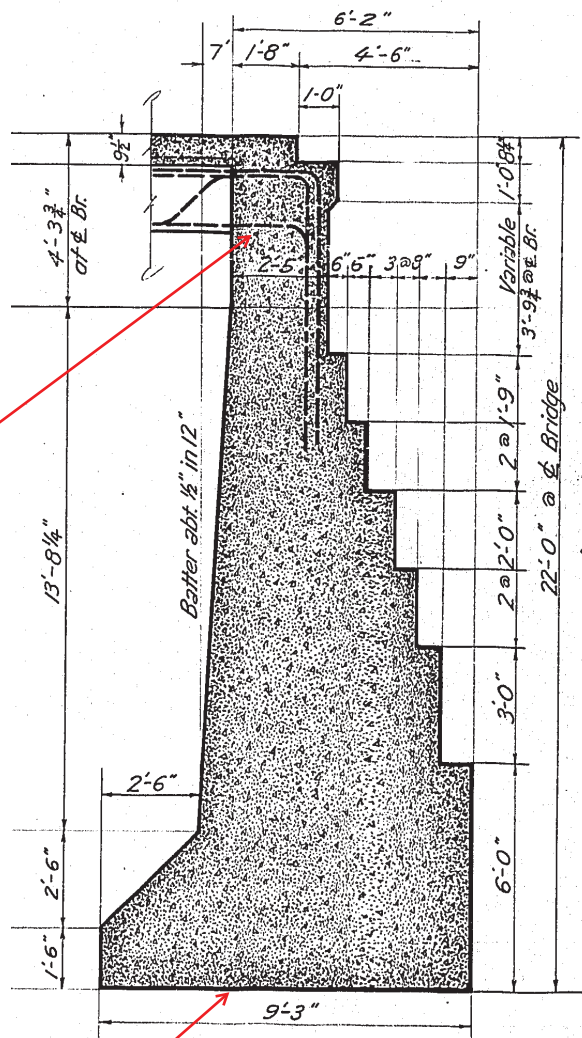
SECTION B-B

Fixed end connection between superstructure and abutment imparts seismic loads on unreinforced abutment wall.

Soil Structure Interaction: Liquefaction induced settlement and lateral spreading not anticipated at Bent 35.

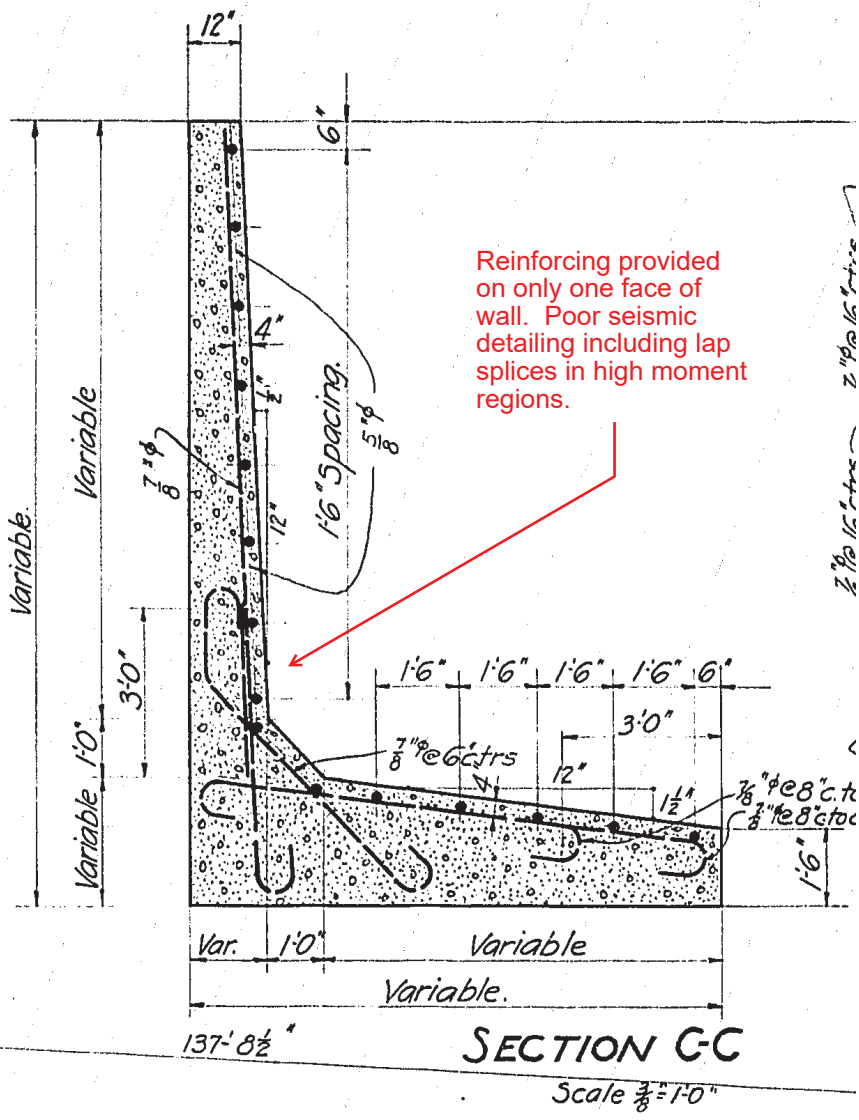
Reinforcing provided on only one face of wall. Poor seismic detailing including lap splices in high moment regions.

Soil Structure Interaction: Liquefaction induced settlement and lateral spreading not anticipated at East Approach retaining walls.
