# Exhibit M – Geologic Hazards Permit

**GEOLOGIC HAZARDS PERMIT (GHP) Form 1:  
 GEOTECHNICAL RECONNAISSANCE AND STABILITY  
 PRELIMINARY STUDY**

# Geotechnical Report & Landslide Hazard Study

12424 NW Springville Road  
Portland, Oregon

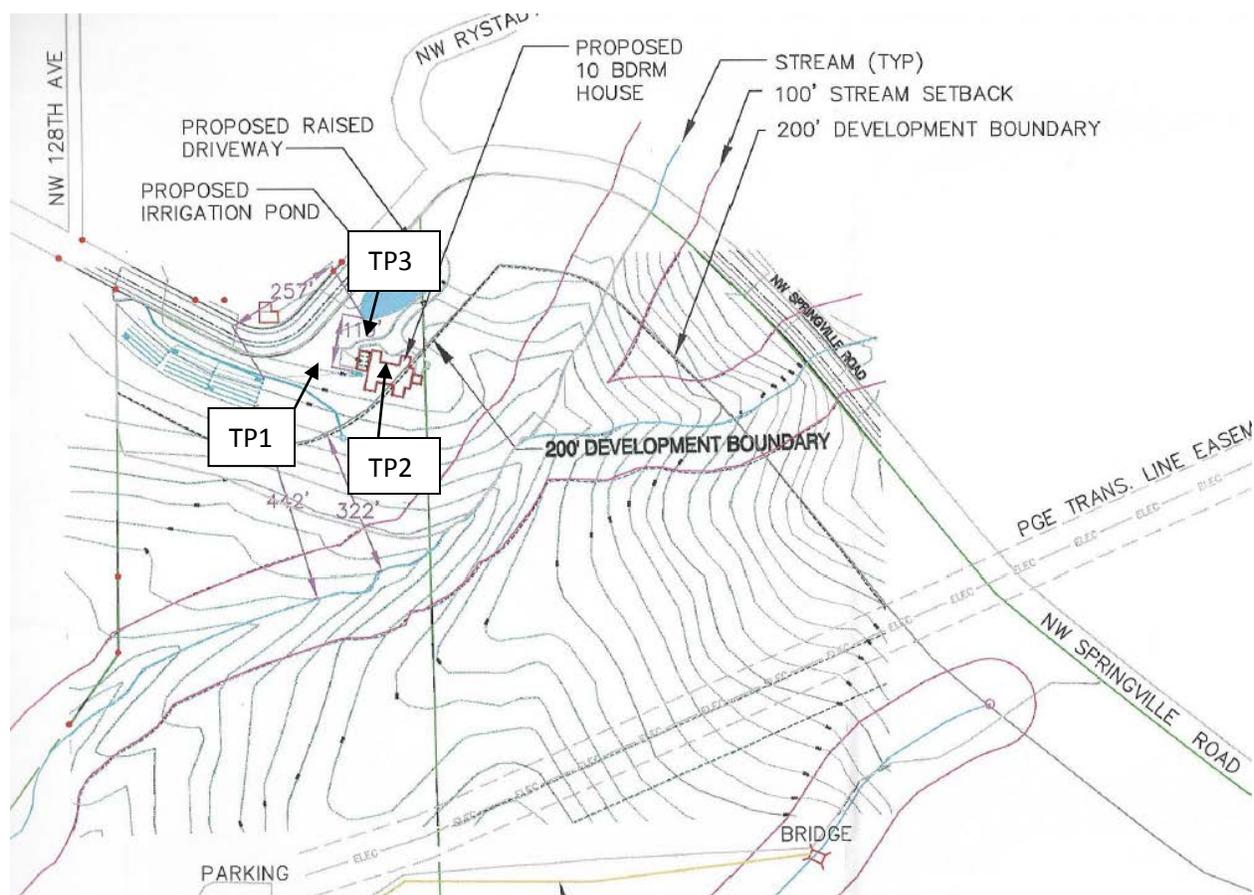
Figure 2- site plan and aerial with testing locations

A total of three (3) test pits were excavated with an excavator. The locations of the test pits are shown on figure 2 in Appendix A. A registered professional engineer observed the excavation and logged the subsurface materials. Boring log detailing materials encountered is in Appendix B. The logs were created using the Unified Soil Classification and Visual Manual Procedure (ASTM-D 2488). Samples were transported to the laboratory for further classification in seal bags. Please see Appendix B for further laboratory results. The soil conditions were stiff to very stiff silty CLAY to a depth of 6 feet. Basalt layer was not encountered. Moisture contents were 22.2% to 28.4%. Groundwater was not encountered.

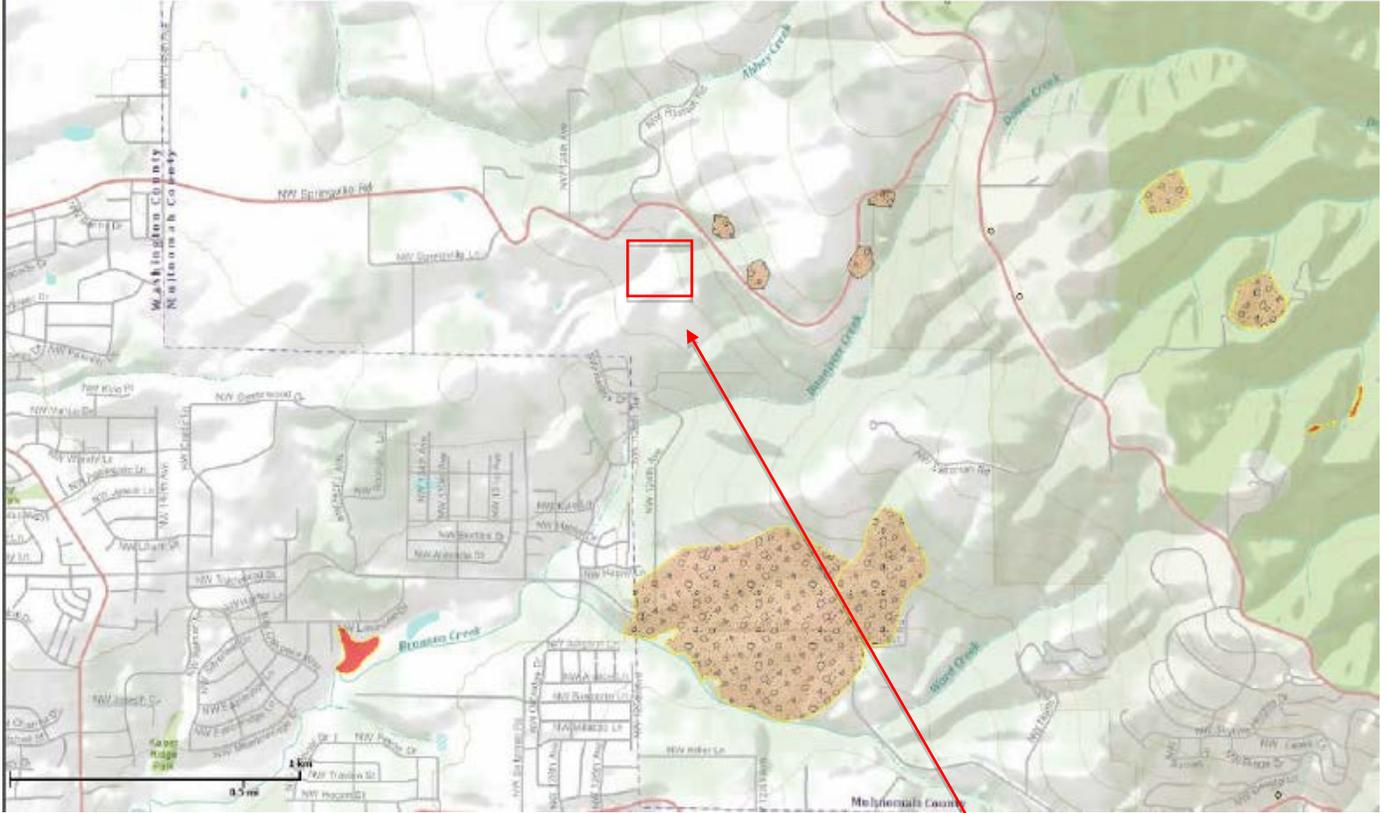
Figure 3- Hazards

O-90-02 and O-08-06 map the Oatfield Fault traversing the southwest corner of tax lot 2800 in a northwesterly direction, downthrown to the southwest. Much of the surface south and southwest of the Oatfield Fault in the site vicinity is mapped as landslide debris, or massive coalesced debris fans. Three small debris fans are mapped in the creek drainages immediately east and northeast of the proposed house location above the Oatfield Fault. A landslide is mapped near the middle of tax lot 600 several hundred feet southeast of the proposed house location. See figure 3. There are no known mapped landslides on the project site. Soil maps are shown below.

LIDAR imaging of the site vicinity figure 3 shows several bowl-shaped scarps with associated down slope debris channels above the project site.

Bannister Creek flows generally southwestward near the eastern margin of tax lot 600 and an un-named tributary of Bronson Creek traverses the site in a southwesterly direction a few hundred feet southeast of the proposed residence location. Two other southwesterly drainages traverse tax lot 600 between these two drainages, making a total of four rather substantial drainages (see LIDAR image, figure 3).
