Downtown Portland Earthquake Preparedness Tour

April 18, 2012, 2 p.m.

Introduction and Purpose

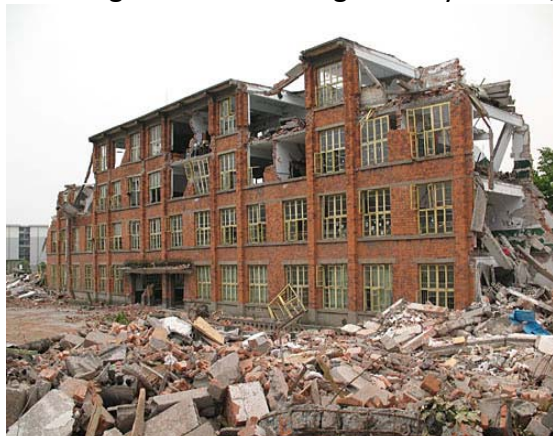
Unreinforced Masonry (URM) buildings can collapse during earthquakes, killing and injuring its occupants. About 19,000 students died in schools in the 2008 Wenchuan China earthquake, including in the Han Wang Primary School, which was a URM.

Han Wang Primary School, China 2008 earthquake damage URM (Source: Kit Miyamoto)

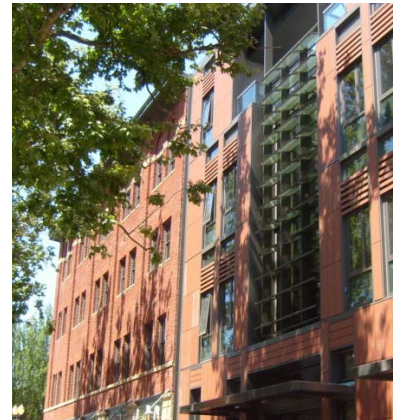
Picture 1: Mercy Corps south side

- The new Mercy Corps Headquarters is an approximate total 80,000-sf building which consists of a new four-story 37,500-sf steel frame building constructed adjacent to and integrally with the existing four-story approximate 42,500-sf Skidmore Fountain Building. **See Picture 1.**

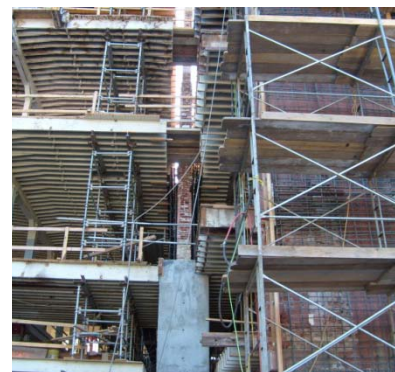
Picture 2: East side of existing building during construction

- Added concrete walls to the existing building to provide more seismic support. **See Picture 2.**
- Added foundations and piles were added to support the building.
- Steel framing along the URM walls. The steel framing helps to provide a backup gravity support for the wood and floor framing the URM walls are supporting as well as to strengthen the URM walls from falling off the

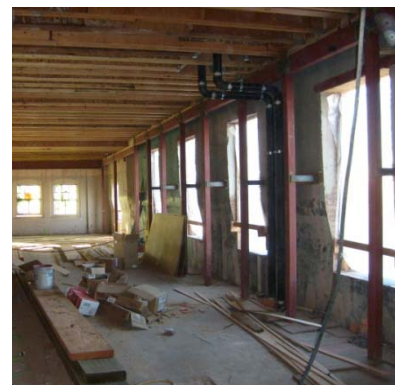
Picture 3: Inside of existing building during construction with added steel

building in an earthquake. **See Picture 3.**

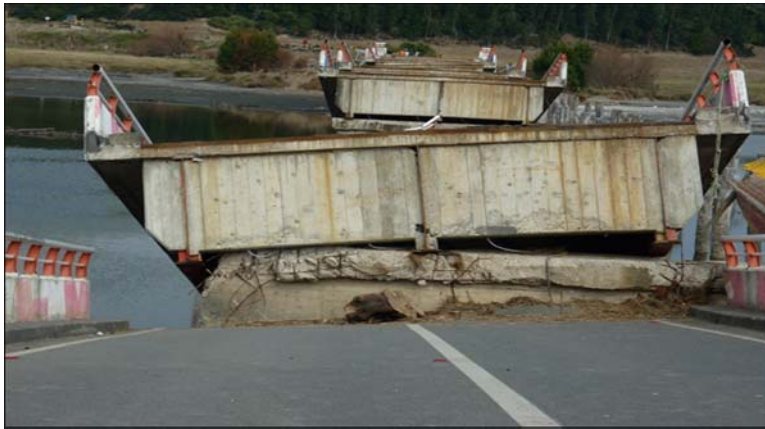
Some bridges are designated emergency routes and should be reliable after disasters, including a Cascadia earthquake. Bridge decks can become dislodged from their supports during earthquake shaking, such as this bridge in the 2010 magnitude 8.8 Chile earthquake.

2010 Chile earthquake, bridge damage (Source: ASCE TCLEE)

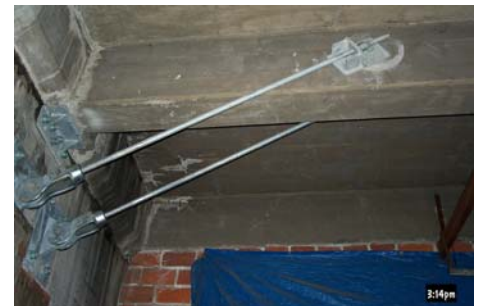
A 2002 Phase I seismic upgrade of the Burnside Bridge included restraining rods to prevent girders from being pulled off piers during an earthquake.

In 2002 Multnomah County did a Phase I retrofit to the bridge. The design was based on a seismic force of 0.2g which is based on a 500-year return event. This retrofit included longitudinal restraints at each of the bents and piers that were subject to pull-off in a seismic event. This included a total of 18 bents. Also at piers 1 and 4 bearing wedges were added to reduce the risk of bearing failure in a seismic event.

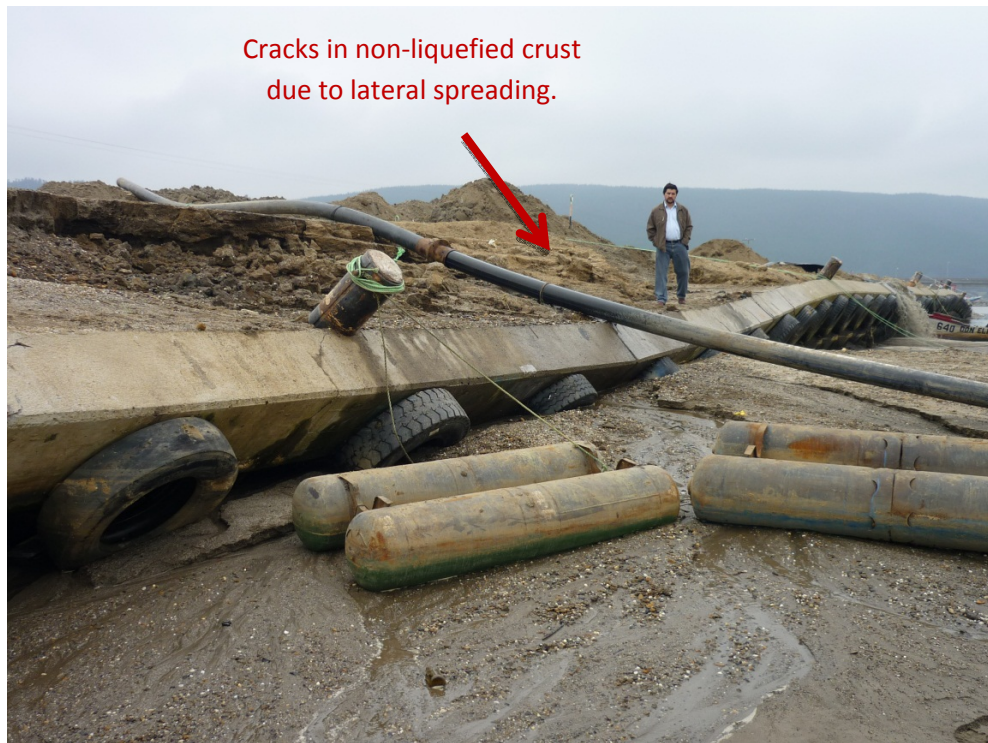
Source: Allison Pyrch and Yumei Wang as part of engineering investigation team for the 2010 magnitude 8.8 Chile earthquake.

Allison Pynch and Yumei Wang took part in an international engineering investigation team that observed numerous waterfront structures that failed in the 2010 magnitude 8.8 Chile earthquake due to liquefaction and lateral spreading. As an example, this sea wall (below) failed due to liquefaction of the foundation soils under the wall, which lost strength such that it could no longer support the weight of the concrete wall, as well as the increase of pressure exerted by the liquefied soils behind the wall. Lateral spreading damage in the form of cracks behind the wall can be seen in the photo.
