# "Lower" Lower Beaver Creek

By Jake Kerlake, Sara Martin, and Joel Campean

Winter 2024

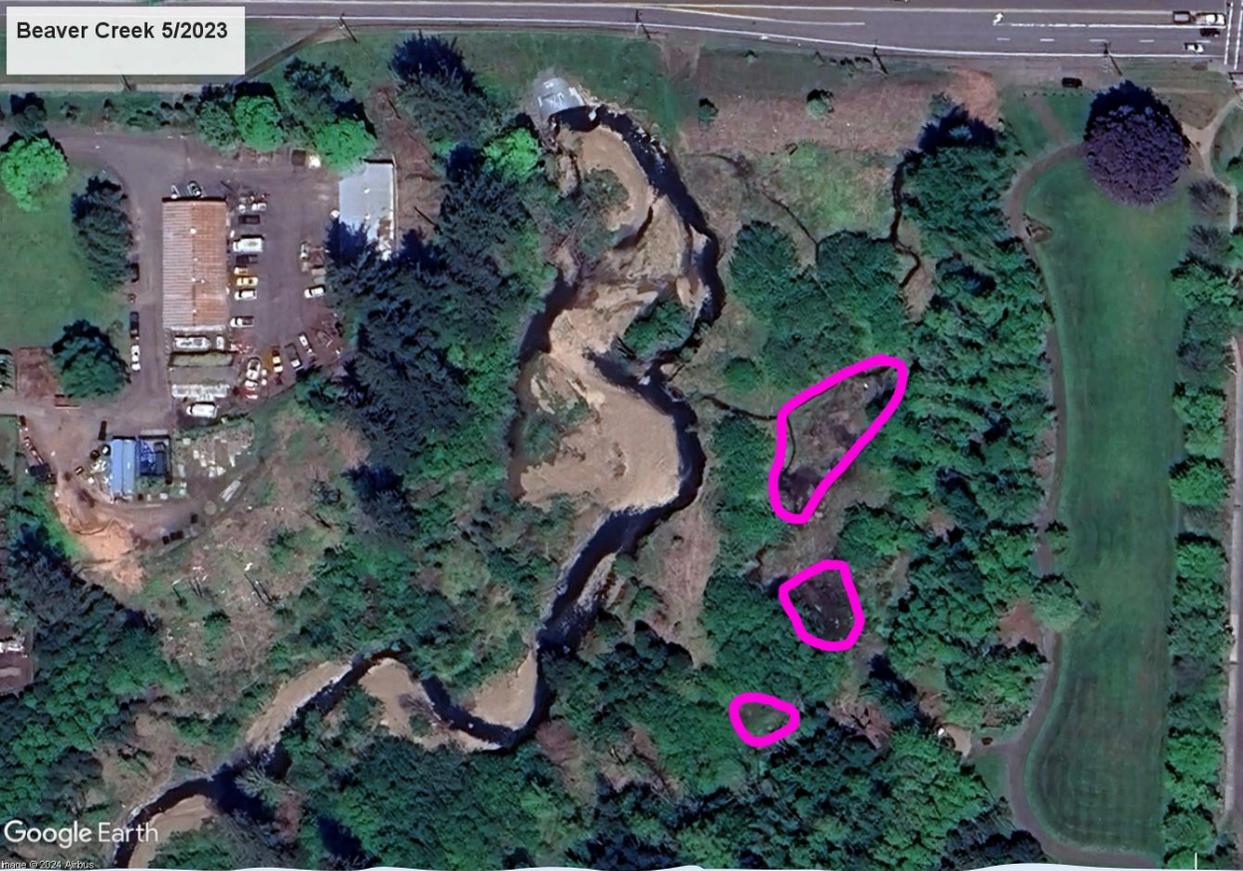
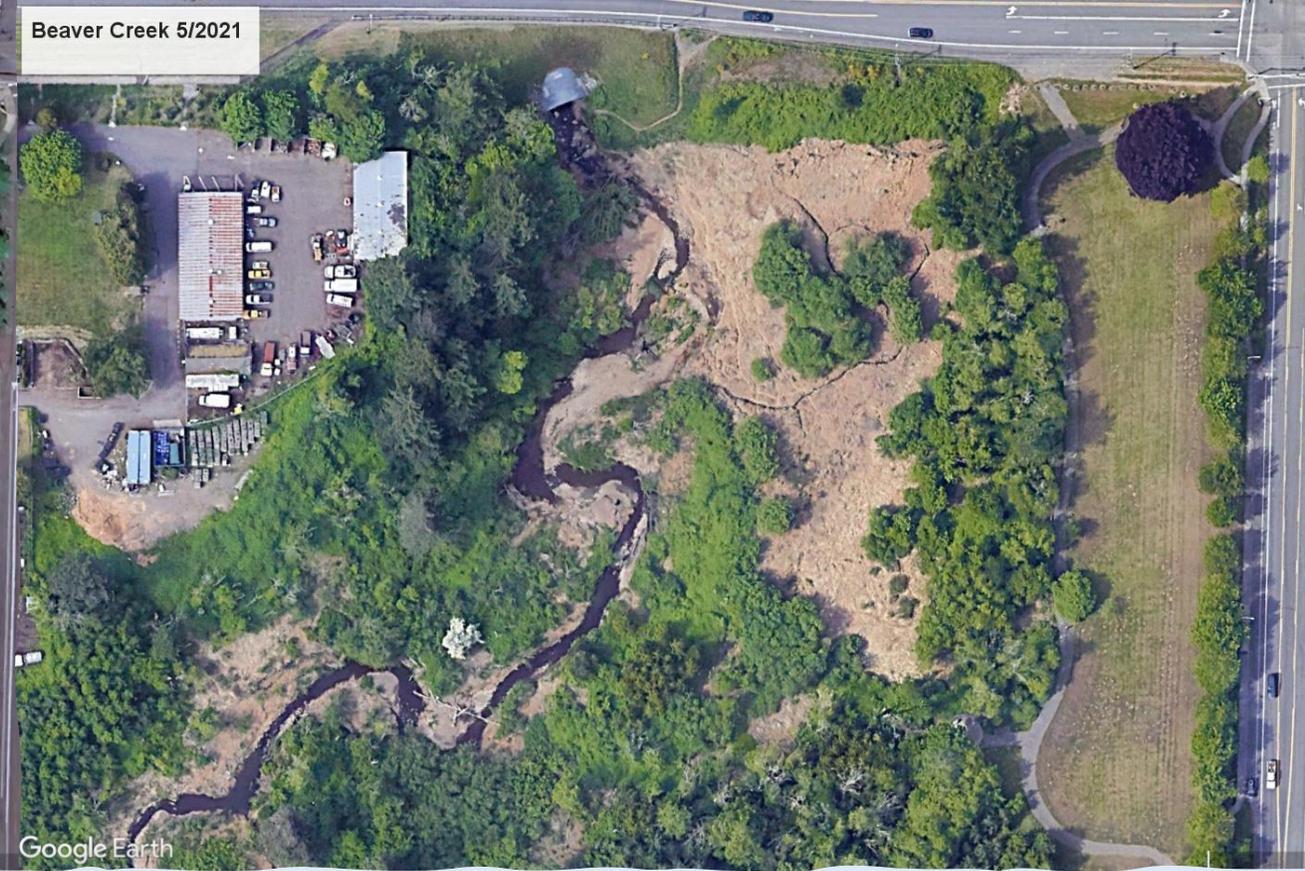
- After 2017 the wetlands began to shrink and disappeared by 2021.
- Between 2021 and 2023, the wetlands began to reappear.

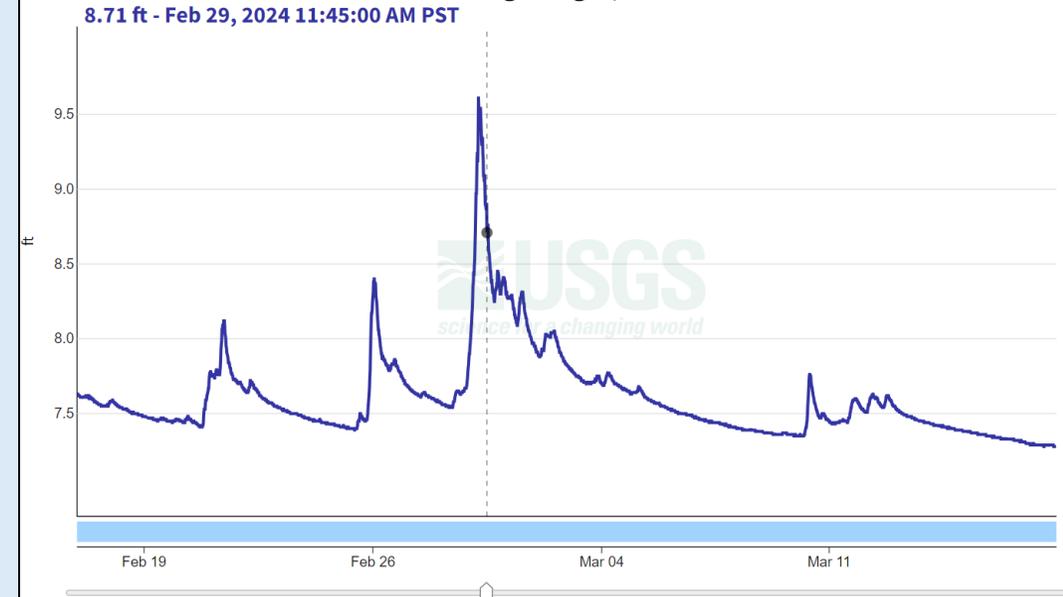
## Beaver Creek at Troutdale, OR - 14142800

- On 02/29/2024 "High Flow Event" there was a big difference between "Gage Height, feet" and discharge cubic feet per second.

Gage height, feet

- Discharge was measured on two different days by taking the average time it took for an orange to float down a 100 foot section of the creek.
- On 2/8 the calculated discharge was  $28.7 \text{ ft}^3/\text{s}$ , compared to actual discharge measured by USGS station downstream  $24.6 \text{ ft}^3/\text{s}$ .
- On 2/13 the calculated discharge was  $21.5 \text{ ft}^3/\text{s}$ , compared to actual discharge of  $17.2 \text{ ft}^3/\text{s}$ .
- There was a high flow event (pictured right) on 2/29/2024, where peak discharge was  $502 \text{ ft}^3/\text{s}$ .

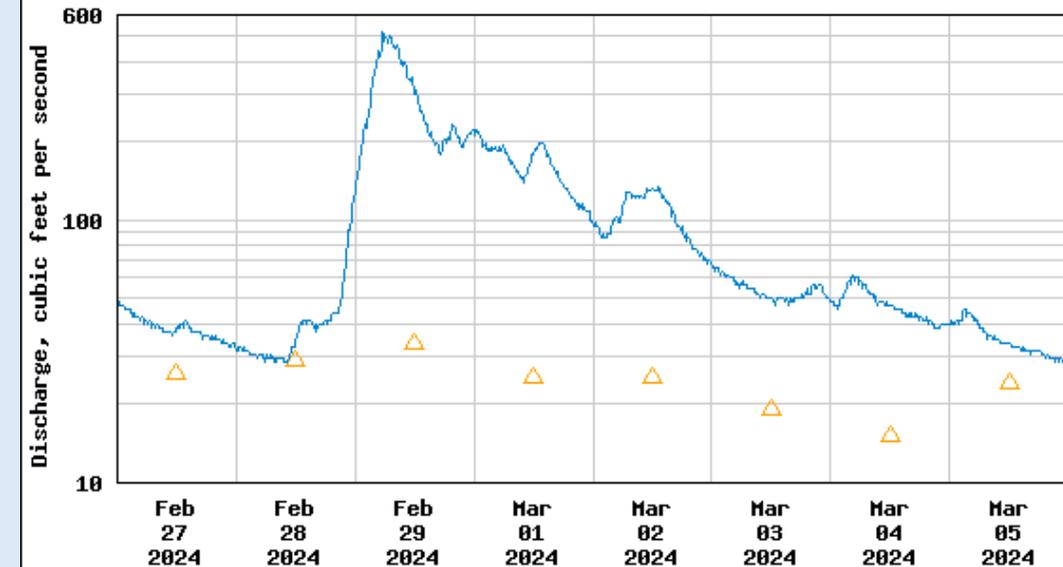
### USGS 14142800 BEAVER CREEK AT TROUTDALE, OR

△ Median daily statistic (23 years) — Discharge

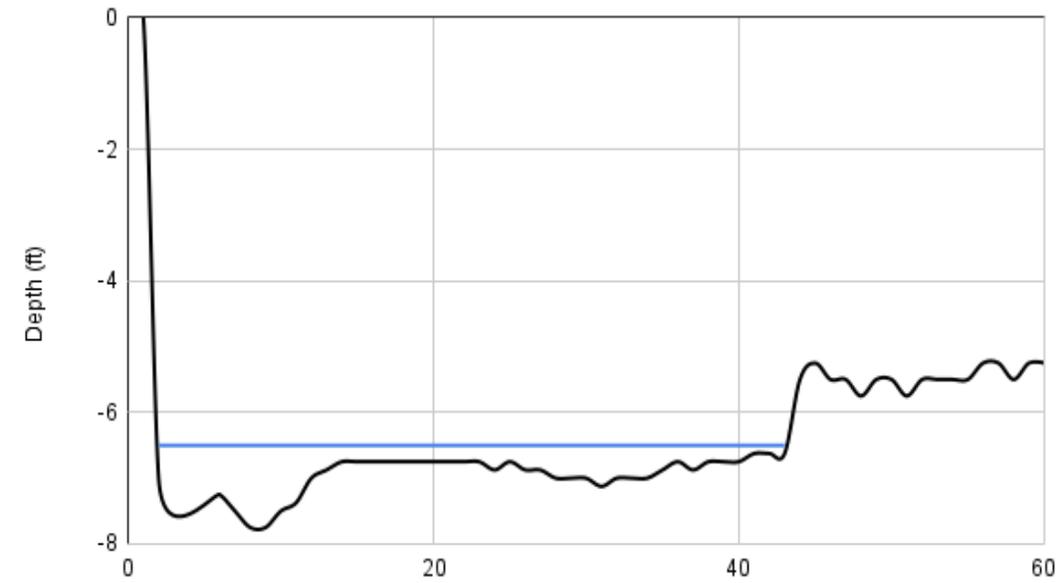
A-A' Cross Section (2/1/2024)

- Cross sectional data was collected on February 1st at three locations, and then collected again at section A on March 7th, after a high flow event.
- Deposition of sediments near the cut bank and the removal of sediments on the point bar was noticed following the high flow event.

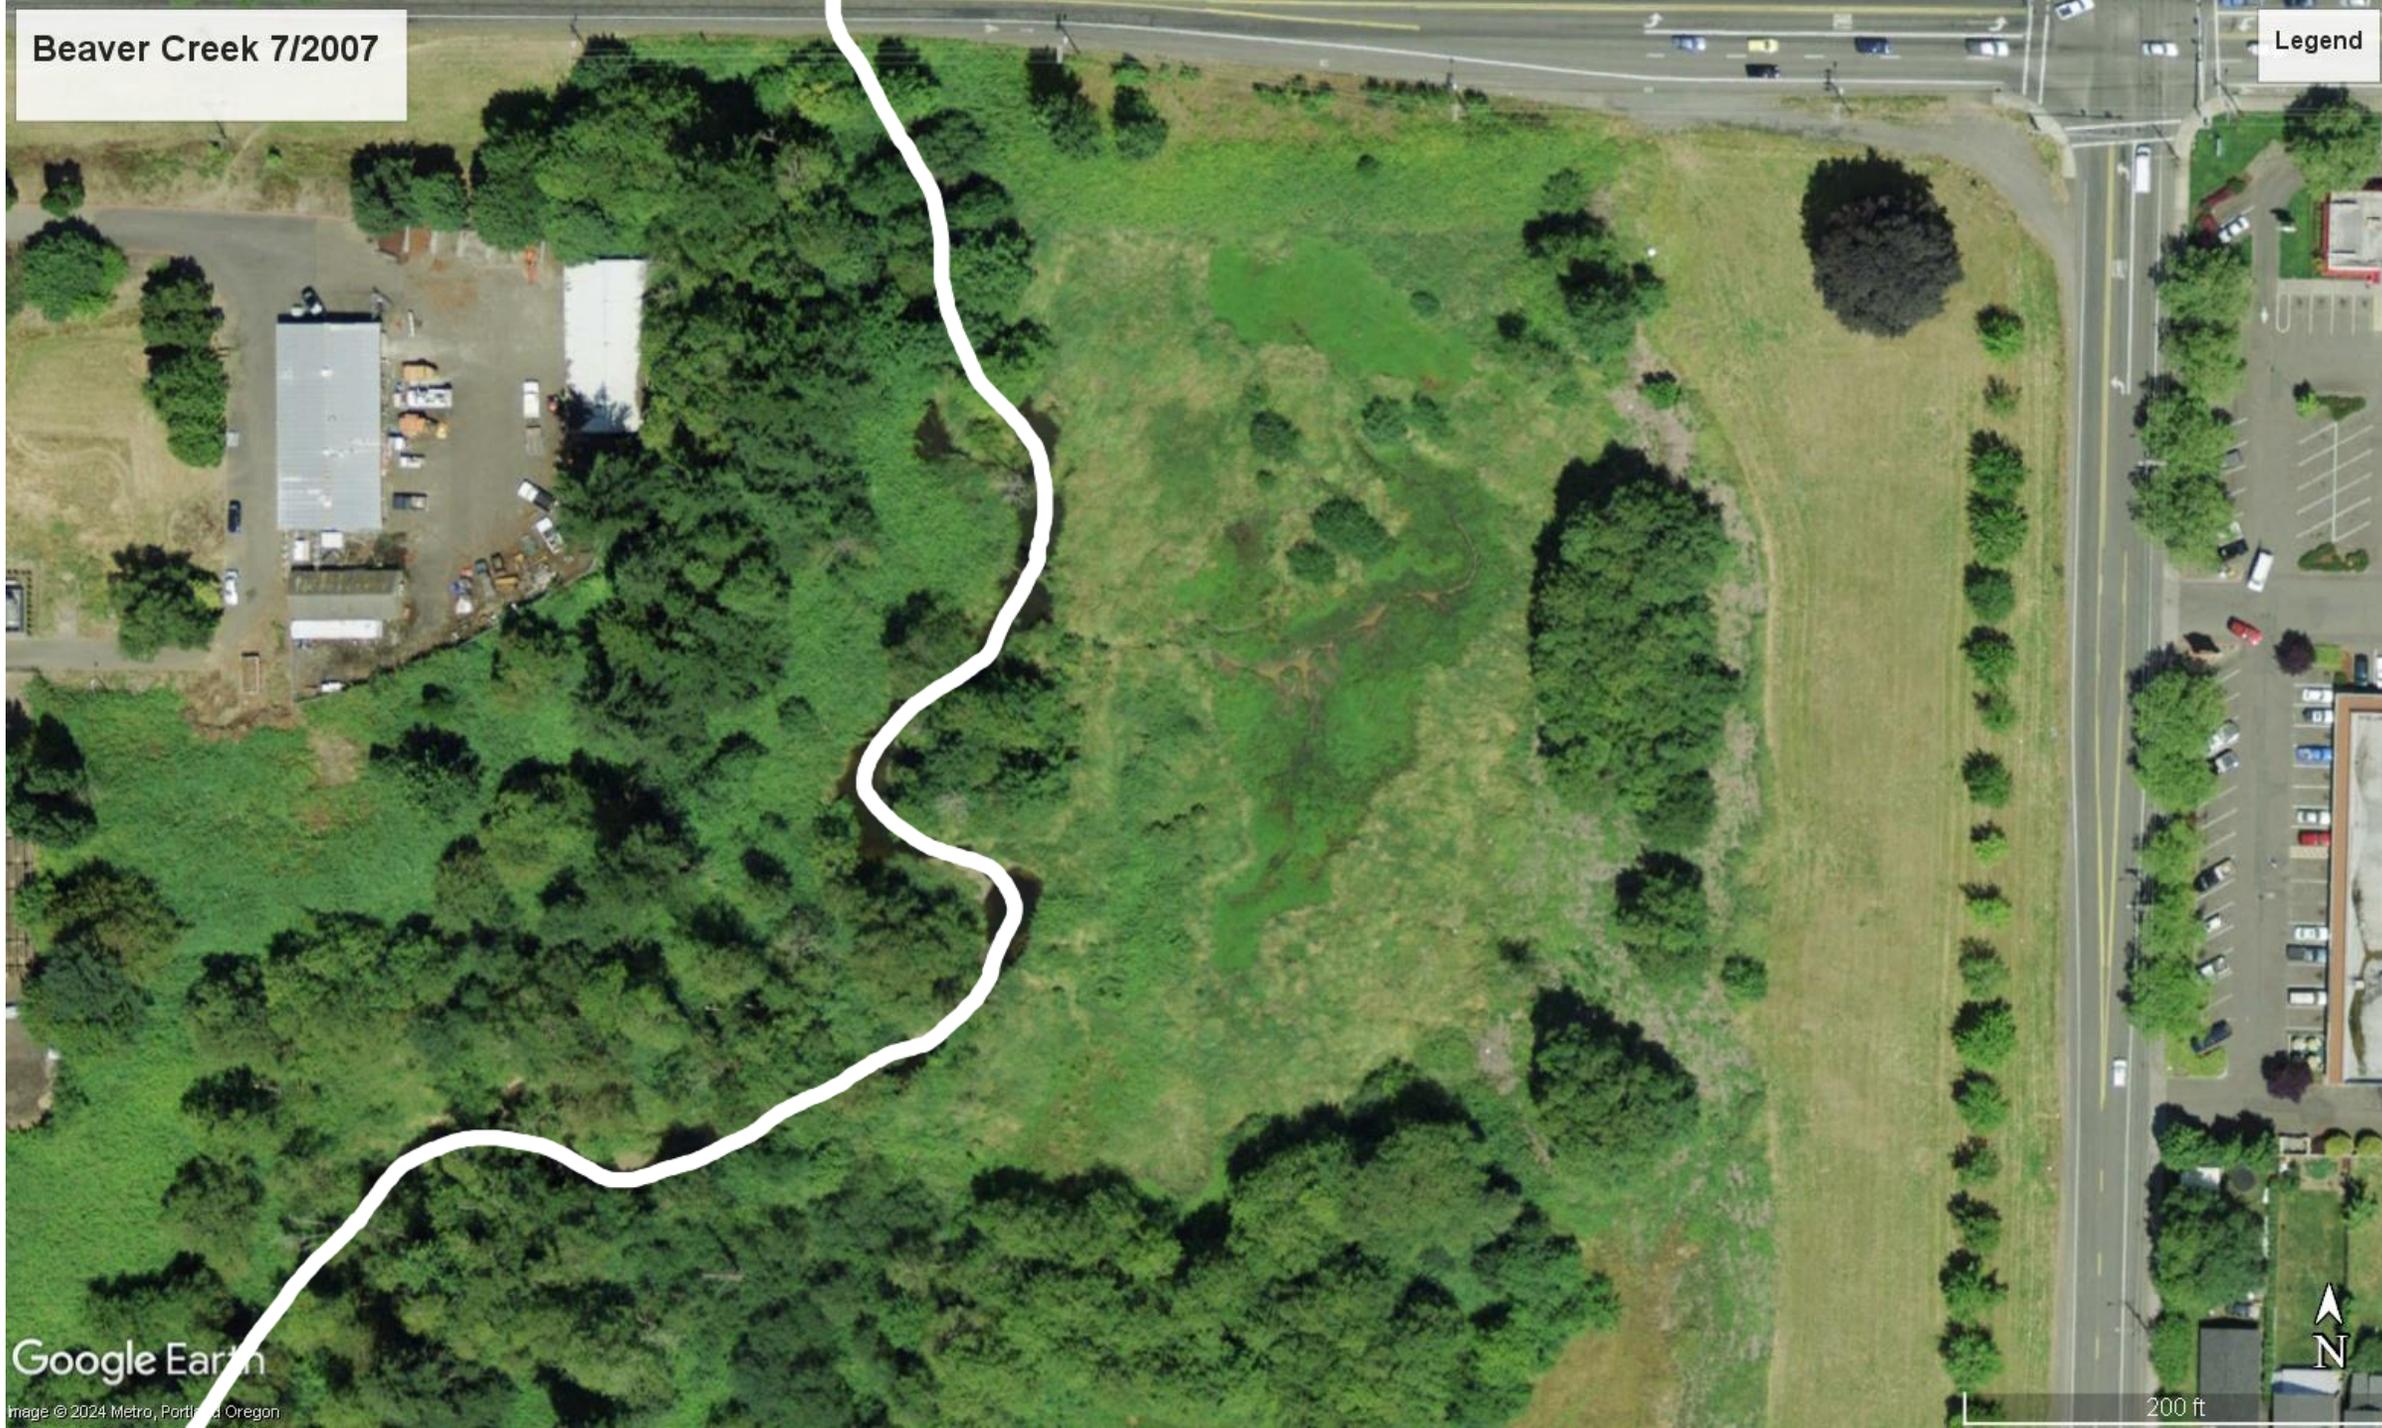
Beaver Creek 7/2007

- Very little change in the stream channel in this 10 year span
- The old culvert acted as a dam, which raised the stream's base level and prevented a large amount of erosion from occurring.

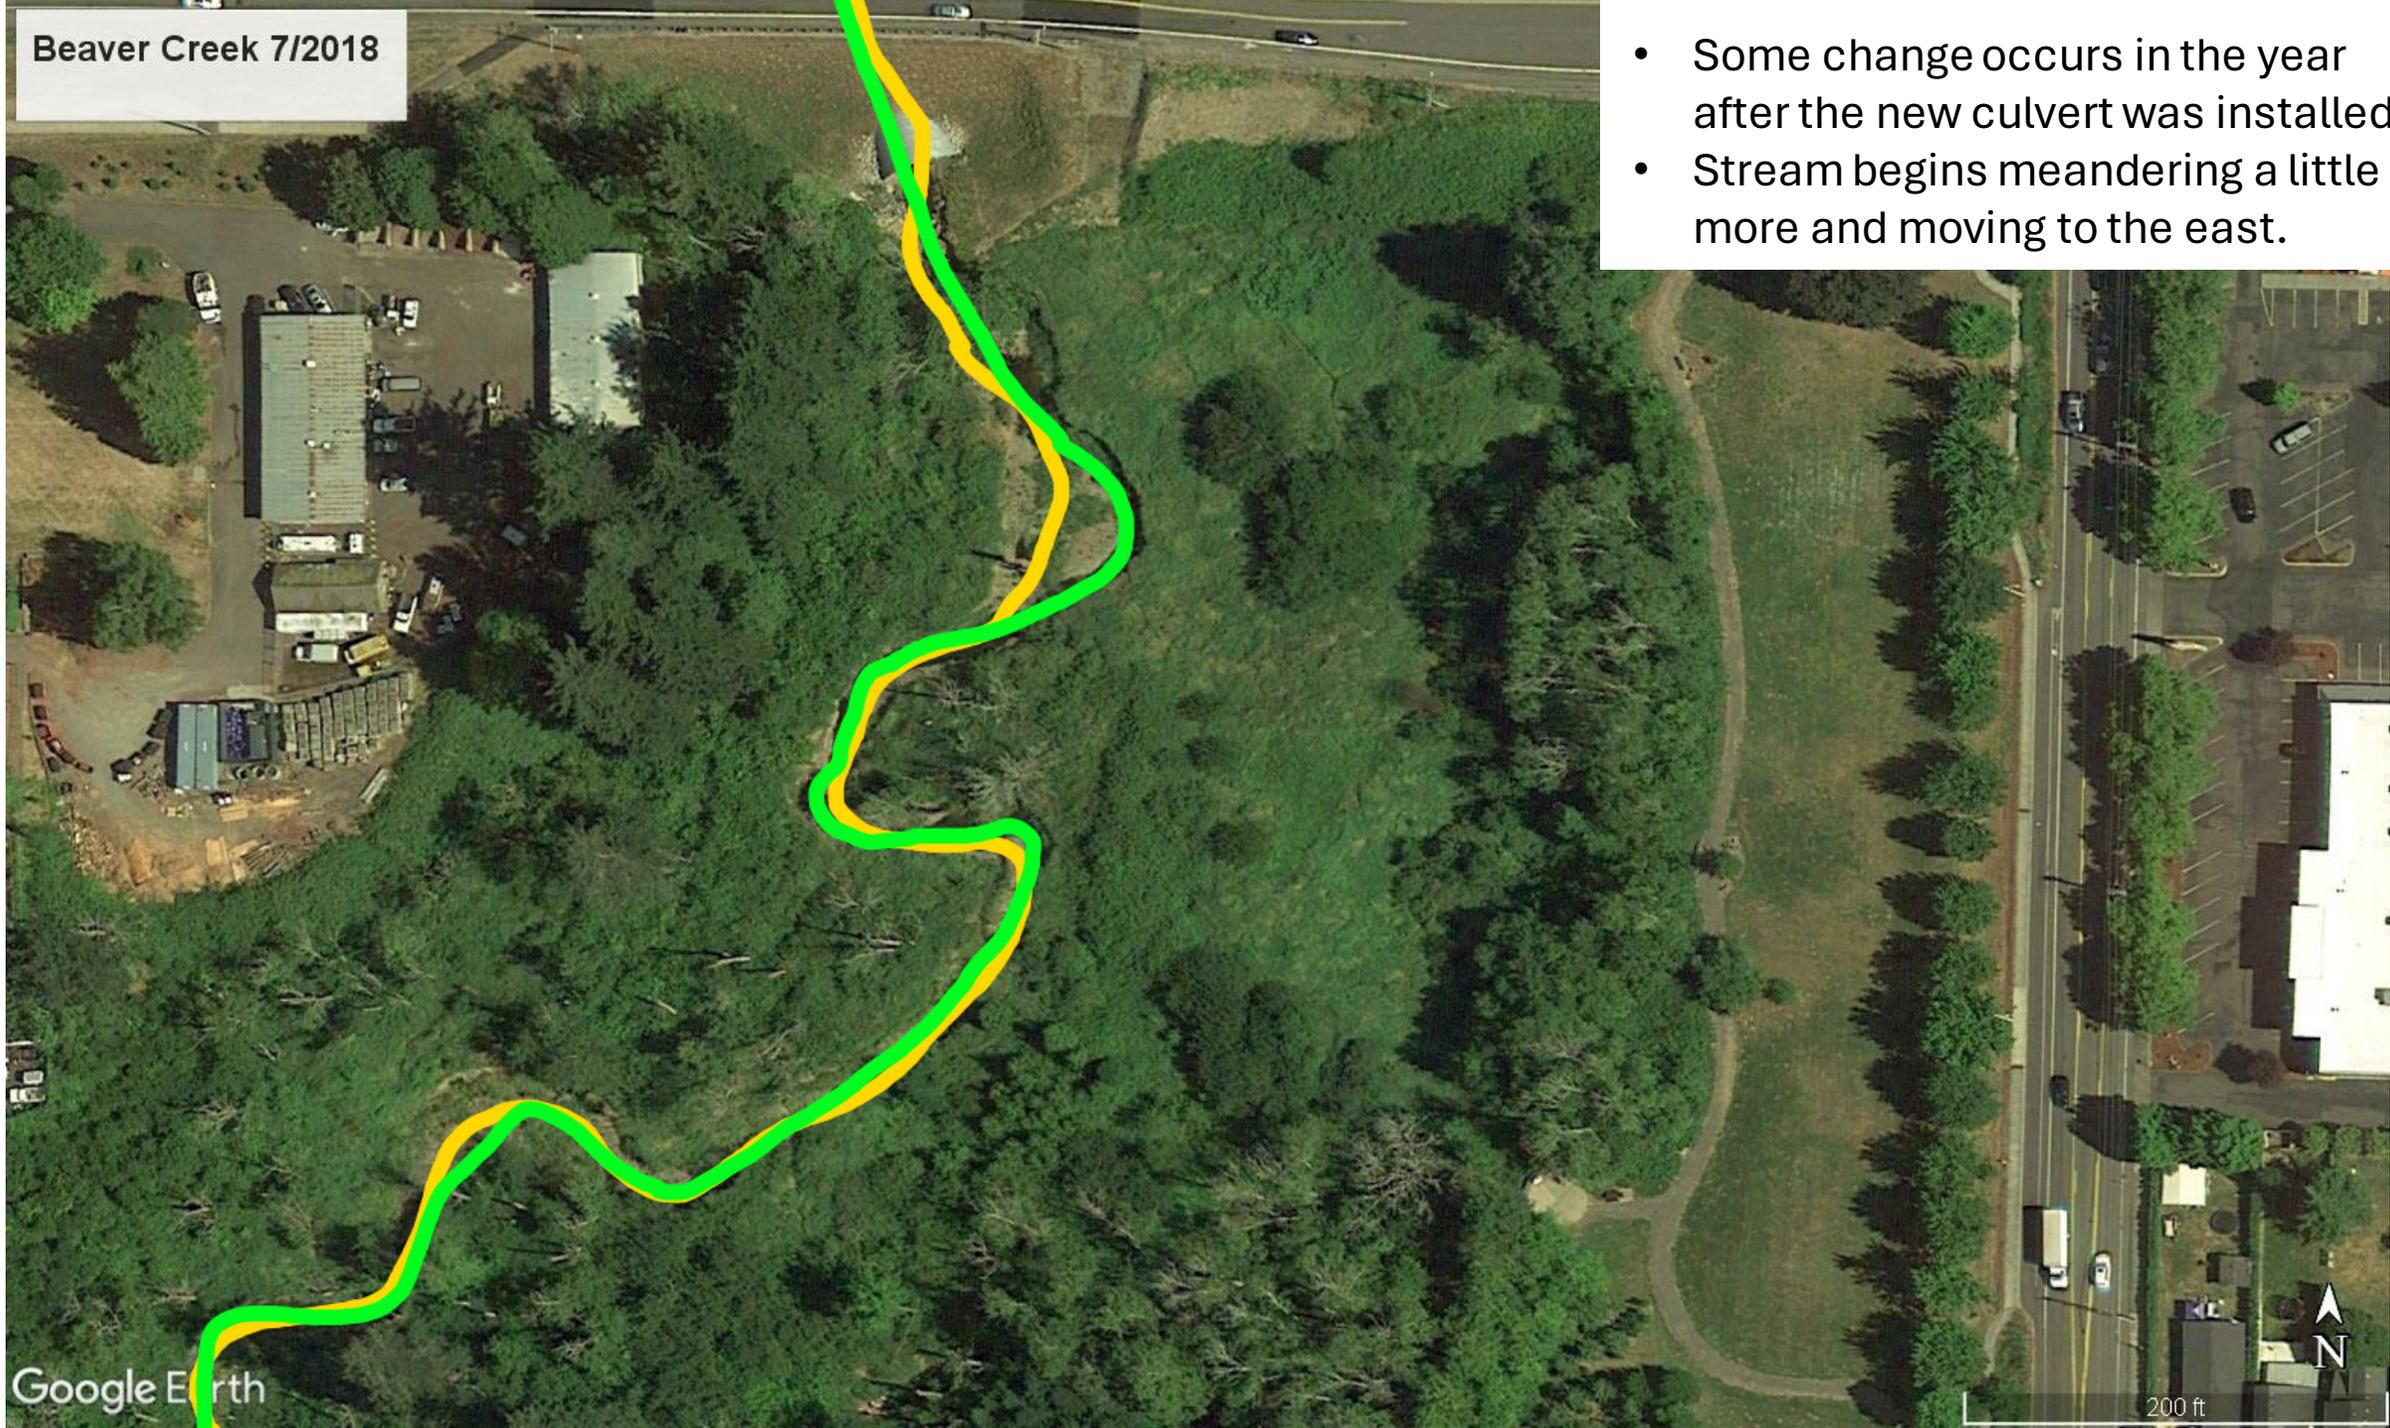
Beaver Creek 7/2018

- Some change occurs in the year after the new culvert was installed.
- Stream begins meandering a little more and moving to the east.

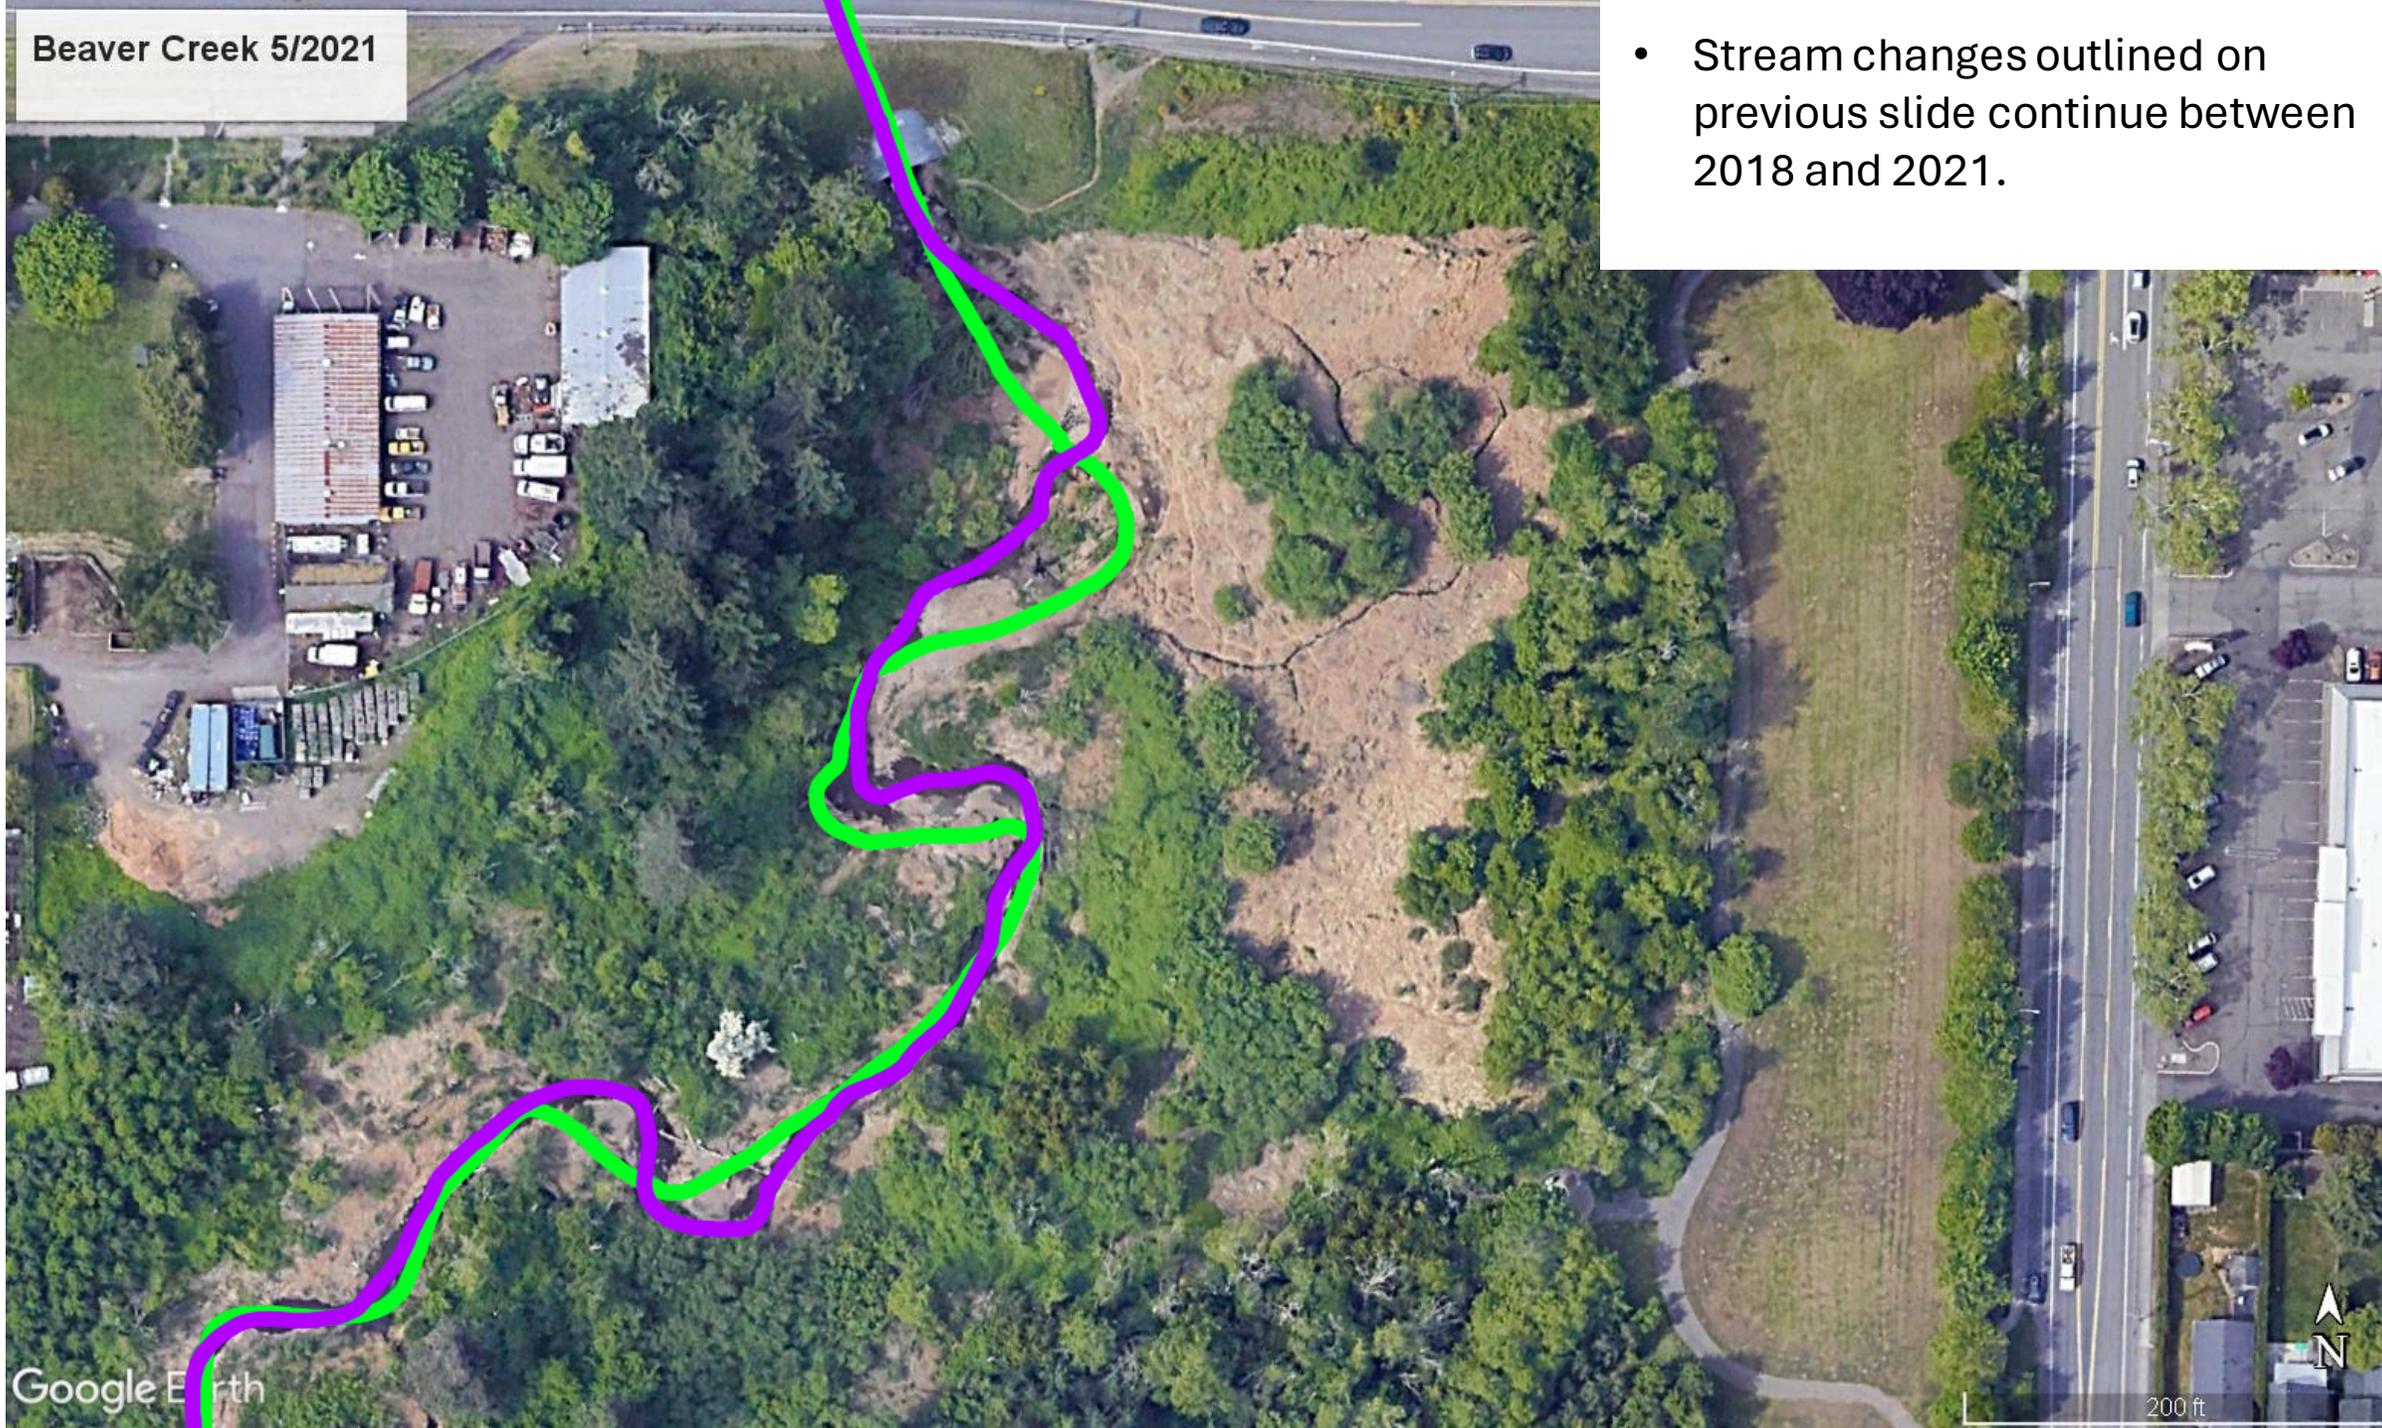
Beaver Creek 5/2021

- Stream changes outlined on previous slide continue between 2018 and 2021.

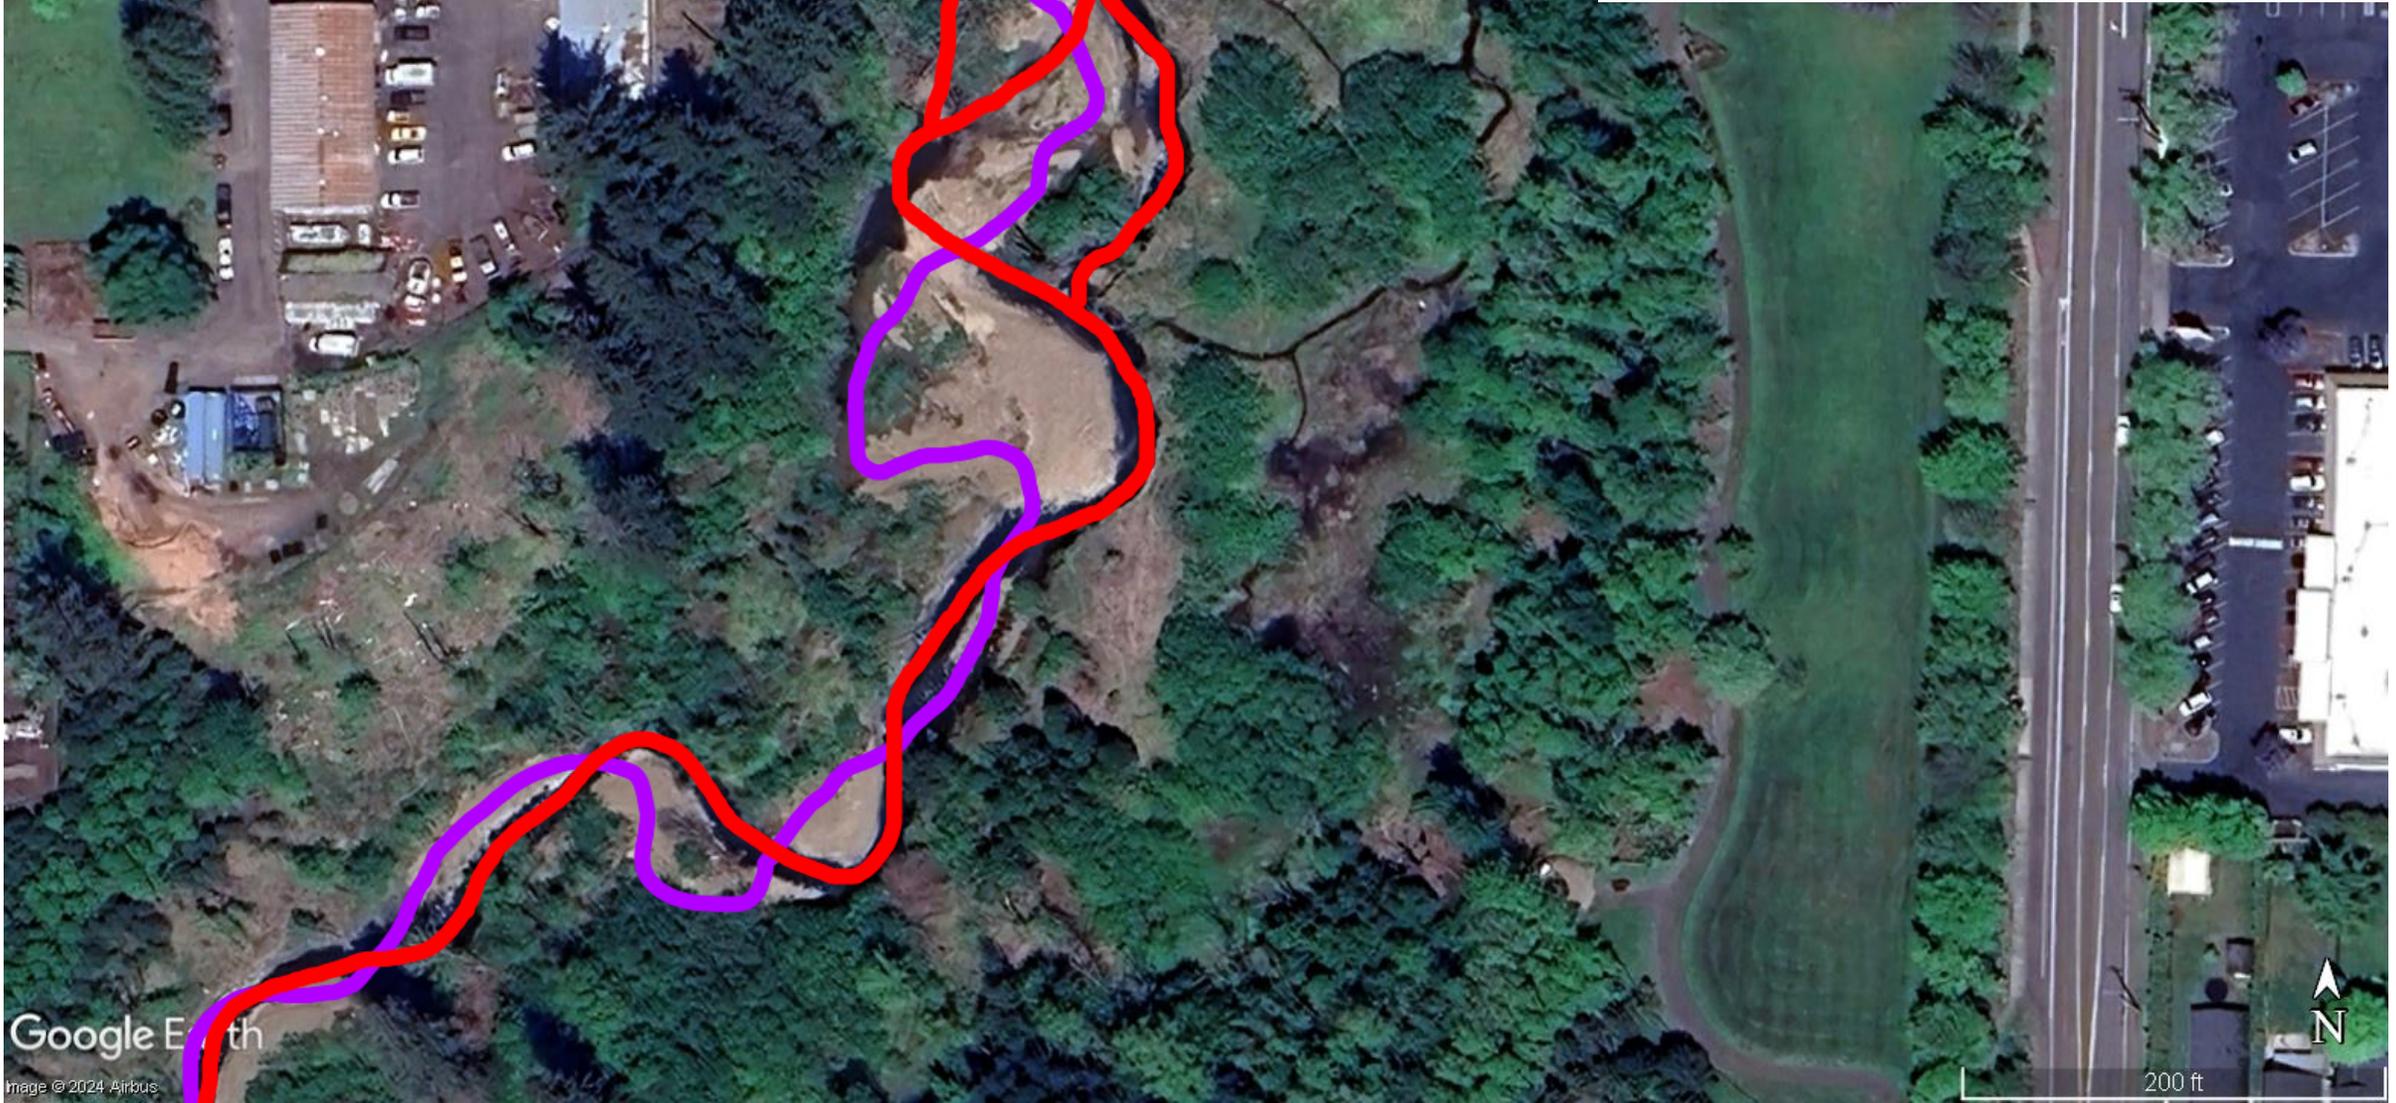
Beaver Creek 5/2023

- Significant change occurred between 2021 and 2023.
- Stream moved even further east, and has eroded a significant amount of sediment.

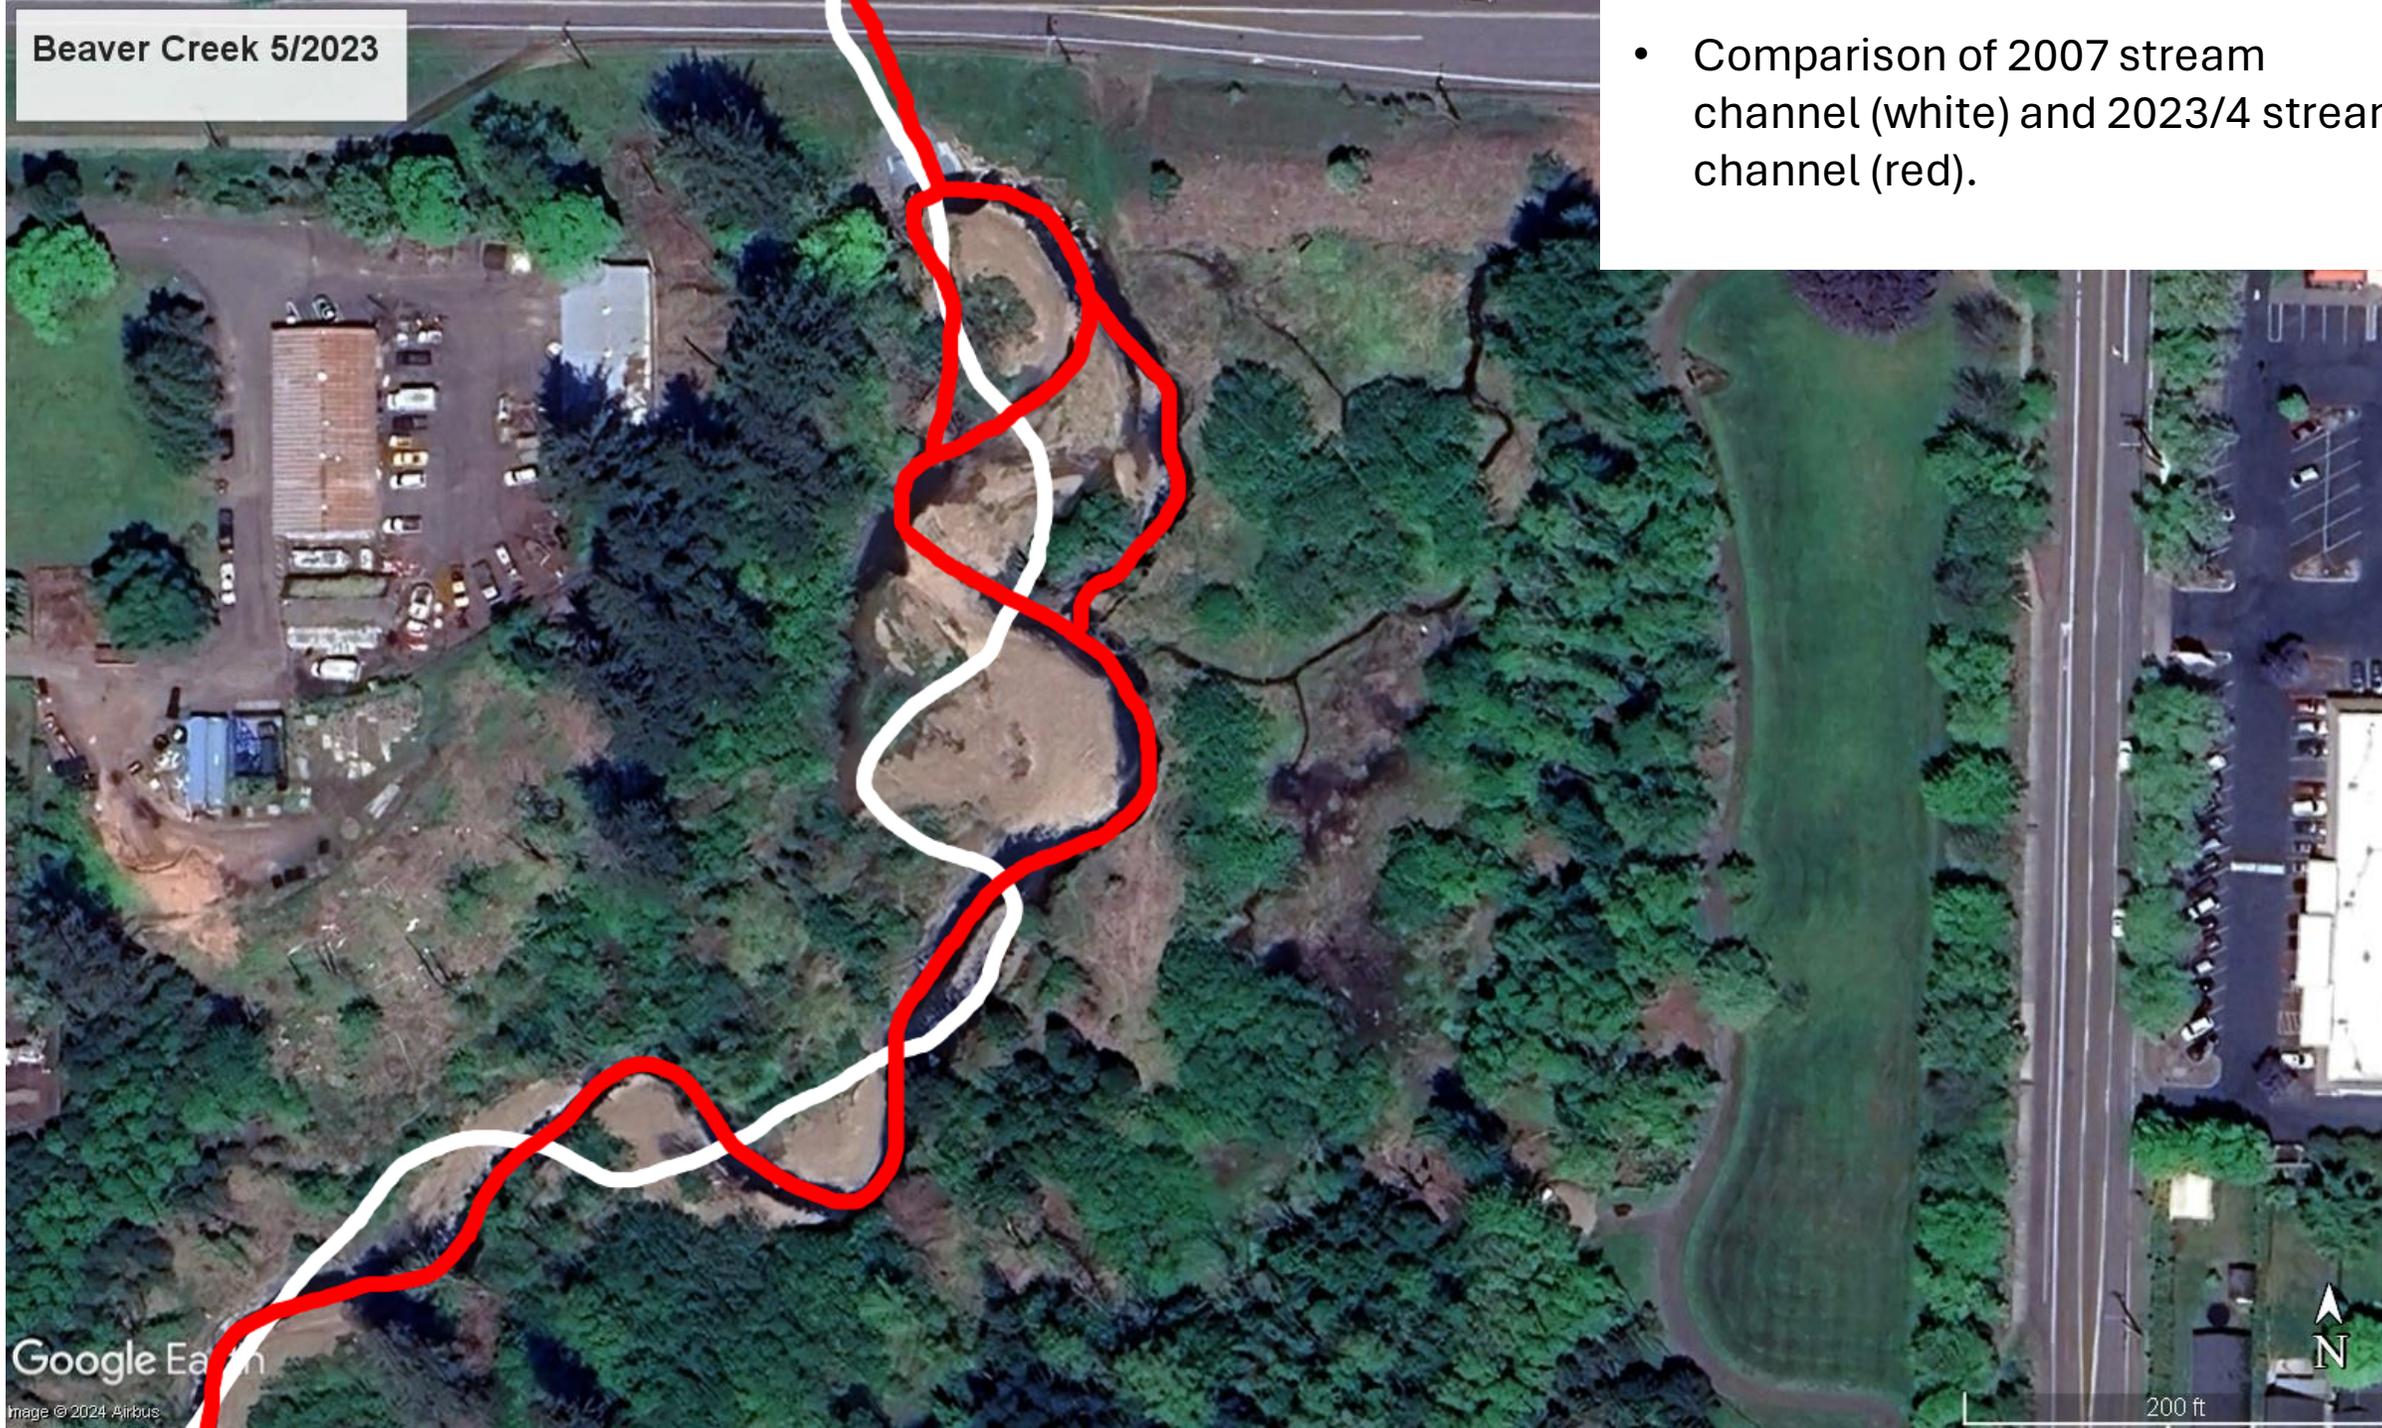
Beaver Creek 5/2023

- Comparison of 2007 stream channel (white) and 2023/4 stream channel (red).
