BUILDING PERMIT REVIEW

Building Permit Description: Single Family Dwelling associated with a form

Property Address: 12424 NW Springville Rd.

Geotechnical Report & Landslide Hazard Study

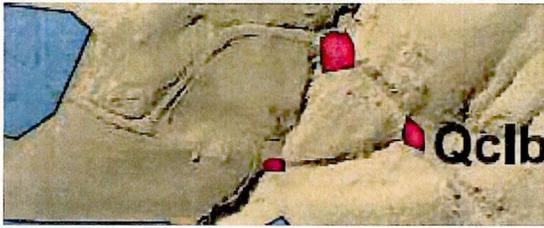
O-90-02 and O-08-06 map the Oatfield Fault traversing the southwest corner of tax lot 2800 in a northwesterly direction, downthrown to the southwest. Much of the surface south and southwest of the Oatfield Fault in the site vicinity is mapped as landslide debris, or massive coalesced debris fans. Three small debris fans are mapped in the creek drainages immediately east and northeast of the proposed house location above the Oatfield Fault. A landslide is mapped near the middle of tax lot 600 several hundred feet southeast of the proposed house location. See figure 3. There are no known mapped landslides on the project site. Soil maps are shown below.

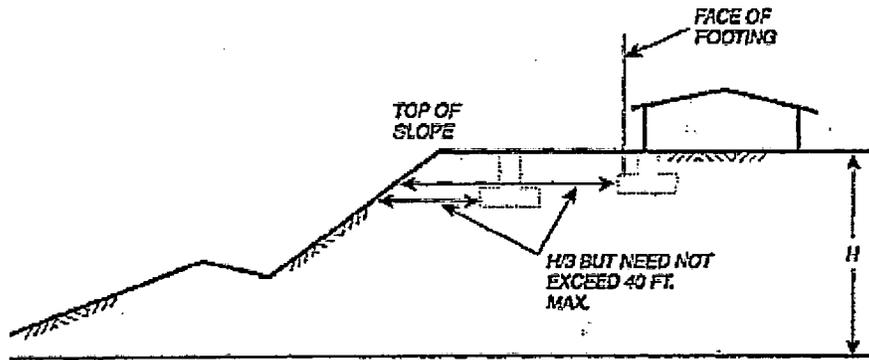
Given the slopes surrounding the house site vary from 13 to 24% the house shall follow the typical setback requirement from IBC and OSSC. See below figure 1805.3.1

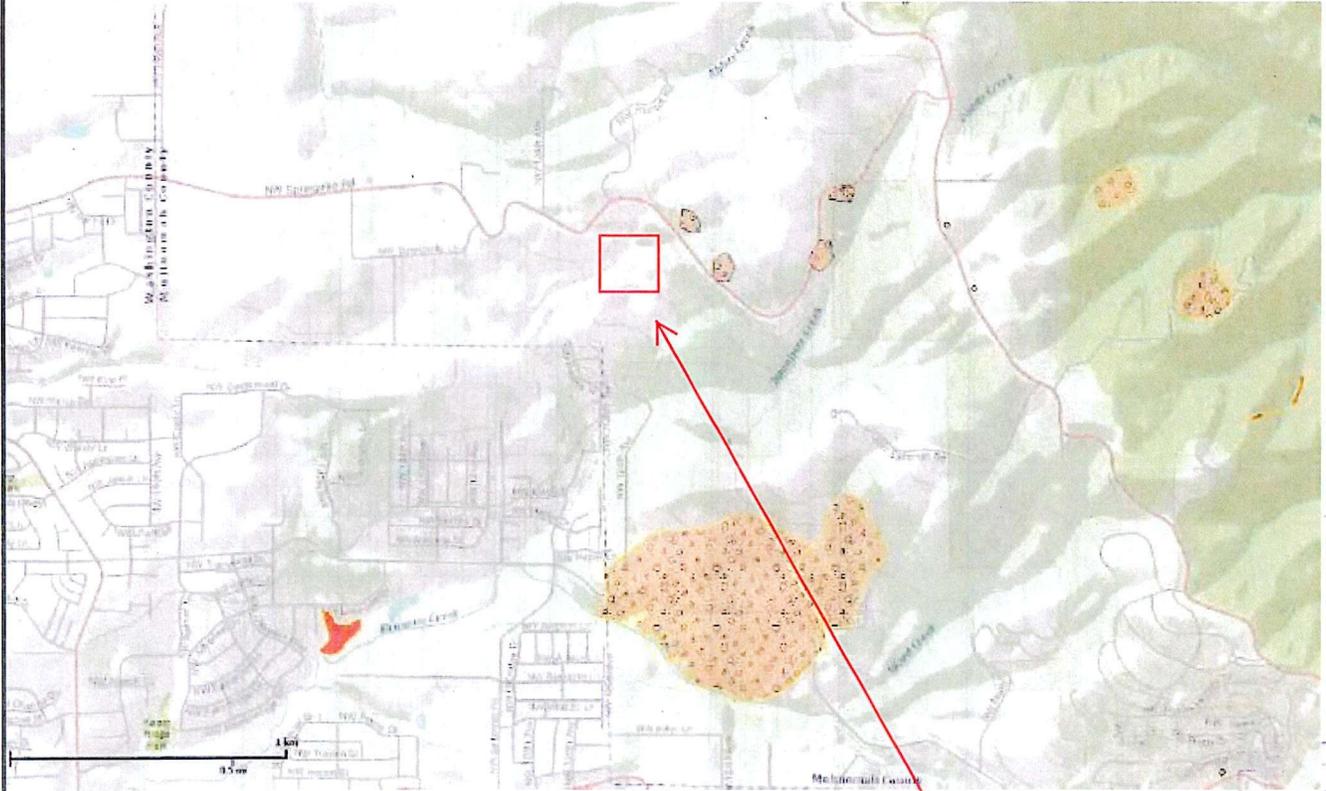
Figure 3- Hazards

Project site

.IDAR Vicinity Map

LIDAR image figure 3). All drainages on the project site flow into the Bronson Creek. The owner reports he owns a water rights document to the property that is approximately 100 years old.

LIDAR imaging of the site vicinity figure 3 shows several bowl-shaped scarps with associated down slope debris channels above the project site.

Bannister Creek flows generally southwestward near the eastern margin of tax lot 600 and an un-named tributary of Bronson Creek traverses the site in a southwesterly direction a few hundred feet southeast of the proposed residence location. Two other southwesterly drainages traverse tax lot 600 between these two drainages, making a total of four rather substantial drainages (see LIDAR image, figure 3).
