# Impacts of Fuel Releases from the CEI Hub Due to a Cascadia Subduction Zone Earthquake

EXECUTIVE SUMMARY

The purpose of this study is to identify the magnitude and extent of potential fossil fuel releases at the CEI Hub from a CSZ earthquake and to evaluate the resulting damages. ECONorthwest, Salus Resilience, and Enduring Econometrics prepared this report for the City of Portland and Multnomah County. For more information about this report, contact: Laura Marshall, Project Manager at marshall@econw.com.

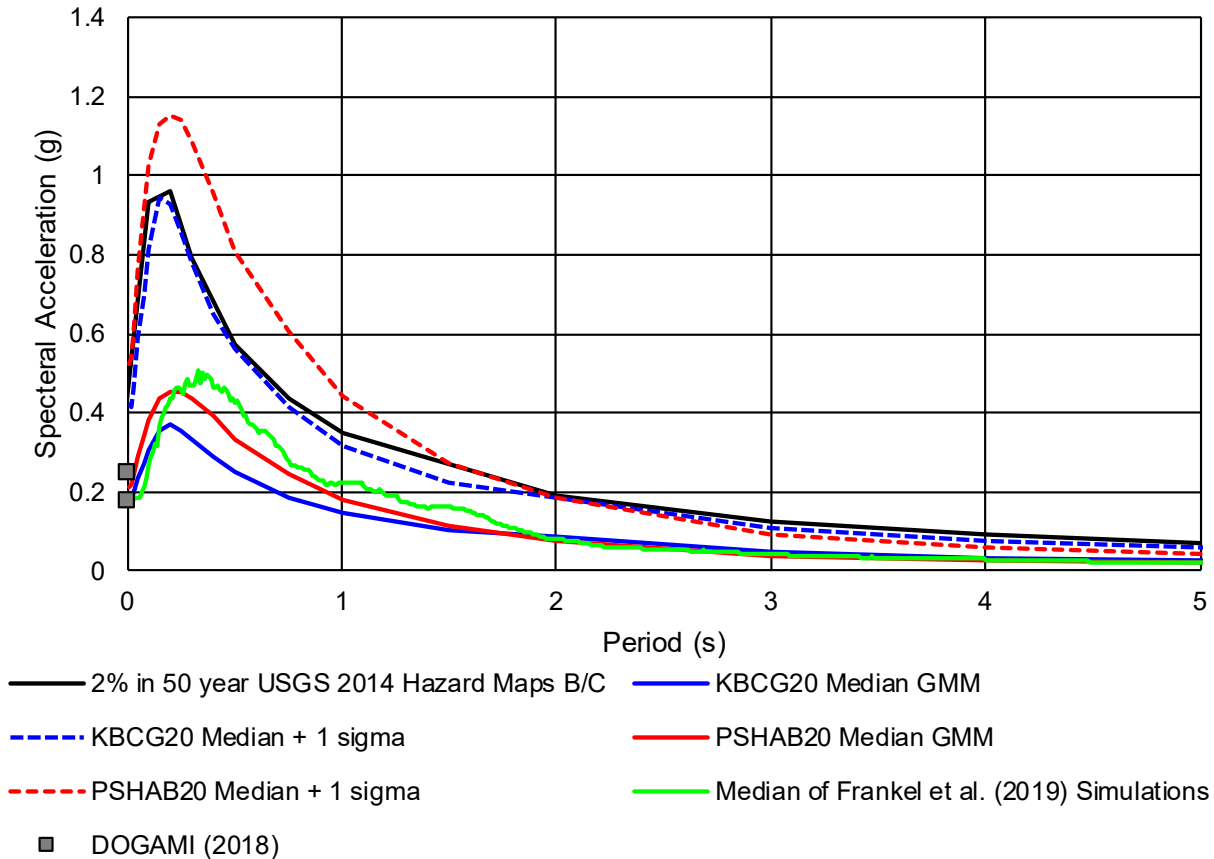
Figure 4.2 CSZ Spectral Response

In engineering design, the ground motions due to seismic shaking are commonly transformed to a spectral acceleration response spectrum that can be used to model how an earthquake is experienced by a building/structure. Spectral acceleration values for the available calculation methods are shown on Figure 4.2 below for a stiff soil or rock-like Site Class B/C condition. The black line represents a probabilistic geometric mean spectrum from the 2014 USGS hazard maps commonly used in IBC design for new construction. This probabilistic curve includes the effects of both subduction events and shallow crustal events, represents the hazard of a 2 percent probability of exceedance in 50 years (equivalent to a 2,475-year return period), and is shown for comparison only. The red and blue lines are computed from the PSHAB20 and KBCG20 GMMs, respectively, with the solid lines representing the median and dashed lines representing the 84th-percentile ground motion (median plus one standard deviation,  $\sigma$ ). The PSHAB20 and KBCG20 GMMs were computed using the earthquake characteristics shown in Table 4.1 below. The green line is the median of the Frankel et al. (2019) simulations. The gray points are the surface intensity values from the DOGAMI (2018) report decreased by a factor of 1.2 to remove the effects of soft soil amplification and approximate a stiff soil or rock-like condition similar to the condition used for the other lines plotted on the figure. The 1.2 factor is consistent with the NEHRP amplification ratio between the site class used in the DOGAMI (2018) map near the project site (Class D, representative of the surface soil condition) and the site class used in this study for the Frankel et al. (2018) simulations and NGA-Sub GMMs (Class C, representative of a stiff soil or soft rock condition).

Figure 4.2 indicates that the level of ground motion shaking shown in the DOGAMI hazard maps is similar to the intensity estimated from the most recent ground motion models for a CSZ rupture. However, the uncertainty range of the GMMs indicates that an 84th percentile event represents a significantly higher level of ground motion shaking than the median earthquake event; specifically, the peak ground acceleration (equivalent to the spectral response at a period of zero seconds) is approximately 100 percent higher for the 84th percentile event than the median event.

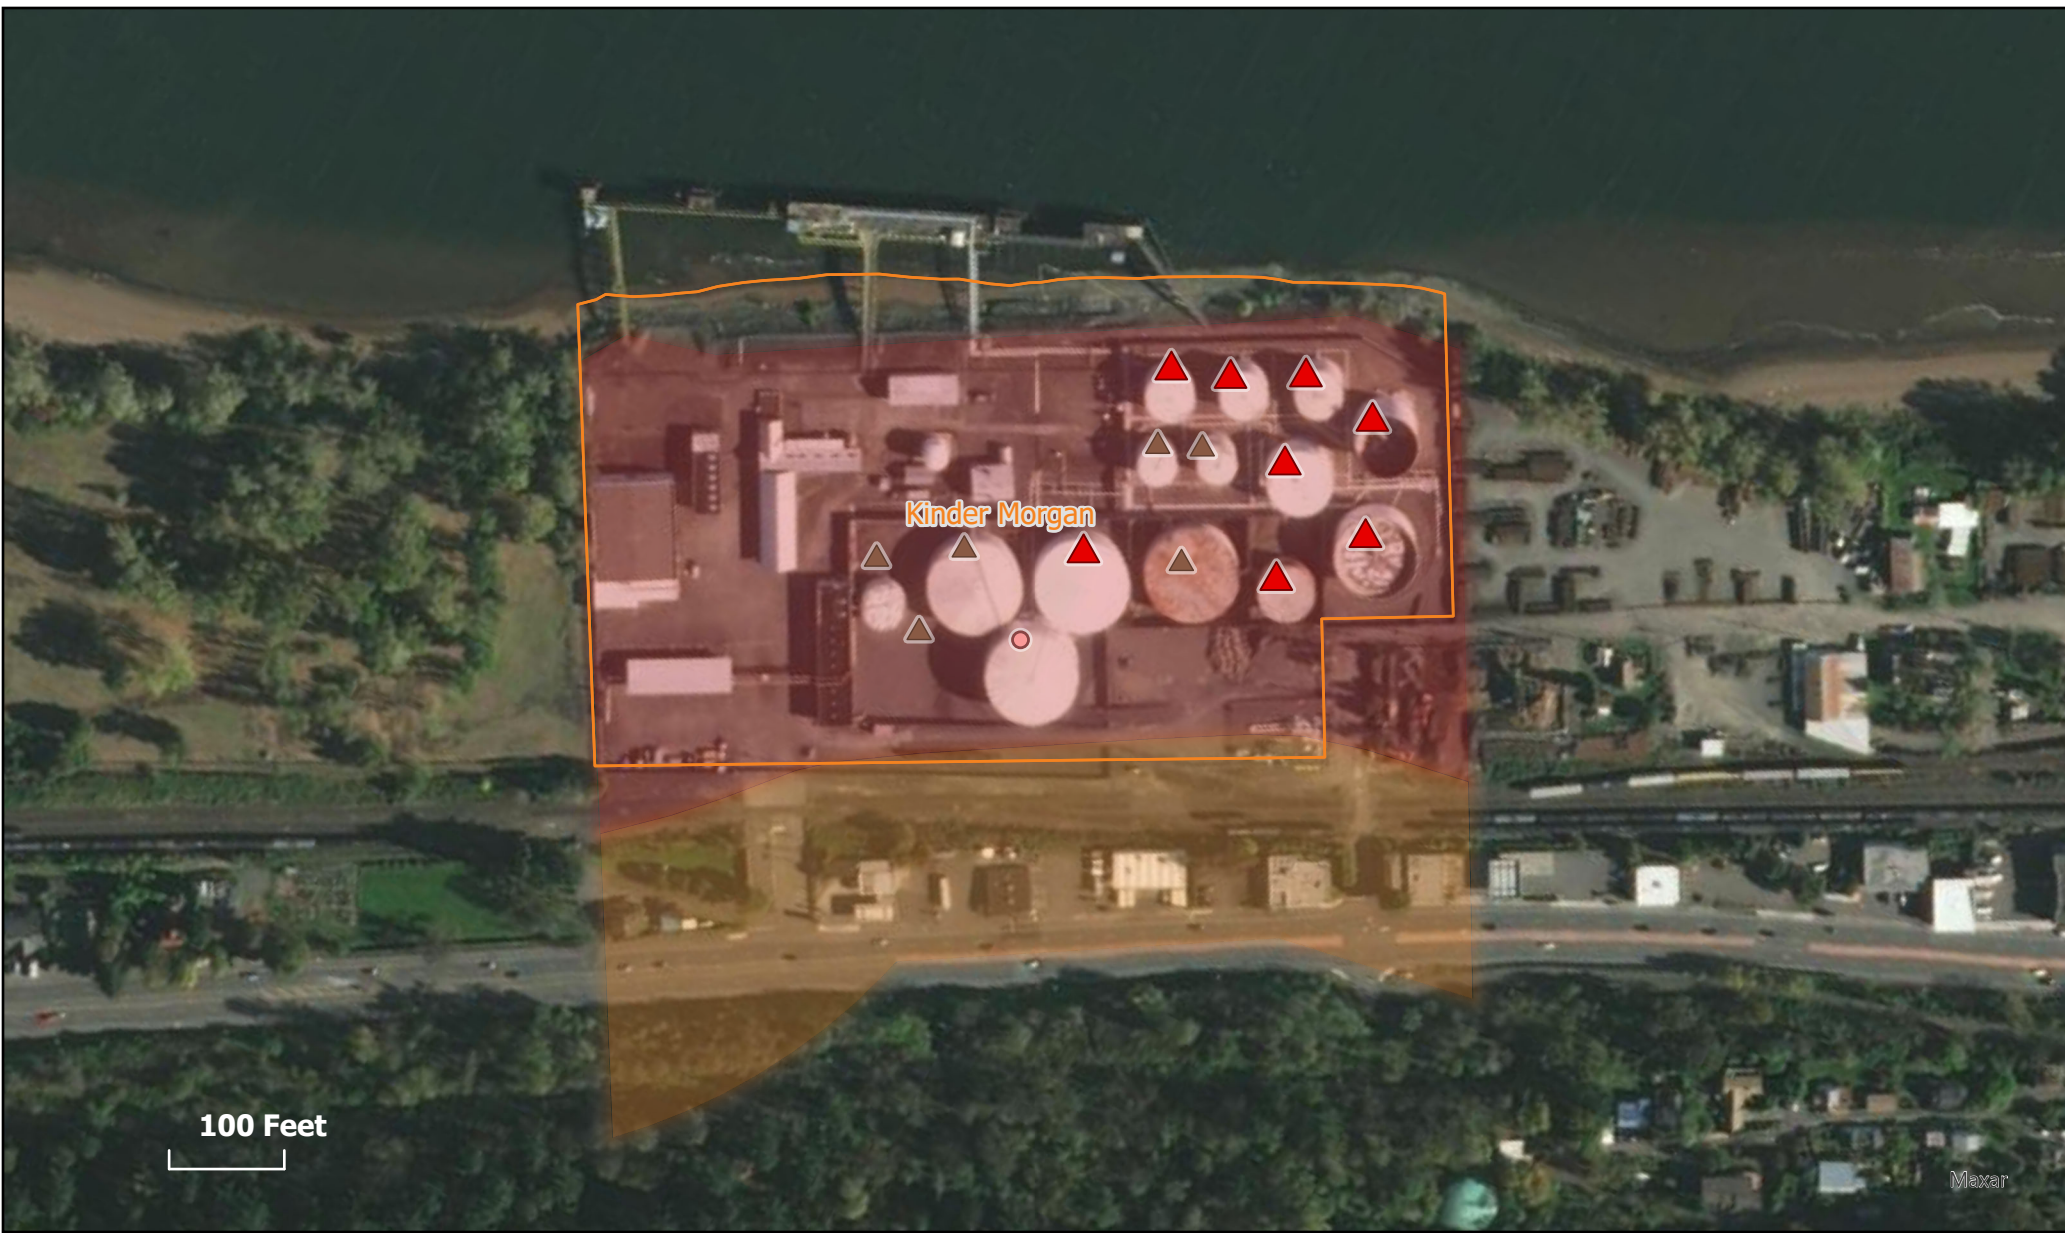
**FIGURE 2A**  
**KINDER MORGAN NORTH**

**Tank Release**

- ▲ Flammable and Hazardous
- ▲ Empty or Out of Service

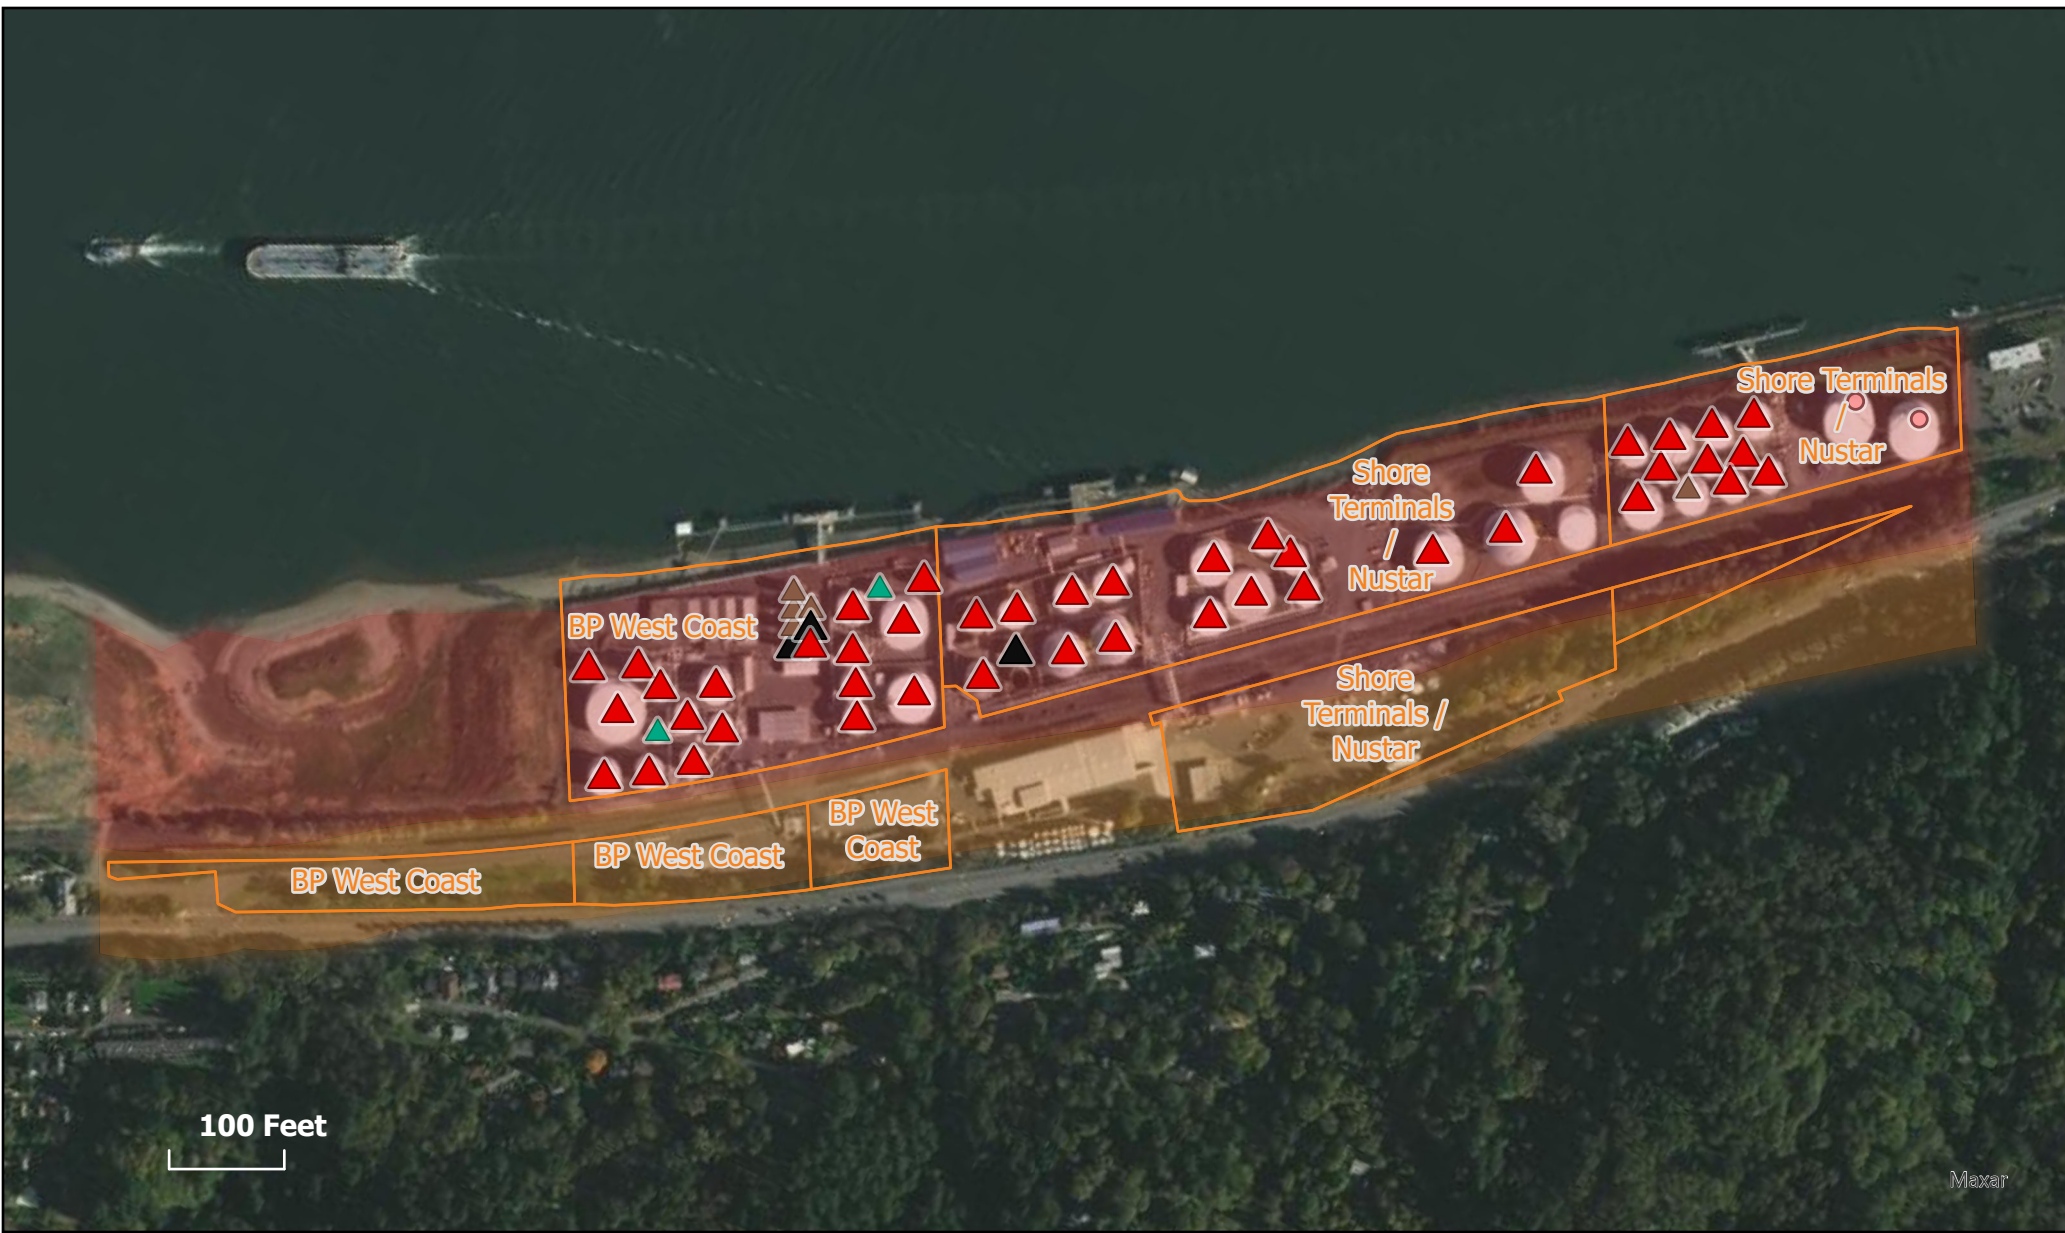
**FIGURE 2B  
LINNTON**

### Tank Release

- ▲ Flammable and Hazardous
- ▲ No Data
- ▲ Empty or Out of Service
- ▲ Tank Failure, not Flammable and not Hazardous

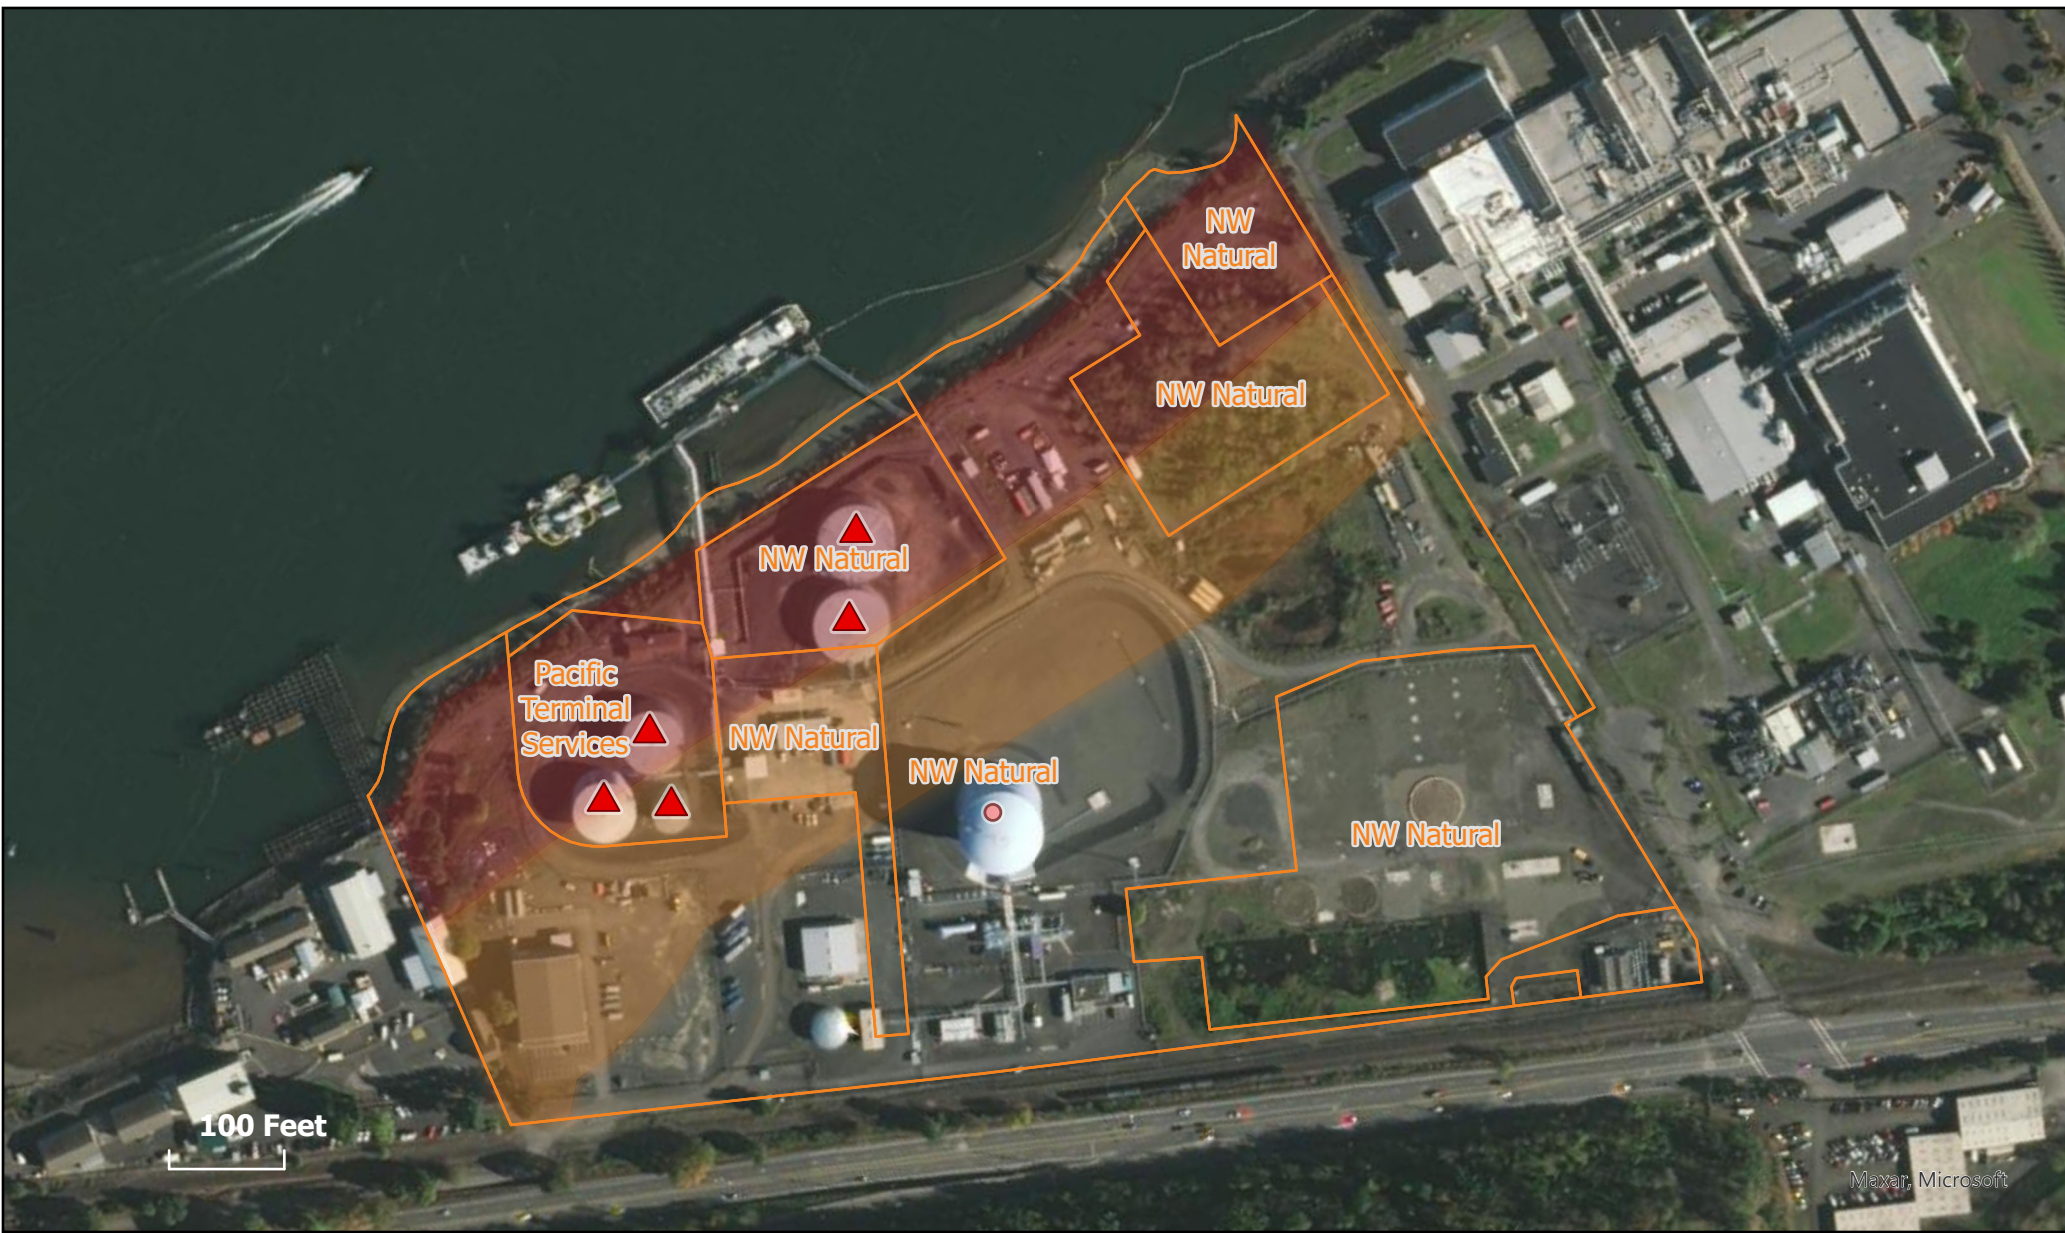
**FIGURE 2C**  
**NW NATURAL**

**Tank Release**

▲ Flammable and Hazardous

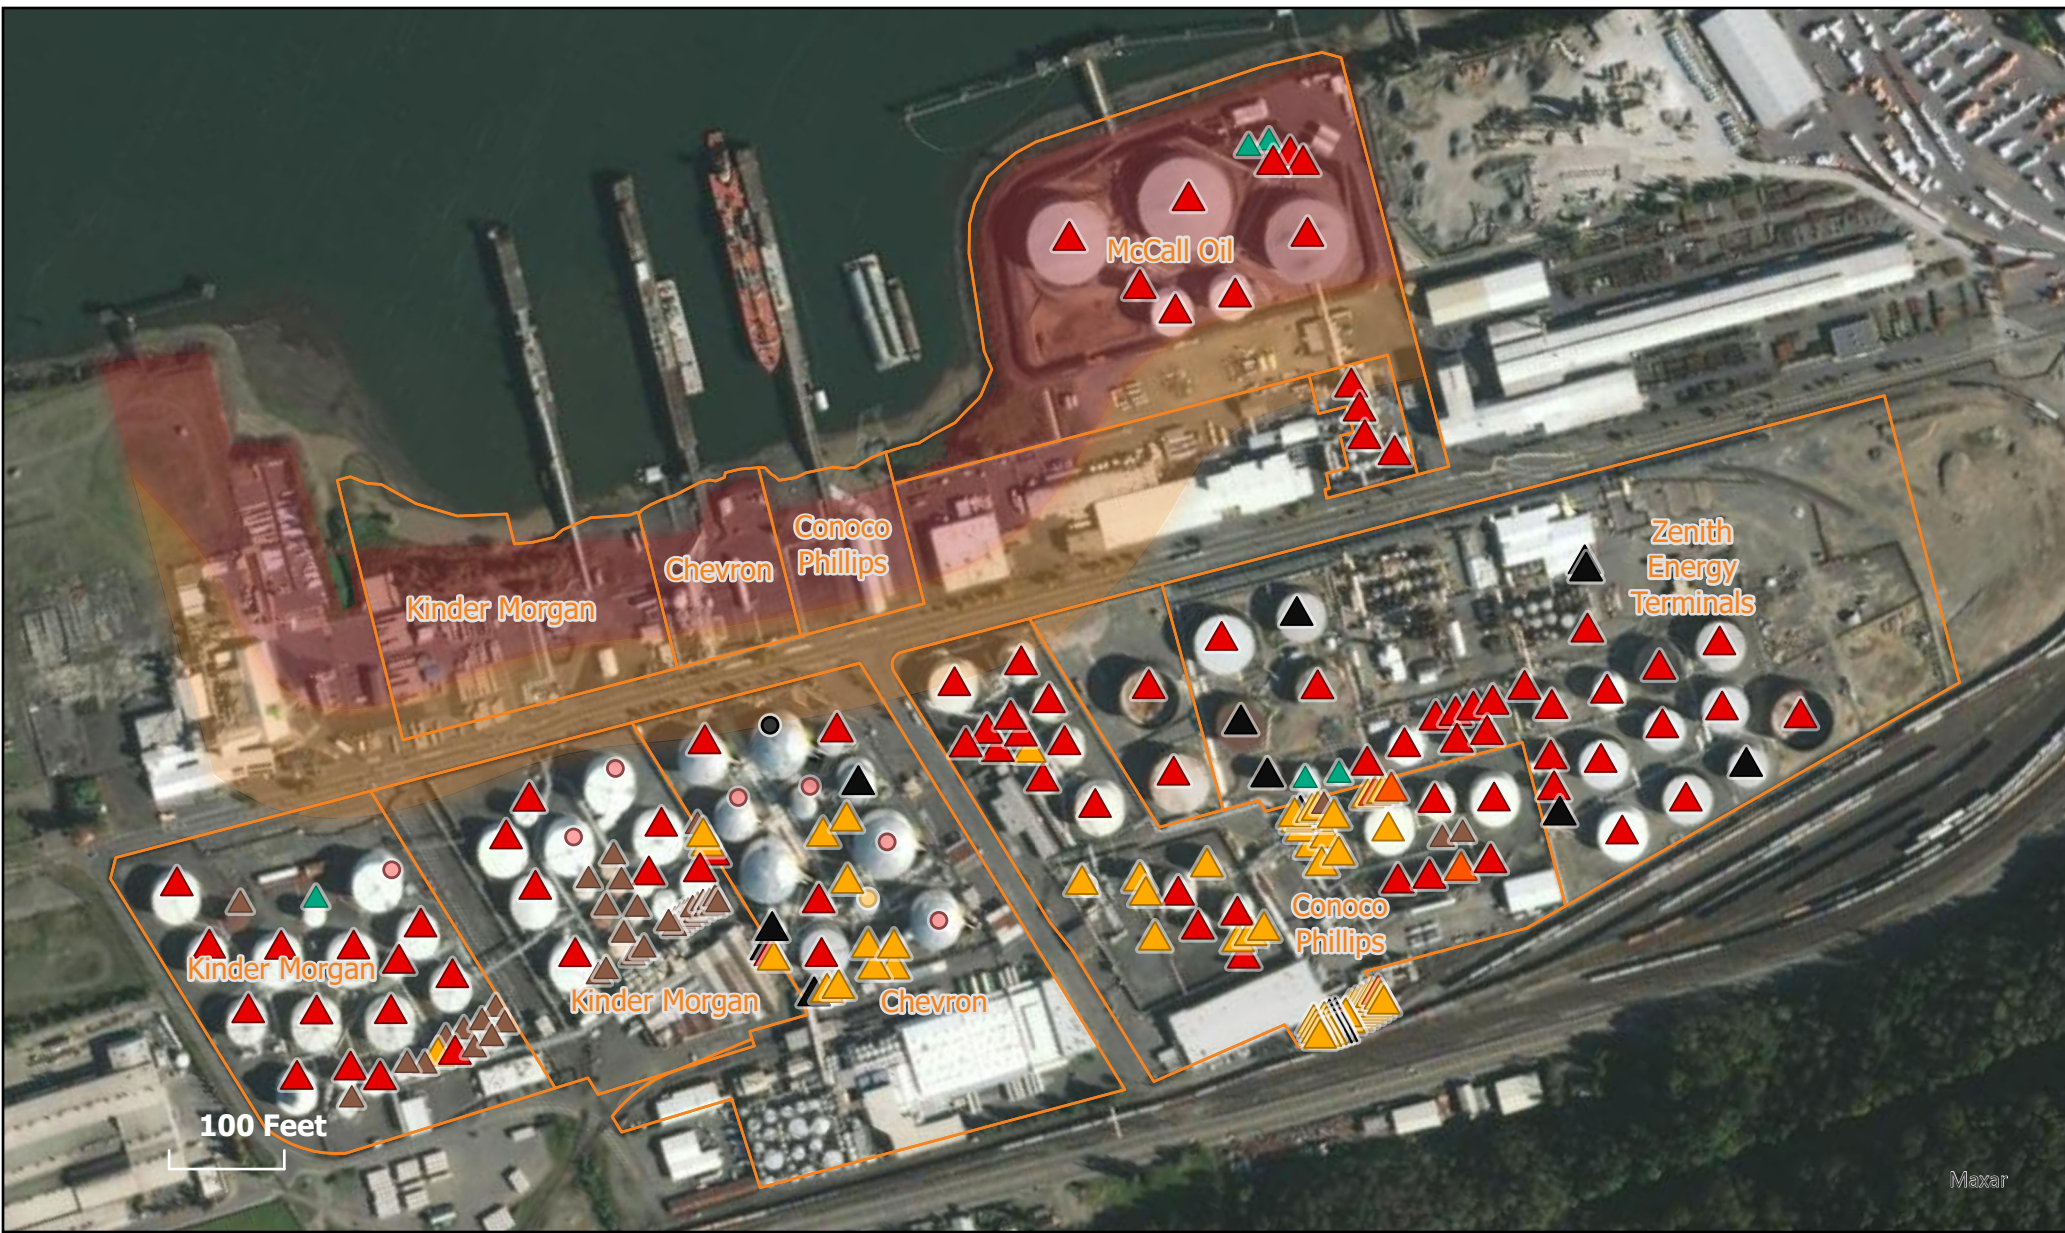
**FIGURE 2D**  
**WILLBRIDGE**

**Tank Release**

- ▲ Flammable and Hazardous
- ▲ Flammable (but not Hazardous)
- ▲ Hazardous (but not Flammable)
- ▲ No Data

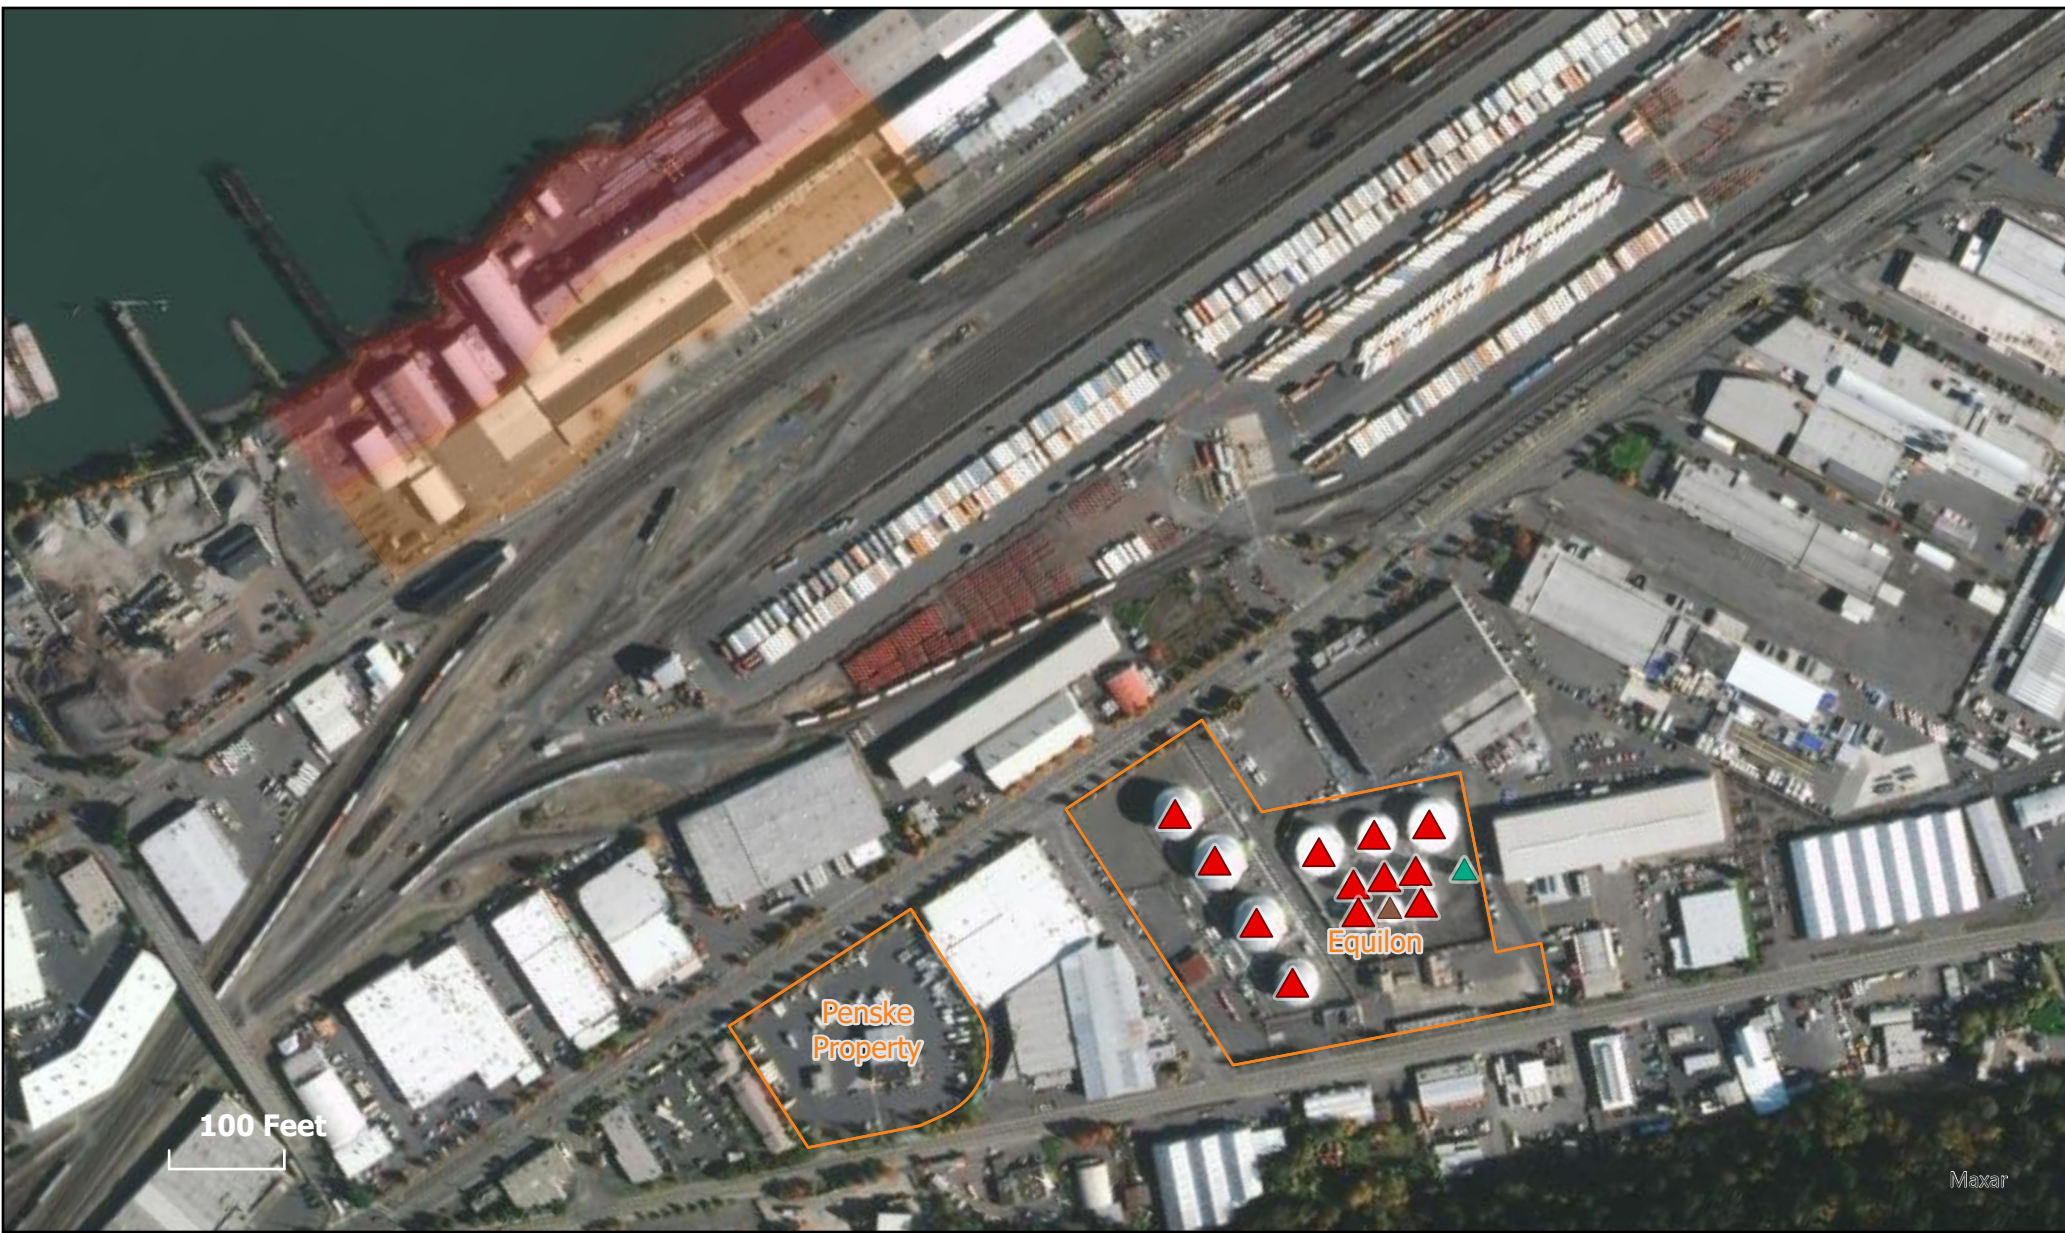
**FIGURE 2E  
EQUILON**

**Tank Release**

- ▲ Flammable and Hazardous
- ▲ Empty or Out of Service
- ▲ Tank Failure, not Flammable and not Hazardous
- Taxlot Boundary
