**Report of
Geotechnical Investigation
ODOT Skyline Storage Shed
Tax Lot 2500, NW Cornelius Pass Road
Portland, Oregon**

CGT Project Number G2005344

September 28, 2020

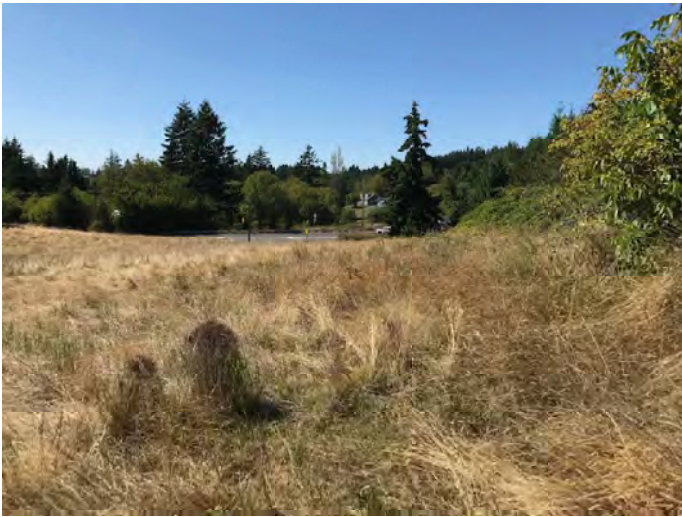
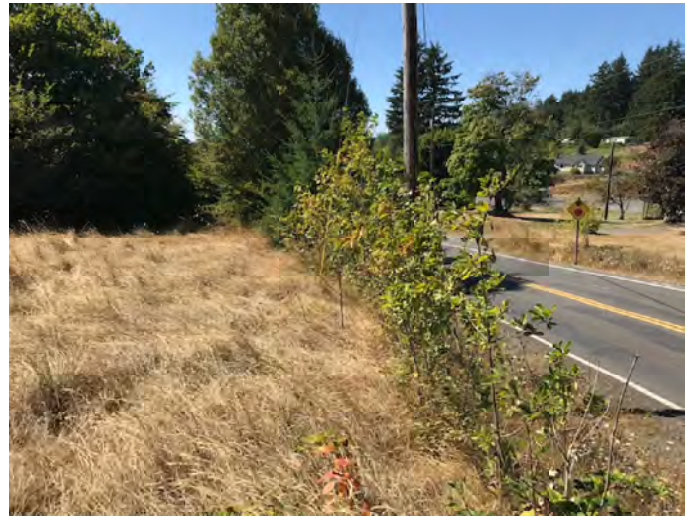
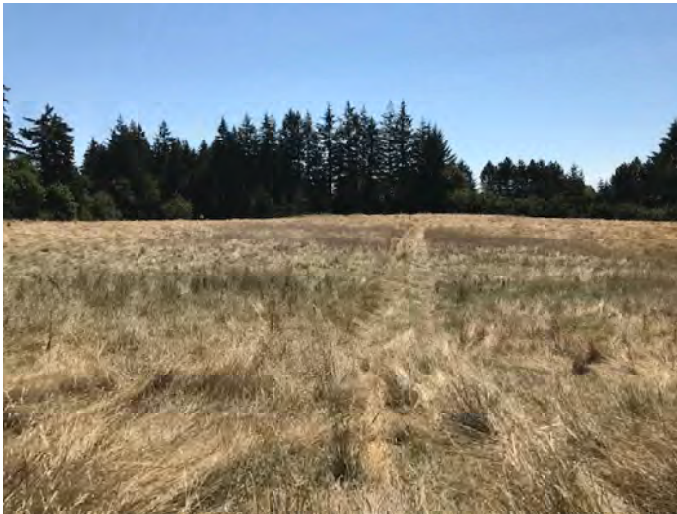
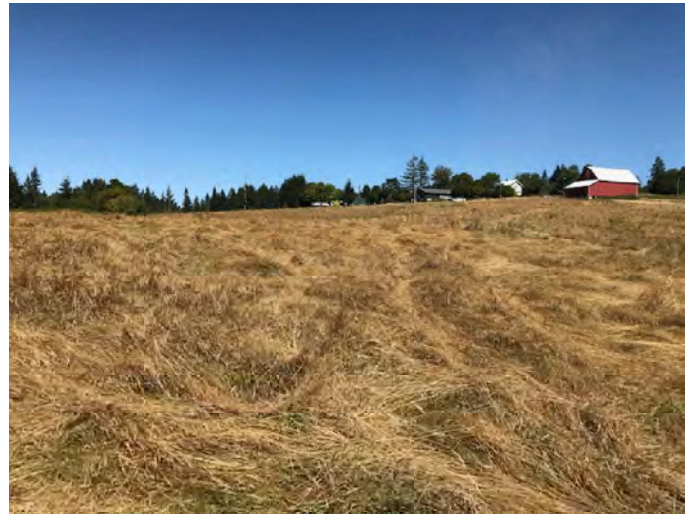
See Figure 2 for approximate photograph locations and directions. Photographs were taken at the time of our fieldwork.

The project site is bordered by NW Skyline Boulevard to the northeast, NW Cornelius Pass Road to the southwest, and undeveloped grass land to the southeast. The vacant site is vegetated by tall grasses and scattered trees to the north and south ends of the site. In terms of topography, the site gently descended to the west at a gradient of approximately 10 horizontal to 1 vertical (10H:1V). Site layout, topography, and surface conditions are shown on the attached Site Plan and Site Photographs, Figures 2 and 3, respectively.

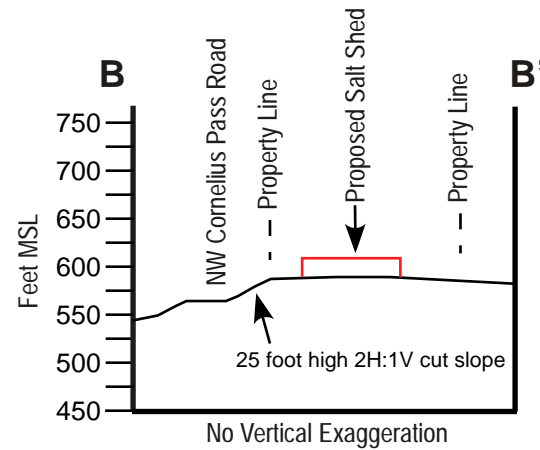
Topographic Profiles

Note: Existing topography from Figure C8

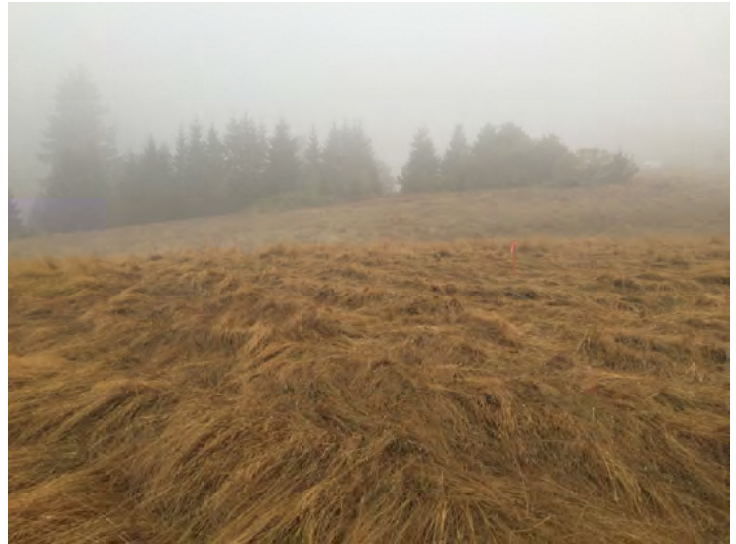
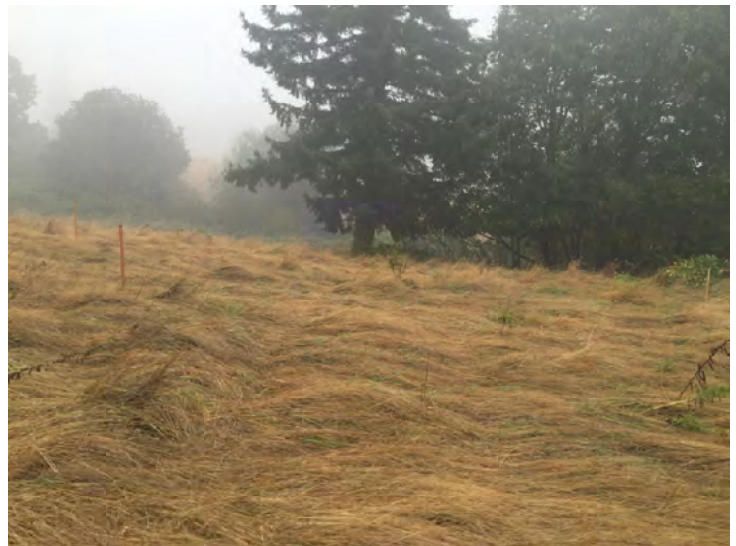
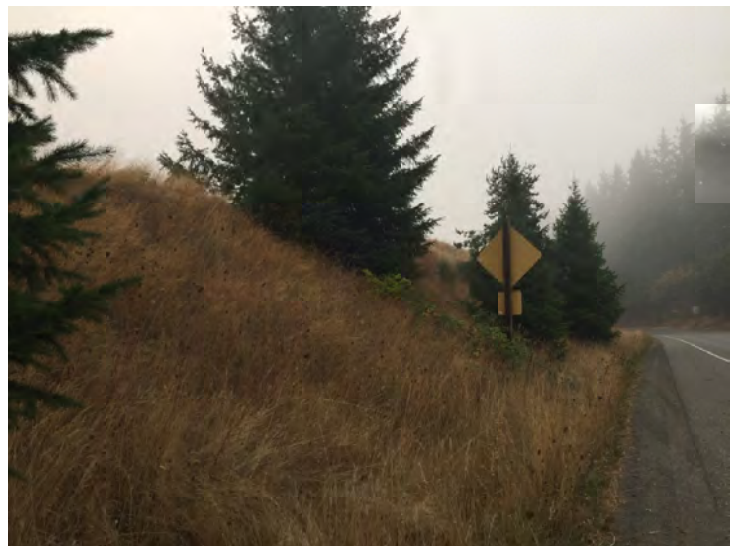
See Figure C8 for approximate photograph locations and directions. Photographs were taken at the time of the site reconnaissance.

South of the cut slope, the site generally descended gently to the west at gradients up to about 9H:1V. The majority of the site was vegetated with grasses (Figure C10, Photograph 1). No signs of slope instability or erosion were noted on the site.

West of the western property boundary, the topography descended to the west at a generally even gradient of 2H:1V. This slope (Figure C10, Photograph 3) was up to about 25 feet in height, and consisted of a cut slope associated with grading for NW Cornelius Pass Road. This slope was vegetated with grasses and scattered coniferous trees. Basalt bedrock was exposed at the base of the cut slope, as indicated on Figure C8. No signs of instability were noted on this cut slope.
