Corridor 8: 238th Dr

SANDY BLVD TO ARATA RD

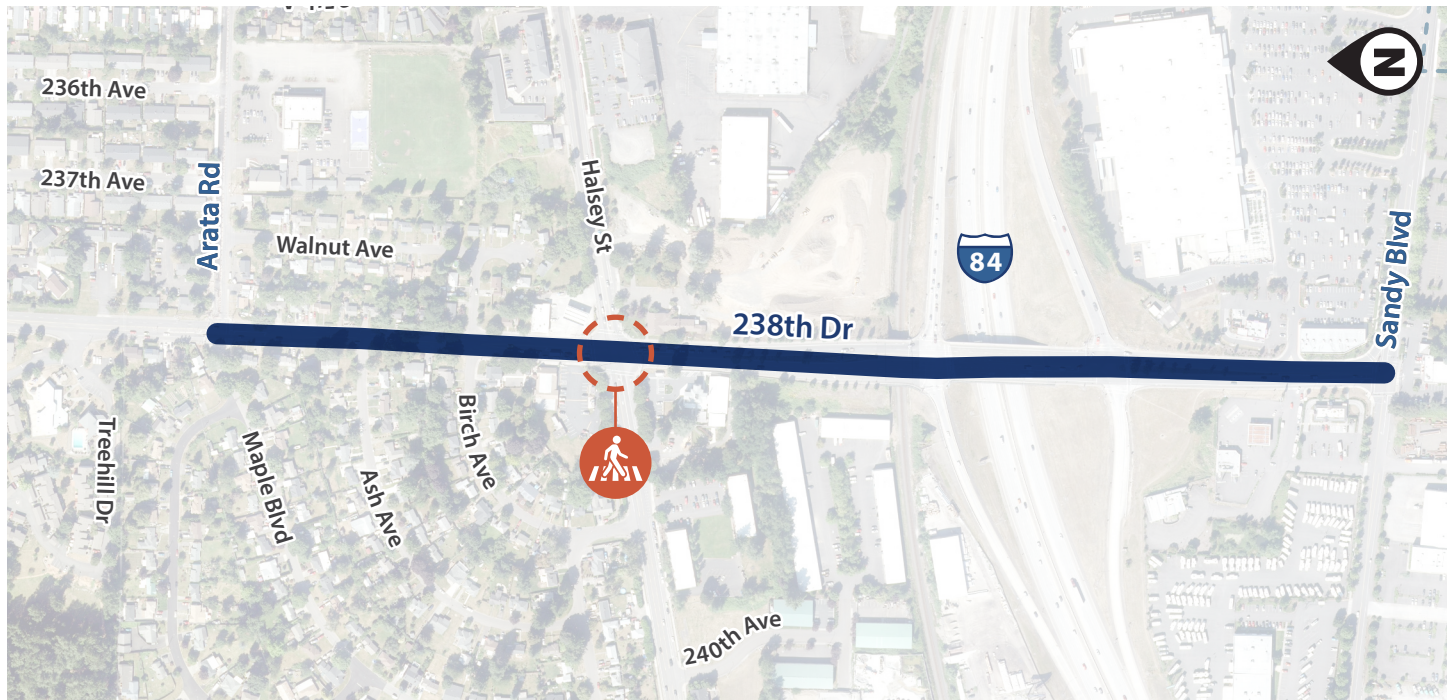
Corridor-wide Safety Concerns	Corridor-Wide Safety Recommendations	Site Specific Recommendations
Speeding	  Lower speed limit	  High visibility crosswalks
Indistinct bike lane crossings	  Bicycle conflict striping	
Speeding	  Speed feedback signs	
Inconsistent roadway cross section	  Roadway reconfiguration	
Uncomfortable bike lanes	  Separated/protected bicycle lane	
Signalized intersection conflicts	  See summary of safety improvement options for signalized intersections
