19114 NW Sauvie Island Road – The Property

Accessory Use Determination (Type II Land Use Permit) – The explanation and the solution

Variance – (Type III Land Use Permit) – The explanation and the solution

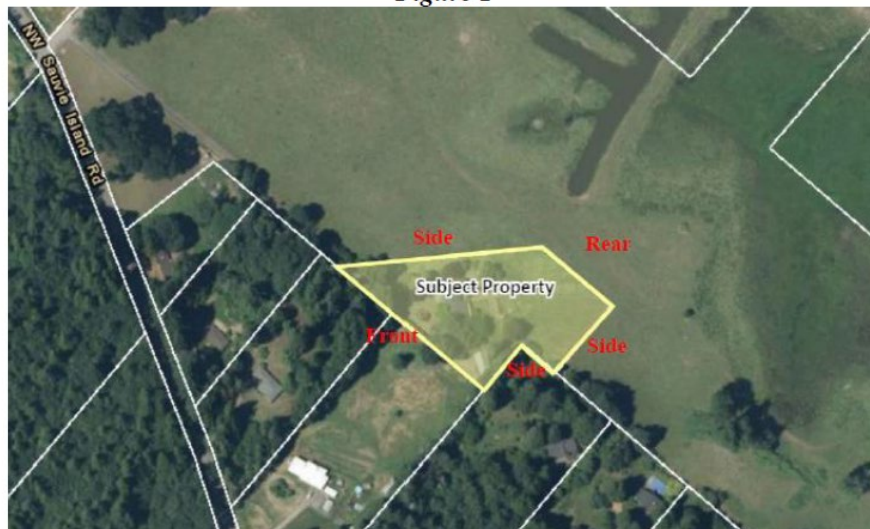
Figure 1

All parts of MCC 39.8215 have been considered in the following. A: The property has a unique size, shape, and location. The property sits behind a row of long rectangular lots that are located on NW Sauvie Island Road. See figure 1 above. All houses in the area are at least 164 feet away from the studio/shed. The property at 19014 NW Sauvie Island Road can see the studio/shed from their house, but it sits 372 feet away. Trees cover the view of the structure for all other neighbors. Because of the seclusion of the lot and the neighbors around them, their lot is unique, and permission should be given to leave the studio/shed where it is. B. Vanessa and Grant did not build this structure but bought this property in June of 2023 where the structure was already built within the setback. The seller did not disclose that the location of the structure was a problem with the county. They are now going through the process to fix a mess they did not create. C. Removing the building would take money and resources that would impose an unnecessary hardship of money, time and resources. D. Considering how far away the homes around the property are, authorization of the variance will not be materially detrimental to the public welfare or injurious to property in the vicinity. With the base zone being MUA-20, it should not affect the development of adjoining properties. E. The Variance requested is the minimum necessary.
