Corridor 10: Stark St

257TH DR TO TROUTDALE

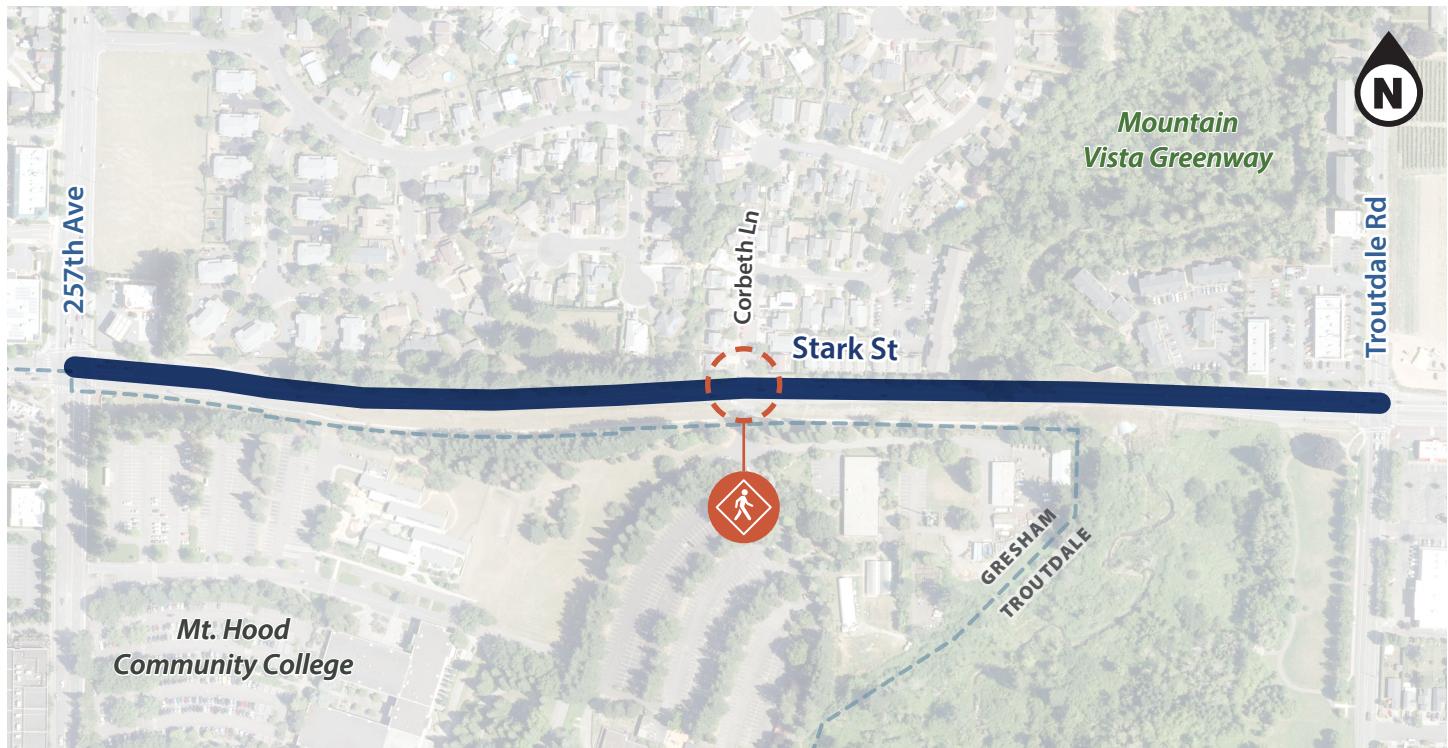
Stark Street carries about 12,000 vehicles per day between 257th Drive and Troutdale Road, with a posted speed limit of 40 mph. The current design standard, if applied, would widen the roadway, leading to more traffic and faster driving. There are gaps in the sidewalk network, including a narrow culvert crossing where people walk on gravel across a bridge with no separation from traffic. Long distances between marked or enhanced pedestrian crossings increase risk for people walking. The bike network is incomplete, and existing bike lanes lack protection or separation from traffic. This corridor is located on the boundary of Gresham and Troutdale and is partially managed by both City of Gresham and Multnomah County.

Corridor-wide Safety Concerns

Current design standard, if applied, would widen the roadway and likely induce demand and encourage higher speeds

Sidewalk facility gaps- people are walking on gravel across narrow bridge

Bicycle facility gaps and lack of protection/separation

Signalized intersection conflicts
