## **Stark St**

## 257TH DR TO TROUTDALE

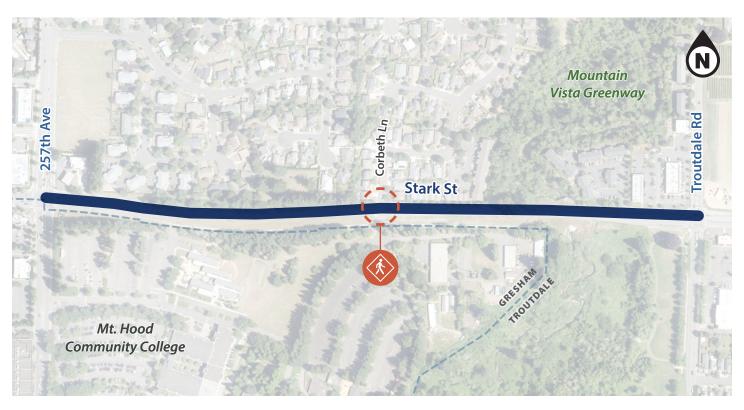
Corridor-wide Safety Concerns		Safety Improvement Options
Current design standard, if applied, would widen the roadway and likely induce demand and encourage higher speeds	*	Two-way left turn lanes
Sidewalk facility gaps- people are walking on gravel across narrow bridge	Ż.	Sidewalk
Bicycle facility gaps and lack of protection/separation	(§\$\)	Separated/protected bicycle lane
Signalized intersection conflicts		See summary of safety improvement options for signalized intersections (on separate page)

The current design standard, if applied, would widen the roadway, leading to more traffic and faster driving. There are gaps in the sidewalk network, including a narrow culvert crossing where people walk on gravel across a bridge with no separation from traffic. Long distances between marked or enhanced pedestrian crossings increase risk for people walking. The bike network is incomplete, and existing bike lanes lack protection or separation from traffic.
