## MEMORANDUM

RE: Rebuttal to Exhibit S.29, 'Response to Testimony Related to Stormwater and Groundwater'

## #T3-2022-16220: Response to S.29 (Hart)

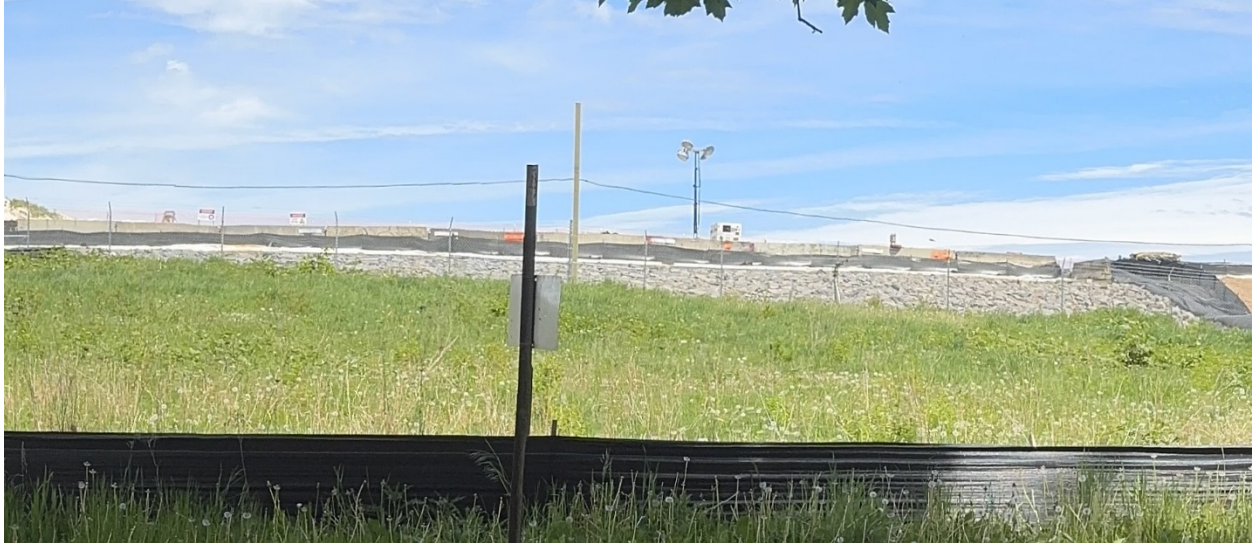
Water flowing through random rocks will not concentrate flow as it is seen. Gravity and topography will. The southeastern most outlet is approximately 6-7 feet lower in elevation according to Fig. 1 Ex. N 59. The downward slope can also be seen in the attached photo.

Water always flows to the lowest point. The entire outfall area below the flow spreader slopes toward the southeastern outlet channel, with a noticeable topographical depression running south across the slope, effectively acting as a collection ditch.

No matter how perfectly riprap is placed, it cannot stop water from flowing downhill—so it's illogical to suggest that a random, accidental rock placement is somehow concentrating the flow. The real forces at work are gravity and topography.

PWB acknowledges this in their own statement: “The issue was identified and remedied with submersible pumps.” Submersible pumps are only needed in low areas where water collects—areas that shouldn't exist if the flow spreader design were functioning correctly. Yet PWB's own topographic maps show one end of the discharge area is significantly lower than the other. This is a basic topographical issue that cannot be solved with riprap or vegetation. Without major regrading of the outfall area and the adjacent SEC, water from this concentrated flow that is greater than the PWB engineers' assumed, more than the flow spreader will handle and far greater than the pre-development flows will continue to follow its natural path, inevitably leading to erosion and the formation of a channel.
